## APPENDIX 4: RIGHT OF WAY REPORT

<b>Title:</b> Photographic Log – Right of Way	<b>Client:</b> Sakhalin-2 Phase 2 Lenders
<b>Site:</b> Sakhalin Energy Investment Company	<b>Date:</b> September 2017

## ROW FROM CHAIVO LANDFALL TO OPF

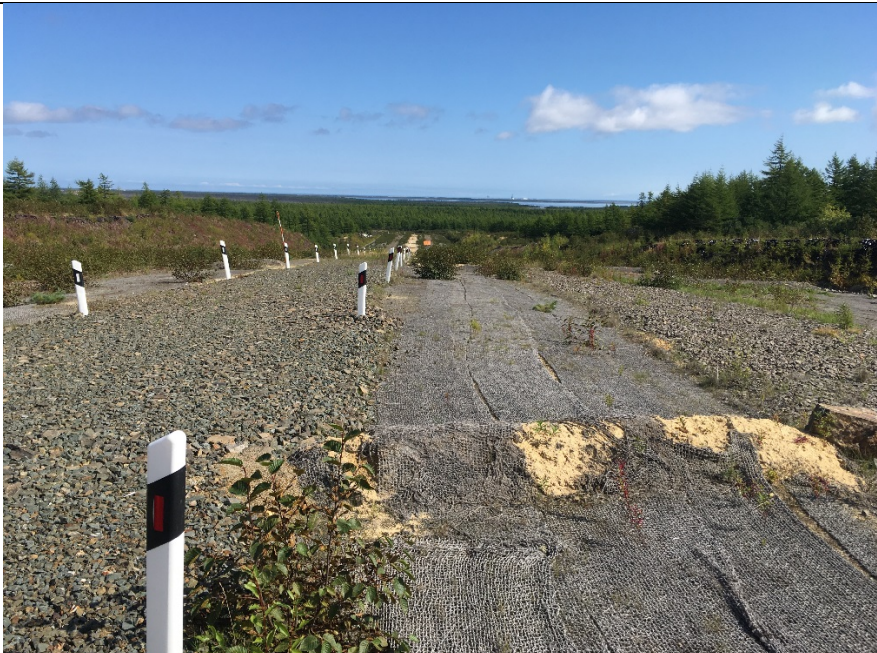
The crossing has a number of detailed engineering design features to reduce the risk of seismic movements causing damage to the two pipelines. At the surface, the soil is quite sandy and only very sporadic vegetation and grass has established despite seeding. However, no signs of erosion were evident and erosion protection features such as slope breakers and geojute matting has been installed in part of the section (Photo 1).

**Photo 1.** View downslope to the east from the top of the low hill, with Piltun Bay in the distance.

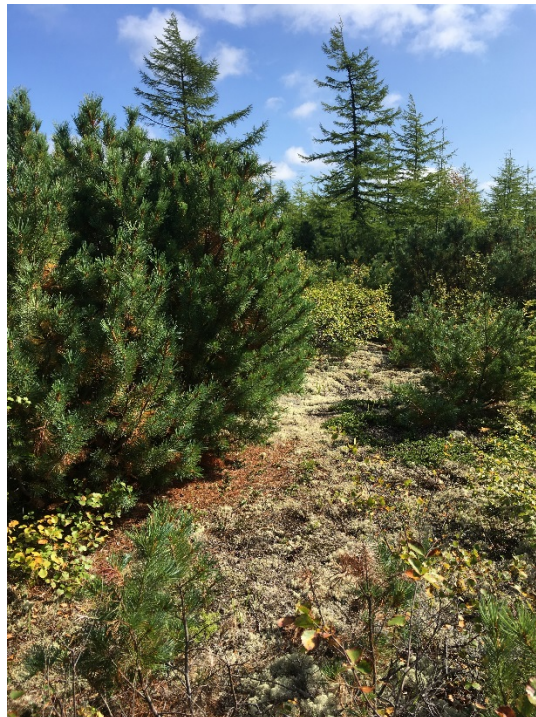
**Photo 2.** Sparse forest vegetation adjacent to RoW

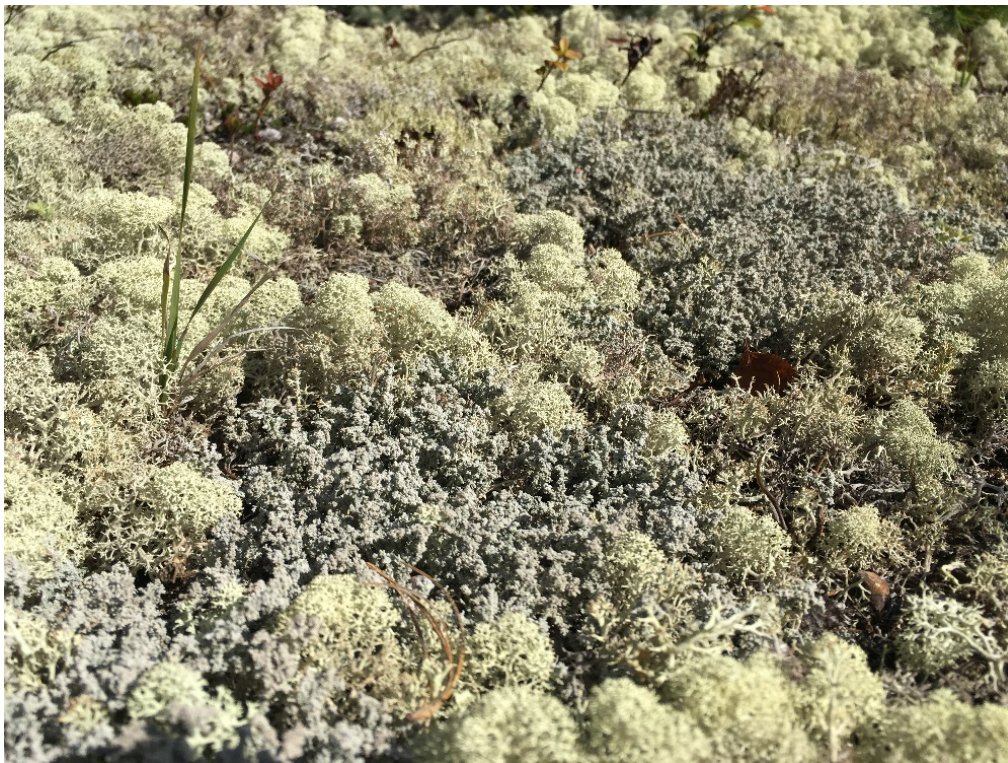
The slow establishment of vegetation may be attributable to the sandy nature of the soil and a probable low nutrient status, combined with the harsh climate. It is likely that any topsoil previously present was mixed with sub-soil. An indication of the difficulty of establishing a natural vegetation can be gained from inspection of the vegetation adjacent to the RoW. The forest is quite sparse in this area and the forest floor comprises a mixture of low woody shrubs, interspersed with mats of lichen mats and what appear to be biogenic crusts. Biogenic crusts are typically a few millimetres thick where the soil surface held together by combinations of microphytic communities such as mosses, lichens, soil algae, bacteria and fungi (Photos 2 and 3). These vegetation types are very fragile and easily damaged but play an important role in reducing erosion from wind and water. They can also take a long time to re-establish post disturbance. It is unlikely that there is much that Sakhalin Energy can do to speed up the natural regeneration of these natural vegetation types.

**Photo 3.** Close-up of forest floor vegetation adjacent to RoW (field layer), showing lichen mat

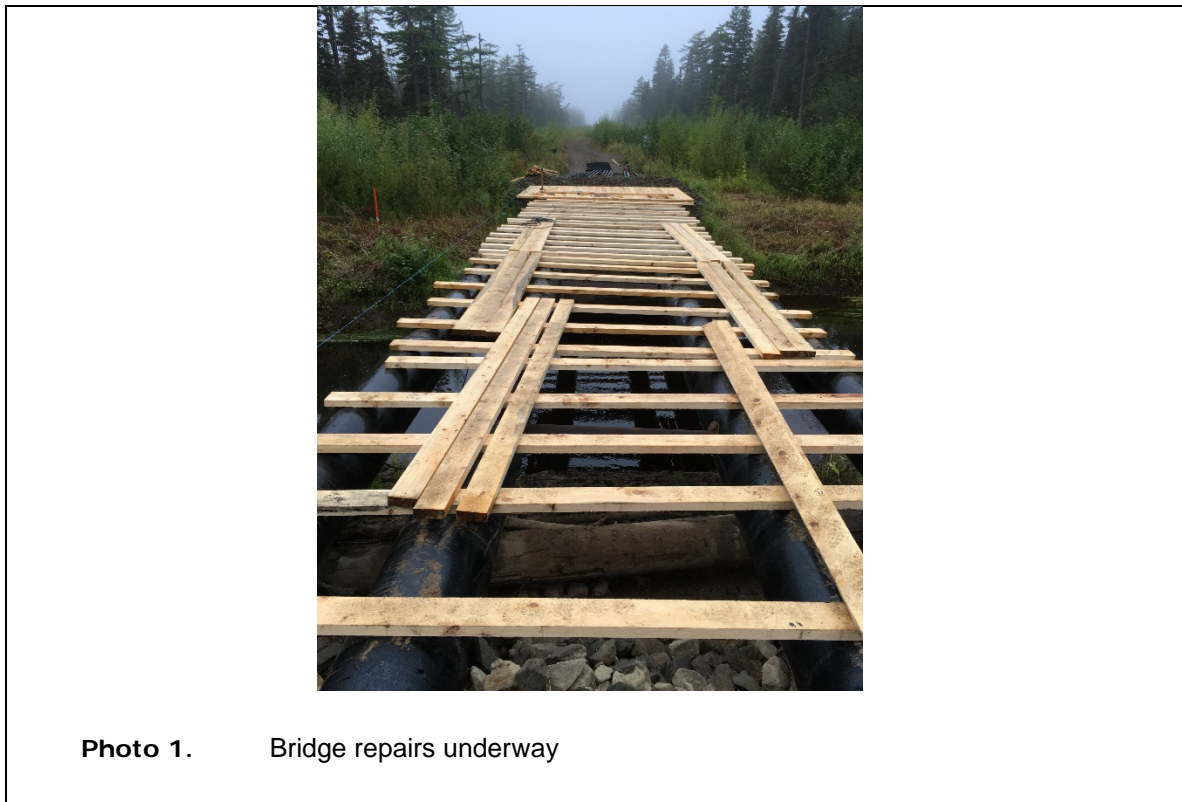
A brief visit was made to inspect the bridge repairs at KP154. Steel supporting structures are routinely used by Sakhalin Energy for maintaining river crossings for access tracks within the RoW. The steel supports are decked with timber, which require routine replacing once they become decayed or damaged.

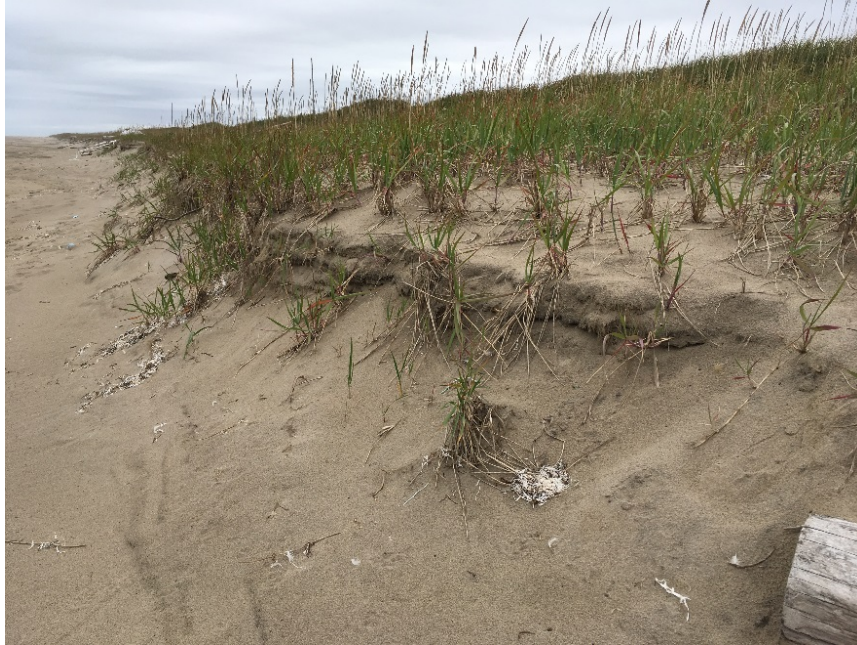
The RoW vegetation has been damaged in this vicinity by fishermen driving from the beach landed facility access road to an illegal camp located to the south. An abandoned fisherman camp is also located immediately adjacent to the RoW, and the remains of temporary shelter, rubbish and a tracked excavator are present. Better security and control of the beach access facility access road is required to prevent the damage caused by this induced access.

**Photo 1.** Beach Landfall showing re-established “yellow” dune vegetation and track created by illegal fishermen.

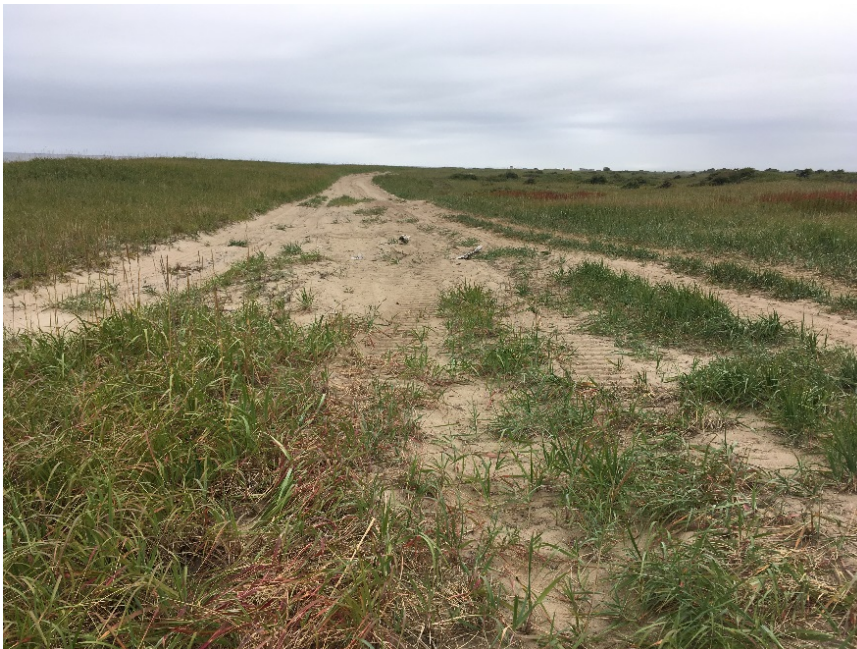
**Photo 2.** Beach Landfall showing re-established “yellow” dune vegetation and track created by illegal fishermen.

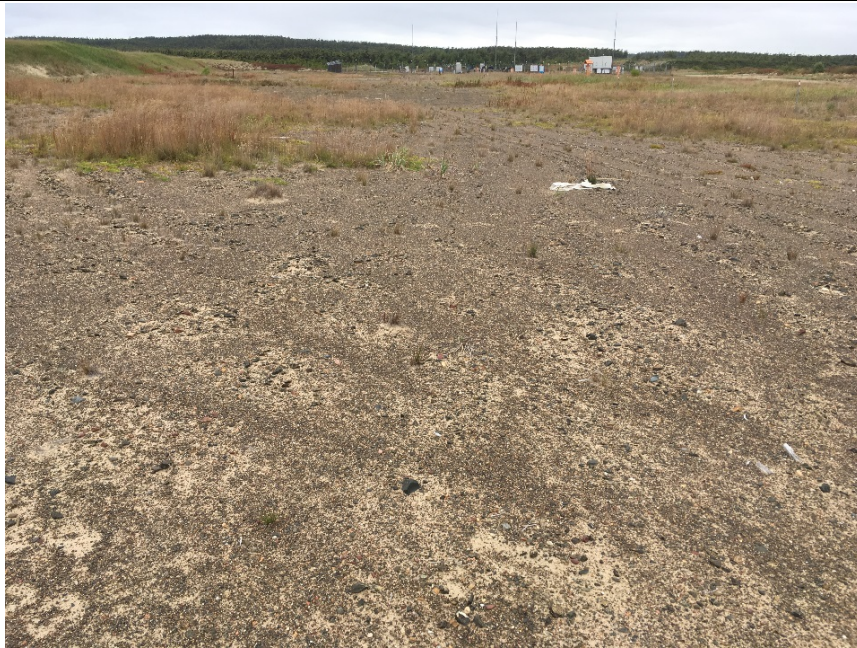
The “yellow” dune vegetation within the RoW has re-established well. Marram grass can spread quickly through rhizomal root growth and has indeed spread inland into the disturbed soils. However, the “grey” dune vegetation has not re-established within the RoW (Photo 3). It appears that the very fragile soil surface layer that would have contained the

small amount of organic matter and seed bank has been lost within the RoW. The grass species seeded in this area is struggling to establish given the very sandy sub-soil present. It is likely that further specialist intervention will be required to restore the vegetation in this area, including the collection of seed and growing of plants in nurseries for transplantation.

**Photo 3.** RoW between landfall and first block station showing lack of dune vegetation

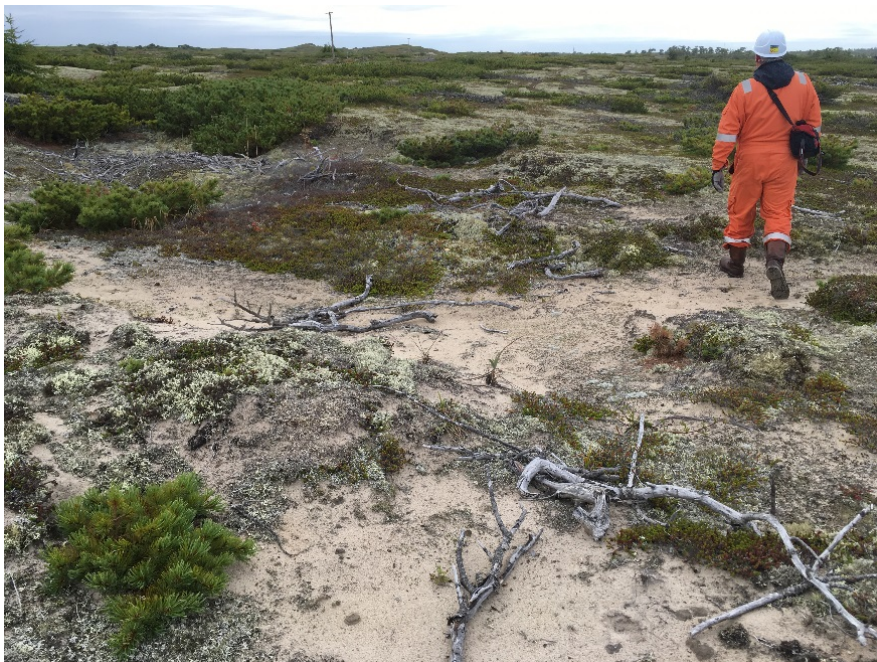
**Photo 4.** Mature "grey" dune vegetation adjacent to RoW.

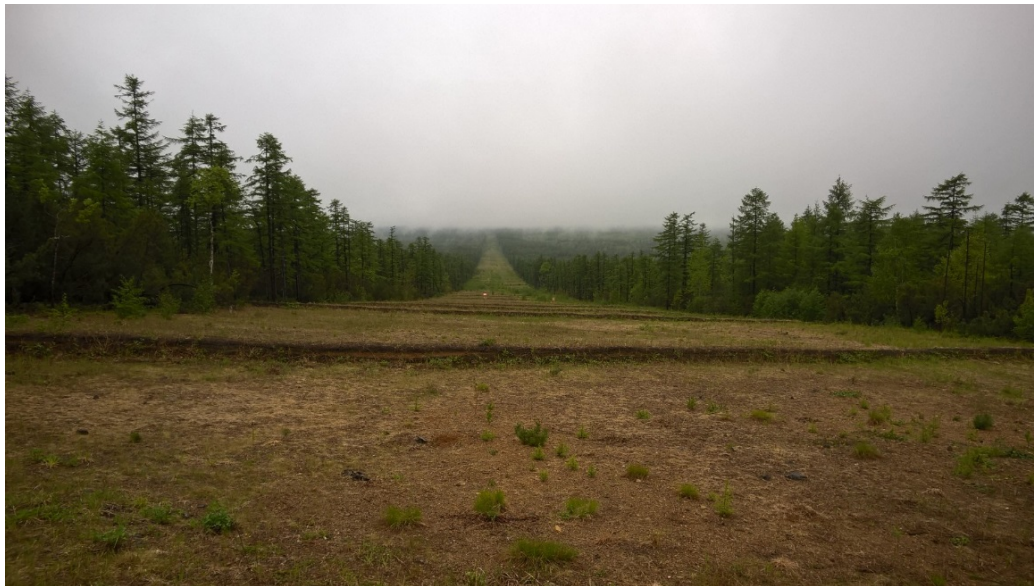
**Photo 1.** June 2016

The sandy slopes have shown a large improvement in vegetation cover since June 2016 (compare Photos 1 and 2). The sown seed mixture of grass and legumes has established well, probably assisted by the legume’s ability to fix nitrogen into the naturally low-nutrient soil. The vegetation within the RoW will assist in the prevention of soil erosion, but does not match the naturally occurring forest floor vegetation present either side of the RoW (Photo 3). This in part is likely to be due to the loss or mixing of the very shallow topsoil along with its seedbank during construction. It may take decades for a more authentic forest floor vegetation to restore within the RoW as the soil profile matures and seeds spread from its edges.

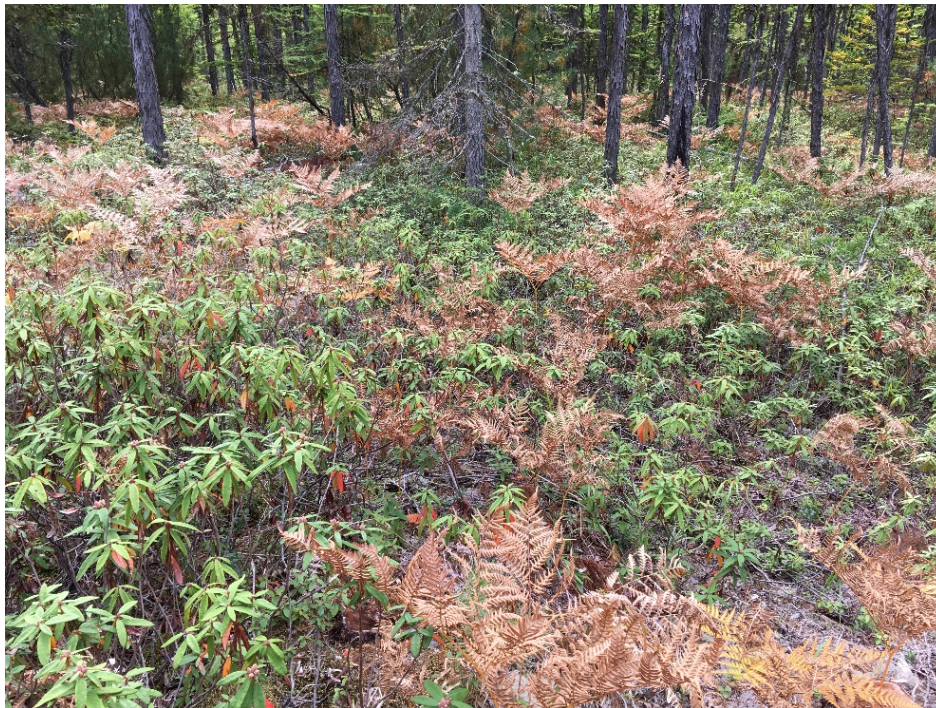
**Photo 3.** Forest floor vegetation adjacent to RoW

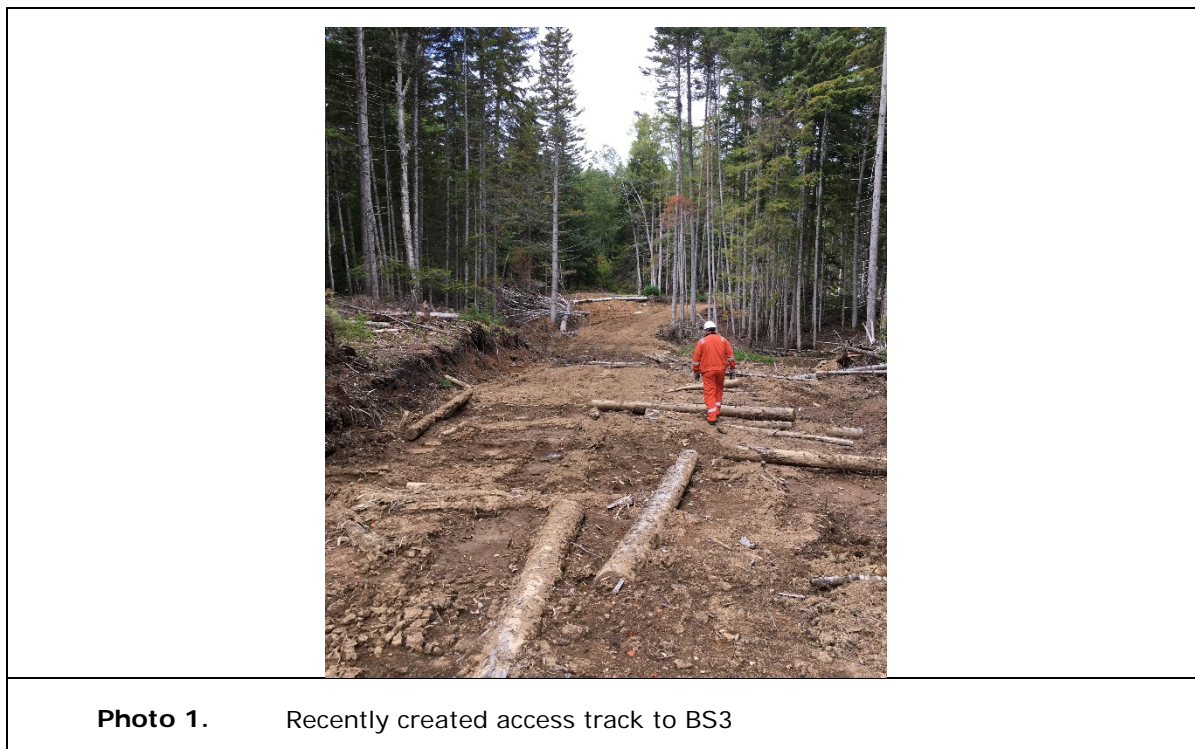
A visit to the proposed site of BS3 was made during the RoW inspection. A new access track has been cleared through the forest from the RoW to the proposed site (Photo 1). The track has not been reinforced with hardcore and comprises loose soil, limiting vehicular access to the proposed site. The track crosses a number of small streams that have not been culverted under the track at the current time.

**Photo 1.** Recently created access track to BS3

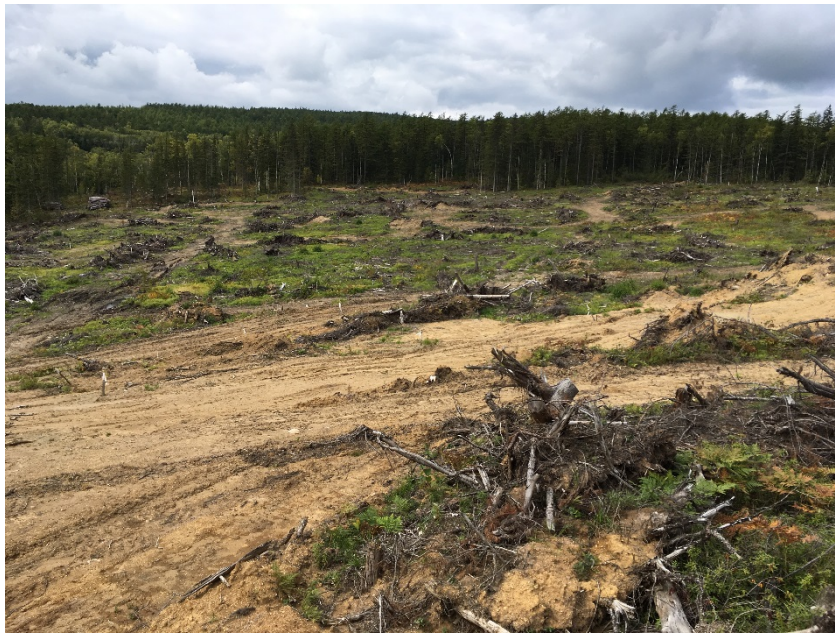
The tree cover on the proposed site of BS3 has also been felled, with the resulting timber currently stacked on-site. The cleared area still has tree stumps in-situ and currently retains forest floor vegetation cover in patches across the area (Photo 2). However, vehicle movements and other forestry operations have removed the

**Photo 2.** View of the proposed site of BS3.

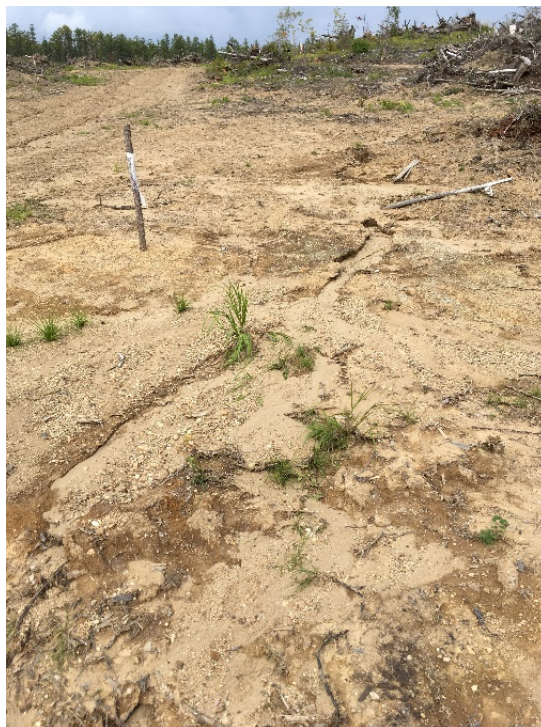
covering of vegetation in many areas, exposing bare soil. The proposed site of BS3 is located on a relatively steep slope and signs of soil erosion are already present (Photo 3). The run-off of sediments poses a significant risk to the adjacent retained forest habitats and nearby water courses unless a robust monitoring and control plan is instigated. This risk will be much higher during construction as the large site will require significant cut and fill of the hillside to create a level site.

**Photo 3.** Soil erosion taking place on cleared BS3 site

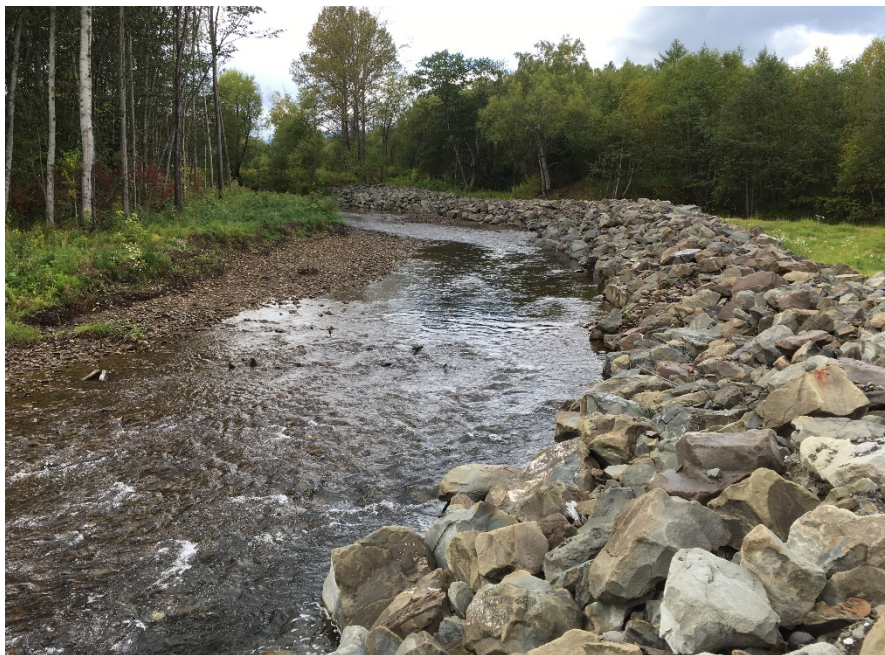
Stone rip-rap has been installed on one bank of the river that was suffering erosion (Photo 1). The rip-rap has been installed along the bank extending either side of the RoW to protect the full extent of the bankside vulnerable to erosion. Based on discussions with Sakhalin Energy, it is understood that the permitting process for works outside of the RoW is relatively complicated and requires a long-lead time. It is understood that river restoration works are completed during low-flow winter periods, outside of the salmon spawning season.

**Photo 1.** Stone rip-rap erosion protection

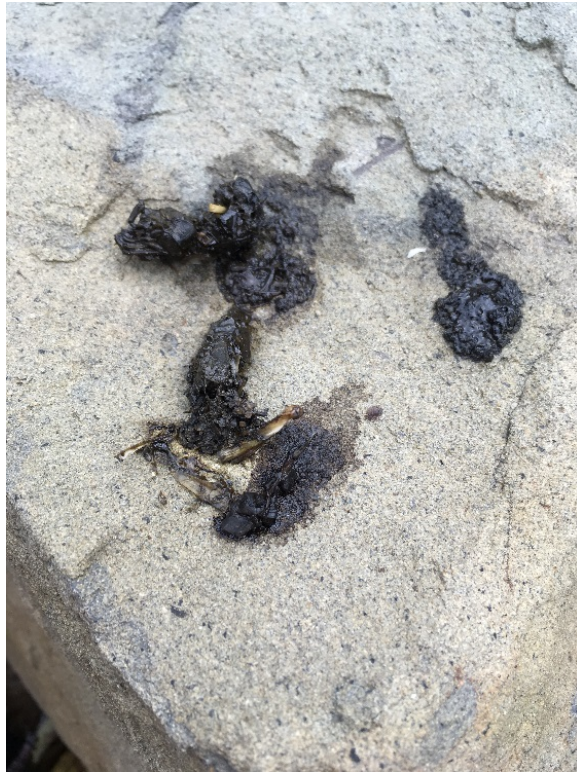
An otter spraint was observed on one of the installed rip-rap boulders (Photo 2). If large crevices are present within the rip-rap, they could be utilised by otters as holts.

**Photo 2.** Otter spraint on rock within the rip-rap

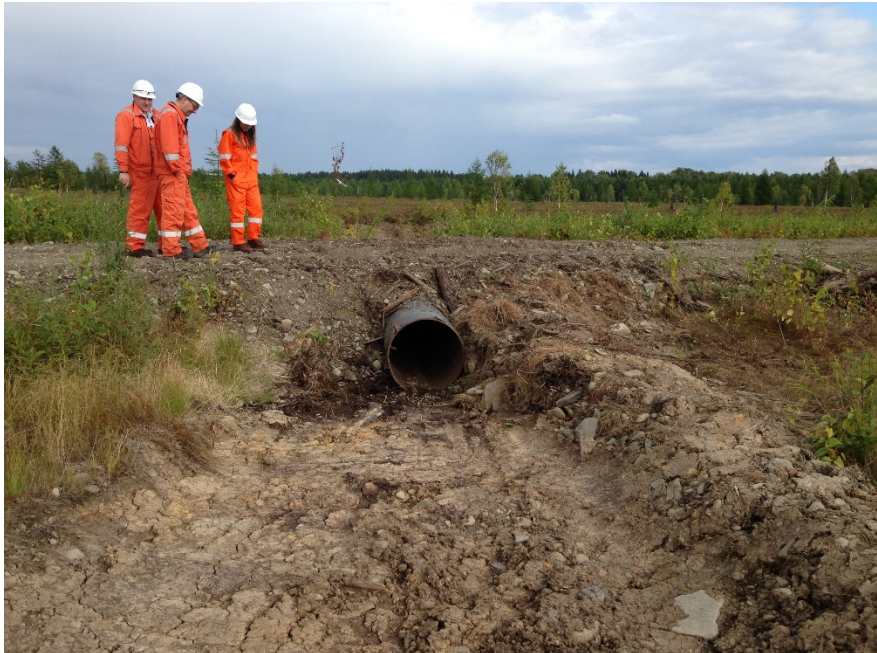
Since the last IEC monitoring visit in June 2016, additional culverts have been installed across the RoW as recommended in the previous monitoring visit report (Photo 1). In addition, shallow ditches and low bunds have been installed to assist water flow to and away from the culverts. Unfortunately, the monitoring visit took place in a period of low rainfall and no water was present to gauge the efficacy of the newly installed works.

**Photo 1.** Newly installed culvert

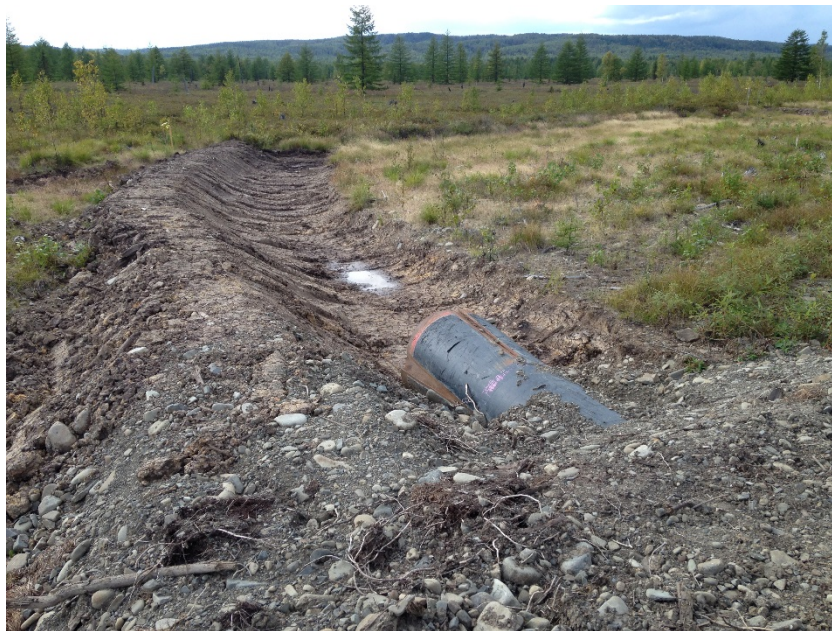
**Photo 2.** New culvert, low bund and shallow ditch

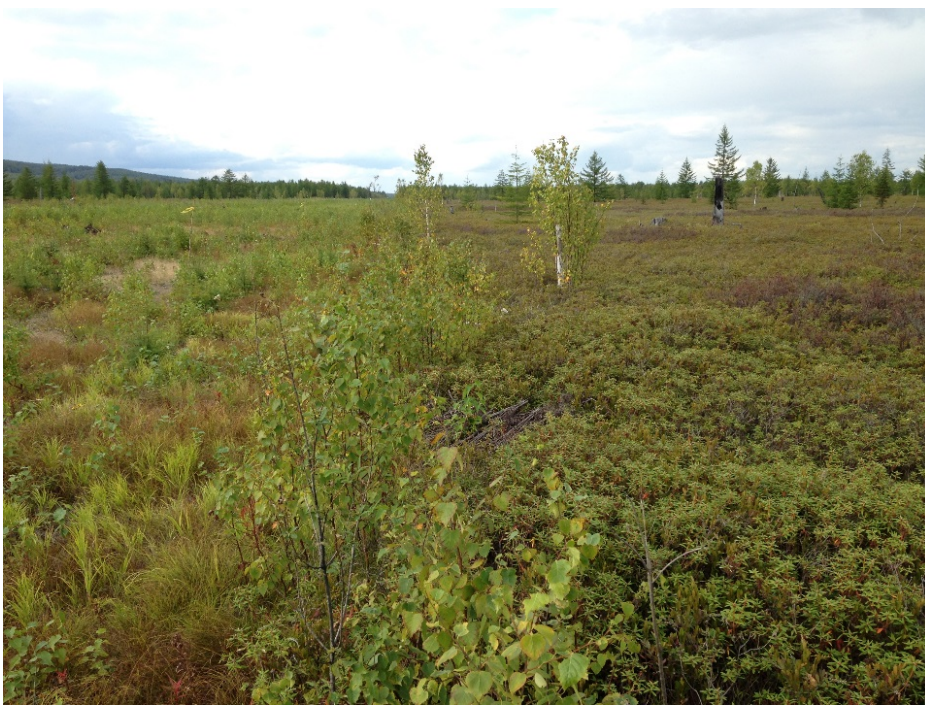
The vegetation within the RoW continues to develop and now provides adequate cover to protect from erosion. However, it is unlikely to develop wetland vegetation similar to a pre-construction condition for many decades. Photo 3 shows the strong contrast between the RoW and adjacent wetland vegetation. An investigation of the soil conditions between the two areas indicates the likely limiting factor, where the original wetland is supported by a deep layer of un-decomposed moss and peat soil (Photo 4). This organic soil has been lost from the RoW during the construction, which now comprises a mineral sub-soil with no organic layer (Photo 5). Whilst restoration to the original condition within the RoW, continued monitoring of the water levels in the wetlands either side of the RoW should continue to ensure that the tow remain hydrologically connected and that effective water movement continues to a level where neither side dries out. In the longng-term, this would lead to a drying and loss of peat soils and a potential change in vegetation over a much larger area.

**Photo 3.** RoW with good cover of vegetation (left), but contrasting with mature marshland vegetation (right).

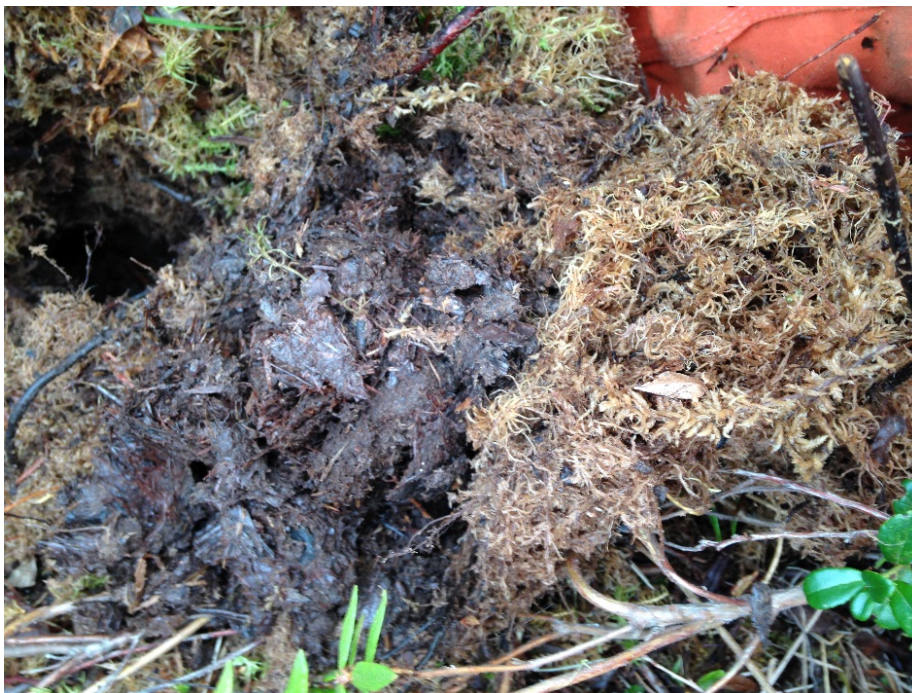
**Photo 4.** Un-decomposed moss and peat soil in mature wetland adjacent to RoW.

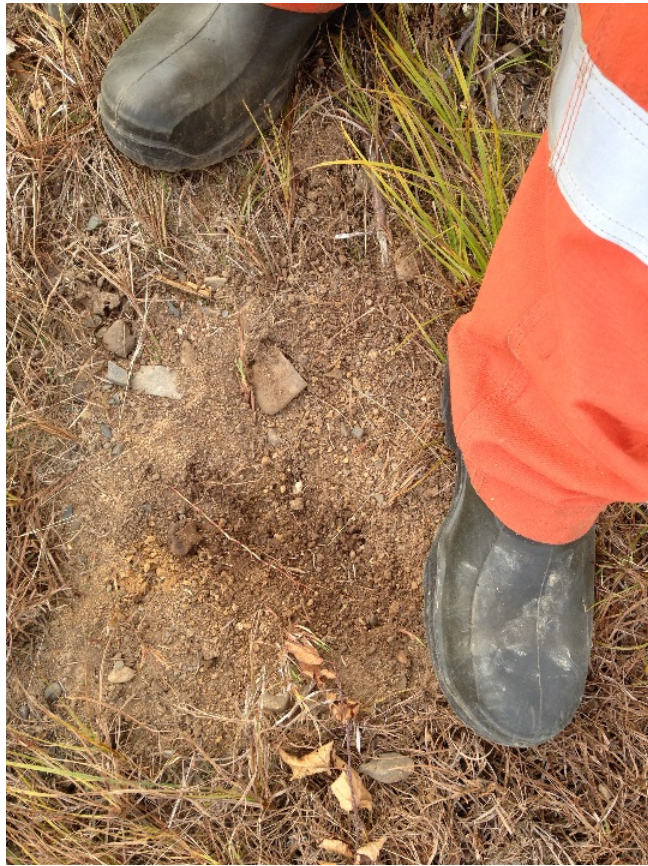
**Photo 5.** Soil surface within RoW – no surface organic peat layer

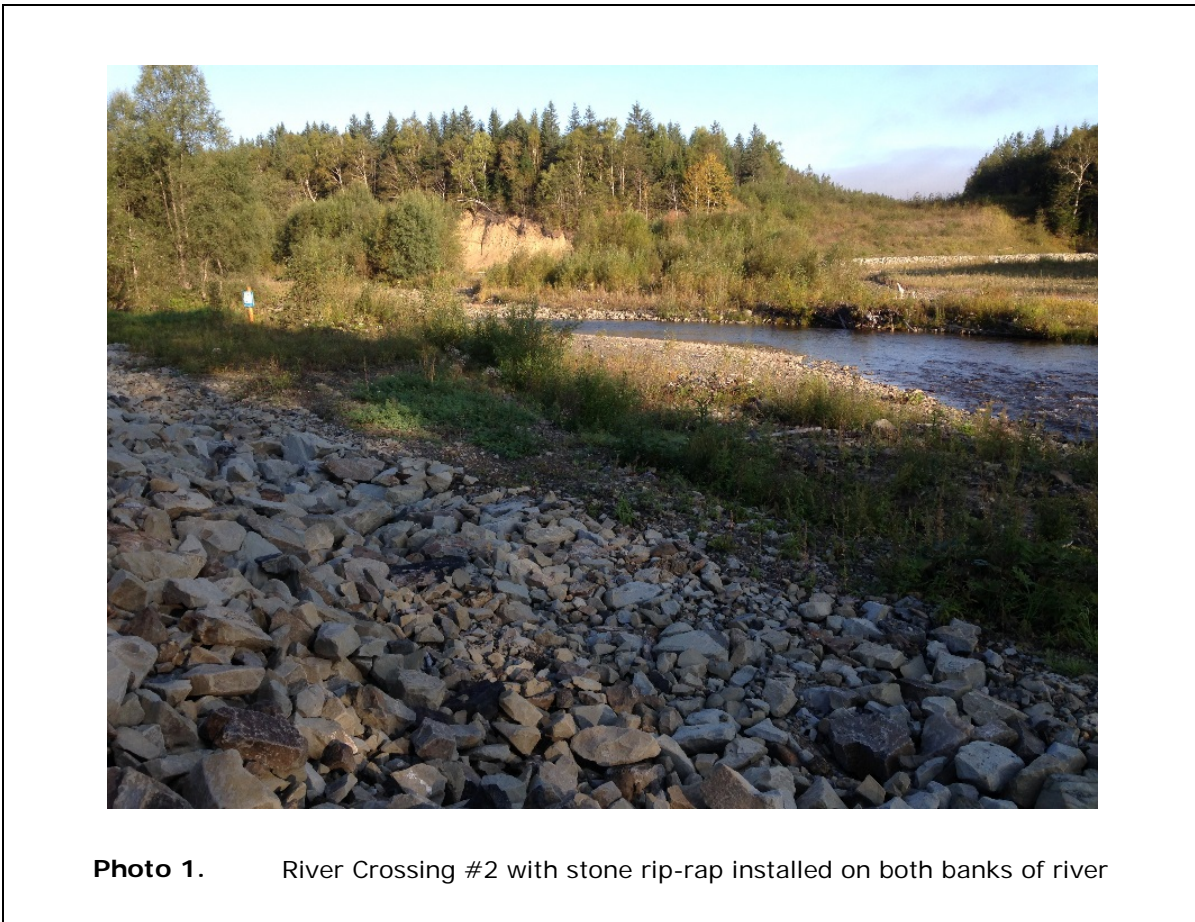
Stone rip-rap has been installed on both banks of River Corssing #2 as both were suffering erosion. In particular, the steep bank to the west of the RoW visible in Photo 1 was eroding, posing a risk of undermining the pipelines that are only buried to 1.5 metres deep at river crossing points. This has required installation of rip-rap beyond the RoW boundaries.

**Photo 1.** River Crossing #2 with stone rip-rap installed on both banks of river

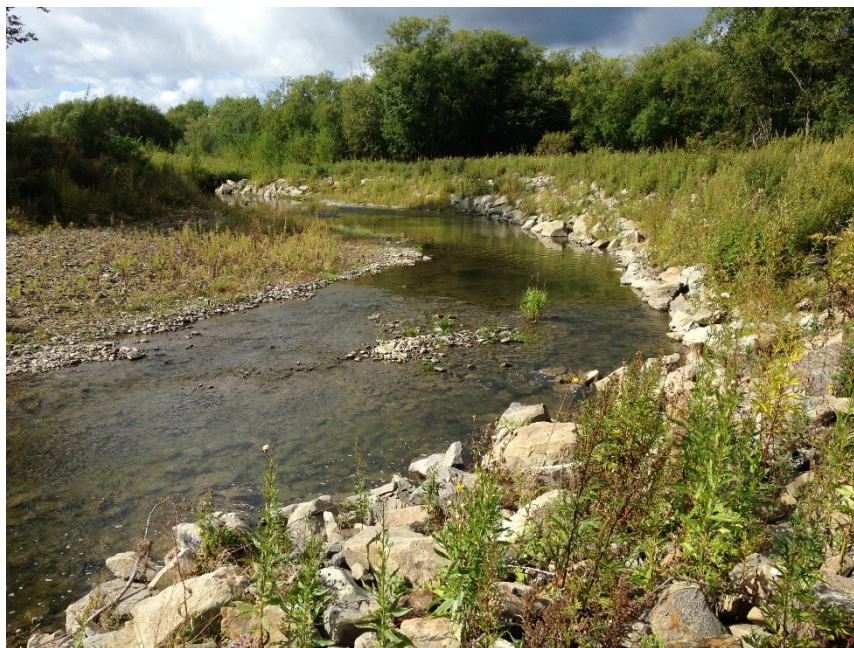
Where rip-rap was installed four years ago, the cracks between stones have become colonised by vegetation and have become much more natural in appearance (Photo 1). No signs of damage to the rip-rap was observed from high water flows.

**Photo 1.** Rock armour placed 4 years ago, showing good vegetation regrowth in cracks

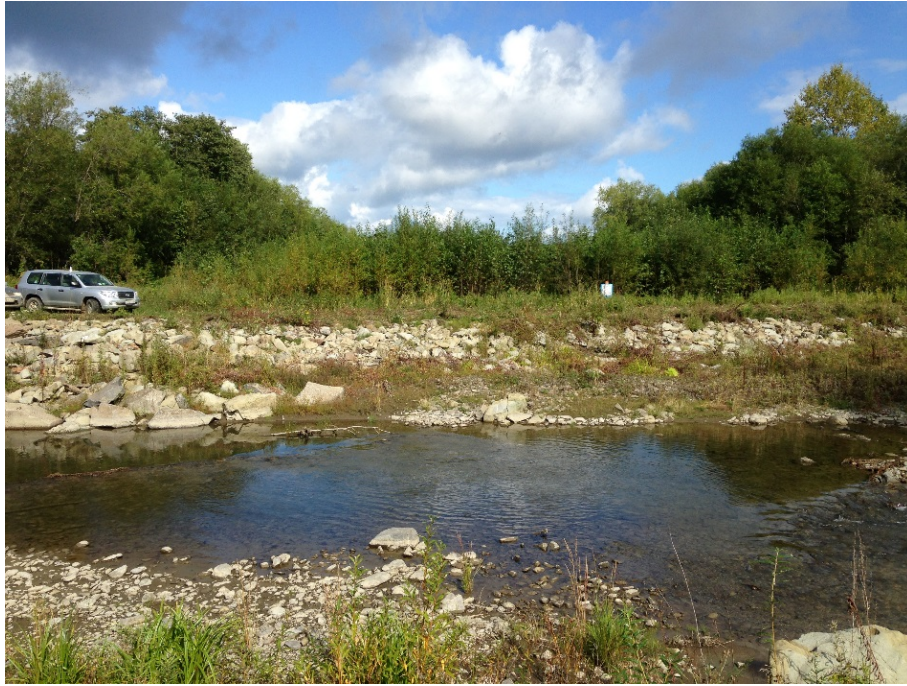
The multi-channel nature of the river, with its stone rip-rap banks, pose a challenge for access to the RoW tree cutting teams. One section inspected had recently been cut, although the section to the north of the River appears due for a cut (Photo 2).

**Photo 2.** Tree growth on RoW due for cutting

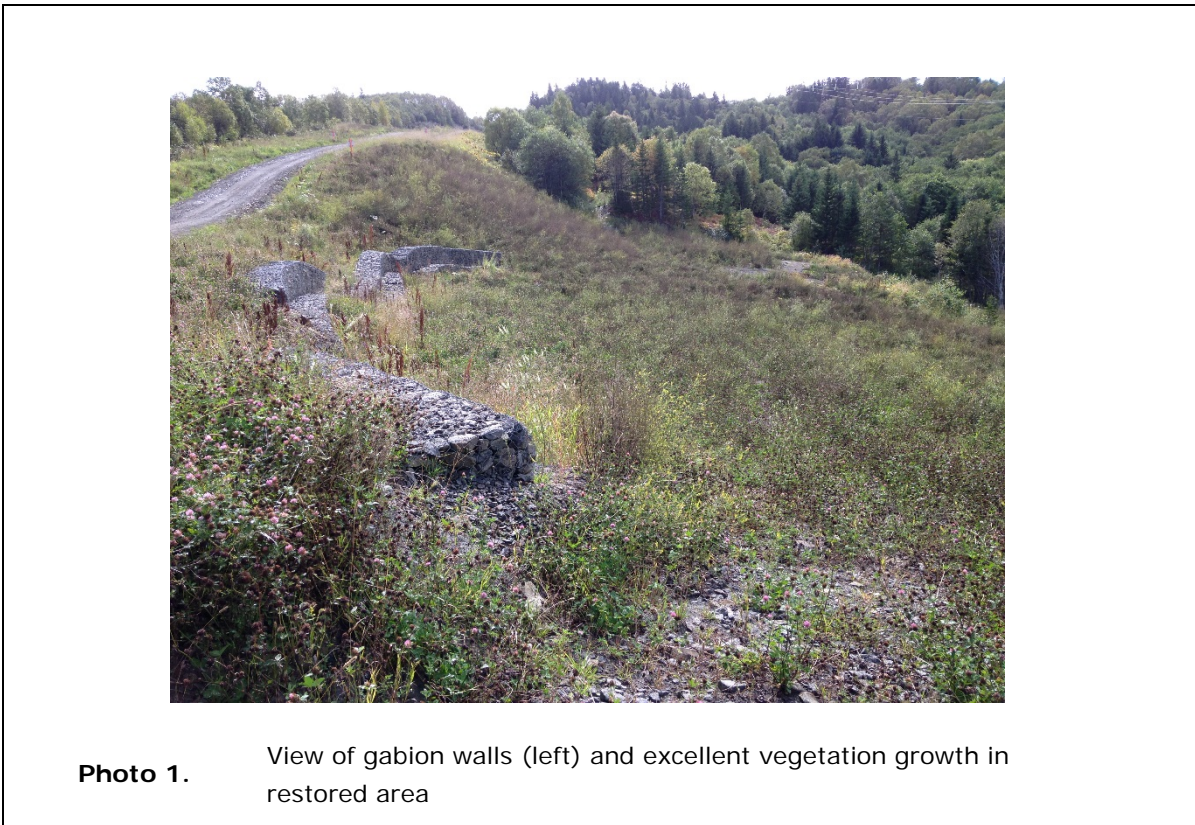
Repairs to this landslide were inspected. The repairs have included the installation of stone-filled gabion walls combined with an extensive network of drains to prevent the build-up of water. The replaced soil slope has been reseeded and has established very successfully (Photo 1). It is understood that Sakhalin Energy is undertaking a proactive monitoring approach to areas vulnerable to landslips to assess when pre-emptive works are required in an attempt to reduce landslides in the future, along with the need for significant engineering works to restore the damage.

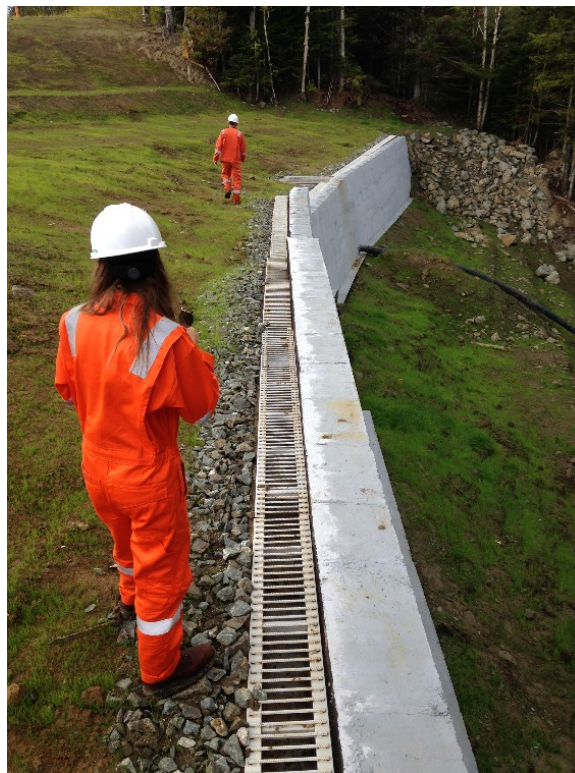
The landslide at this location presented significant engineering challenges to restore the slope. This has included re-enforced concrete piles to support a large retaining wall. Underground drains have been installed and water is collected at a central location and removed by a pipe lain over ground (Photo 1). The works have been completed recently, and the reseeded surface is still establishing itself.

**Photo 1.** View of reinforced concrete retaining wall, outflow drainage pipe and recently reseeded soil surface.

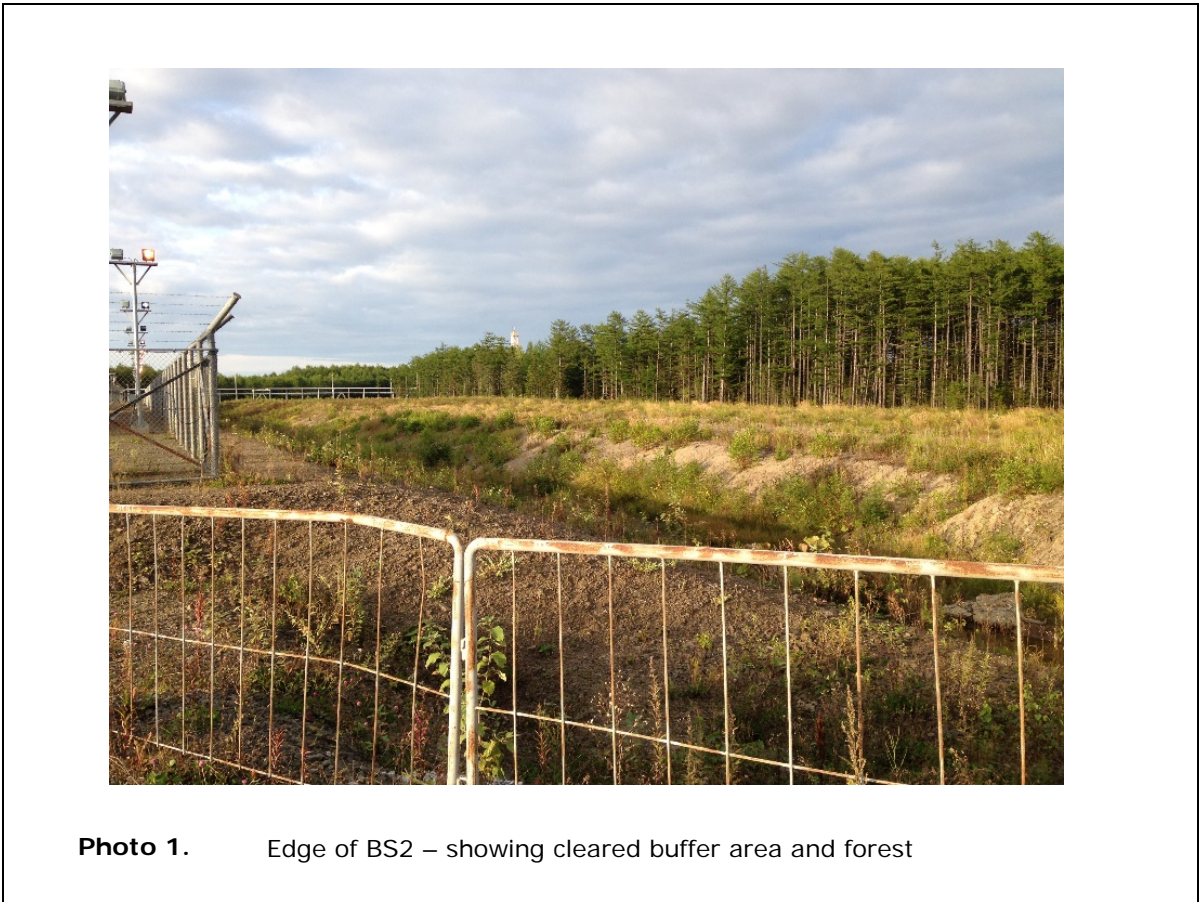
A very brief visit was made to BS2 during the RoW inspection. It is understood that as part of the Train 3 Project, additional plant will be installed within the existing footprint of the site. The BS2 site is situated within an area of previously cleared forest and it is understood that no additional tree clearance will be required for the main train 3 related works at BS2 (Photo 1).

**Photo 1.** Edge of BS2 – showing cleared buffer area and forest

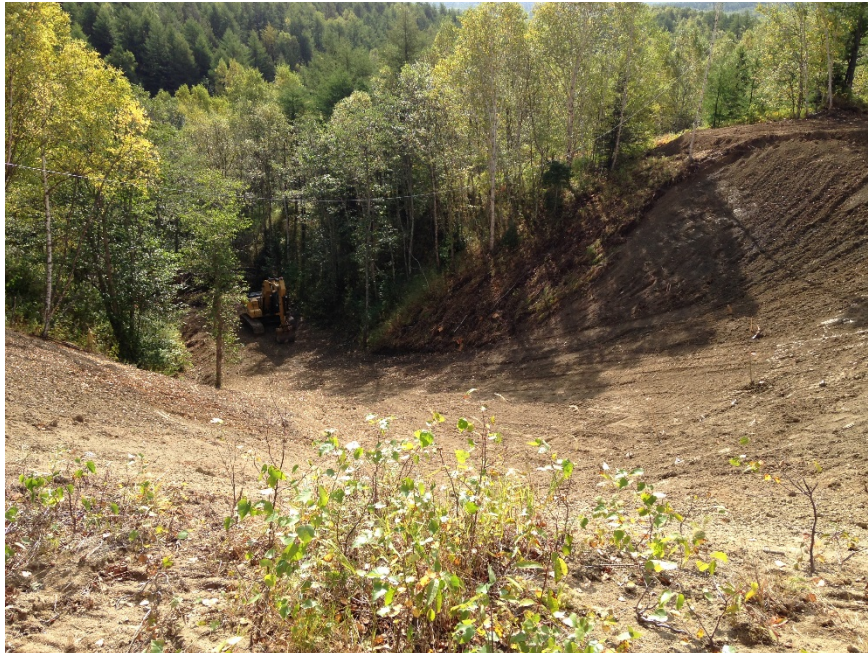
The landslide at KP420 is less severe than the previous two reported examples. This is an example of work being completed in attempt to pre-empt the situation worsening and requiring more extensive engineering solutions. It is understood that the situation at this loction has been exacerbated by a trench excavated by a third party along an adjacent cable right of way.

At the time of the visit, it is undertsood that the slope reprofiling at been completed (Photo 1) in preparation for the installation of surface netting and ground anchors. The area had yet to be reseeded due to ongoing construction.

**Photo 1.** Re-profiled slope – ready for installation of netting

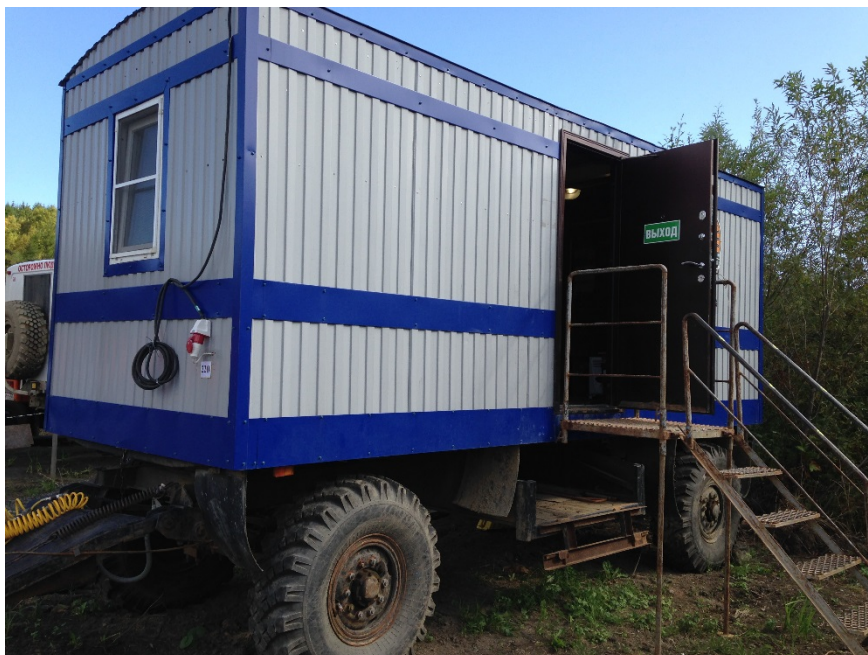
The temporary contractor construction campe was visited and very brief inspection completed (Photo 1). The temporary camp looked in good order and obvious signs of environmental management was evident including a generator with a spill trap installed, waste bins provided for collection of rubbish, as well as the collection of sewage and waste water for removal sewage collected in a tank for removal. One oversight observed was that the camp has been established on a pre-existing old lay-down area that had subsequently been used for fly tipping by third parties. This fly-tipped waste has been pushed to one side and incorporated into the fill brought in to establish the temporary camp. It is understood that Sakhalin Energy plans to remove and dispose of this waste when the camp is decommissioned following completion of the nearby construction works.

**Photo 2.** Construction contractor temporary work camp accommodation.

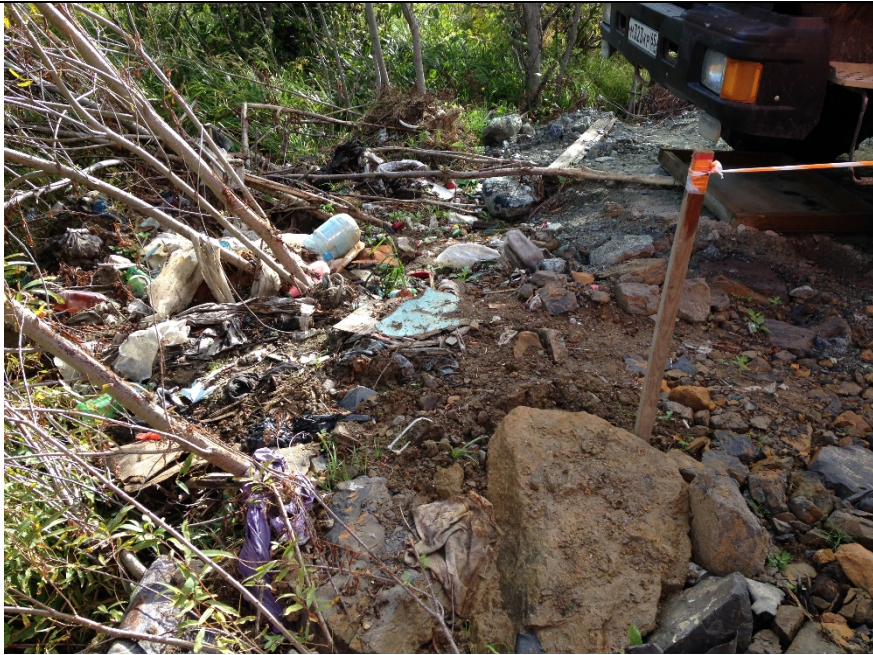
**Photo 3.** Fly-tipped rubbish that has been incorporated within the filled base of the temporary work camp.

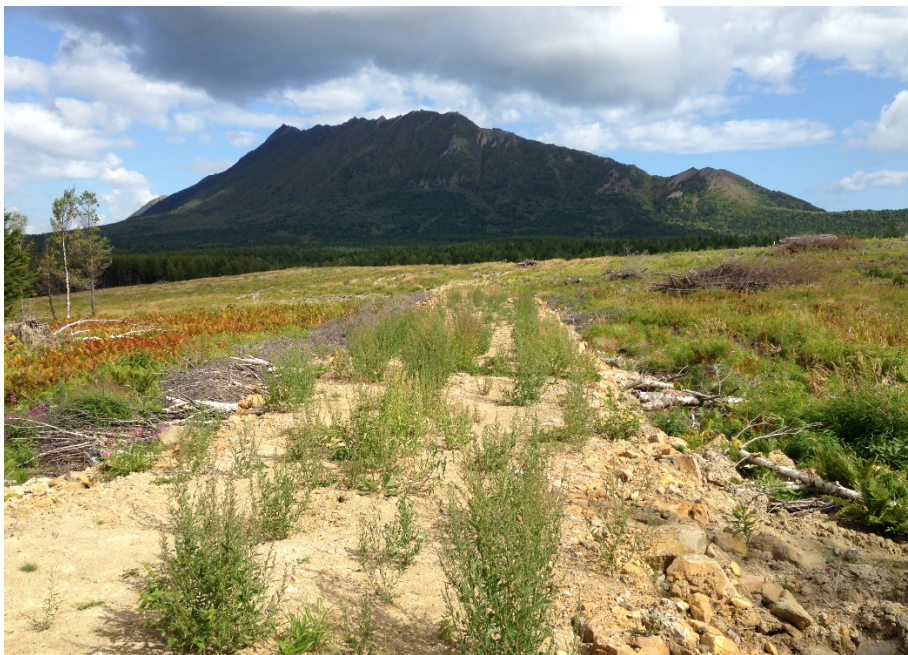
The proposed site for BS4 was visited during the RoW inspection. As with BS3, the site has been recently clear-felled and the timber stacked in piles on-site (Photo 1). The cleared site has incurred less damage during the forestry operations than at BS3, and a relatively intact vegetation cover remains. However, soil erosion and sediment run-off will be a significant risk during construction. Due to the large size of the site and the slopes present, it is likely that significant cut and fill will be required to create a level site.

**Photo 1.** Part of the cleared site for BS4
