## APPENDIX 4: RIGHT OF WAY REPORT

<b>Title:</b> Photographic Log – Right of Way	<b>Client:</b> Sakhalin-2 Phase 2 Lenders
<b>Site:</b> Sakhalin Energy Investment Company	<b>Date:</b> September 2017

## ROW FROM CHAIVO LANDFALL TO OPF

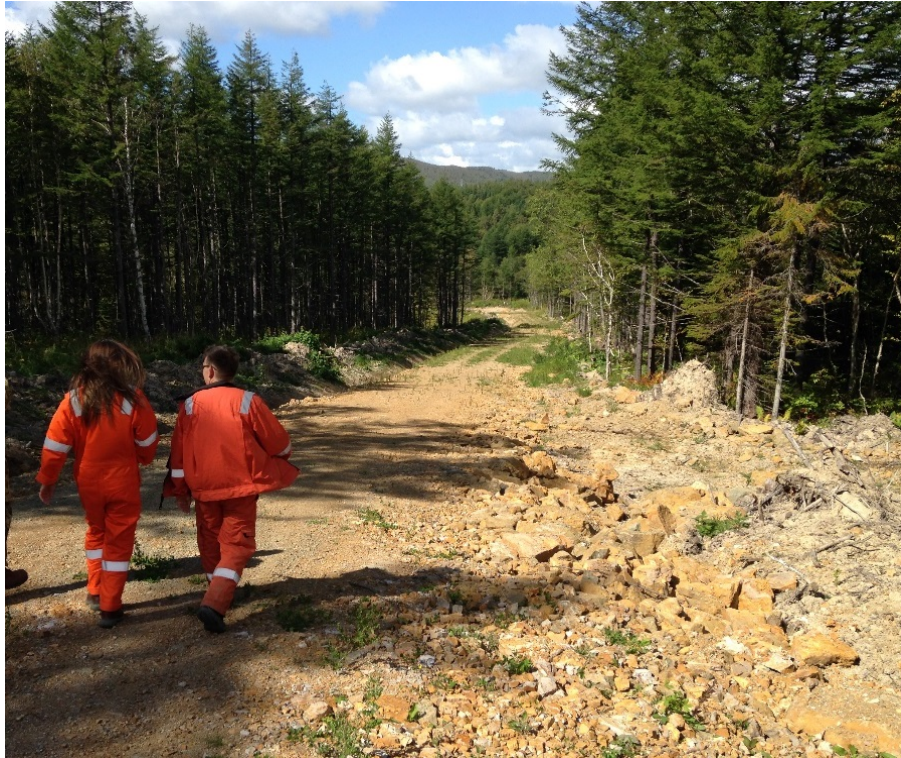
An access track has been created to the proposed BS4 site (Photo 2). This has required some tree felling in places and stone fill appears to have been imported to create a temporary road surface. The access track crosses a water course, which has yet to be culverted and forms a barrier that limits vehicular access to the site (Photo 3).

**Photo 2.** Recently cleared access track to BS4

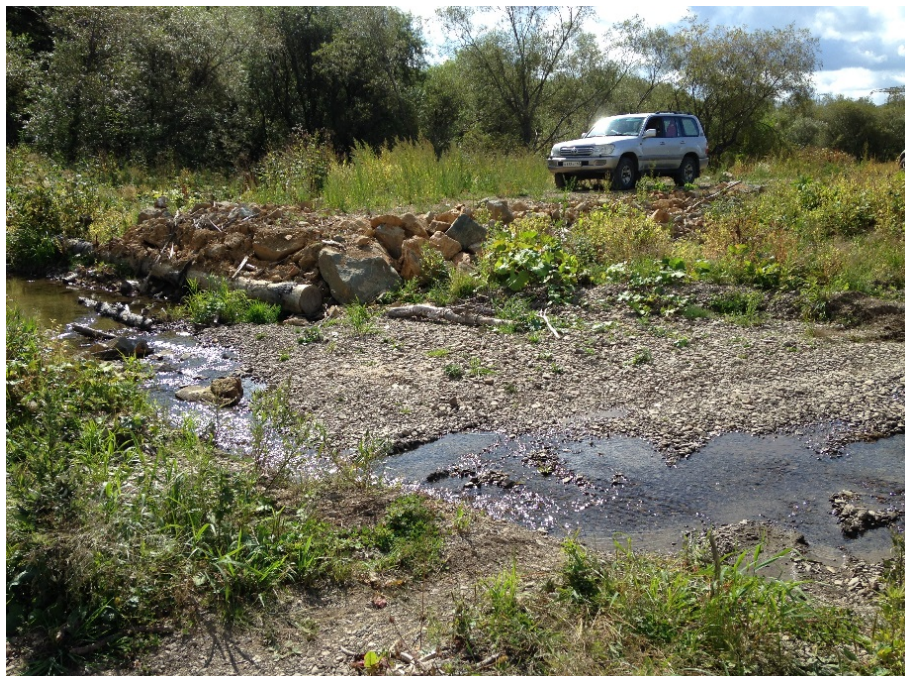
**Photo 3.** Small watercourse crossing on access track to BS4

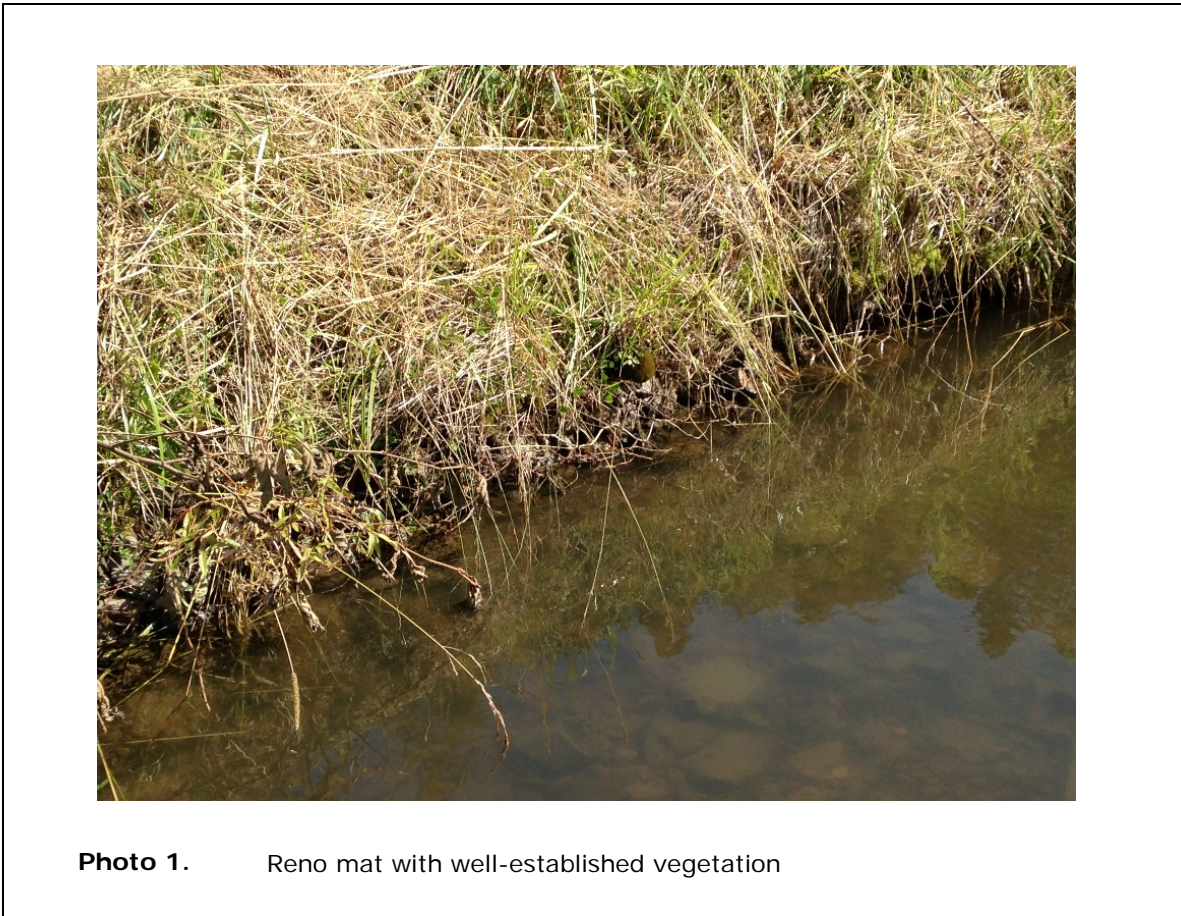
A brief visit was made to the Duet River crossing at KP 449. The river banks at this location are still protected by reno mats that have been left in situ (Photo 1). Vegetation has grown up through the mesh of the reno mats, providing further protection against erosion.

**Photo 1.** Reno mat with well-established vegetation

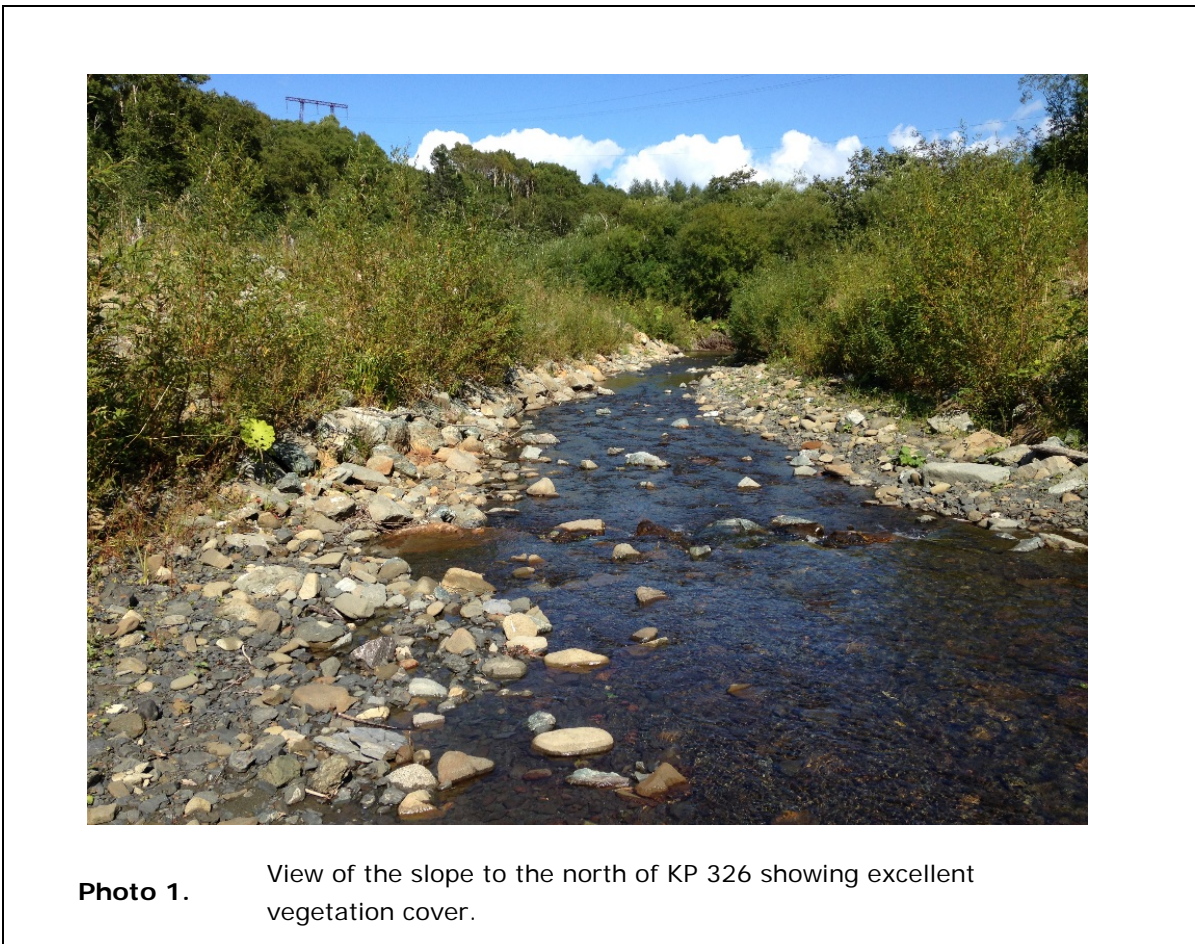
The River crossing at this location has been reinforced with stone rip-rap. The works were completed four years ago and vegetation has established itself well amongst the large stones, providing a more natural appearance.

No signs of erosion of the protected banks were evident.

**Photo 1.** View of the slope to the north of KP 326 showing excellent vegetation cover.
