## **Annex D: Individual RoW Descriptions**

### Fault Crossing 1 and adjacent RoW – KP 12 to 14

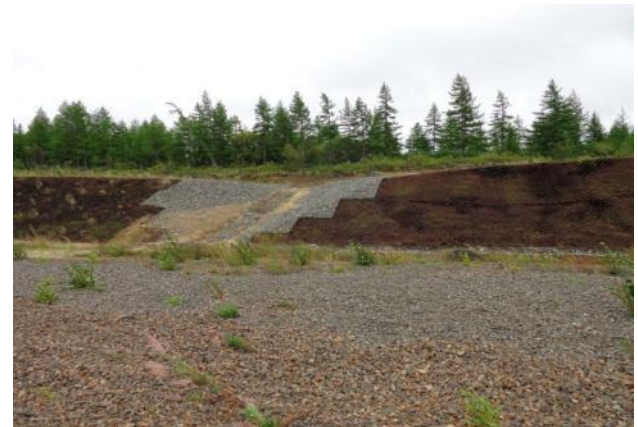
**Photo 3** – View of north facing side cut with a horizontal failure of the geonetting.

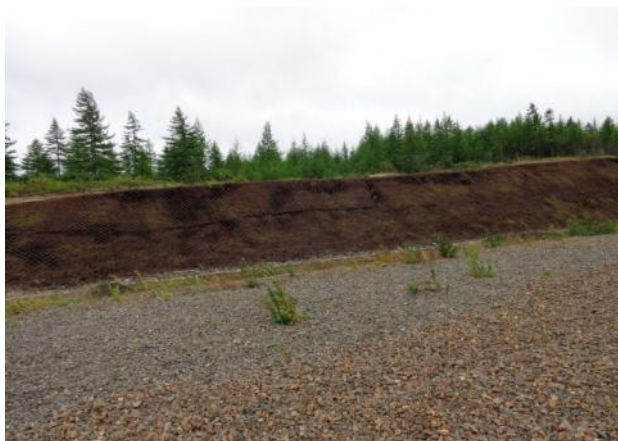
**Photo 4** – Failed geonetting on side cut.

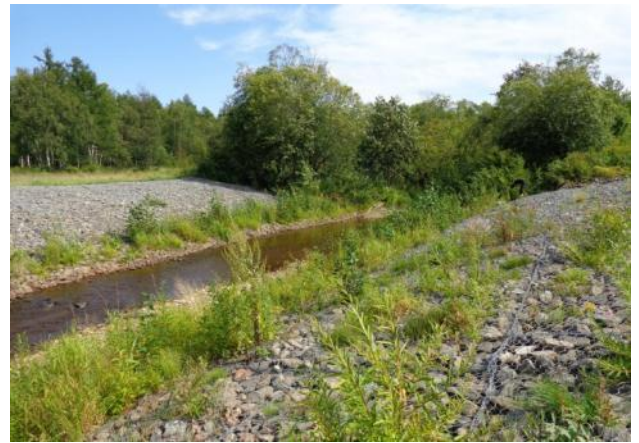
The Voskresenovka River is protected on both banks with Reno mats. The mats are intact and some vegetation is growing through the matting (Photos 1 and 2). The leading edge of the Reno mat on the upstream impact point shows some wear and tear and may need maintenance in the future (Photo 3).

**Photo 3** – View of the toe of the Reno mats at the upstream with damage at the leading edge.

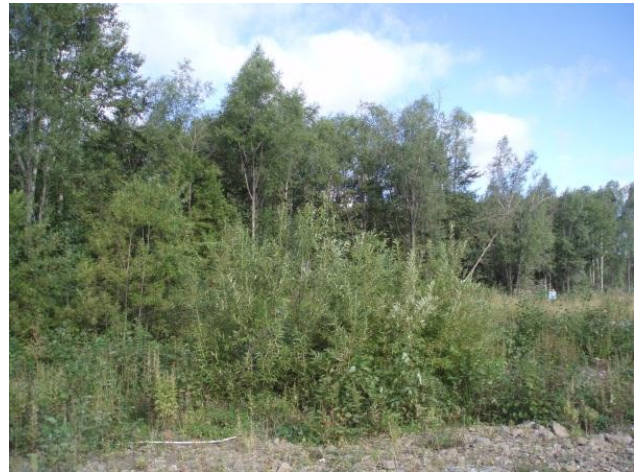
The RoW north and south of the river is well vegetated, although in some places north of the streams, maintenance is required to remove tree growth (Photo 4).

**Photo 4** – View north from Gastellovka River showing well vegetated RoW but with need for tree removal

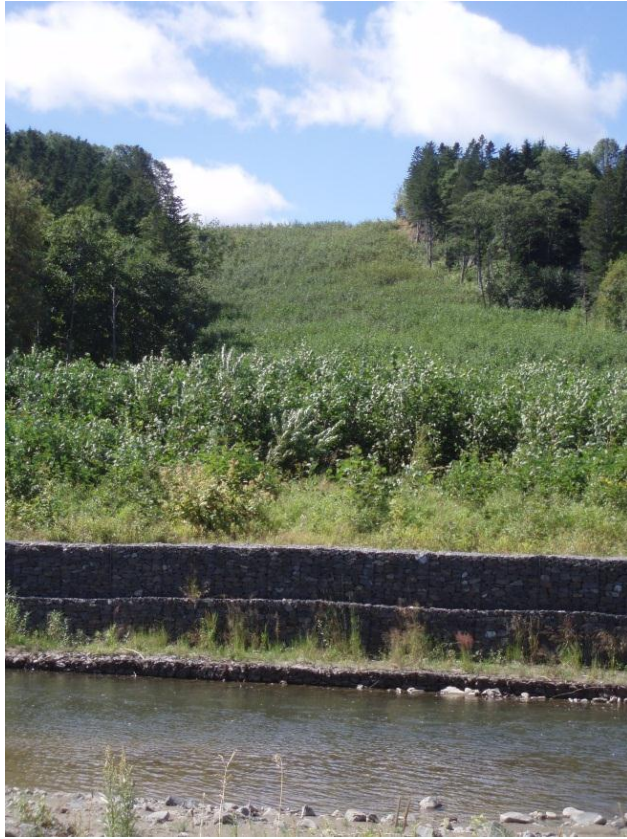
The crossing itself appears intact and the south bank is protected by a gabion wall (Photo 3), which was found to be in generally good condition, although minor damage on the downstream edge of the wall was observed (Photo 4). During the current visit significant re-vegetation on the RoW was observed (Photo 3), but this included significant tree (alder) sampling growth that needs to be removed.

**Photo 4** – Minor damage to downstream portion of gabion wall

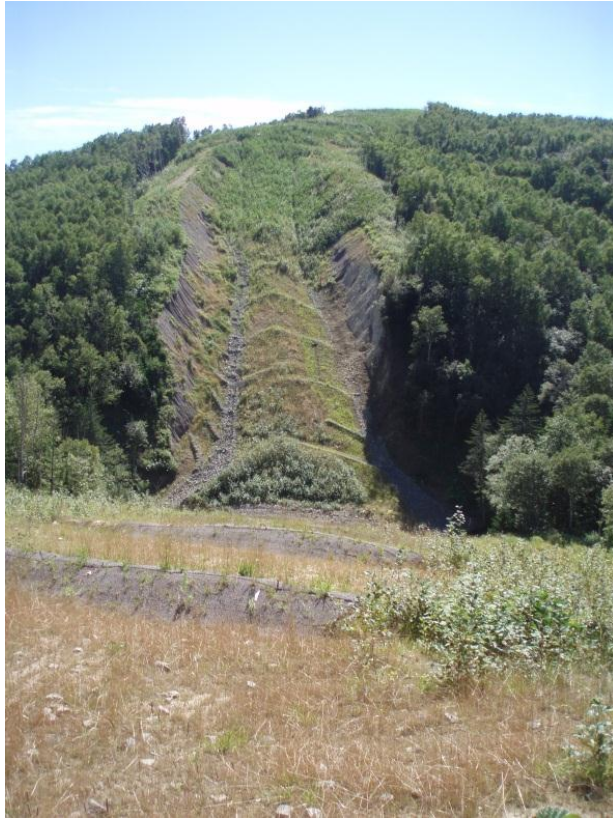
Drainage channels at the side of the RoW on the southern slope are armoured with rock, but some wash-out was observed on the eastern side and there was also evidence of minor collapse of reno matting on the southern riverbank (Photo 4).

**Photo 4** – View of southern slope showing tree growth above reno matting and also minor failure of the reno
