Lenders' Independent Environmental Consultant: Monitoring Report June 2010 Sakhalin-2 Phase 2 Project

Report to Sakhalin-2 (Phase 2) Project Finance Parties

Restricted – Commercial
AEAT/ENV/R/3052 Issue 1
July 2010

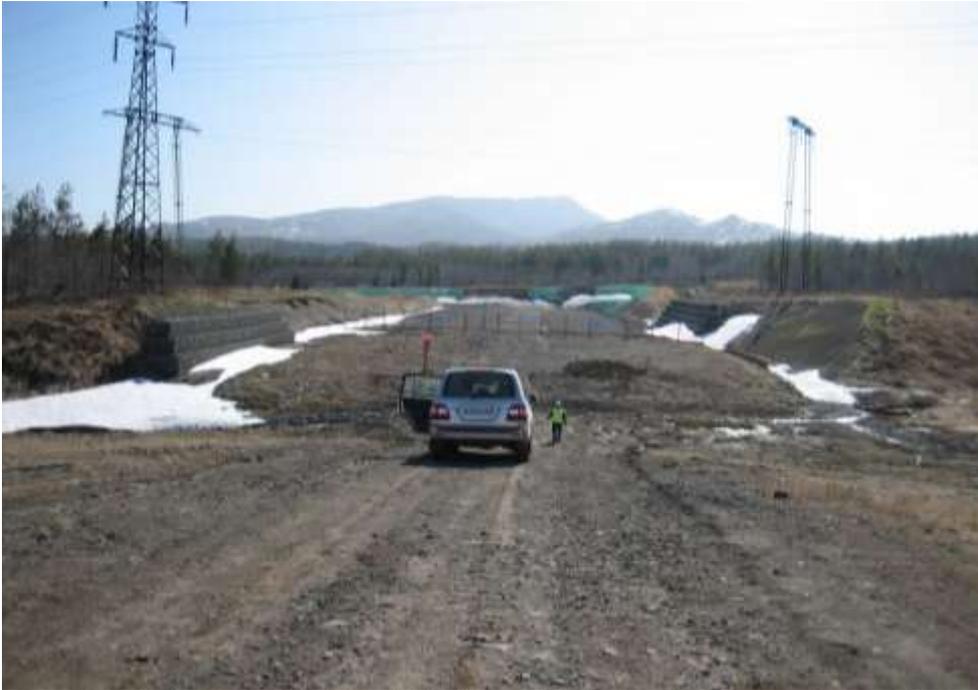
Photo 6 Side cut buttressed by a multi level gabion wall and soil backfill – KP 304

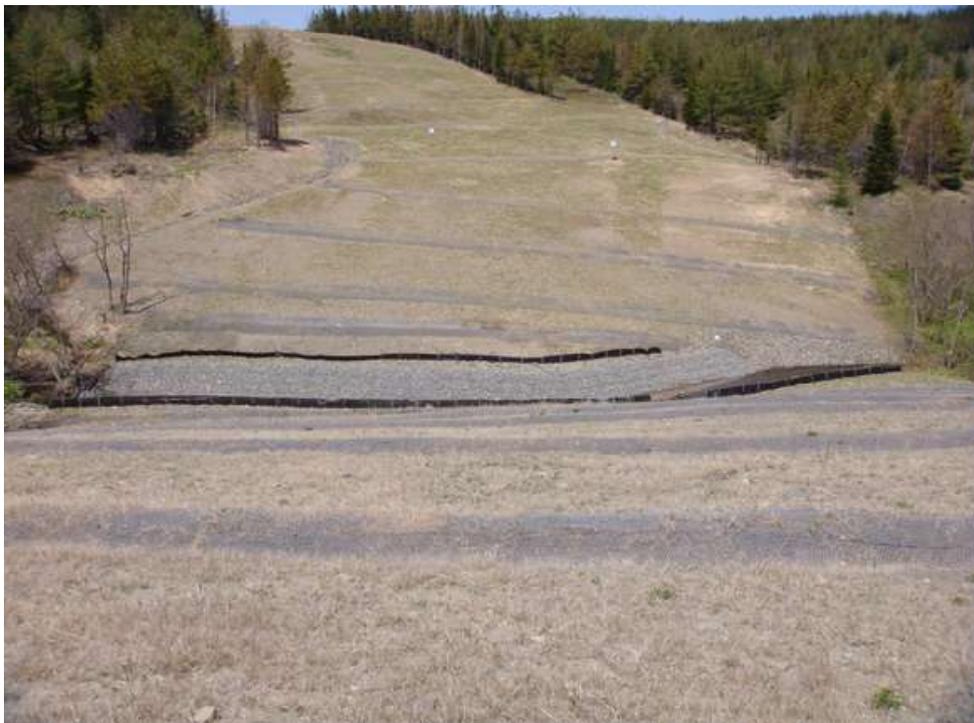
Photo 7 Well constructed slope breakers on the Vulkanka River Slopes

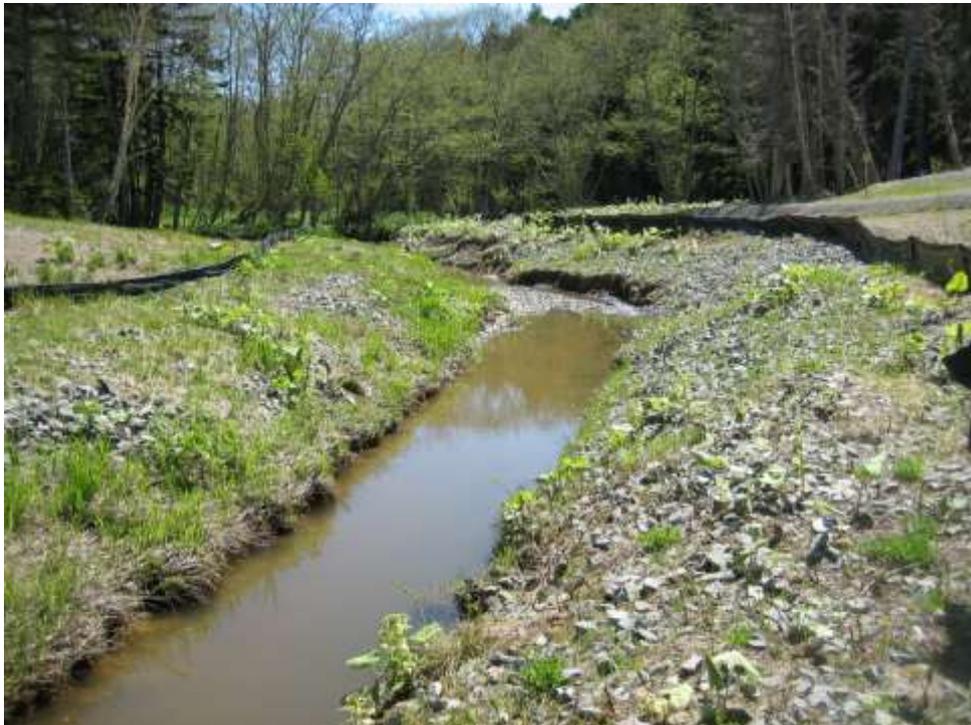
Sakhalin Energy used silt fencing extensively and effectively during construction. Some locations still have the silt fences in place and they continue to function well (Photo 15). In other locations, the fences are damaged from storms and from occasional theft of the textile (Photo 16). AEA recommends that Sakhalin Energy evaluates the need to replace and/or upgrade the fences on a site by site basis. It is clear that some locations do not require the protection any longer.

Photo 15 KP 510.4 Silt fence on the Podgorodnaya River

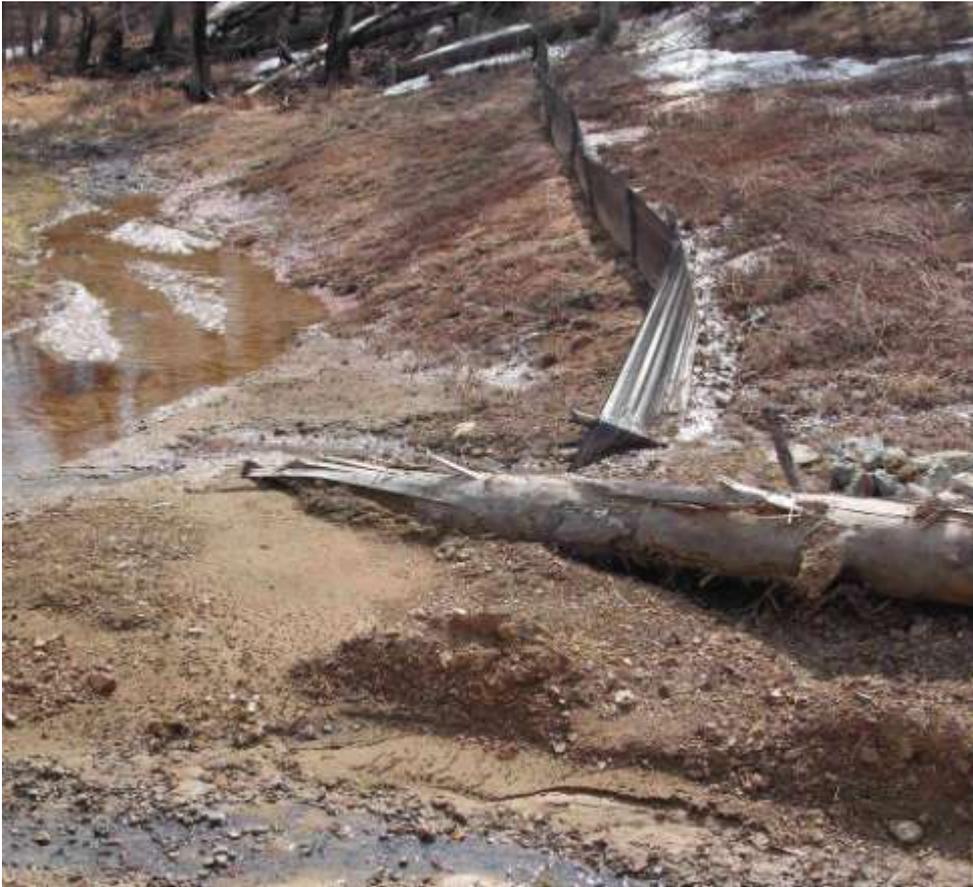
Photo 16 **KP15 Failed silt fencing**

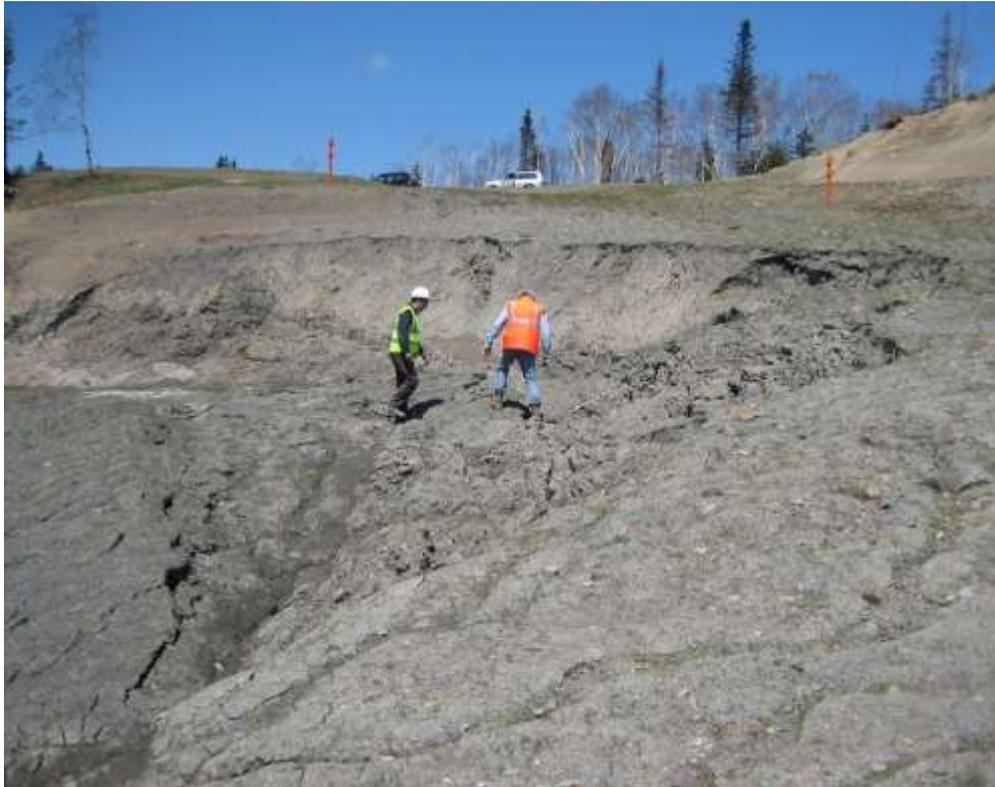
Photo 35 Slope failure at the northern slope leading to the Sedlet River KP 387

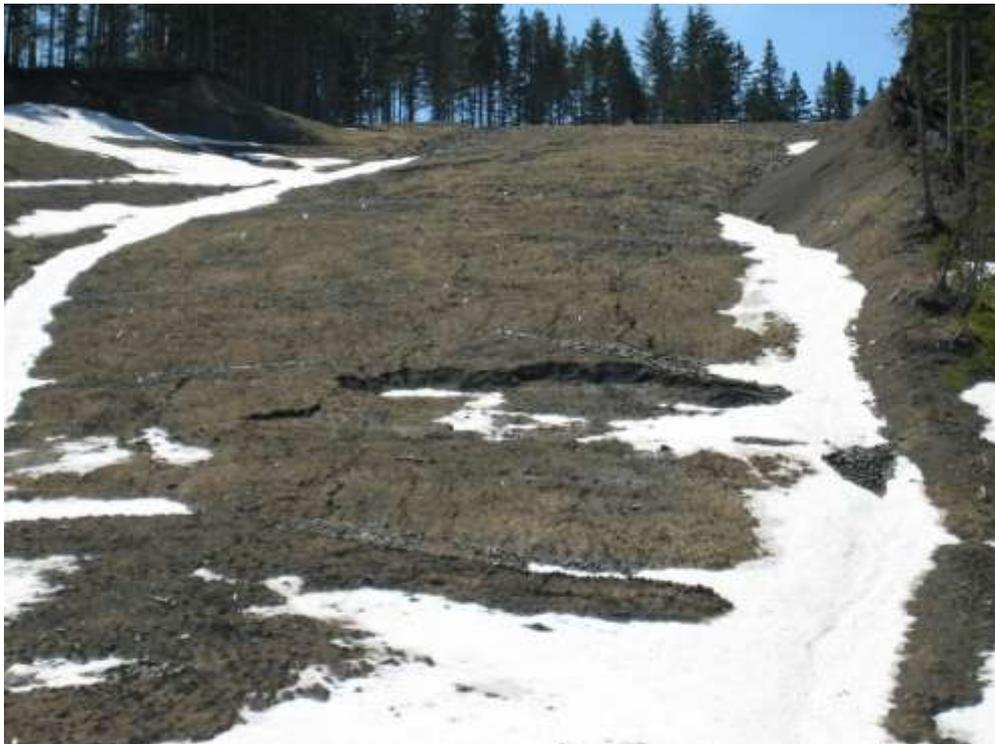
Photo 36 A start of a failure on the southern slope of the Lesnaya 3 River KP 380.6

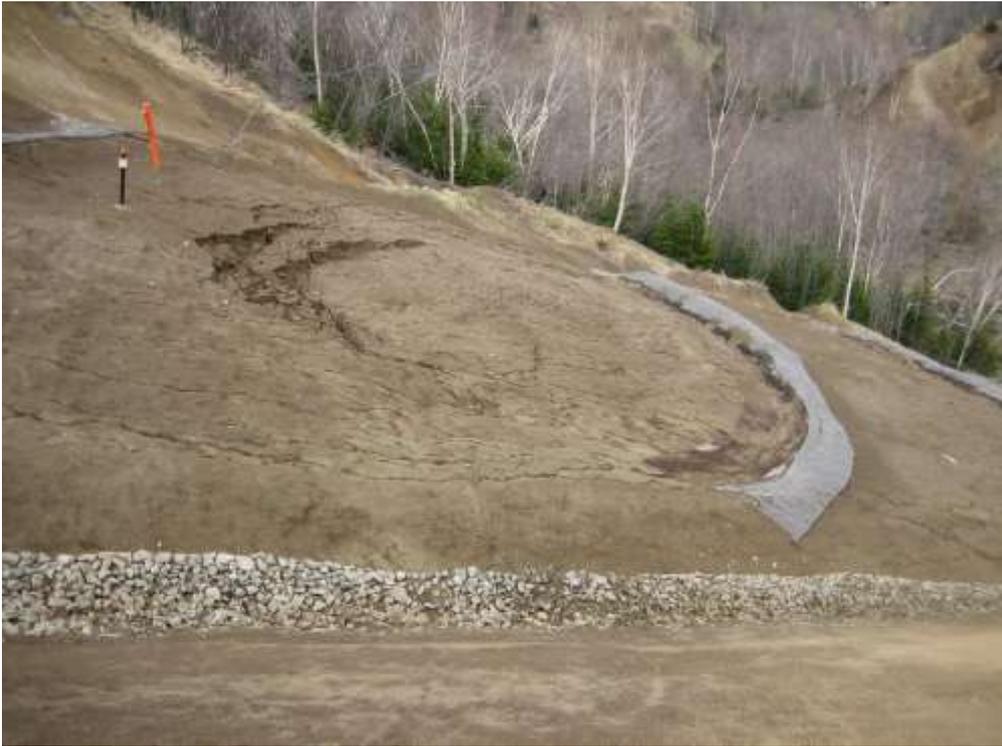
Photo 37 A start of failure at the southern slope of Kormovaya River – KP 351

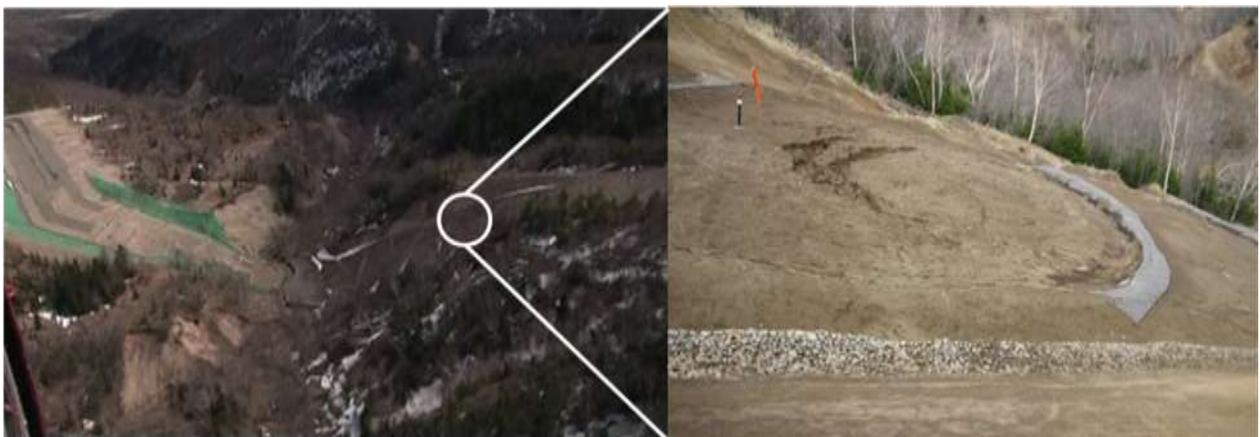
Photo 38 Video still and on-site photo of Khormovaya River Slope failure

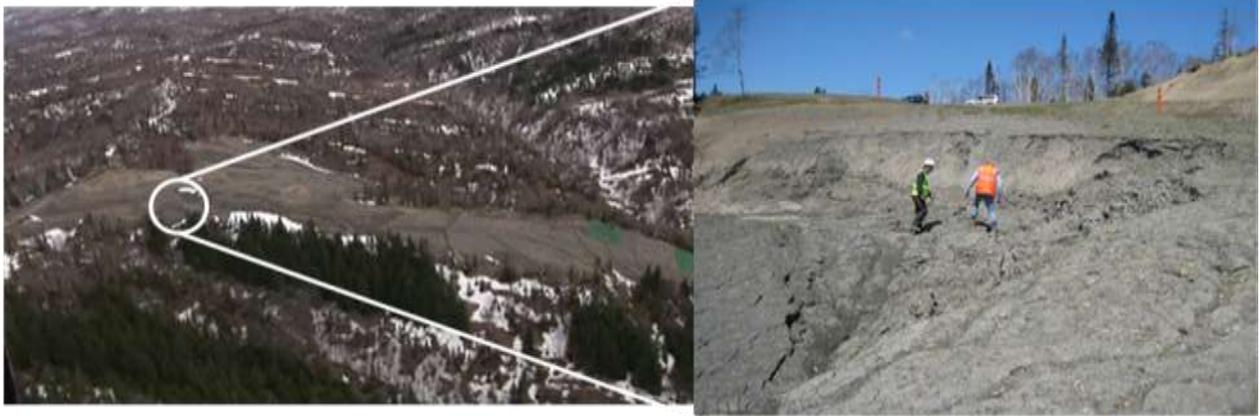
Photo 39 Video still and on-site photo of Sedlet River Slope failure

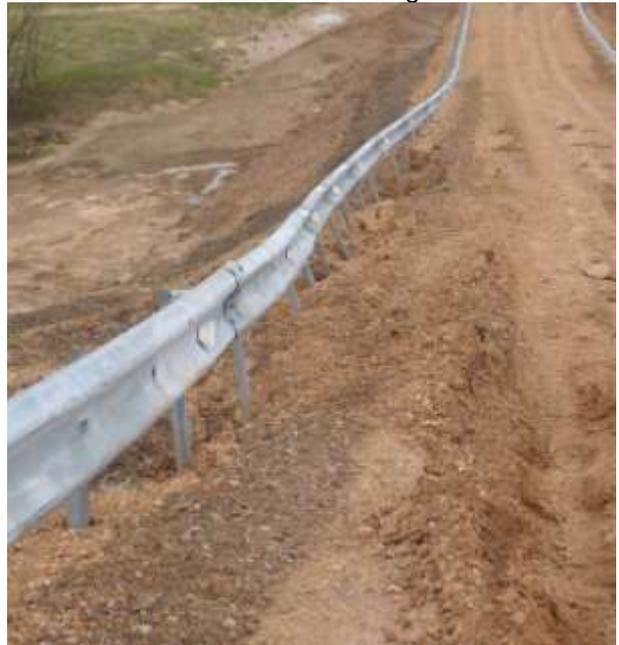
Photo 4 – Road and barrier damage detail

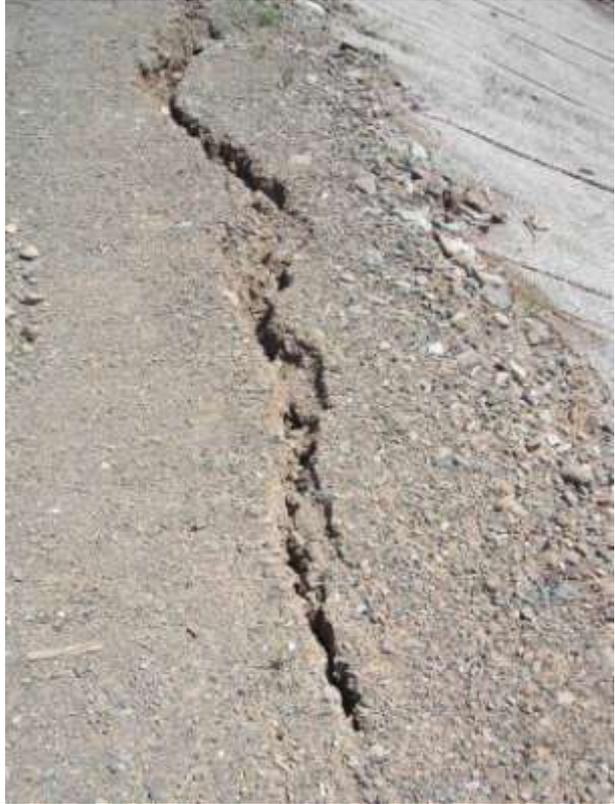
During the visit it was noted that a tension crack had opened up at the top of the slope behind the gabions on the south bank (Photo 4). While this is not a major problem at present it will require monitoring in order to ensure that does not become a structural concern and may require drainage control and further engineering works.

Photo 4 – Tension crack on southern bank

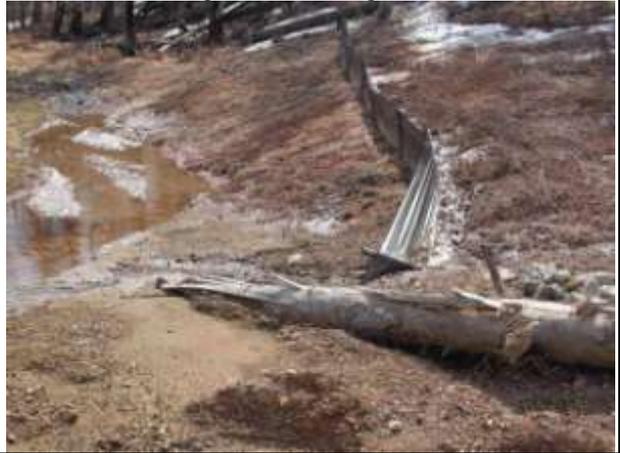
Photo 6 – Damaged silt fencing KP 20

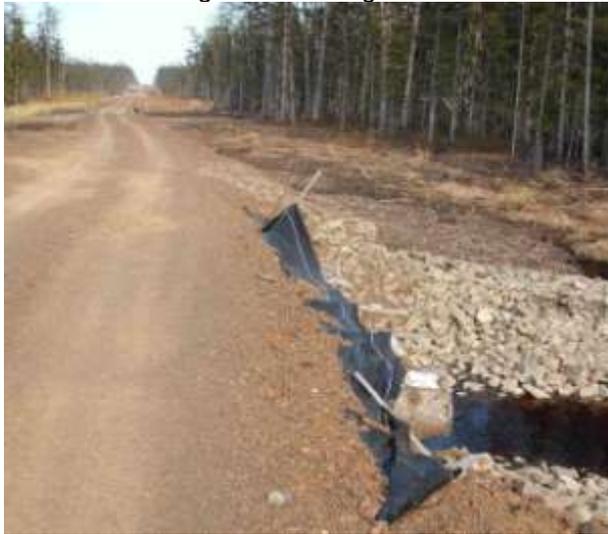
Photo 7 – Damaged silt fencing

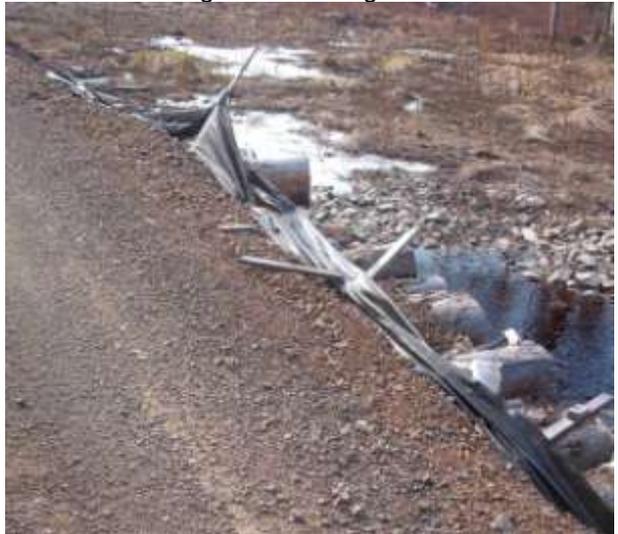
Photo 8 – Damaged silt fencing

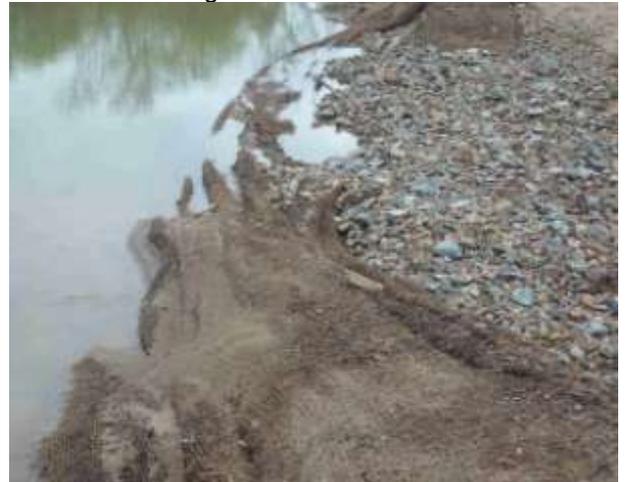
Photo 4 – Damaged bund on north bank

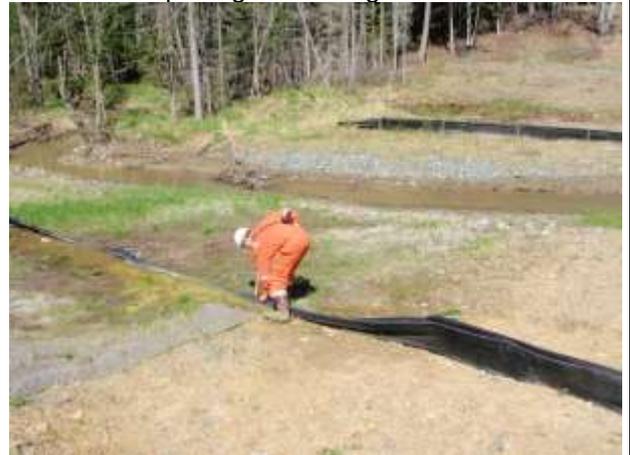
Photo 4 – Repairing silt fencing

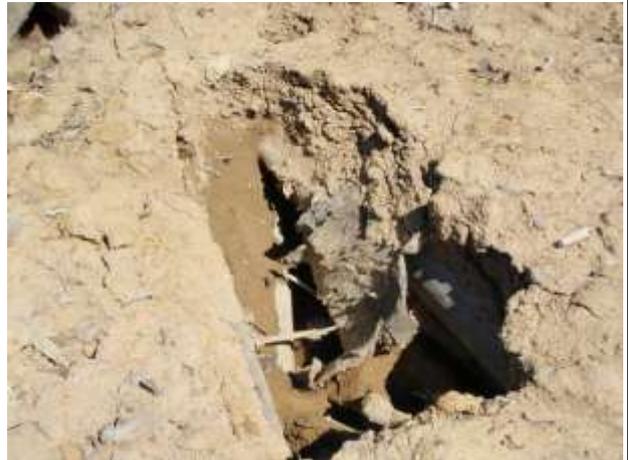
A hole measuring ~ 1 x 0.5 m was noted at the edge of the southern slope of the RoW, at approximately KP 178.8. Layers of cut logs placed on the RoW during construction (parallel to the pipeline, possibly for vehicle platforms) had been uncovered, showing a water-filled gap beneath. Construction debris should have been removed from the RoW and it is recommended that these logs are removed and the hole backfilled. It should be noted that the integrity of the pipeline is not under threat.

Photo 6 – Hole under RoW

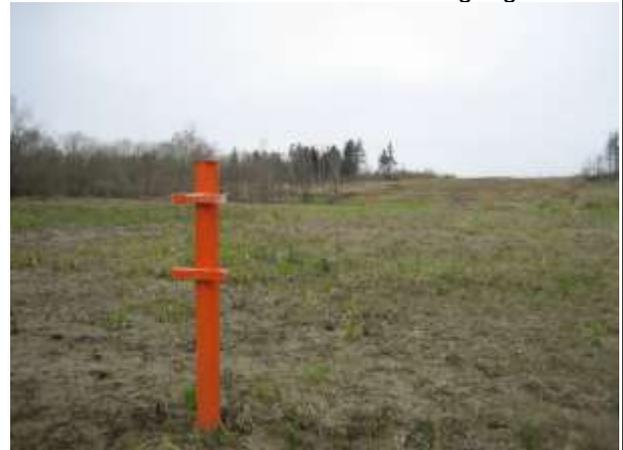
Photo 4 – View of ROW and lack of signage
