Lenders' Independent Environmental Consultant Site Visit Report: November 2008 Sakhalin II (Phase 2) Project

Report to Sakhalin II (Phase 2) Project Finance Parties

Restricted – Commercial
AEAT/ENV/R/2738 Issue 2
February 2009

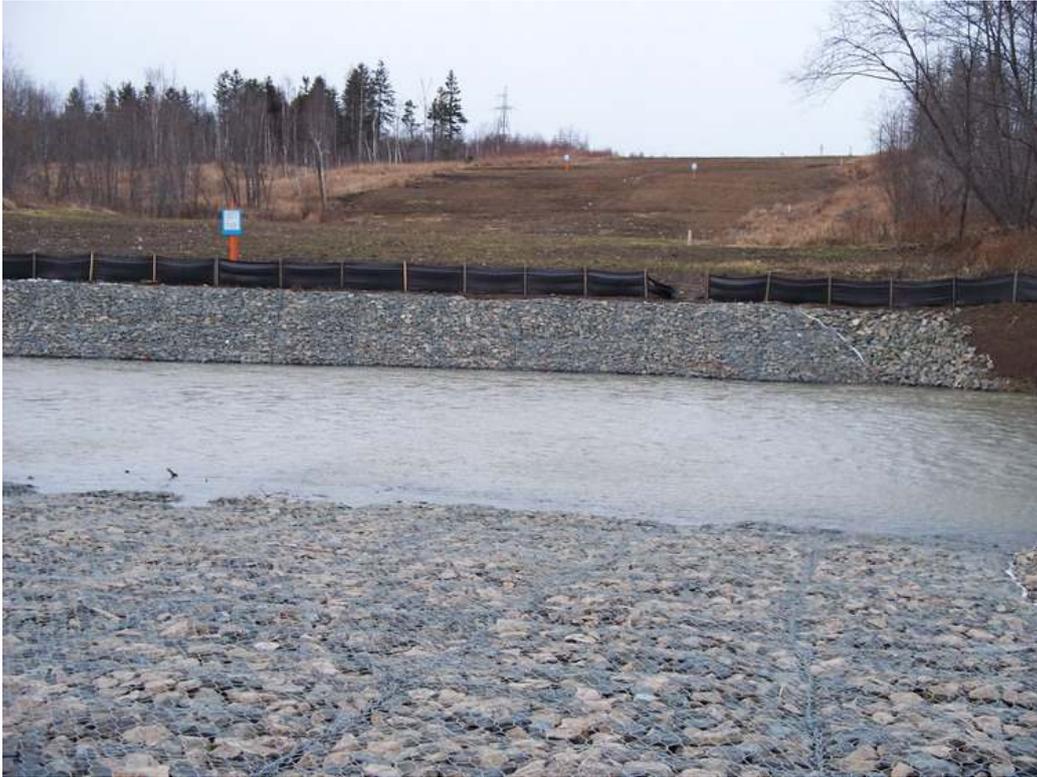
Section 3A is the northern segment of Section 3. This segment is mostly flat with few low relief slopes, and works are mostly complete. Among the locations visited during the November visit we observed some sites in which works were recently completed. These include Goryanka River (KP 313), Mana River (KP 314), Klinovka River (KP 317) and Chulumyka River (KP 319). The Goryanka and Klinovka rivers provide examples of the scope and good quality of riverbank protection in this segment (Photos 1 and 2).

Photo 1 – Goryanka River – KP 313 – View to the north showing Reno mats on the banks and reinstated RoW beyond the sediment control above the bank.

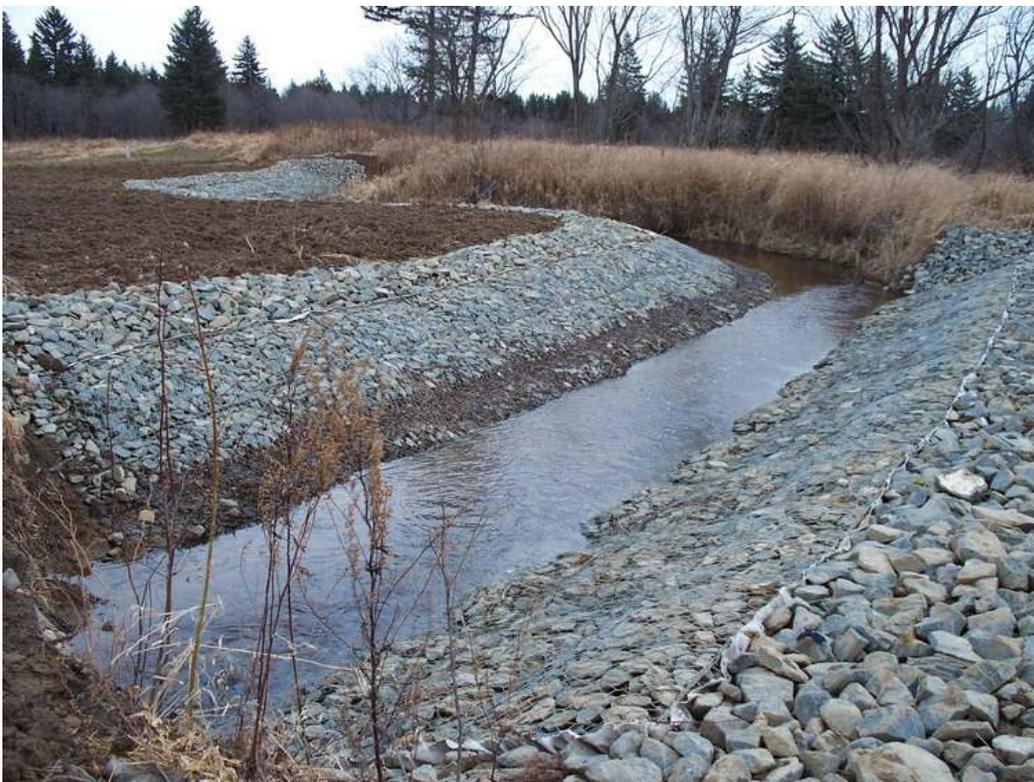
Photo 2 – Klinovka River – KP 317 – View of the riverbanks protected with Reno matting at the crossing and at the meander adjacent to the RoW. Also, note the graded RoW beyond the banks.

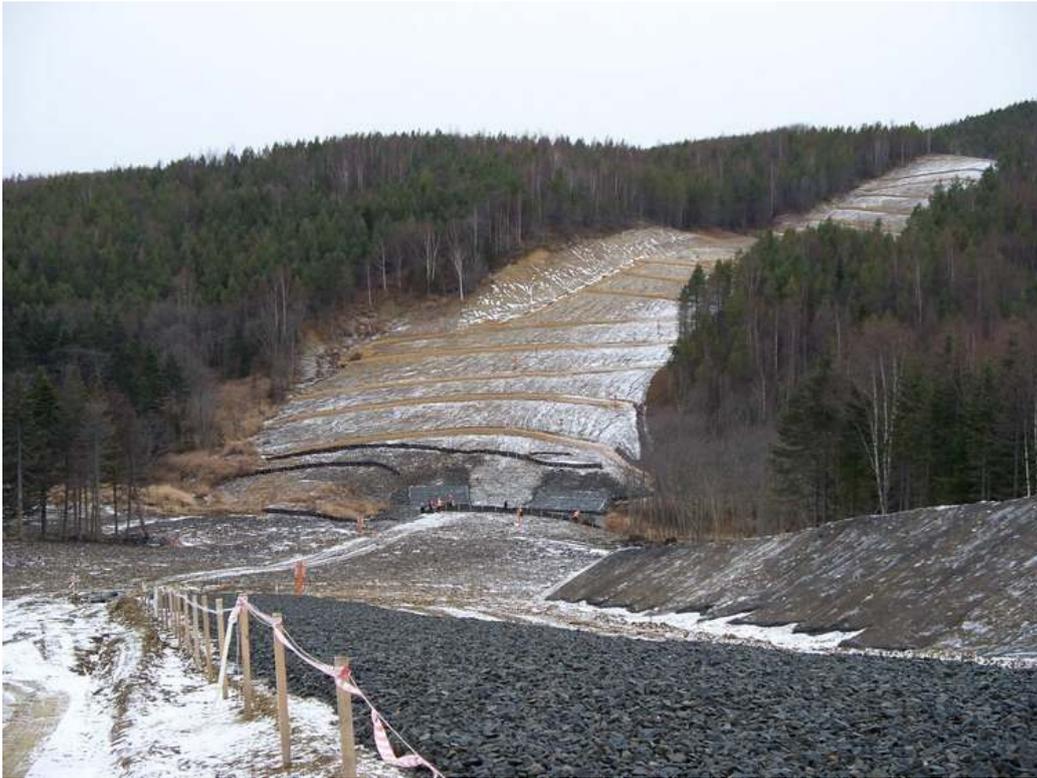
Vidnaya River and Slope – KP 343 – At the time of the visit, work was in progress on riverbank protection, which includes Reno mats and silt fences (Photo 3). The steep slope on the southern side has geojute fortified slope breakers and drainage control. While the RoW has been winterised, small erosional trenches are forming between the slope breakers on the southern side and should be monitored during the spring thaw. The northern slope of the Vidnaya River is part of Fault Crossing No. 11-14. The fault crossing has been hydroseeded and works are completed. Side cuts are sloped back, although remain unseeded and should be monitored.

Photo 3 – Vidnaya River and Slope – KP 343 – View south showing armoured slope breakers and on going work on the riverbank. Photo taken from completed Fault Crossing No.11-14

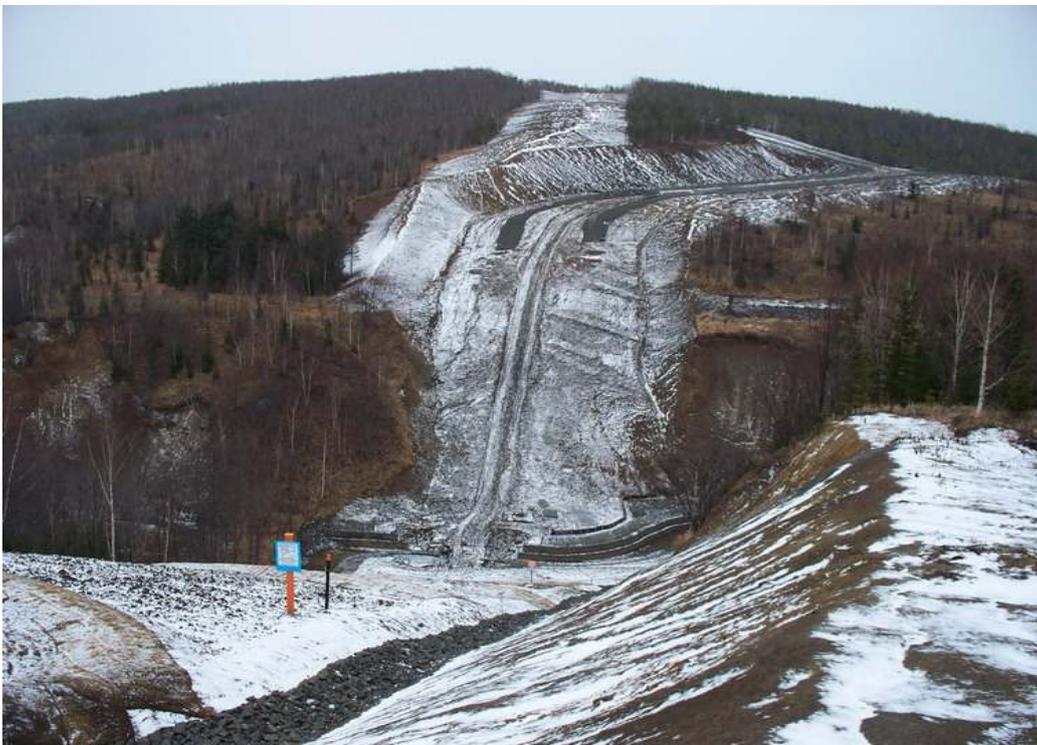
Kormovaya River and Slopes – KP 347 – Crews were working at the Kormovaya River at the time of the November visit (the crews were reportedly at lunch during our brief visit, but ongoing works were evident). Reno mats were being reconstructed/repared and new gabion walls were under construction. The bridge was still in place to allow workers to access both sides of the river. Use of the bridge appeared to be primarily foot traffic with no vehicles being driven onto the winterised northern slope. The bridge will reportedly be removed this year following completion of the above-mentioned works. Side cuts at Kormovaya have neither geojute nor any type of seeding. The northern slope has been winterised; biological reinstatement is planned for spring 2009 (Photo 4).

Photo 4 – Kormovaya River and Slopes – KP 347 – View to the north showing pending winterisation on the northern slope. Gabion wall on the riverbank is in the process of construction

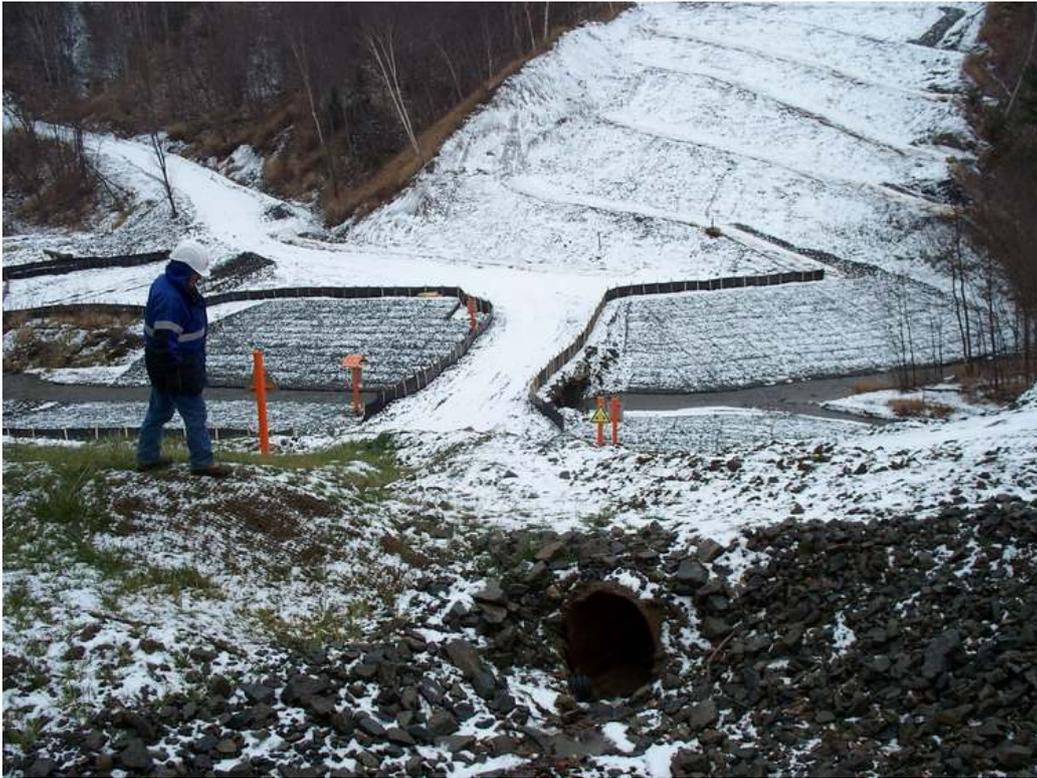
Krinka River and Slopes – KP 348 – Work has been undertaken on both slopes to the river, as well as riverbank protection. The slopes are equipped with armoured slope breakers and in the case of the northern slope, also with a subsurface drain. The riverbanks are protected with Reno matting and the river and the bridge are protected with silt fences (Photo 5). Works to date at the Krinka were found by AEA to be of excellent quality.

Photo 5 – Krinka River and Slopes – KP 348.5 – View south showing riverbank protection of reno mats and silt fences and both slopes with slope breakers. Note the growth of vegetation on the near slope, which was seeded early this year.

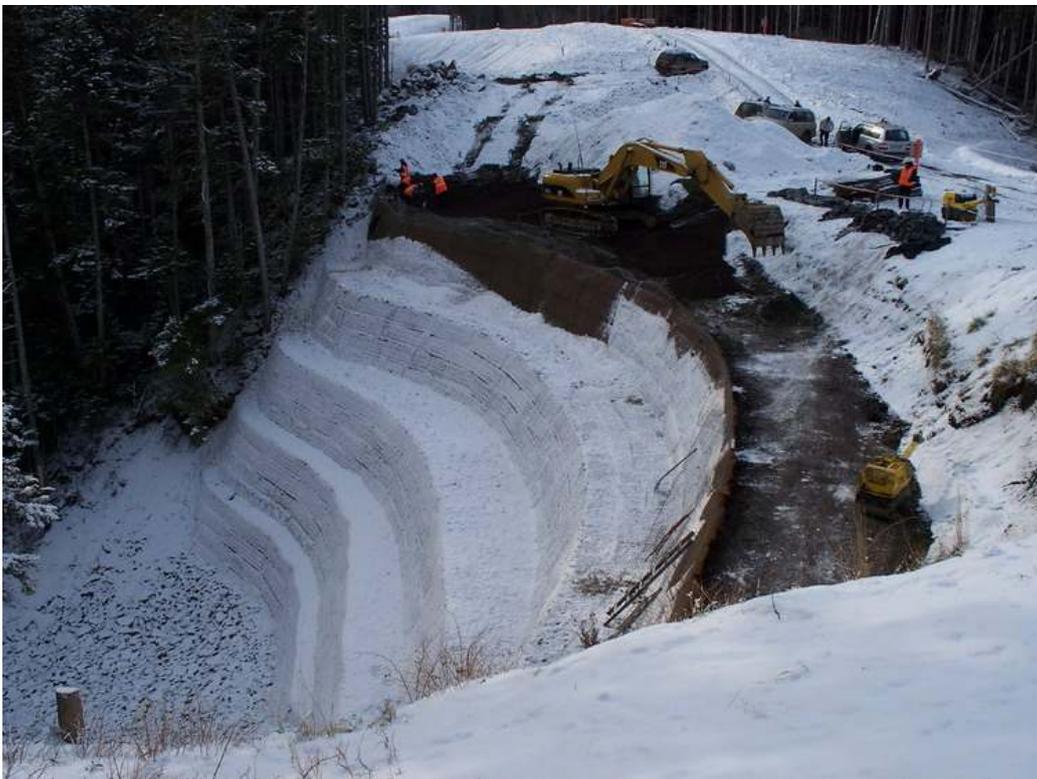
Varvarka Ridge – KP 364 – Work is in progress to repair the side slope of the ridge. This project required a detailed engineering design, which involved terracing the repaired slope with Terra Mesh steps (Photo 6).

Photo 6 – Varvarka Ridge – KP 364 – Work in progress to stabilise the eastern slope of the ridge. The RoW is visible in the top of the photo.

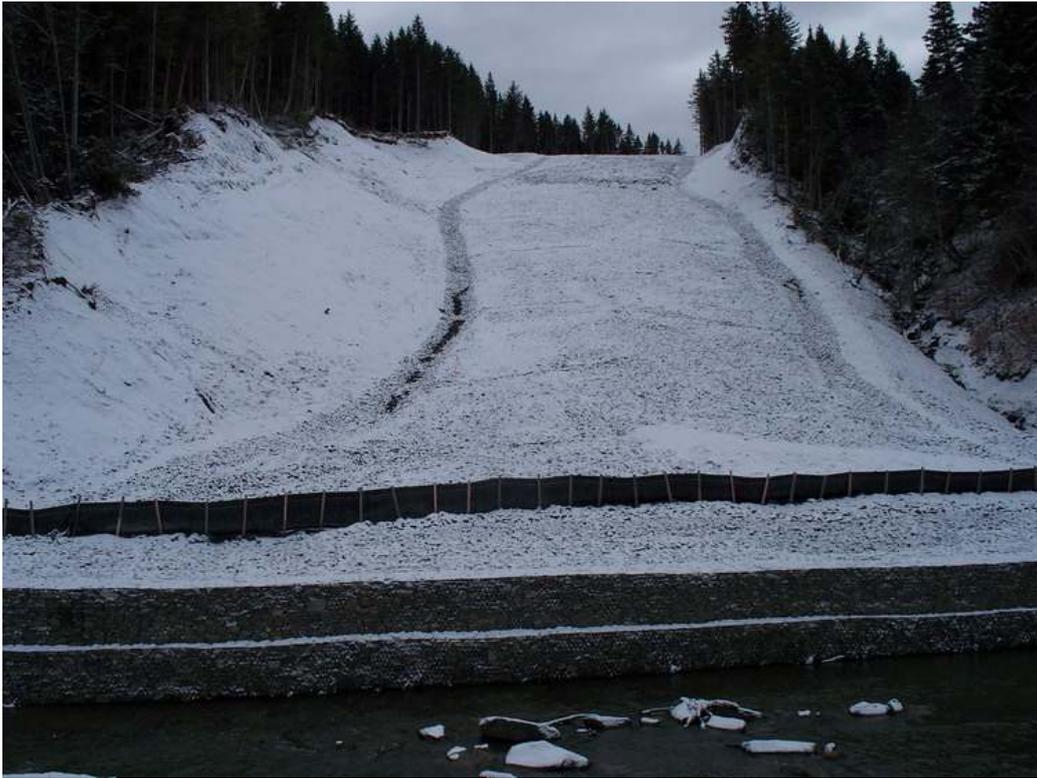
Lesnaya 3 River – KP 376 – Work was recently completed on the steep slope to the south of the river, and the riverbanks are protected with gabion walls. The slope has slope breakers and drainage control (Photo 7), which AEA considers to be of good quality.

Photo 7 – Lesnaya 3 River Crossing and Slope – KP 376 – View south showing completed winterisation works on the slope including slope breakers and drainage. The riverbanks are protected with gabion walls.

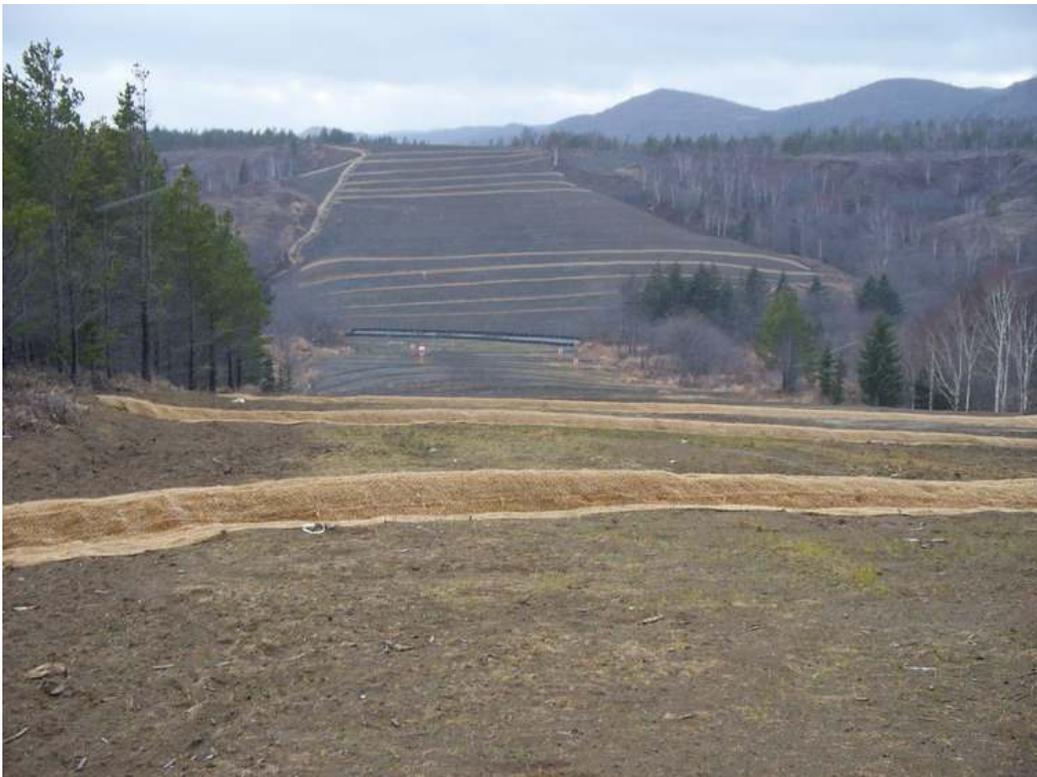
Section 3C is the southern most segment of Section 3. Within this segment the steep slopes (mostly the very southern portion) are already reinstated and protected with armoured slope breakers and are seeded. Good examples were seen at the Ssora and Tura rivers in KP 407 and KP 409 (Photos 8 and 9).

Photo 8 – Ssora River and Slopes – KP 407 – A view south showing the river with Reno matting and sediment control. The slopes on both sides of the river have armoured slope breakers and drainage.

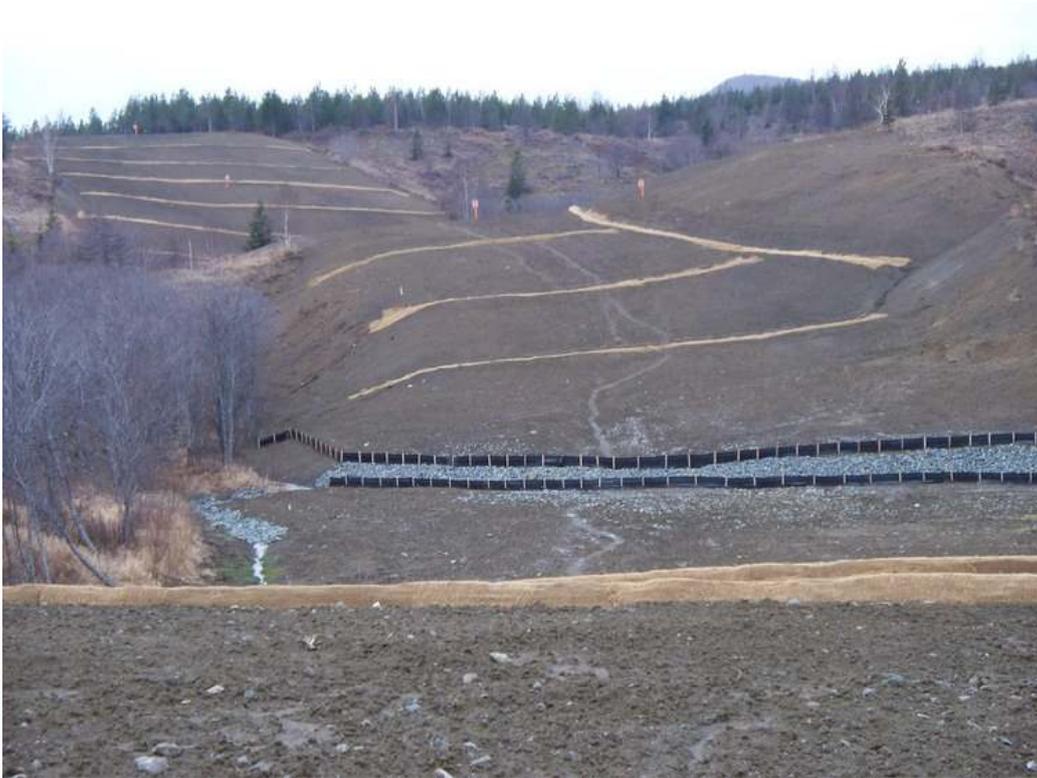
Photo 9 – Tura River – KP 409 – View across the river to the southern direction showing the riverbanks protected with riprap and partial coverage of erosion control on the opposite slope.

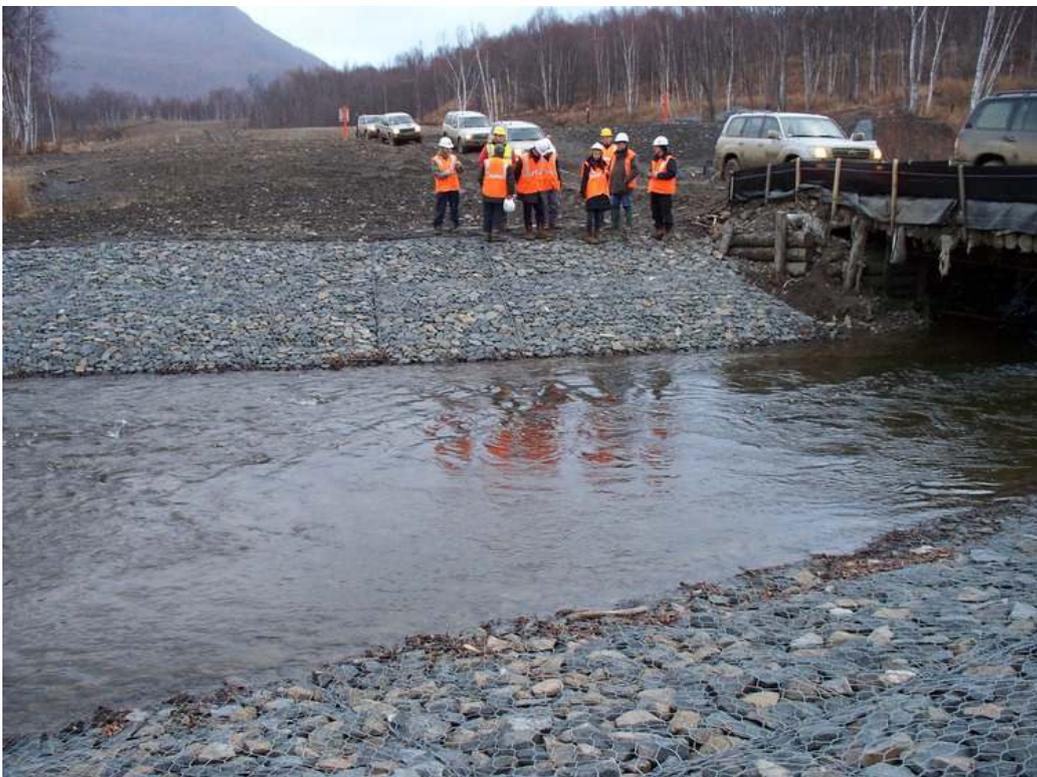
The Zvanka River has riprap, Reno mat and recently repaired silt fencing. The bridge is still in place for access to the BVS. Malakhitovka River is similar except the silt fence on the bridge has failed, allowing relatively minor amounts of sediment to enter the river, and needs repair.

Photo 10 – Zvanka River – KP 391 – The riverbanks are protected with Reno mats. The bridge and running track are still in place to provide access to the BVS.

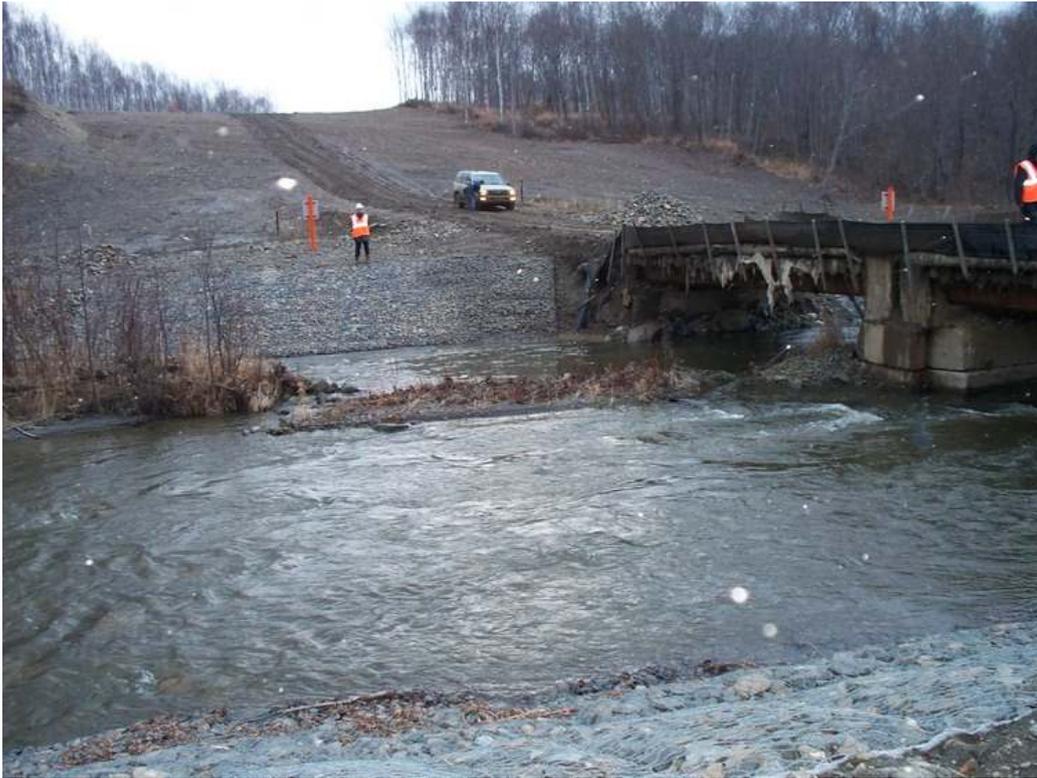
Photo 11 - Malakhitovka – KP 395 – The riverbanks are protected with Reno mats. The bridge and running track are still in place to provide access to the BVS.

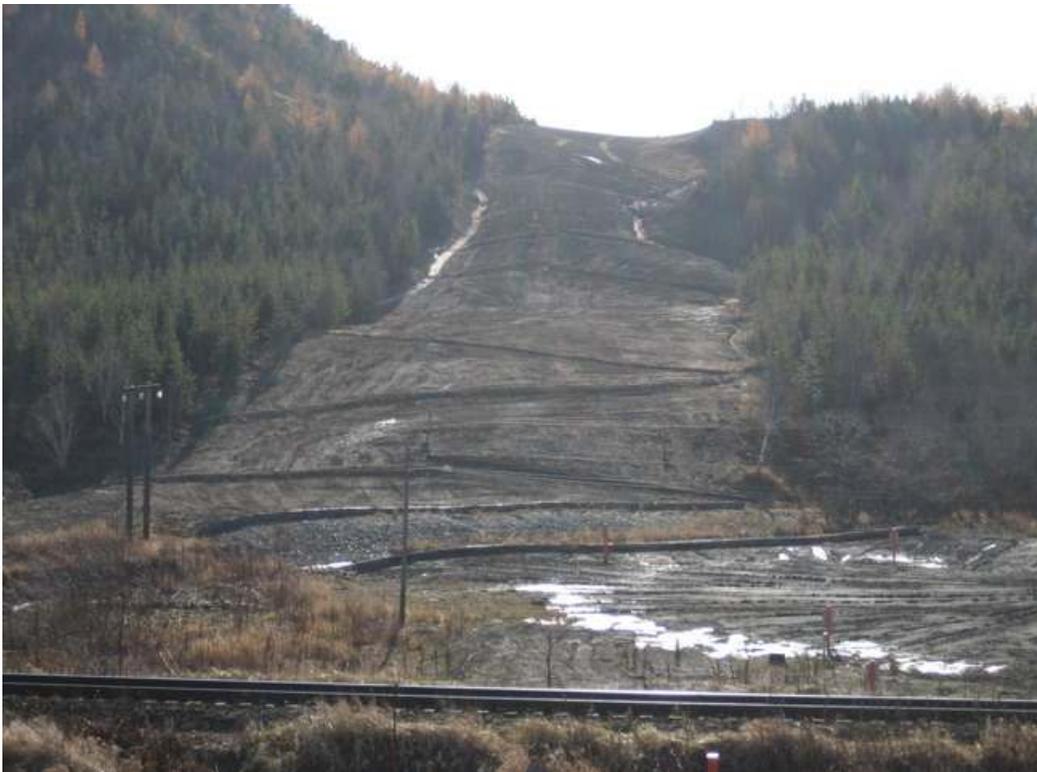
Photo 12 – KP 461 – Krasnaya River and Slope – view to the south showing the river protected with Reno mats and sediment control and the slope graded to contour and with drainage control.

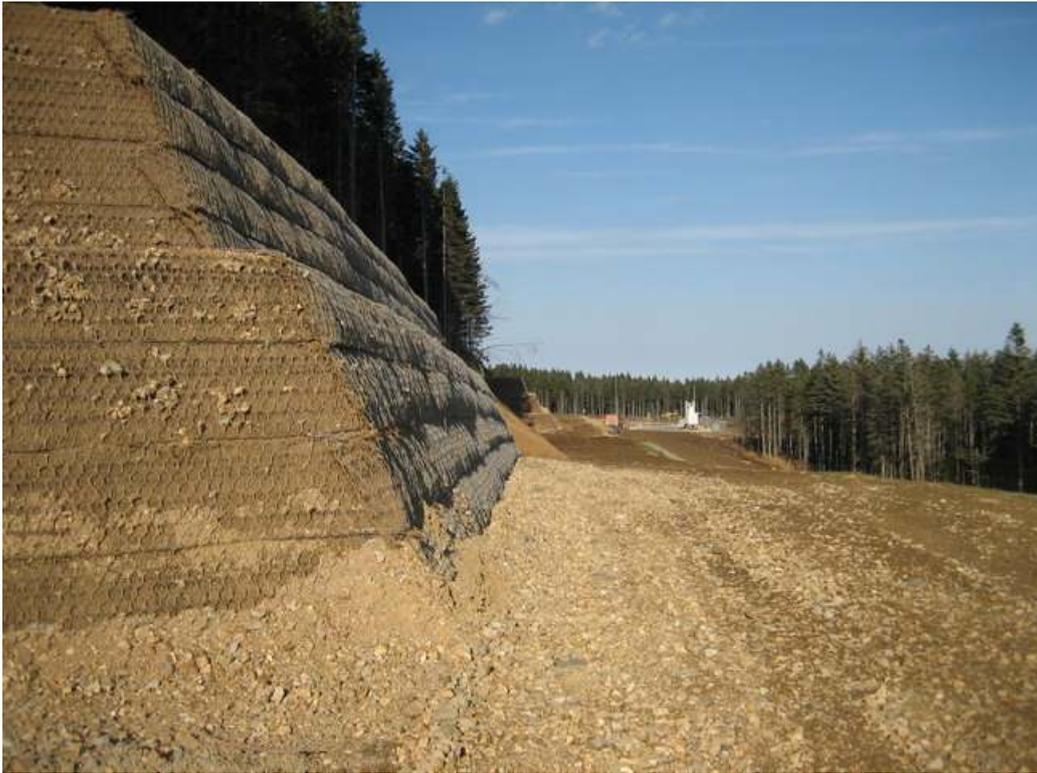
RoW and Side Slopes – KP 483 – This location includes the river and a series of steeply cut side slopes. The riverbanks are protected by Reno mats and natural vegetation. Along the side cuts, Sakhalin Energy has implemented an engineering design to stabilise the cuts using gabion walls to build up the RoW elevation and reduce the overall impact of the cuts. The running track is still in place to provide access to the BVS at KP 482. This temporary track is due to be replaced in the future by a permanent access road (Photo 13).

Photo 13 – RoW and stabilised sidewall at KP 483 – The sidewall is stabilised with Terra Mesh and gabion walls. The RoW is graded but with only temporary road to the BVS.

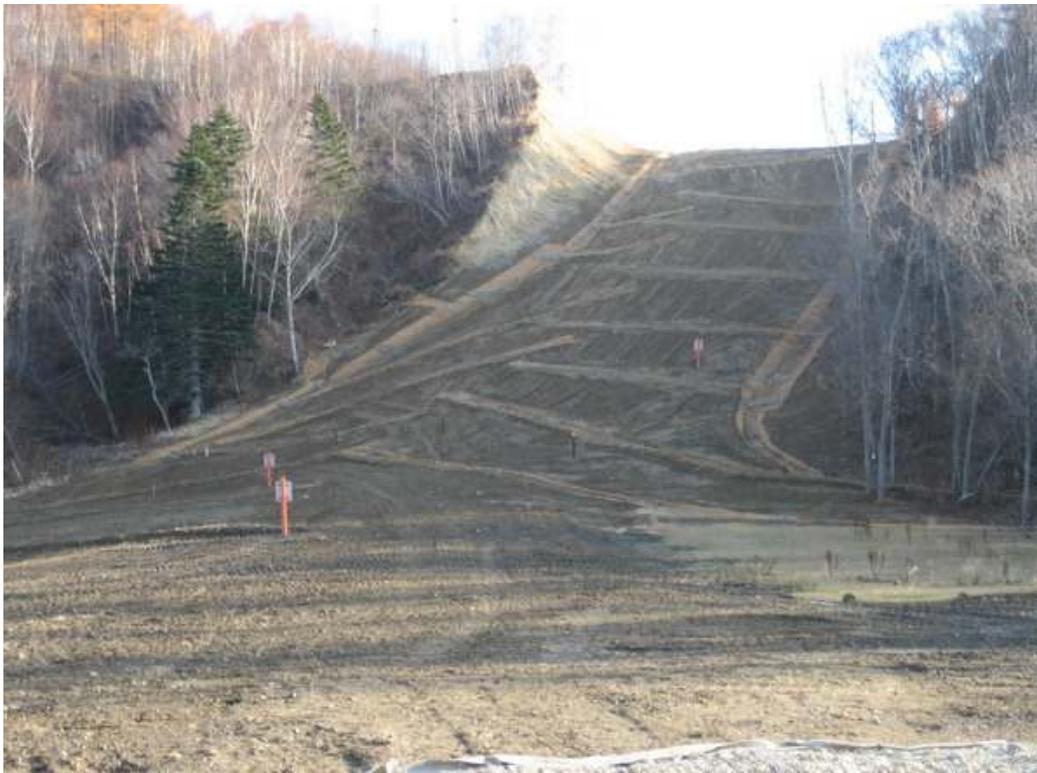
Photo 14 – KP 493 – Listvenitsa River Slope – Note the extensive armoured slope breakers on the slope.

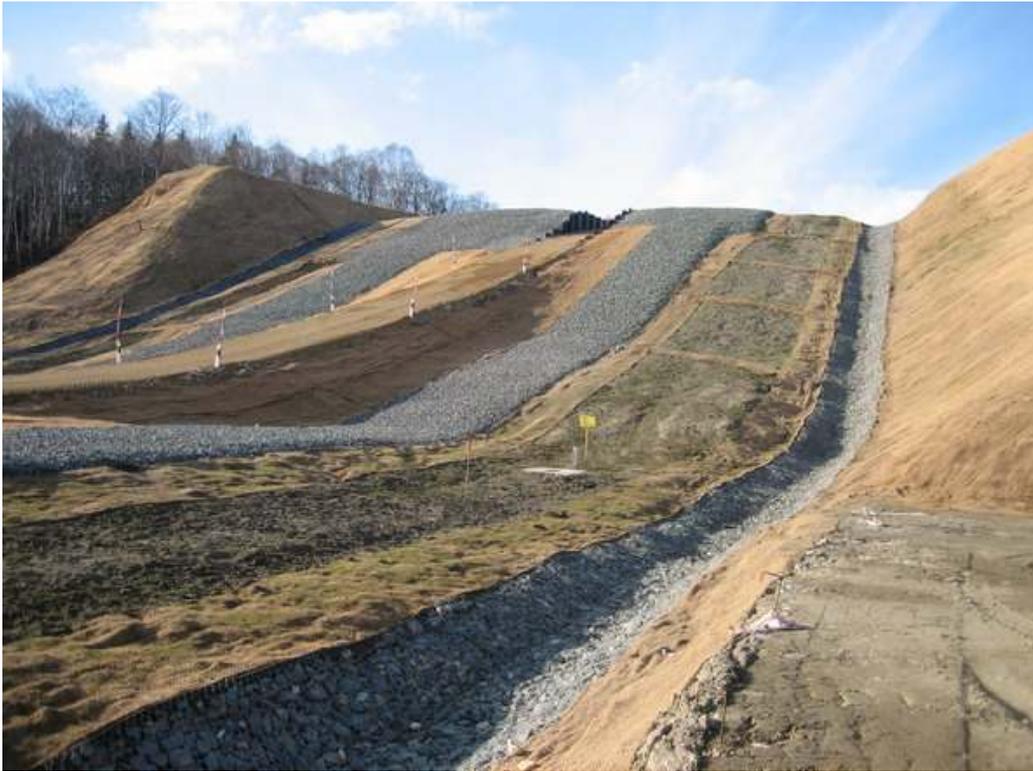
Photo 15 – KP 493 - Listvenitsa Fault – Completed fault crossing works. Note the feathered back side cuts with geojute protection.

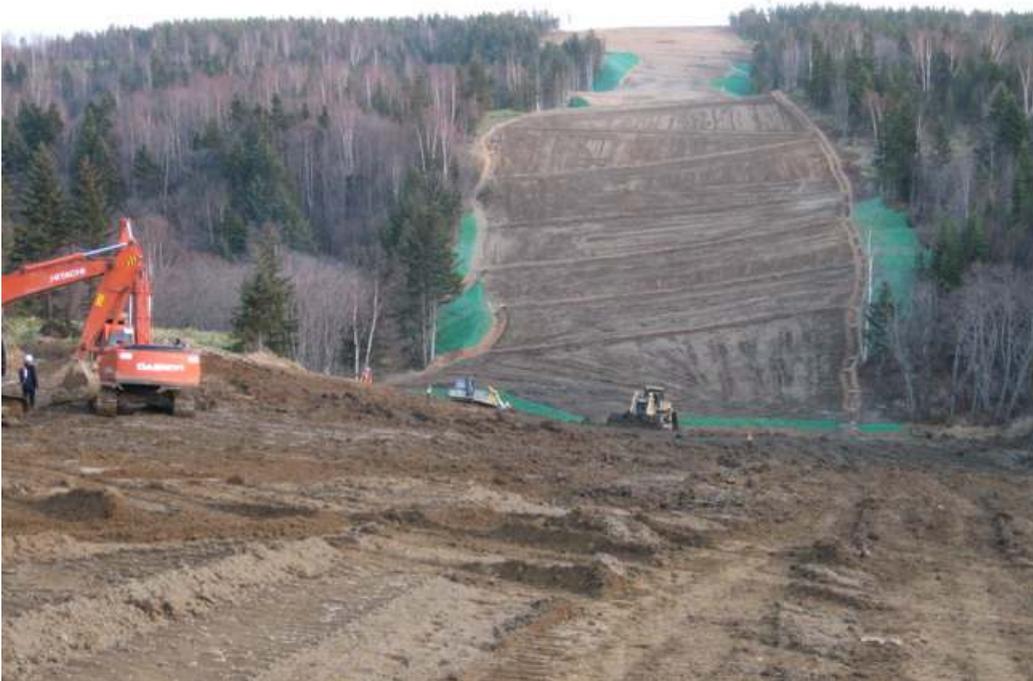
KP 506 to 508 – Final reinstatement work-in-progress was observed in the area of KP 506 to 508. The works included the full range of reinstatement requirements: grading to contour, construction of drainage and slope stabilisation with slope breakers, fortification of slope breakers with geojute, and stabilisation of side slopes with geojute and Rubulon Green geotextile on side slopes (Photos 16 and 17). Seed bags were already present on site and reportedly manual seeding will follow completion of the earth works.

Photo 16 – KP 507.5 - On-going grading to contour at KP 507.5. Note the Rubulon Green geotextile on the side cuts of the opposite slope.

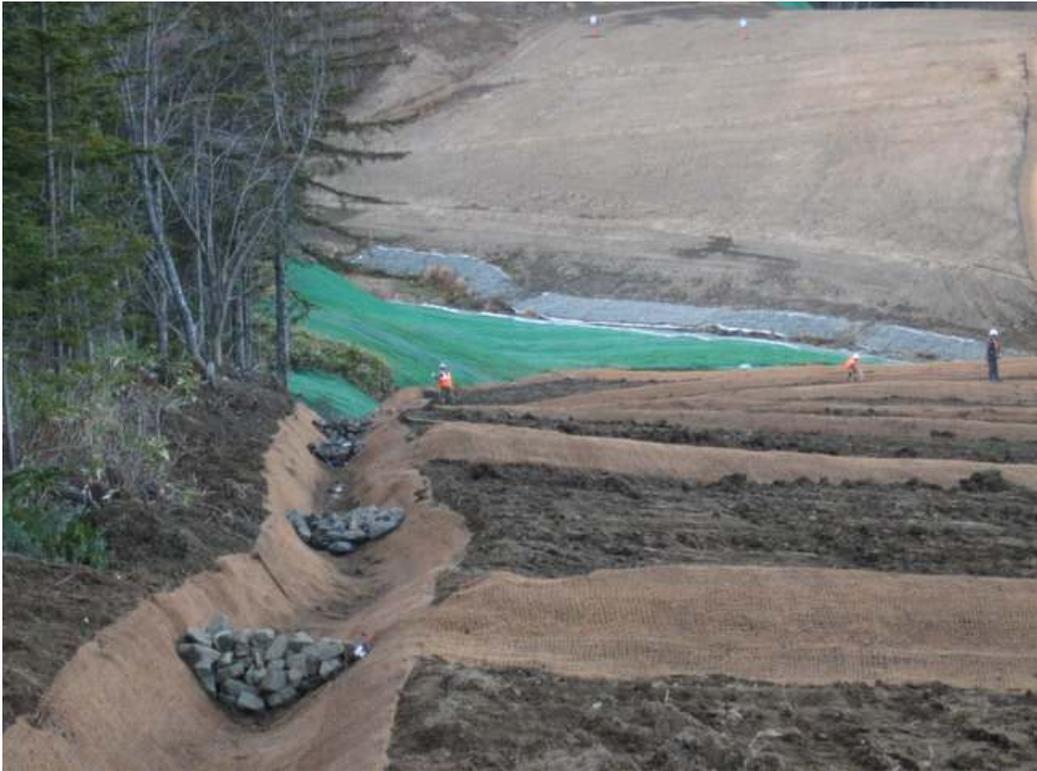
Photo 17 – KP 507 – Completed geojute armoured drainage and slope breakers on the near slope. Note the Rubulon Green geotextile on the lower side cut above the Reno matting.

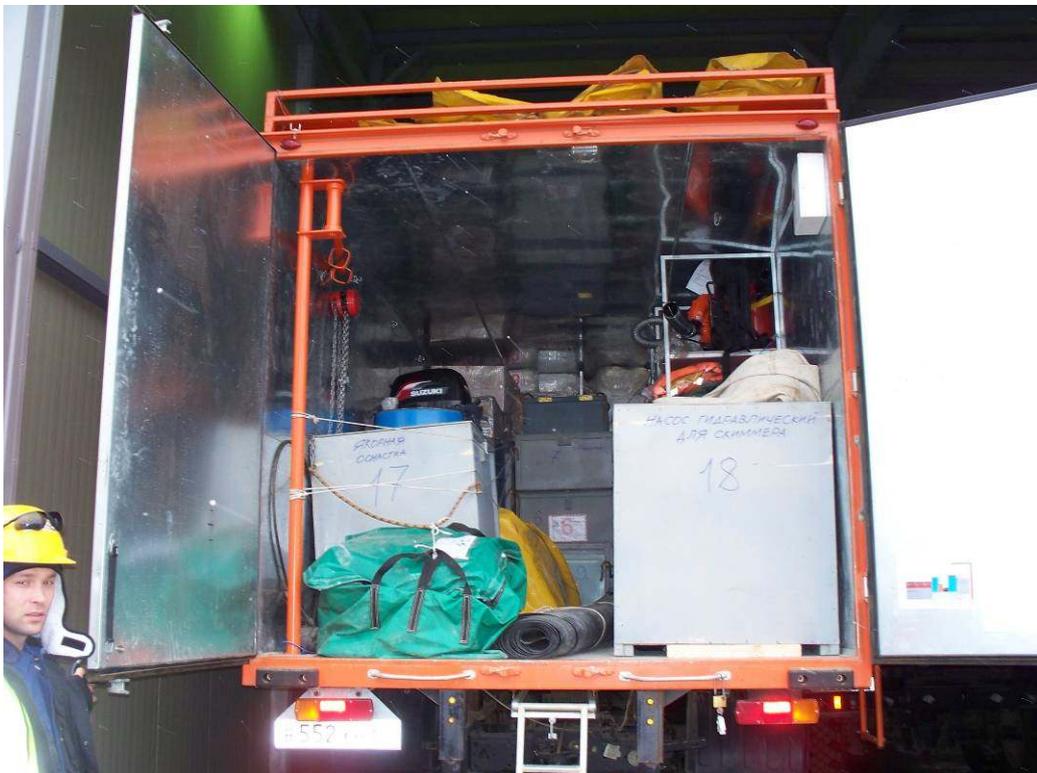
The OSR equipment held at the PMD was found to be comprehensive and appeared well maintained, neatly stored and in good order. Vehicles dedicated for OSR were pre-stocked with equipment and ready to mobilise in an emergency (Photos 18 and 19).

Photo 18 – OSR vehicle at PMD, pre-stocked and ready for mobilisation

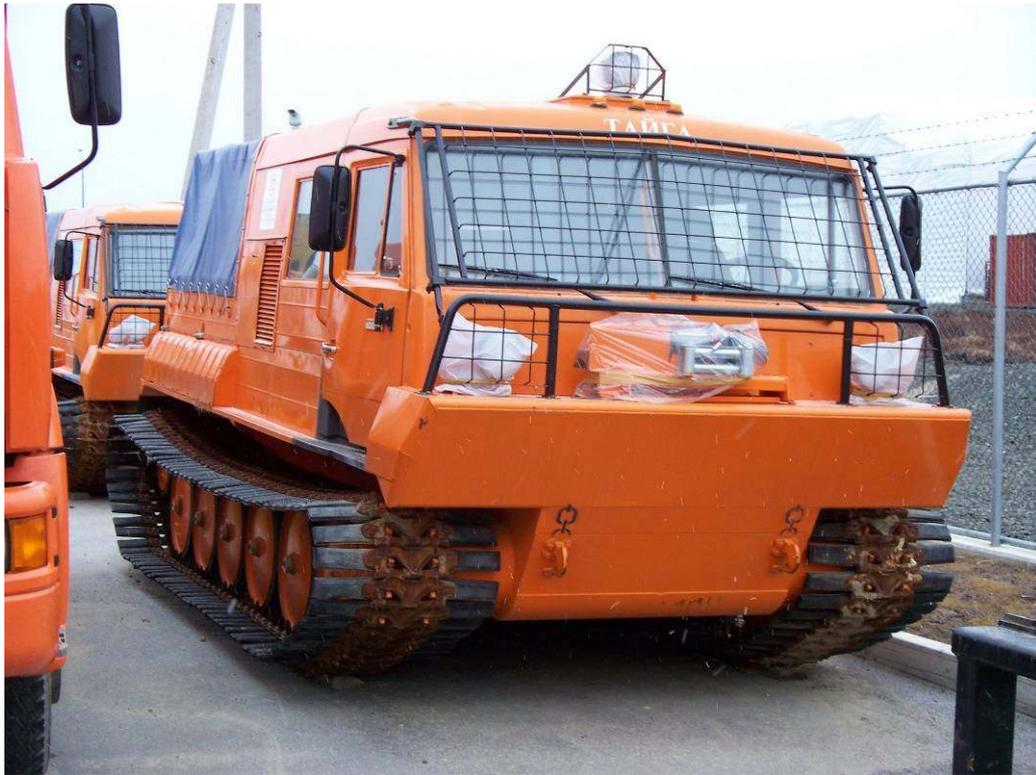
Photo 19 – Tracked OSR vehicles at PMD

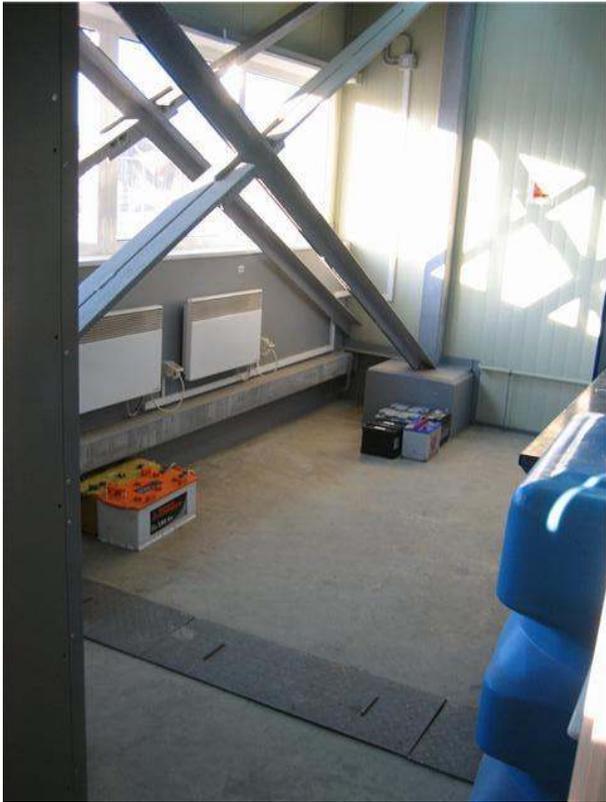
A newly constructed vehicle maintenance facility is incorporated into the PMD. During the visit, we observed that the facility was very clean and well organised. Batteries were stored in a segregated room (Photo 21) and there were spill cleanup materials and segregated waste containers on site. Used oil is collected in a labelled container and recycled. The sub-floor work bay and concrete floor appeared very clean and stain free (Photo 22).

Photo 21 – PMD vehicle maintenance building: segregated battery storage area

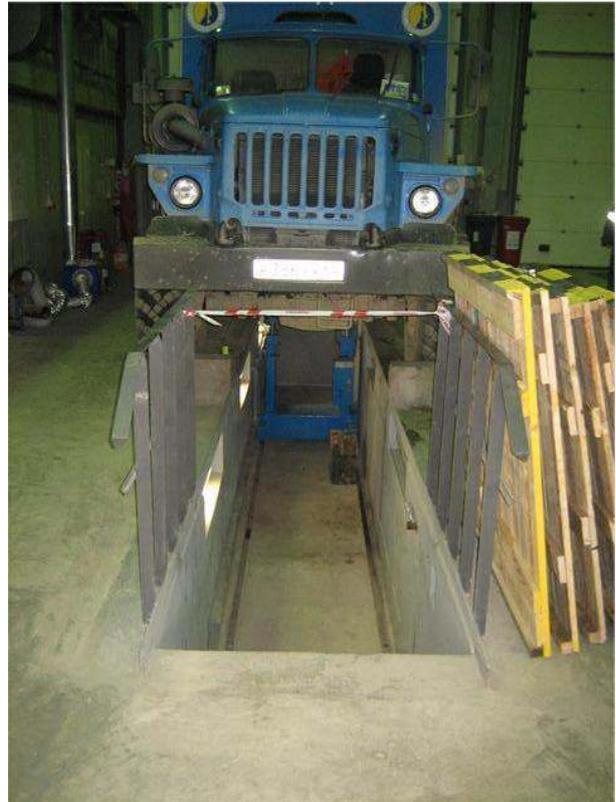
Photo 22 – PMD vehicle maintenance building: sub-floor work bay

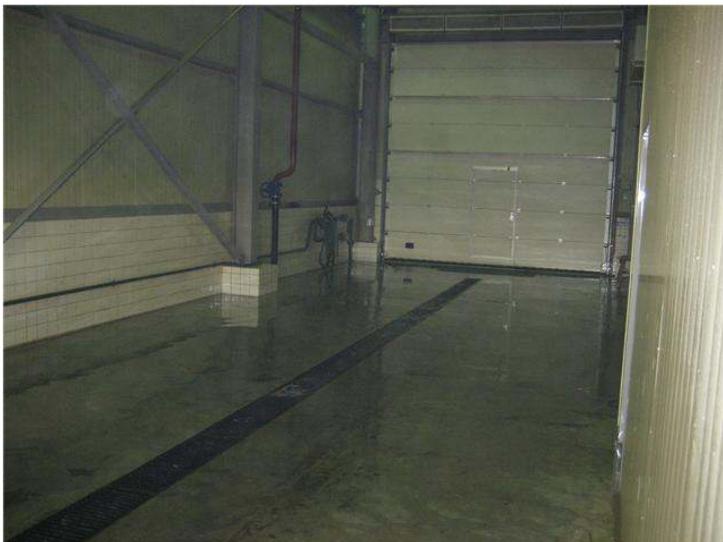
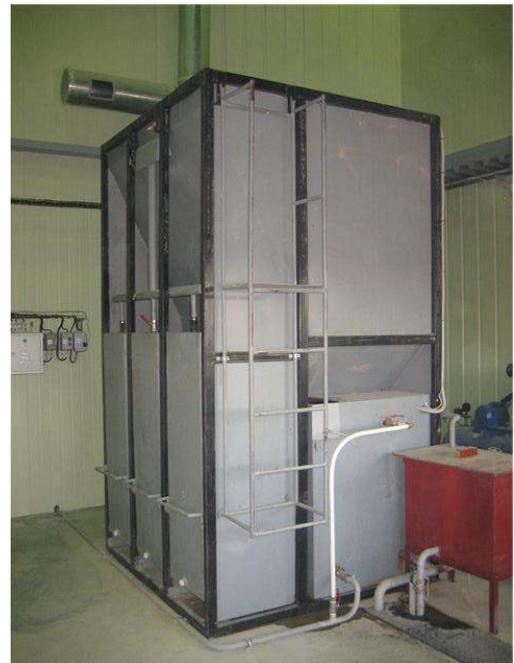
Photos 23 and 24 – PMD indoor vehicle wash building and wastewater treatment

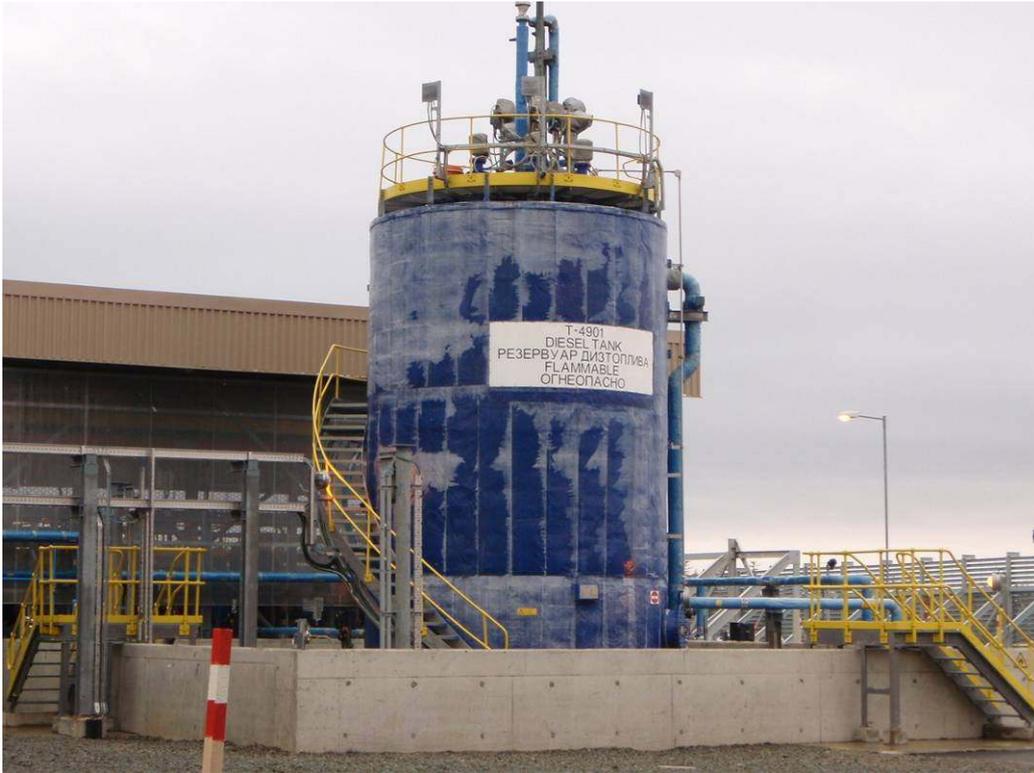
Photo 25 – Diesel storage tank within open bunded area – rain/melt water in drainage sump leads to multi-stage separator, through treatment system, into storm water overflow tank

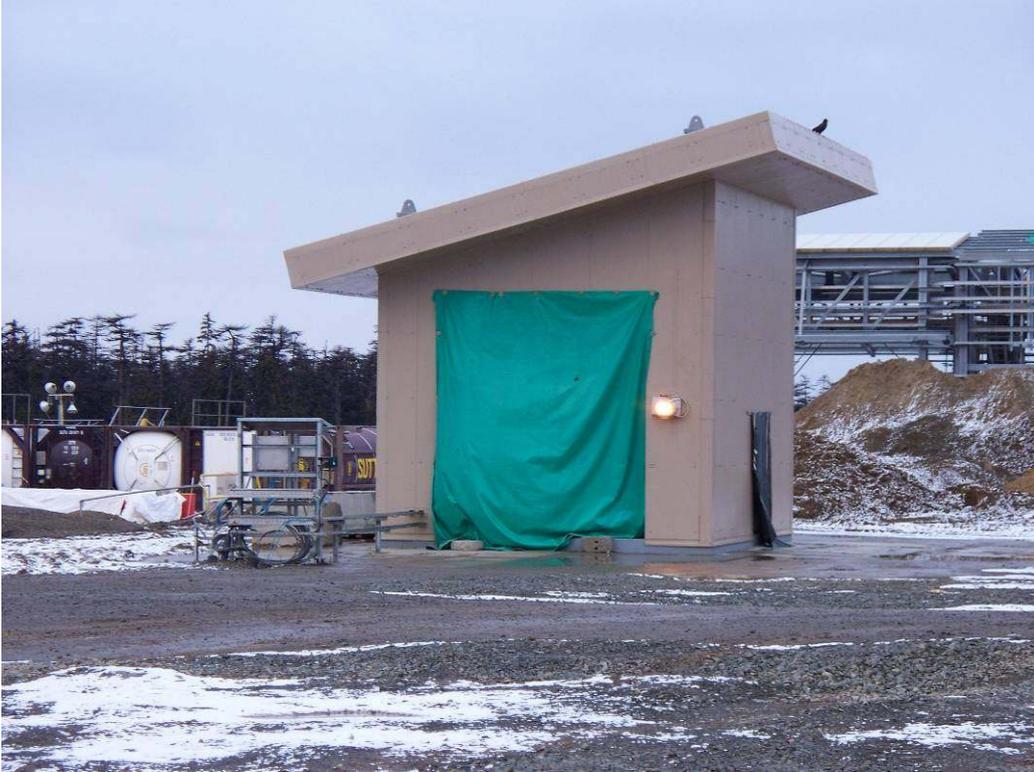
Photo 26 – Structure housing injection disposal wells – note tarpaulin-covered openings

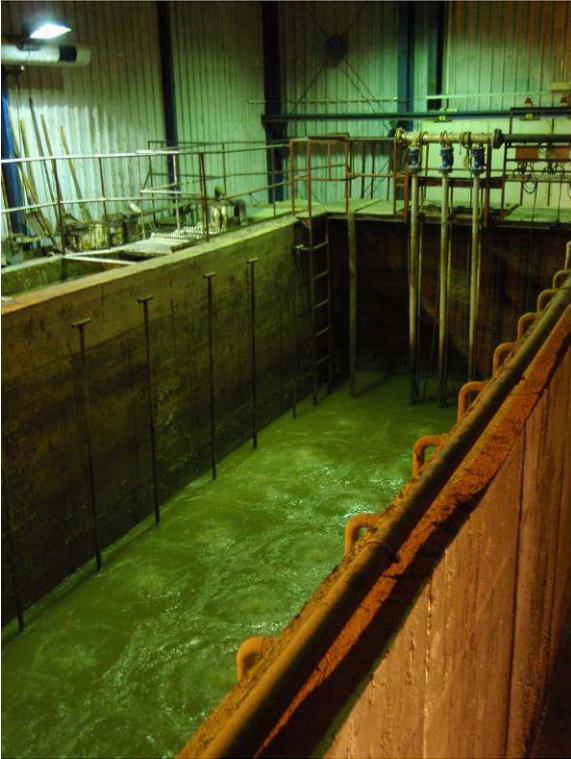
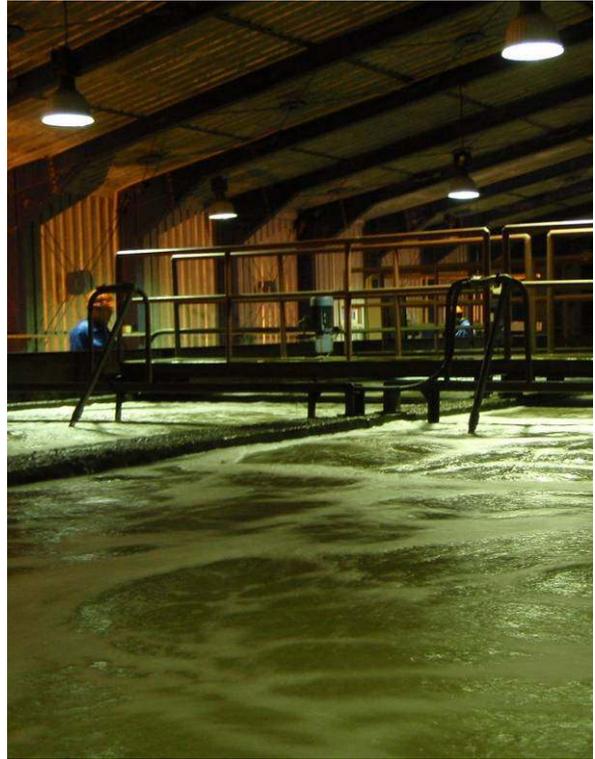
The BETS STP facility was visited and found to be in good condition with a trained operator on hand (Photos 27 and 28). It has a small in-house bench laboratory that is able to analyse parameters such as nitrates, nitrites, phosphates and BOD₅ in real time (Photo 29). External contractors (DRC Group) undertake formal laboratory analysis of the discharged effluent on behalf of Sakhalin Energy once a month, as per RF regulations. Laboratory results indicate frequent exceedences of permitted concentrations of some parameters during 2008. Exceedences of suspended solids were noted early in the year, however falling within permitted levels more recently. It is understood that actions are considered in the event of an exceedence to prevent possible recurrence, such as changing to phosphate-free kitchen and laundry detergents, and clearing drains of excess sedimentation. However, of greater concern are the high levels of BOD, which have exceeded the permitted values every month in 2008 with only one exception. However, as the wastewater volume decreases with reduced workforce, the allowable residency time of wastewater at the STP should increase, resulting in lower levels of BOD upon release. (In addition, we note that the treated wastewater is discharged to the surrounding wetland (rather than to a stream) and this reduces the significance of elevated BOD levels.)

Photos 27 and 28 – BETS STP facility

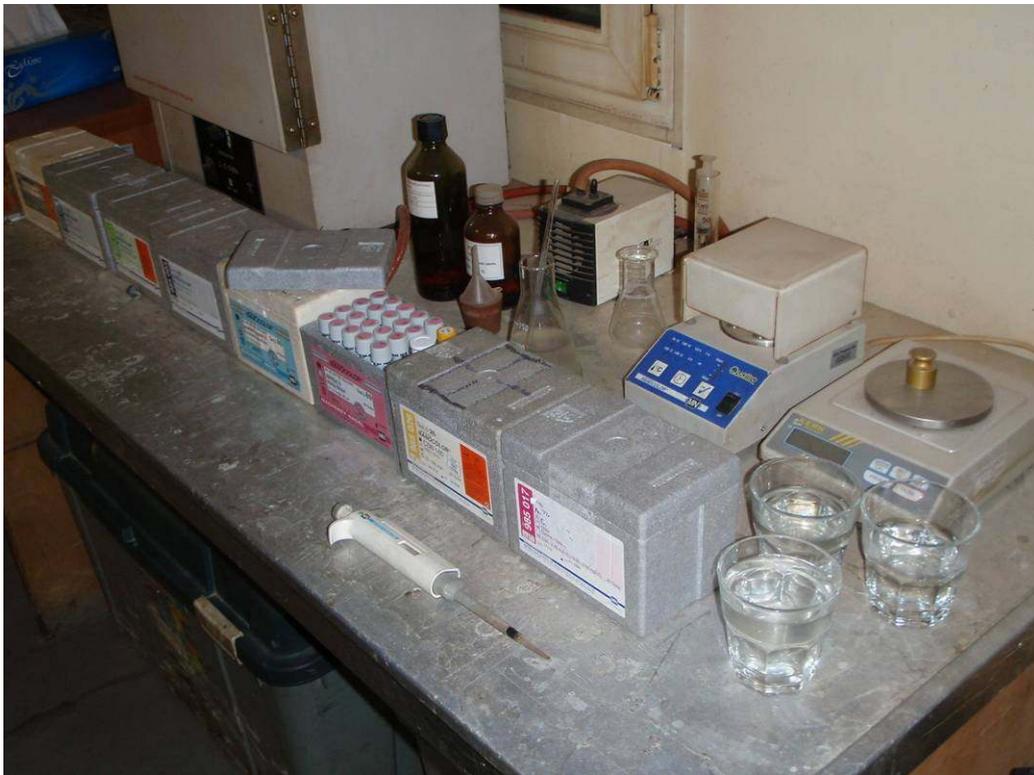
Photo 29 – Small scale, real-time chemical analysis at the BETS STP
