Lenders' Independent Environmental Consultant Site Visit Report: November 2008 Sakhalin II (Phase 2) Project

Report to Sakhalin II (Phase 2) Project Finance Parties

Restricted – Commercial
AEAT/ENV/R/2738 Issue 2
February 2009

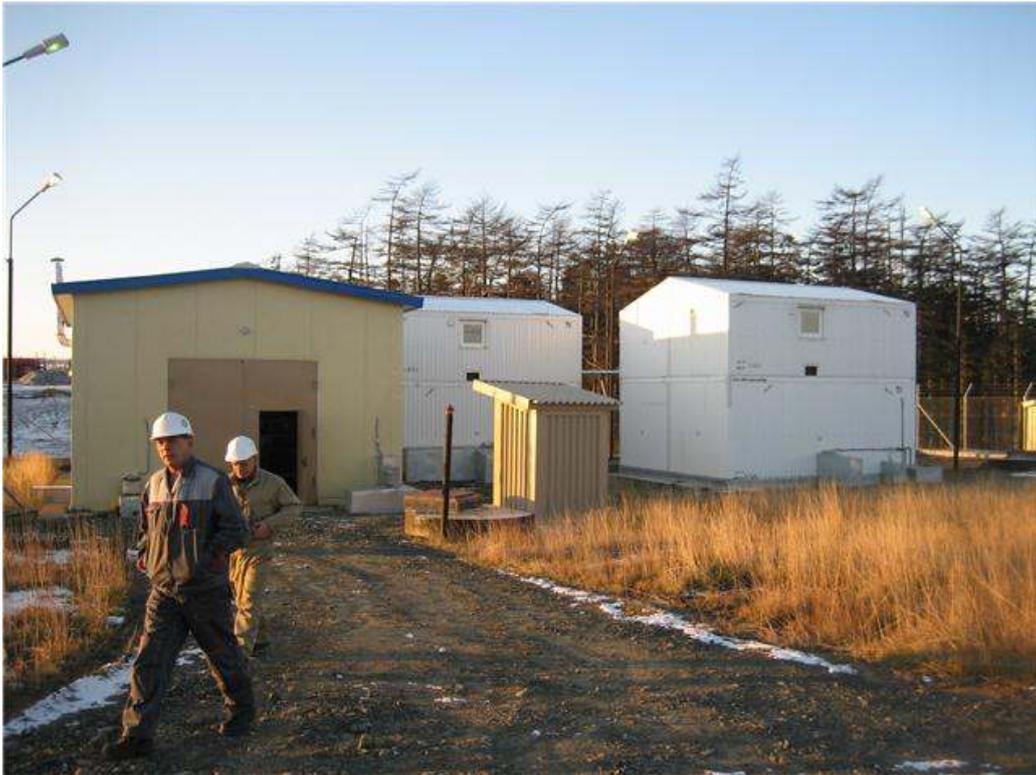
Photo 30 – Operations STP (for PAO and PMD)

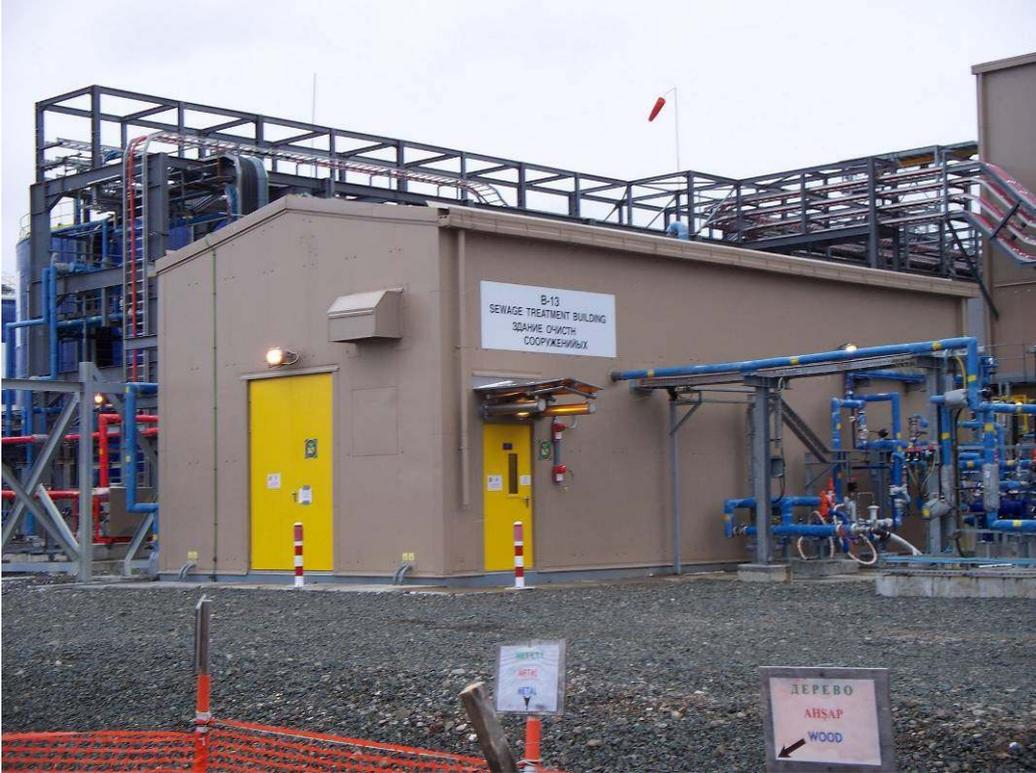
Photo 31 – OPF process facility STP, not used

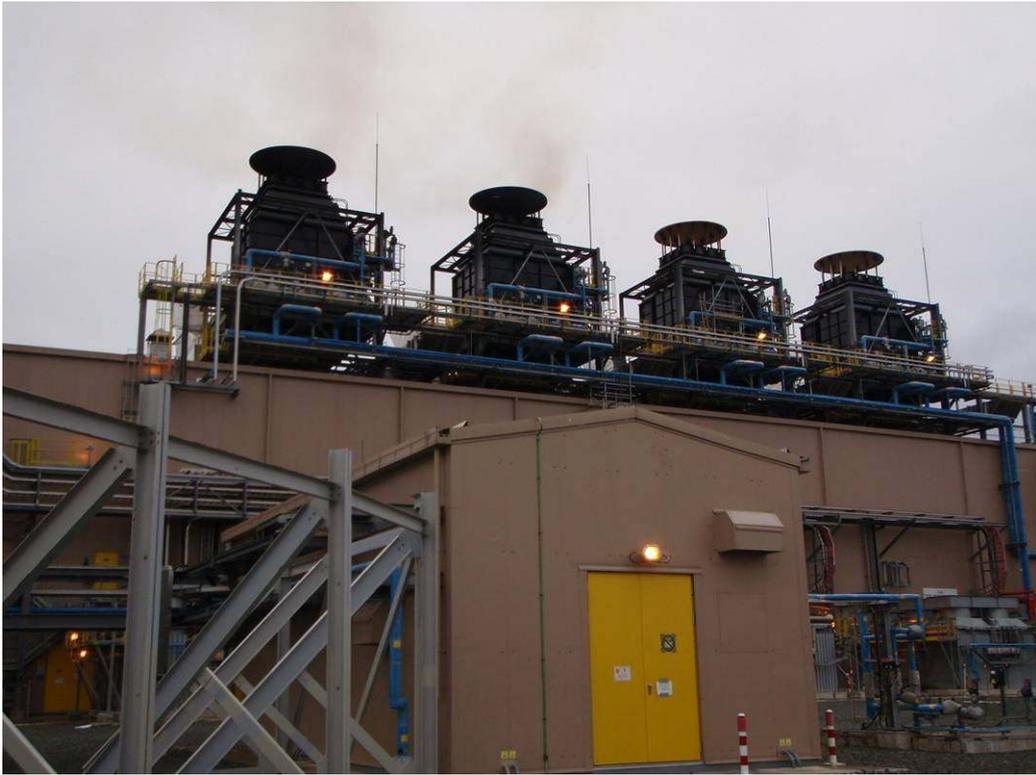
Photo 32 – Power generation turbines: A-4001C/D (left of picture) currently on diesel, and gas turbines A-4001A/B (right of picture) due to be commissioned November 2008

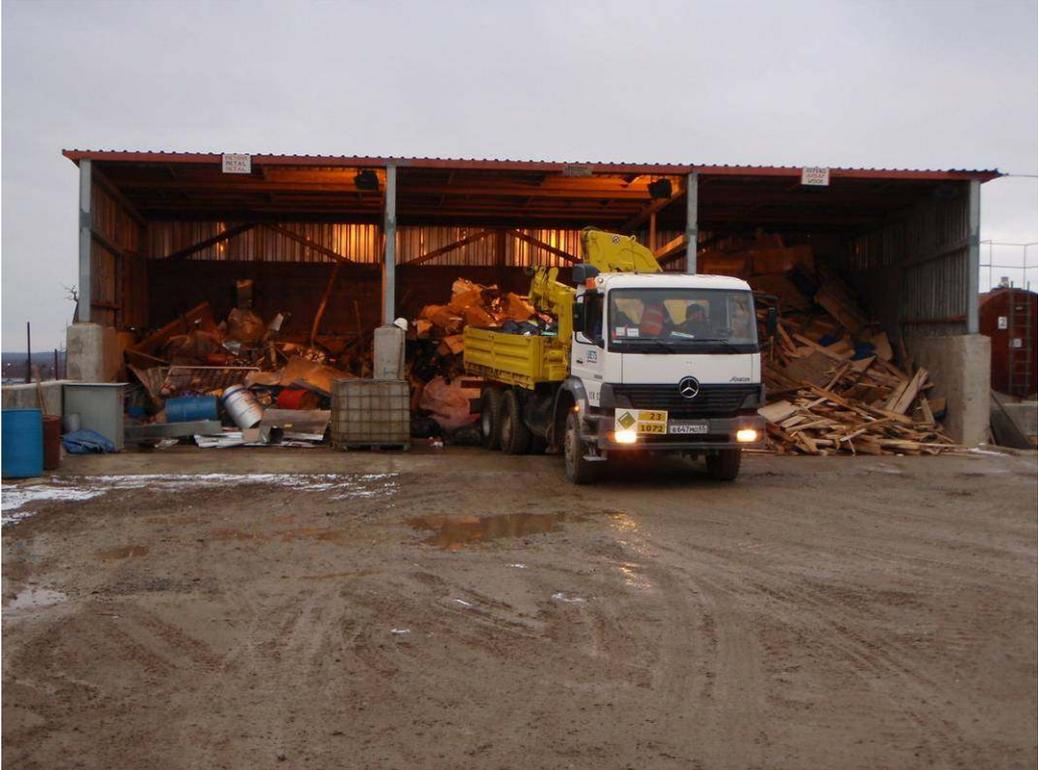
The running and record keeping for the temporary waste transit area was found to be good at this visit, with the bulk waste of metal, general trash and wood wastes being separated in concrete bays and covered with a roof (Photo 33). The general trash from the OPF is transferred to the Nogliki upgraded landfill by Ecoshelf, and metal is taken for recycling in Yuzhno. The negotiation over gifting the wood for use in the local community is still ongoing – there are tax implications associated with proposed gifting, and it is hoped that these will be resolved soon.

Photo 33 – Segregated waste storage bays at temporary waste transit area

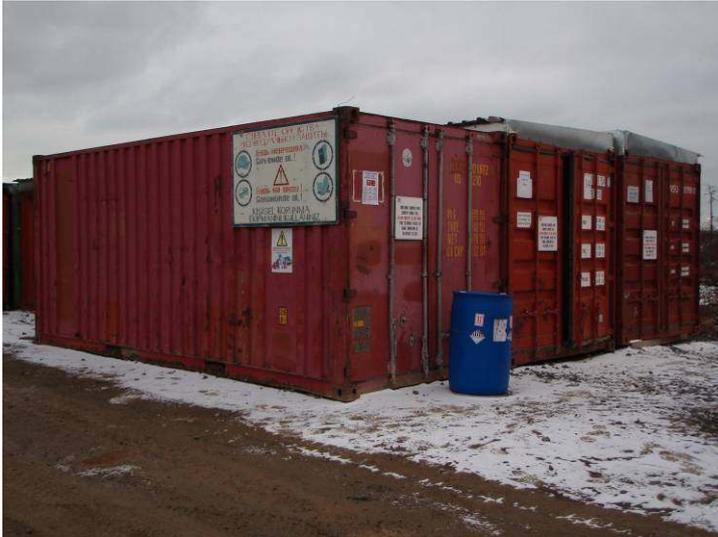
Used drums are stored in separate concrete bays adjacent to a drum washing facility and are collected by Ecoshelf for disposal. Hazardous waste is also stored in separate, locked ISO (shipping) containers and with very few exceptions was found to be well labelled and segregated (Photos 34 and 35).

Photo 34 – Hazardous waste in locked ISO containers

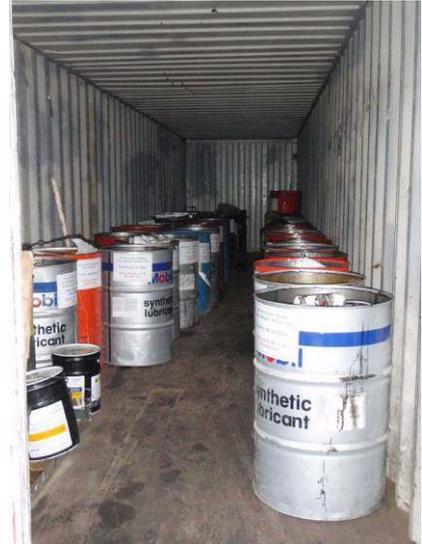
Photo 35 – Typically tidy storage of waste within ISO containers

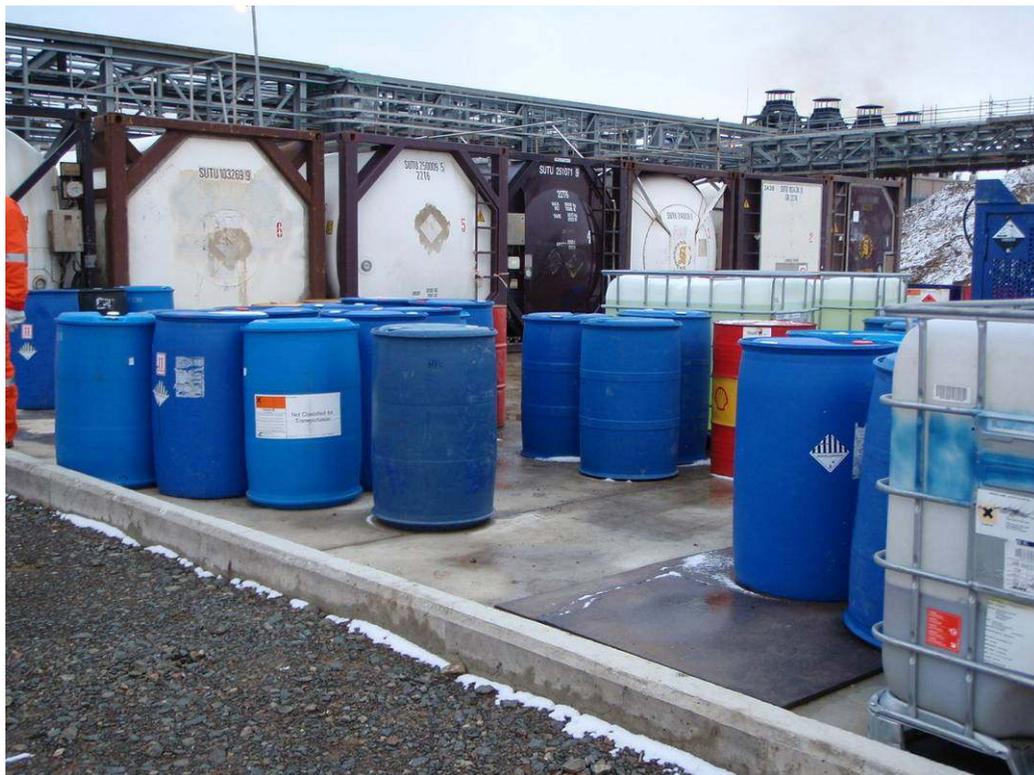
Photo 36 – Temporary chemical storage area, shared by project and operations teams

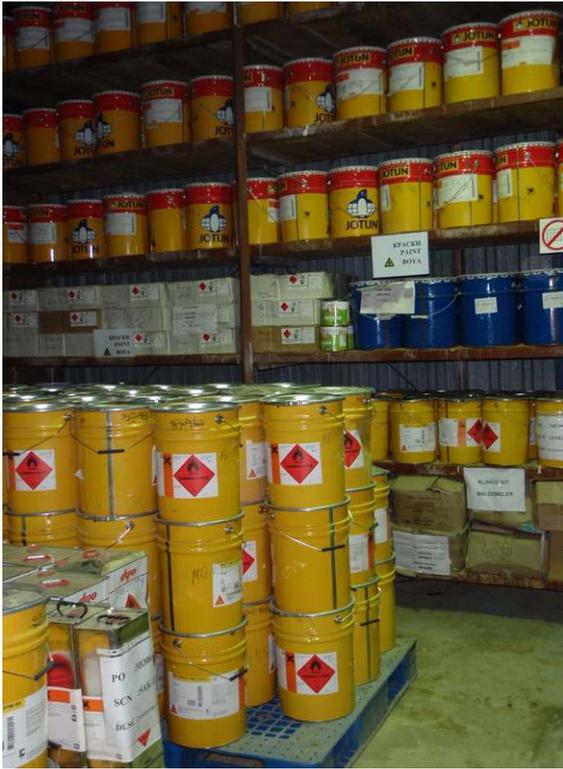
BETS operates a chemical storage warehouse. The warehouse was observed during the visit to be well organised, clean, and without stains on the concrete flooring (Photo 37). The majority of the chemicals stored comprised a variety of paint products. Also noted were drums of grease, oil and trichloroethylene (solvent). No handling of chemicals was noted on site. MSDS were present in organised folders on a dedicated shelf (Photo 38). MSDS were available in Russian, English and Turkish. The warehouse also included materials for the cleanup of spills and spill waste containers. This warehouse is proposed to be retained by the project expansion team.

Photo 37 – BETS chemical storage warehouse

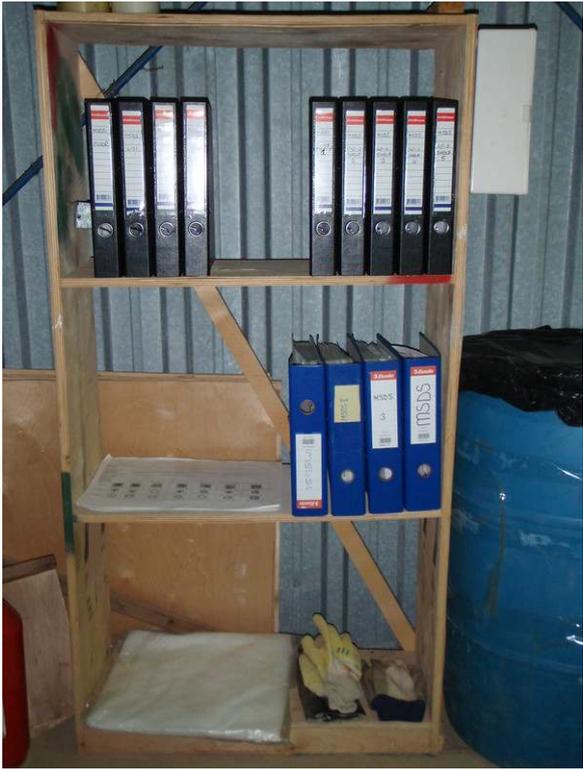
Photo 38 – Easily accessible MSDS and stocked spill kits (blue drums, right)

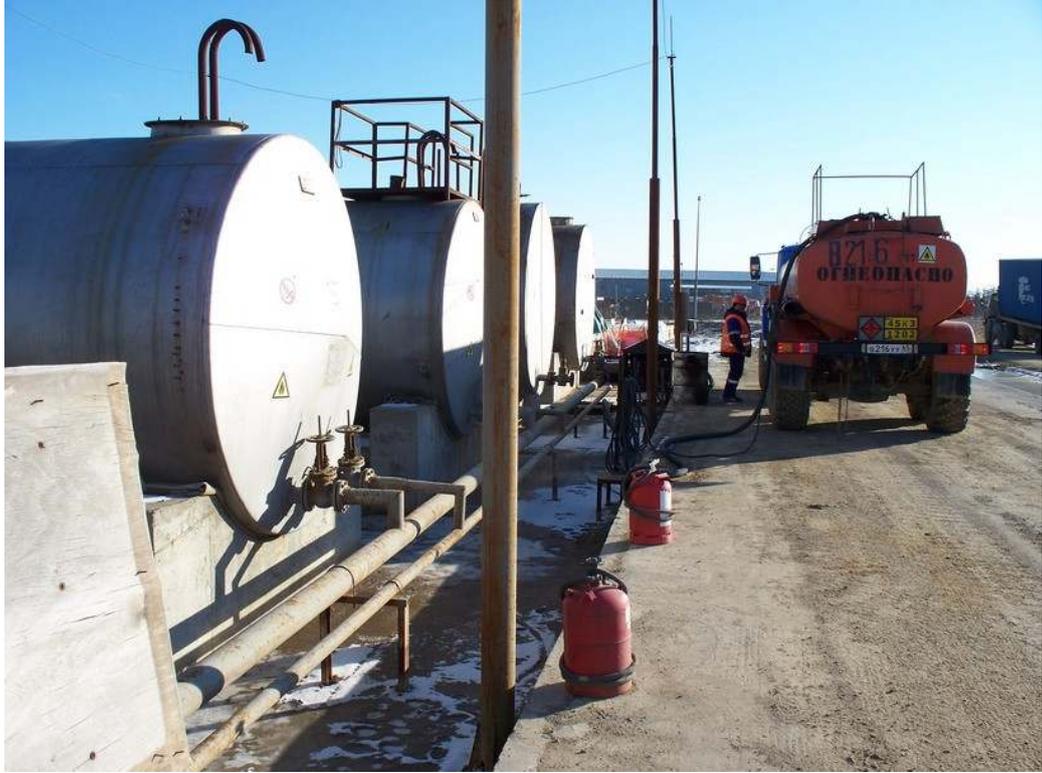
This area is currently used by BETS project team and is designated for mothballing. The site was visited and was found overall to be clean and well organised. There are six above ground storage tanks situated on a bunded concrete floor (Photo 39). Tanker trucks used to re-supply the above ground storage tanks park in a separate area also containing a bunded concrete floor with inclined ramps to allow vehicle access in and out.

Photo 39 – Diesel storage area

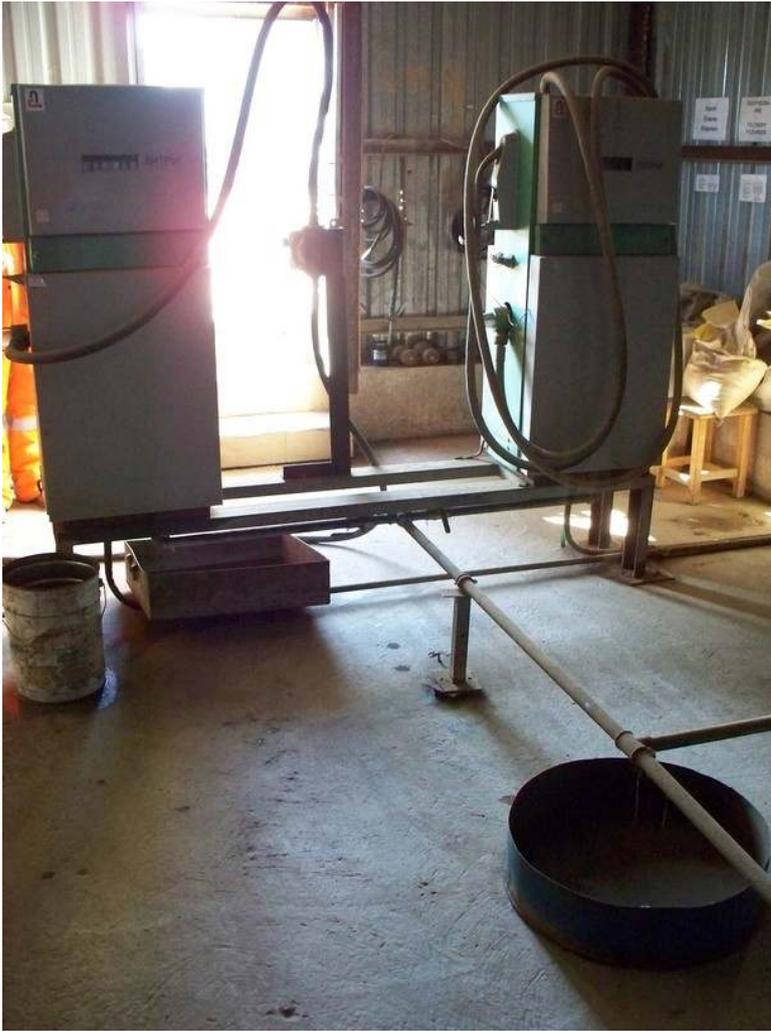
An attached building houses the hand pump, which is used to refuel smaller vehicles (Photo 40). This is situated within the same bunded area. Inside the building, the concrete floor was clean with no evidence of leaks and secondary containment was used under joints in the piping and the hand pump unit. The actual hand pump was resting in its own secondary containment unit. Several large fire extinguishers were on-site and were easily accessible.

Photo 40 – Indoor diesel hand pumps at diesel storage area
