APPENDIX 4: RIGHT OF WAY REPORT

Title: Photographic Log – Right of Way	Client: Sakhalin-2 Phase 2 Lenders
Site: Sakhalin Energy Investment Company	Date: October 2015

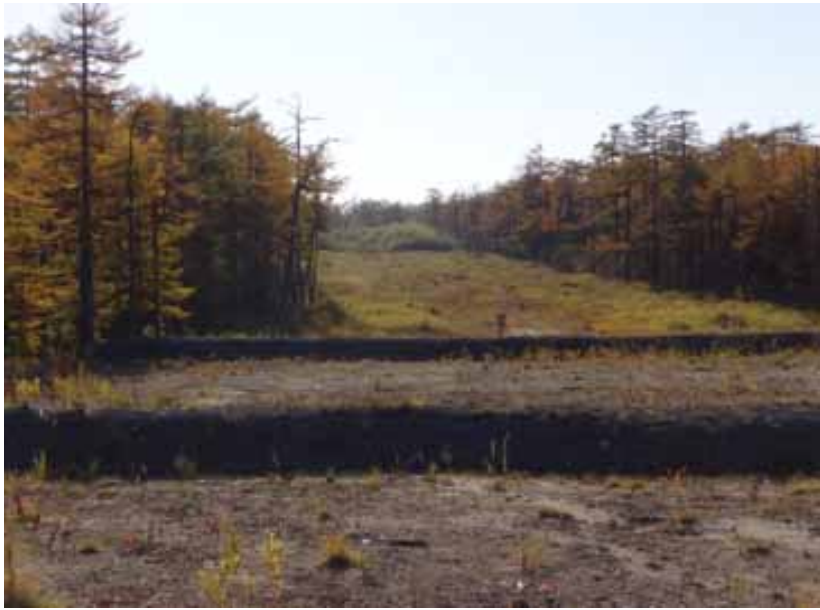
The RoW in the immediate vicinity of the access road to NOB-4 is poorly vegetated (Photo 1). The ground cover in the background of Photo 1 shows a slight improvement over the surface cover in October 2014 as indicated (for comparison) in Photo 2. The site has erosion and sediment control in place and reportedly the site is scheduled for additional seeding.

Photo 1. View to the west showing poorly vegetated area in the foreground and good vegetation cover further west towards the riverbank.

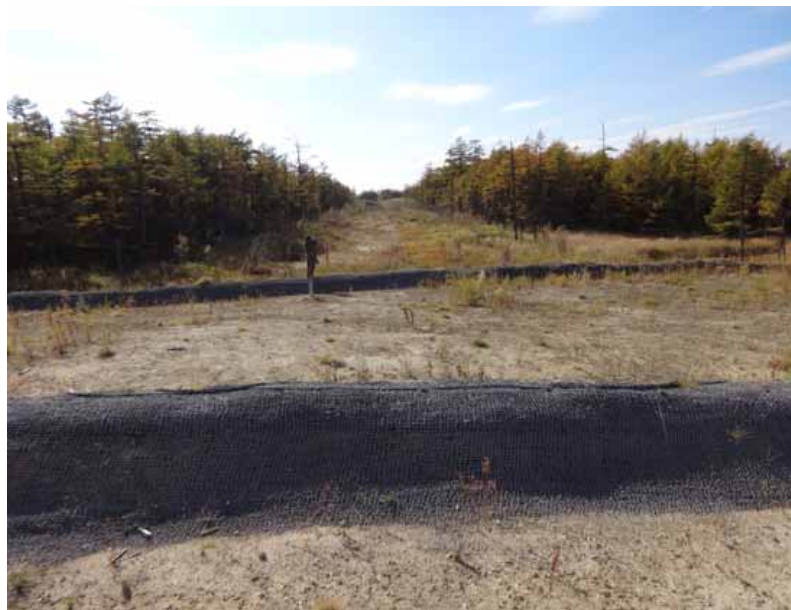
Photo 2. View to the west during the 2014 site visit – note only slight improvement of the vegetation cover in the foreground.

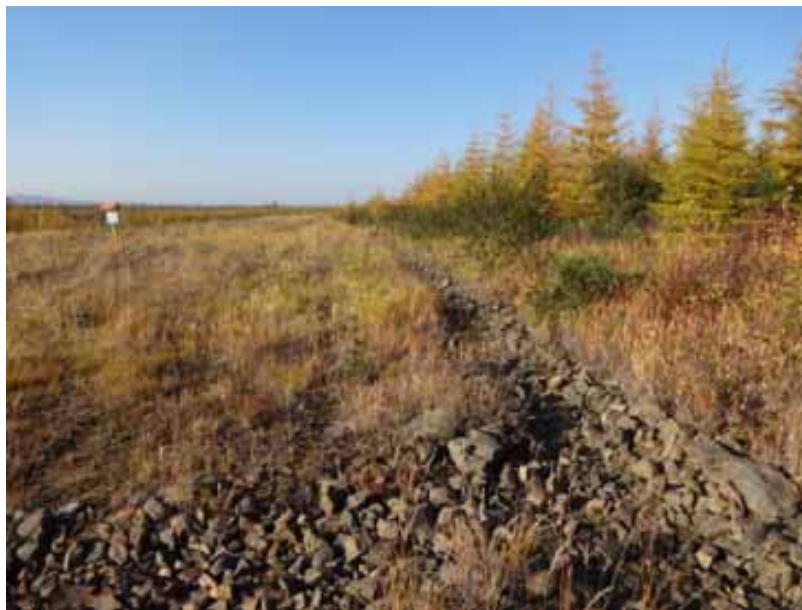
This RoW segment has a slight slope to the west across the RoW. The Company has installed a riprap-protected cut-off drainage ditch that directs the discharge into shallow riprap-protected cross drainage channels, which discharge into flume pipes that cross the access road (Photos 1 and 2). This arrangement appears to be effective since no erosion was visible along the sandy RoW.

Photo 1. Showing rip rap lined cut off channel with a junction of a cross channel

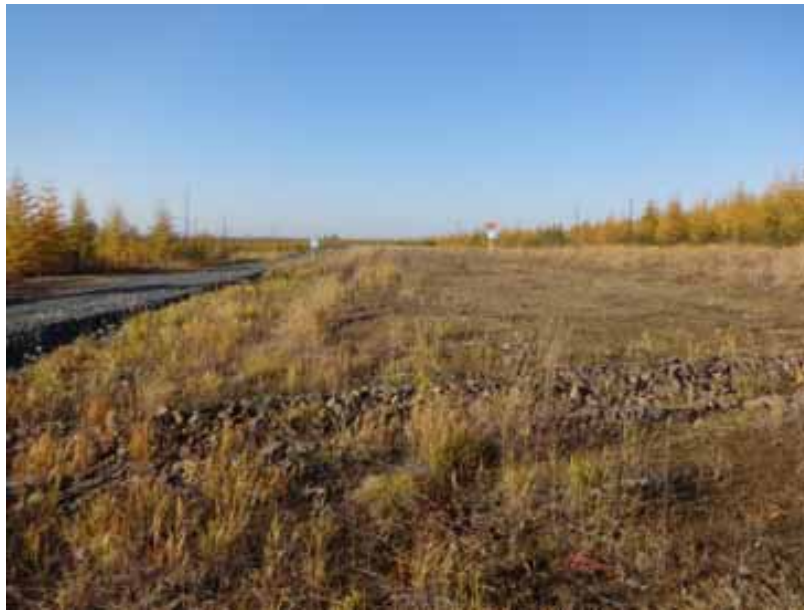
Photo 2. Showing cross channel leading to culvert under the access road

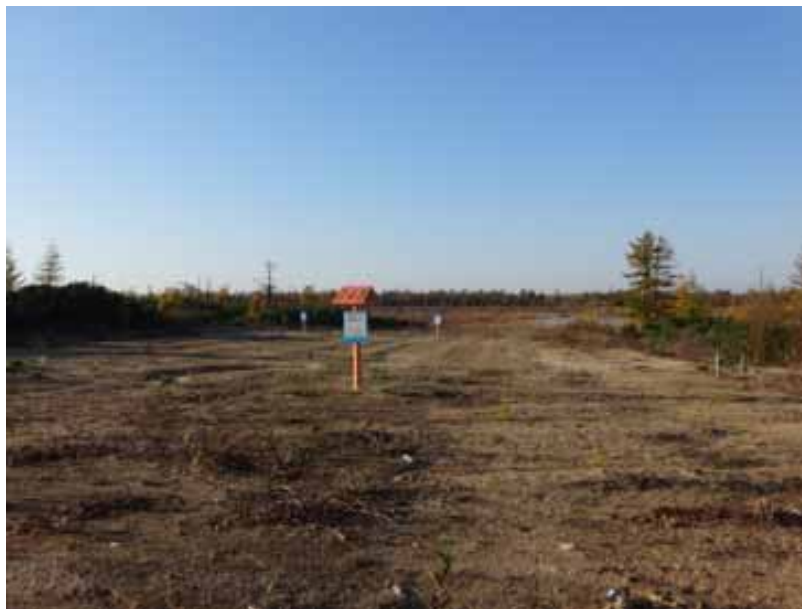
The Evai River was flooding the low lands and reportedly may be developing a new channel. The RoW leading to the river from the south is sandy and with little ground cover. An erosional channel is developing on the slope to the river (Photo 2). Saplings have been cut and the Company has reported that the site is scheduled for reseeded. It is recommended that interim sediment and erosion control measures are considered on the slope.

Photo 1. Showing sandy slope leading to river with minimal vegetation cover.

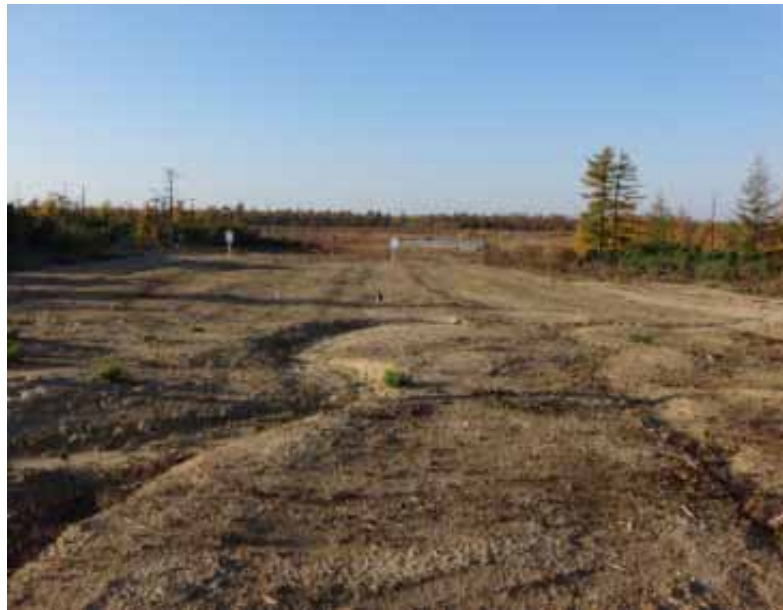
Photo 2. Showing erosion channel.

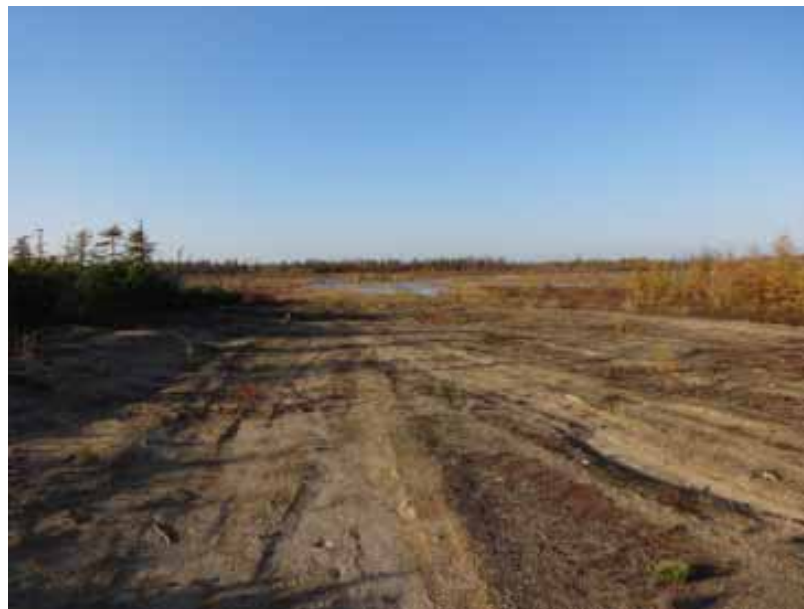
There are many vehicle tracks visible on the RoW between NOB-9 and the river (Photos 1 to 3).

Photo 3. Many vehicle tracks are visible on the RoW.

All efforts should be made to minimise access to vehicles.

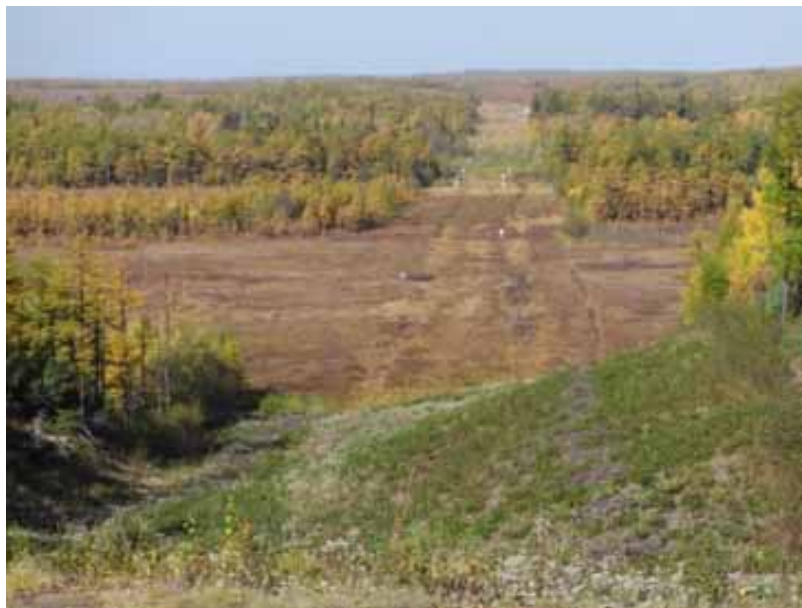
Tree removal was conducted in the previous year (see piles of cuttings in Photo 2) and the saplings that are re-emerging are still very small (Photo 1)

Photo 1. Oct 2015 – View to the north at the Dagi River wetland showing minor improvement over the previous year (October 2014).

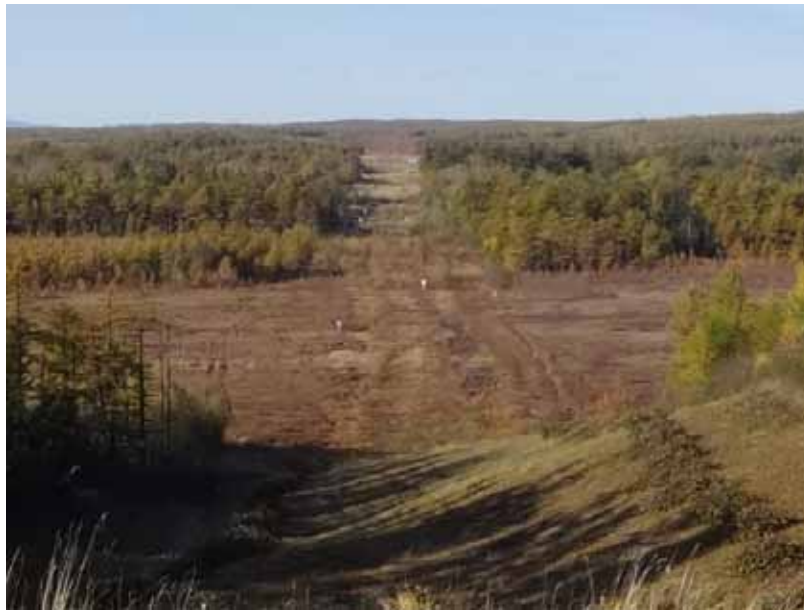
Photo 2. Oct 2014 View to the north at the Dagi River wetland.

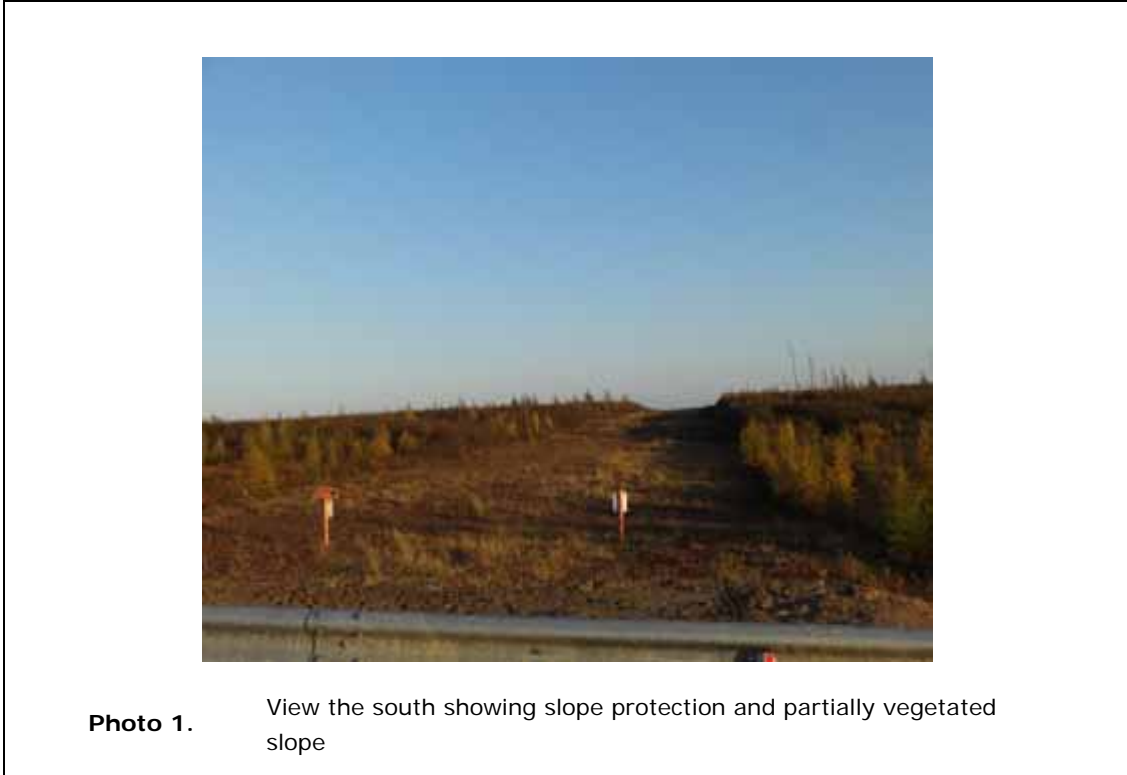
Photo 1.

The RoW at the road crossings at KP 79 has poor vegetation cover on a sandy slope on the north side of the road (Photo 1) and partial cover on the south side of the road (Photo 2).

View the south showing slope protection and partially vegetated slope

It is recommended that the site be placed on the reseeding schedule.

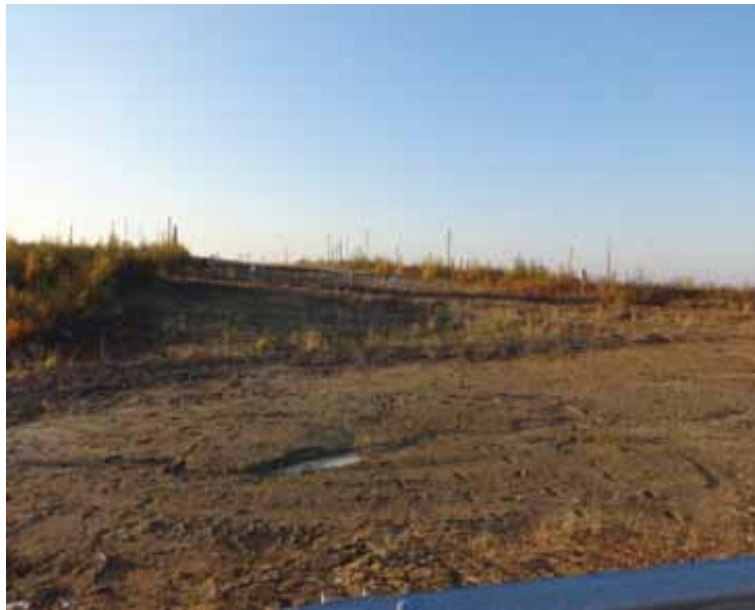
Photo 2. View to the north showing poorly vegetated sandy slope with slope breakers at the upper portion.

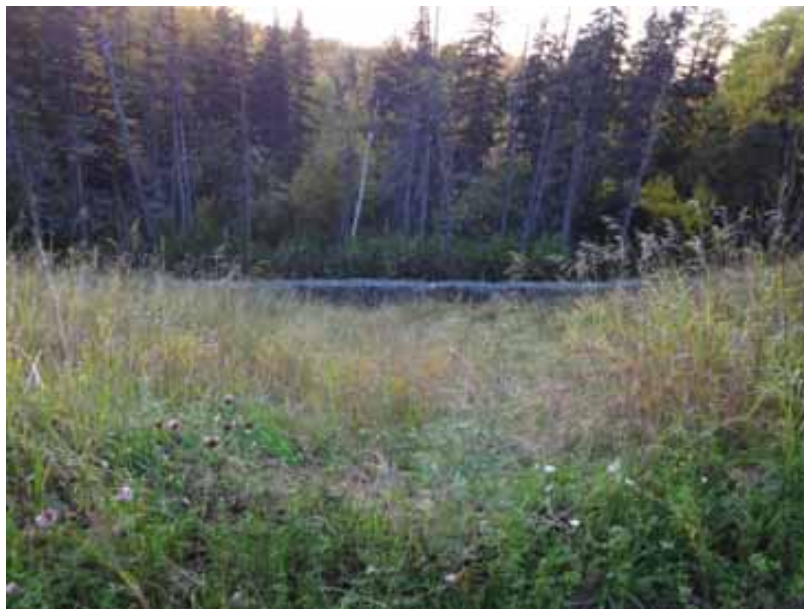
The section at approximately KP 87.5 required repair along the side slope. The section currently appears stable (Photo 3) and is monitored.

Photo 3. View to the side of the RoW showing gabion wall to stabilise slope.

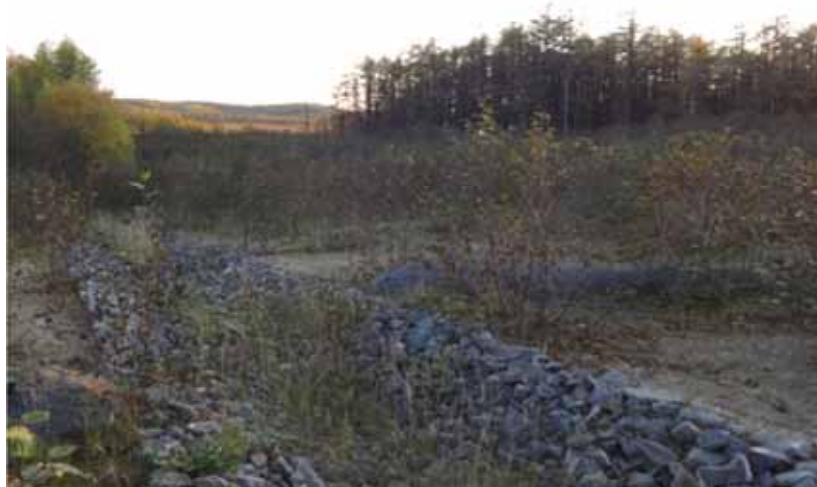
During last year’s monitoring visit the RoW south of NOB-16 Block Valve Station and north of the Djimdan River crossing on the slope leading to the river was covered by dense growth of Alder trees that reached two or more meters in height. Since then, the trees on the RoW between NOB-16 and the river have been removed – See comparison in Photos 2 and 3.

Photo 3. Oct 2014 - View south from the Block Valve Station showing dense growth of Alder on the RoW.

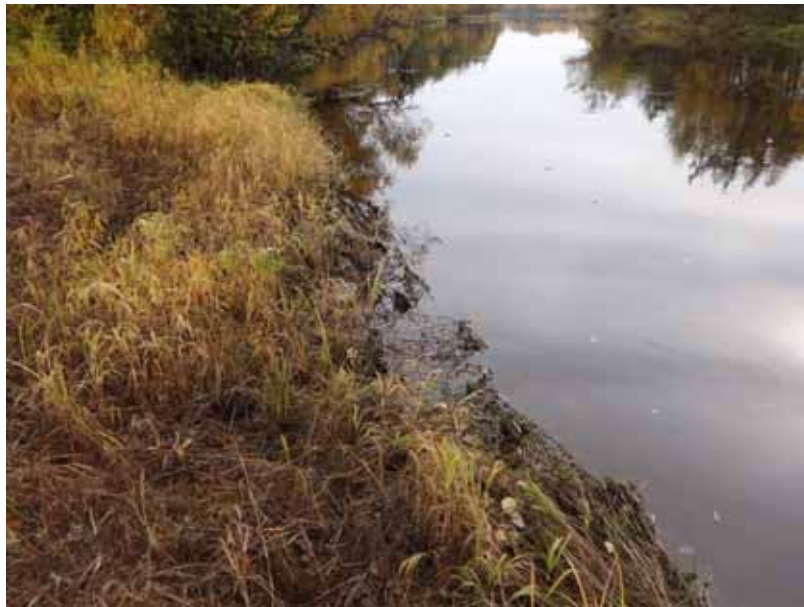
The riverbanks are well vegetated and with Reno matting on both banks. On the northern bank there are signs of reno mat deterioration that will require monitoring.

Photo 5. Close up view on the north bank of the river showing deterioration of Reno matting.

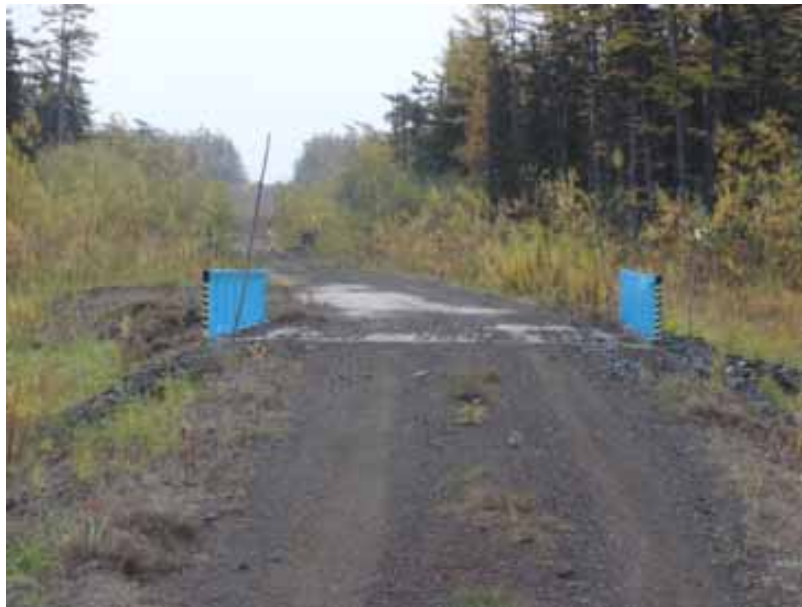
Few of the existing bridges along the access road were repaired/improved including the silt fences along the bridge and riprap covering the banks by the bridge footings (Photos 3 and 4).

Photo 3. View of bridge and silt fence. Note the sapling rich area behind the bridge.

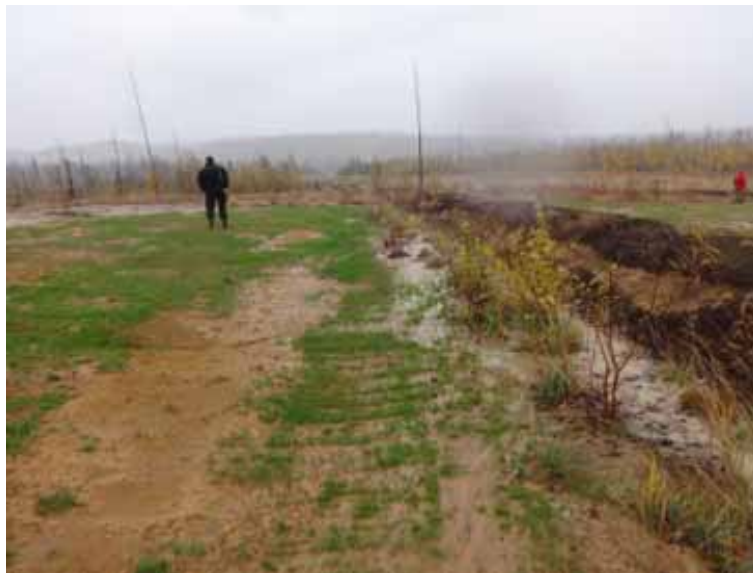
Previously, this area (which was likely used as a staging area during construction) was bare of any vegetation. The area was reseeded earlier in 2015 and the results are shown in photos 1 and 2.

Photo 1. View of reseeded sandy area.

The site should be monitored to see if the new grass growth will regenerate following the winter.

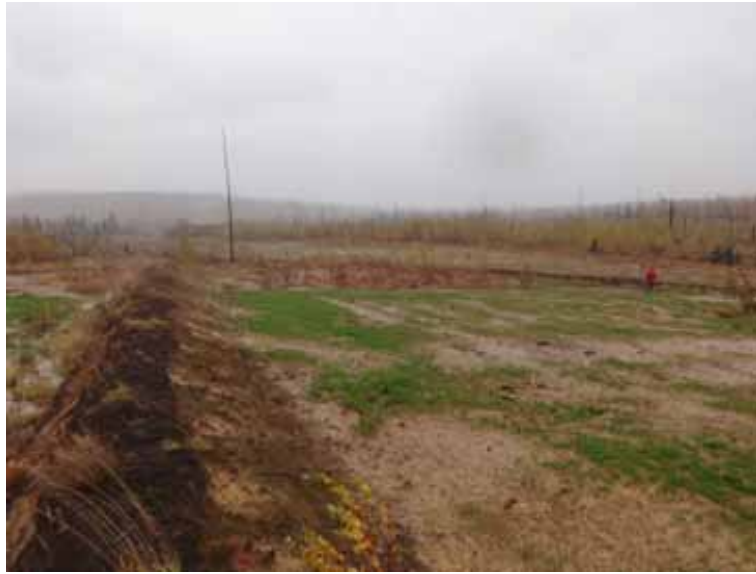
Photo 2. View of reseeded sandy area.

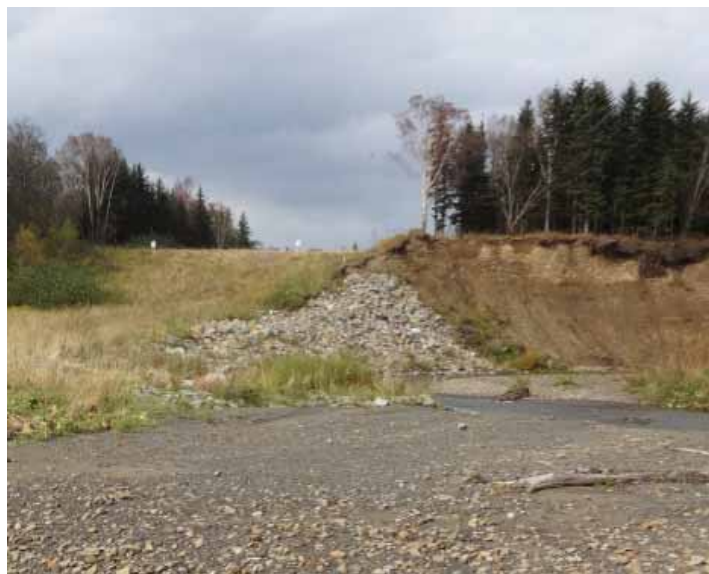
The Kirpichnaya River crossing has two locations that require monitoring. The first is the downstream band cuts and erodes into the eastern side of the RoW. The Company has installed a heavy riprap wall to stabilise the bank (Photo 1). The second location is in the upstream of the river crossing on the northern bank – the river current cuts into the northern bank behind a protection layer of riprap (Photo 2).

Photo 1. View of the repair of the riverbank at the band.

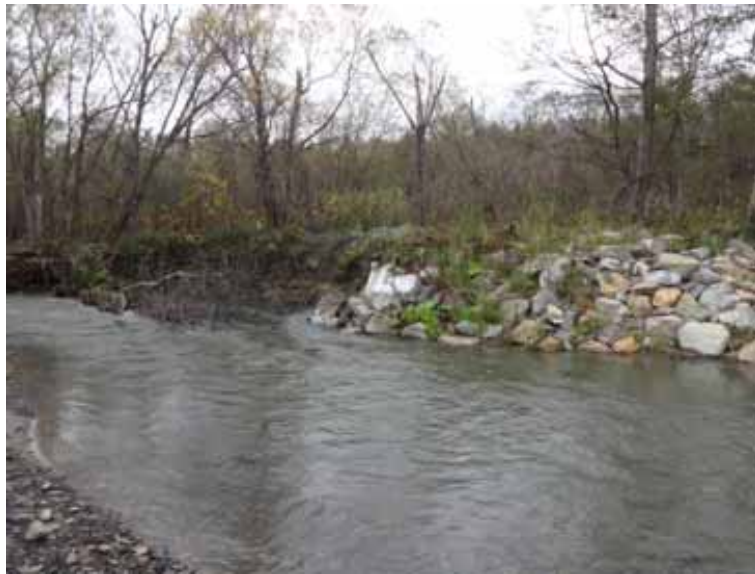
Photo 2. View of the north bank where the current is cutting into the bank behind the riprap protection layer.

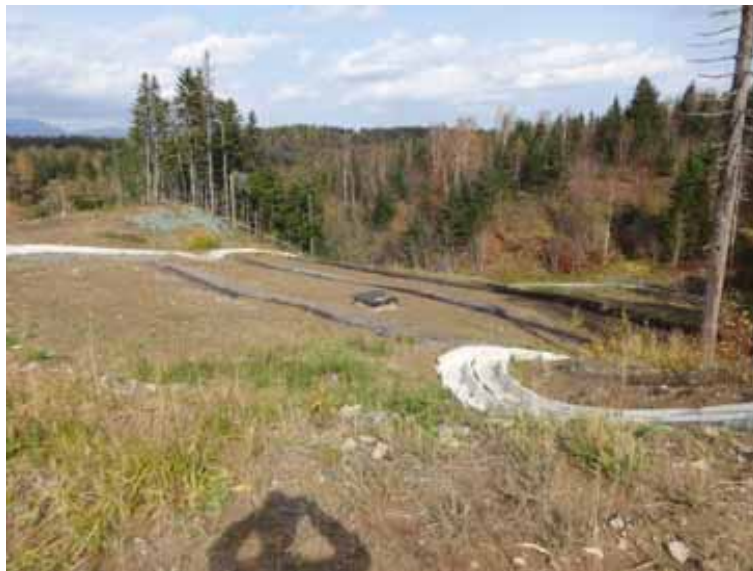
The RoW at KP 514 experienced a landslide from the edge of the RoW toward the east. The slide was stabilised and new drainage control and slope protection was constructed (Photo 1).

Photo 1. View from the RoW to the east of a repaired landslide area.

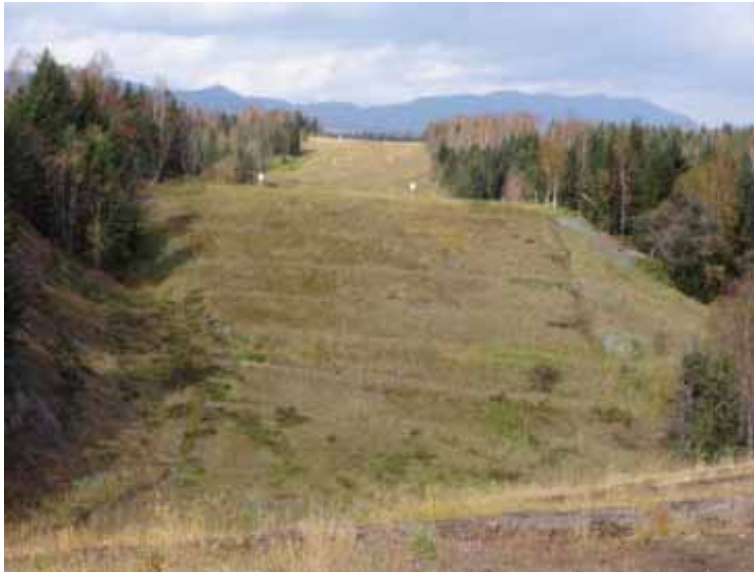
The RoW to the north and south has sandy, undulating short but steep slopes with partial vegetation cover and slope protection (Photo 2). The side slopes are protected with Geojute but are still poorly vegetated. These slopes should be monitored regularly.

Photo 2. View to the north of the RoW showing undulating steep slopes with partial vegetation cover.

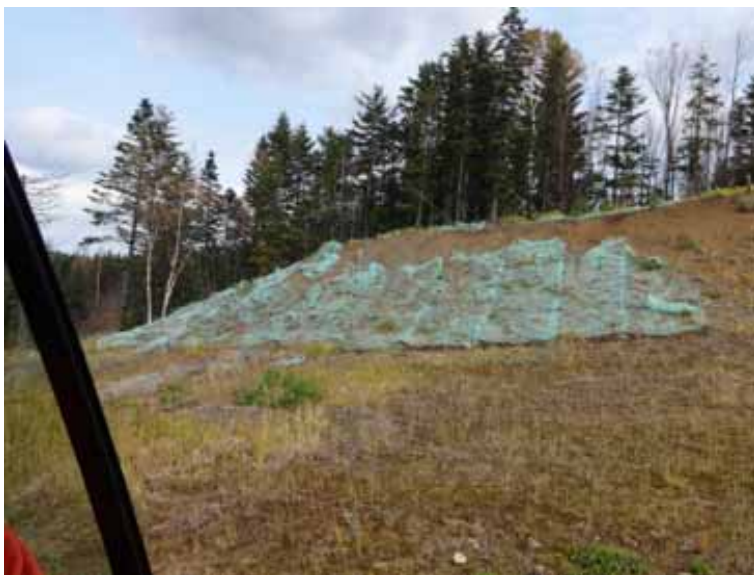
It was observed that tree saplings were cut on a side cut on the east side of the RoW (Photo 3). This practice should be re-evaluated.

Photo 3. View of a RoW side cut with trees cut on the slope itself, and additionally failing geojute.
