Appendix 2: Individual RoW Descriptions

List of RoW Locations Visited		
KP	River / Location	Date Visited
33	East of Val River Near NOB 04	3 October 14
36-37	Wetland near NOB 06	3 October 14
63	Dagi River	3 October 14
95	Djimdan River Crossing	3 October 14
15 - 21	Plelarnya River and RoW	6 October 14

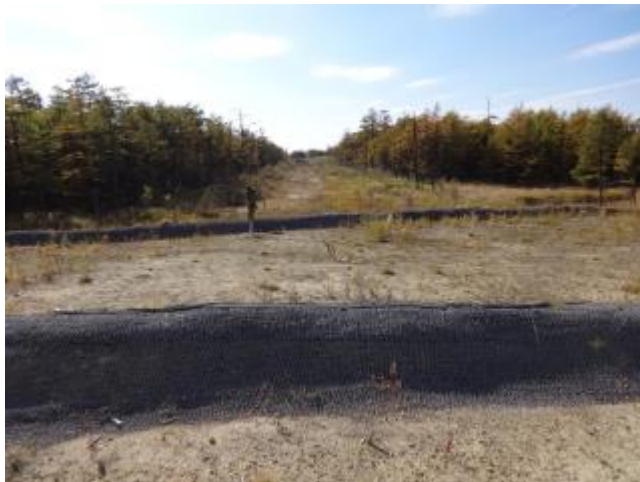
The RoW in the immediate vicinity of the access road is poorly vegetated (Photo 1). However, further to the west the RoW has good vegetation cover, which includes grasses on the running track section (Photo 2), and Alder and Willow trees above the pipes and on the periphery (Photos 3 and 4). Some of the trees reach four meters in height. The area was visited as part of the review of wetland. However, at the time of the visit the wetland area was mostly dry. There is evidence of rush *Juncus* sp. Growth, but no other wetland species and we suggest that this area should no longer be considered as a wetland.

Photo 1 – View to the west showing poorly vegetated area in the foreground and better vegetation cover further west.

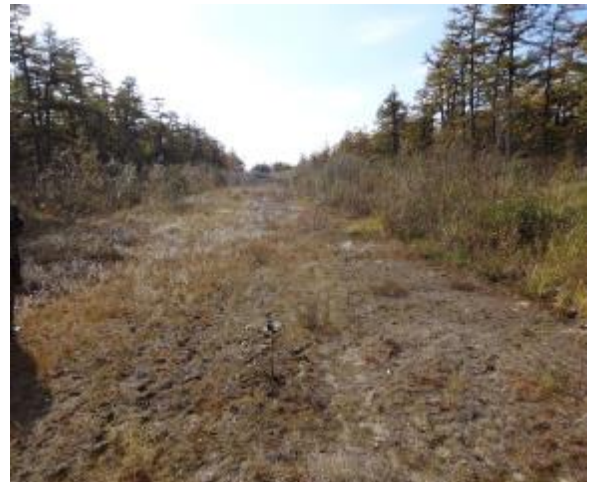
Photo 2 – View to the west showing good vegetation cover across the RoW with mostly grass in the middle and trees on the sides.

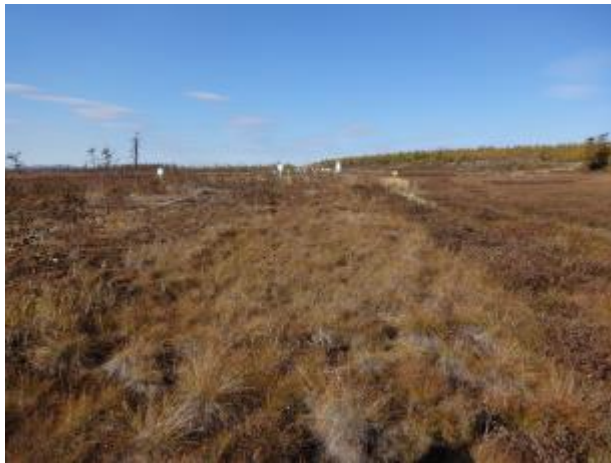
The area west of the Val River near NOB 06 is a well developed wetland. The RoW shows good signs of recovery with native wetland plant species encroaching from both the north and the south (Photos 1 and 2).

Photo 1 – View to the East towards NOB6 showing well recovered wet land.

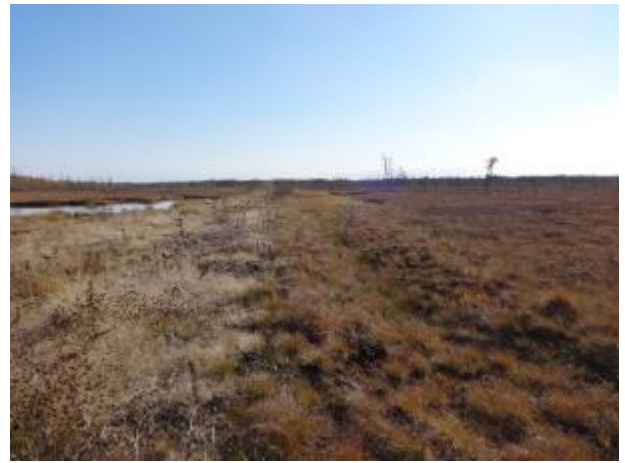
Photo 2 – View to the West from NOB6 showing well recovered wet land.

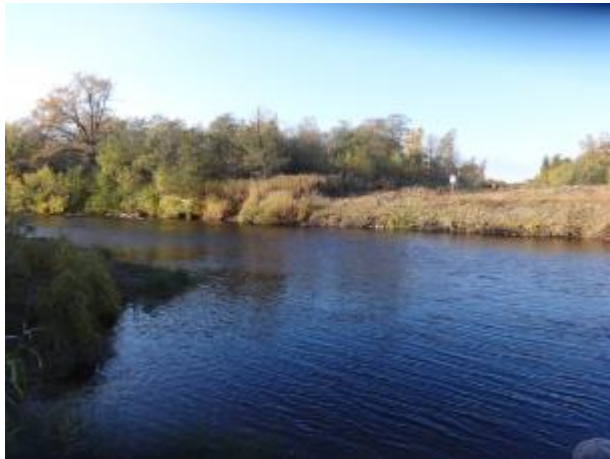
The riverbanks are well protected with reno mating and vegetation. The northern bank has willows on it, but on the southern bank the willows were removed together with other trees on the RoW (Photos 1 to 3).

Photo 1 – View to the upstream showing stable river banks. Note that the trees are being cut at the time of the visit.

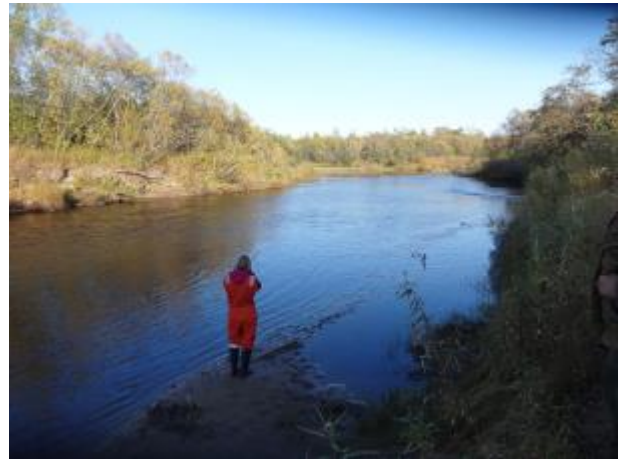
Photo 2 – View to the down stream showing stable and vegetated banks.

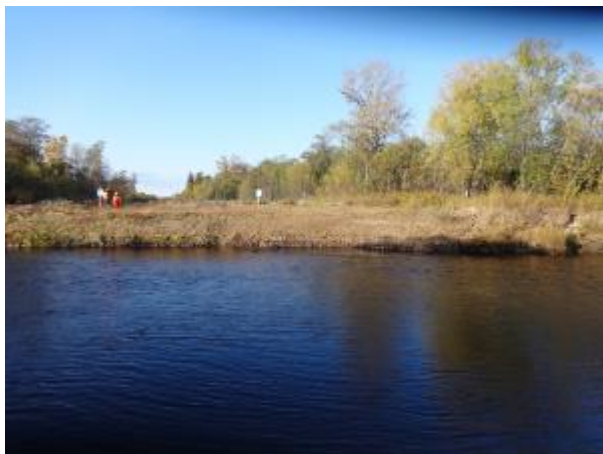
Photo 3 – View north showing river bank with reno mats and good vegetation cover.

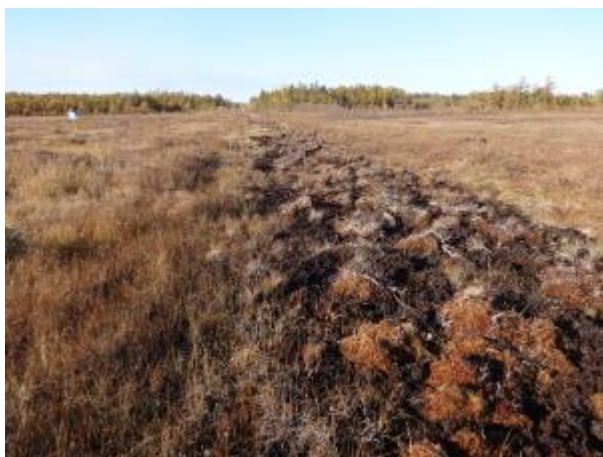
Photo 5 – View north showing wetland vegetation on pipeline and running track

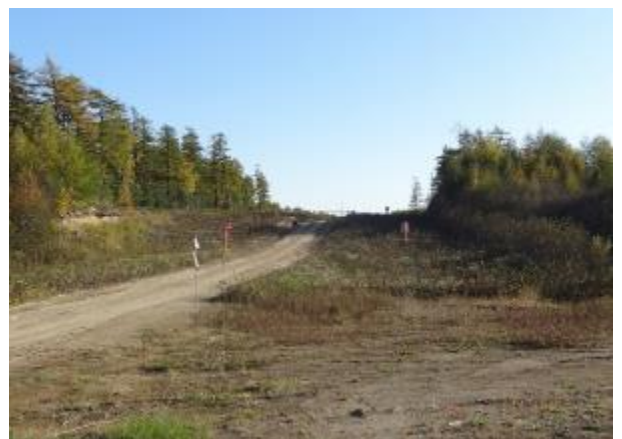
An area of Alder growth on the RoW next to KP 63 was de-vegetated last year using mechanical mean (tractor mounted). However, during the current visit it was observed that saplings were re-growing in the same area (Photo 6).

Photo 6 – View south of the Dagi valley showing recovered Alder saplings in an area where they were cut last year.

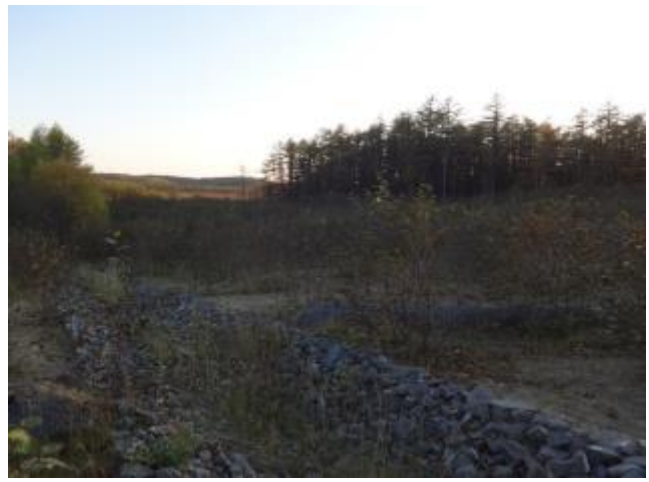
The RoW south of NOB 16 and north of the Djimdan River crossing on the slope leading to the river is covered by dense growth of Alder trees that reach two or more meters in height (Photo 1).

Photo 1 – View south from the Block Valve showing dense growth of Alder on the RoW

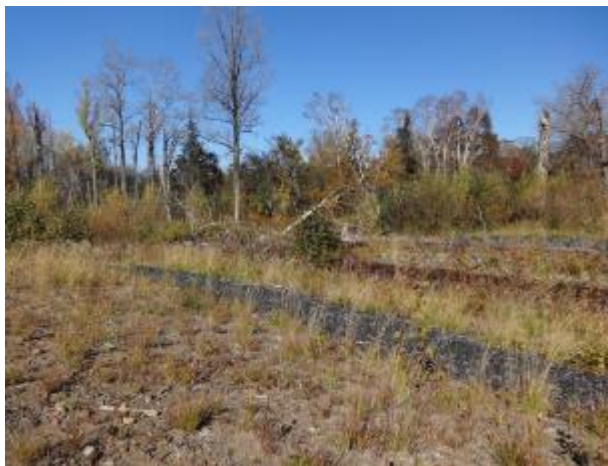
Photo 1 – View to the upstream showing riverbanks with reno matts

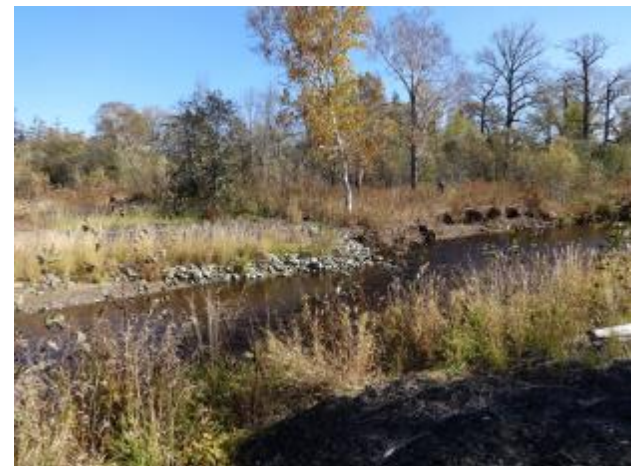
Photo 2 – View to the downstream showing partially vegetated riverbanks

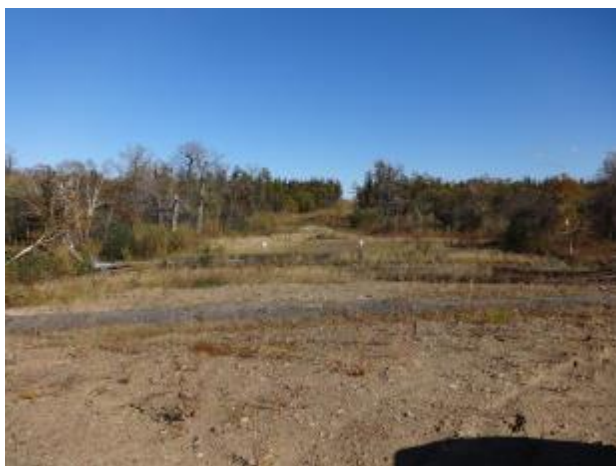
Photo 3 – View across the river showing stable vegetated banks with Reno mats.

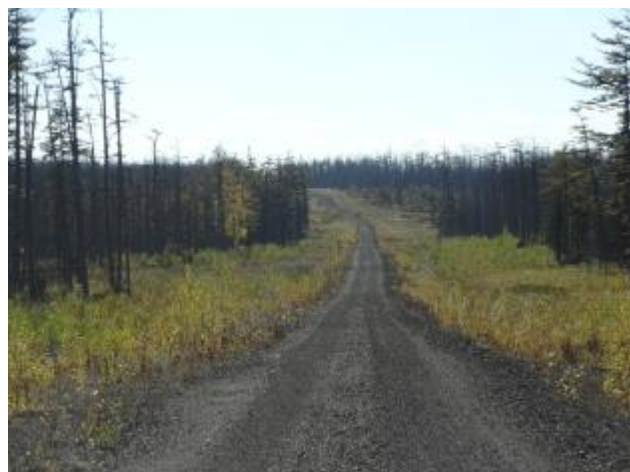
The RoW between KP 21 and 15 has good vegetation cover on each side of the access road (Photos 4 and 5). A sloping section of the RoW just north of NOB 01 had deep erosion along the slope last year that has since been repaired.

Photo 5 – View North showing good vegetation cover on the RoW

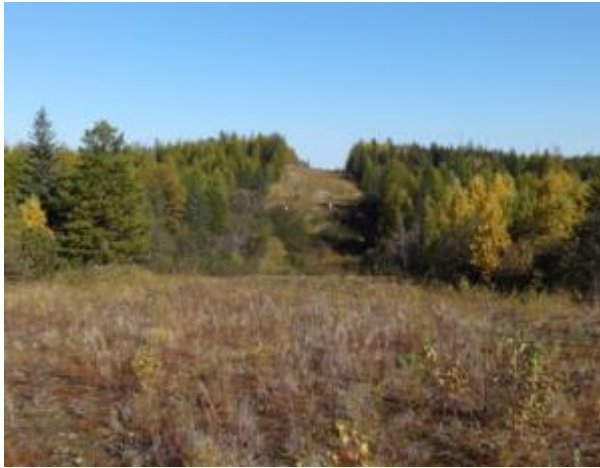
The RoW at the road crossing at KP 131 shows good vegetation cover and stable slopes. Vegetation is mostly comprised of grass, but trees were seen to be growing in the low areas where the RoW crosses a drainage ditch (Photos 1 and 2)

Photo 1 – View north showing good vegetation cover on the slopes

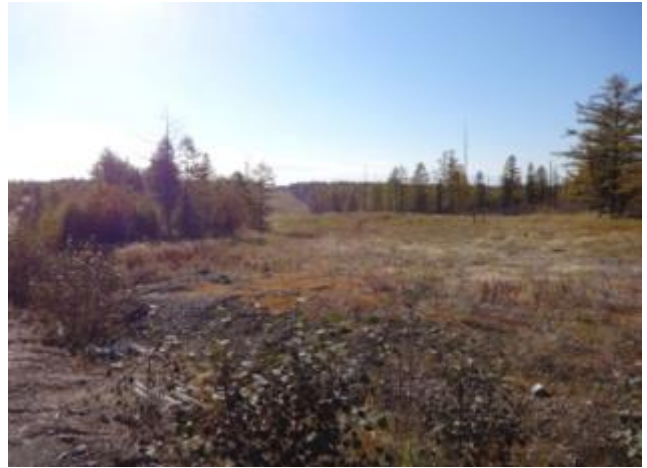
Photo 2 – View south showing good vegetation cover on the RoW

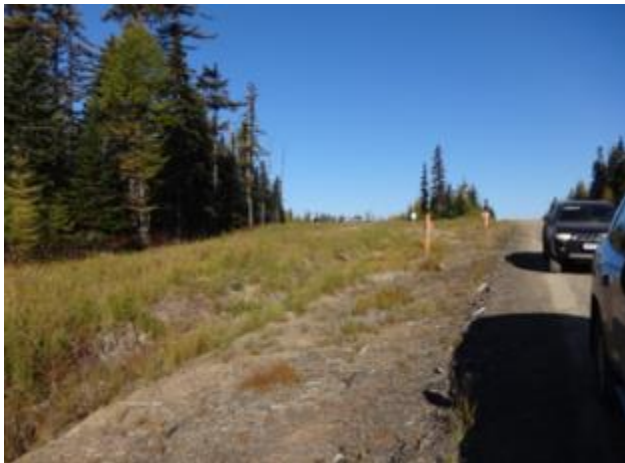
Photo 1 – View to the north showing good grass cover on the RoW

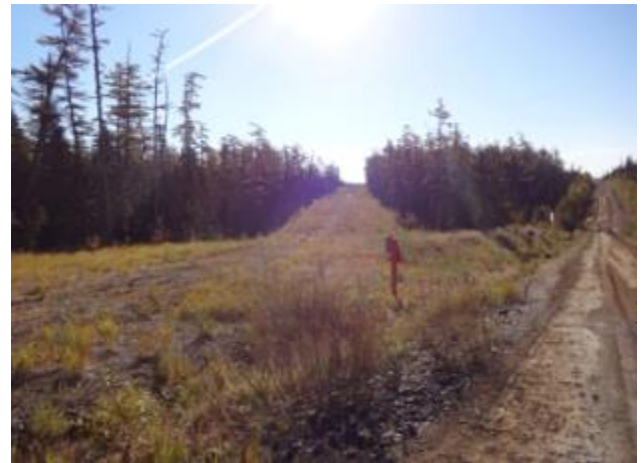
Photo 2 – View south showing grassy RoW

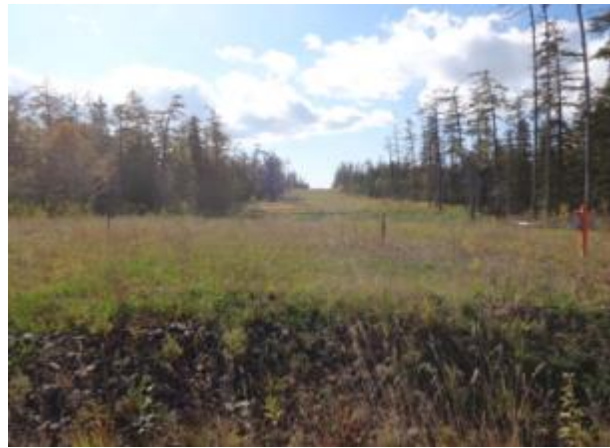
The RoW at this crossing has gently sloping topography towards the south. The RoW has good vegetation cover, which consists mostly of grasses (Photo 1).

Photo 1 – View to the south showing the RoW with a gentle slope and good grass cover.

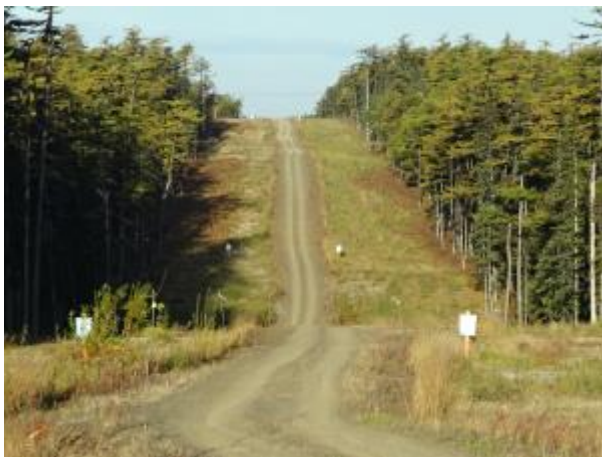
Photo 1 – View north along the RoW showing good vegetation cover

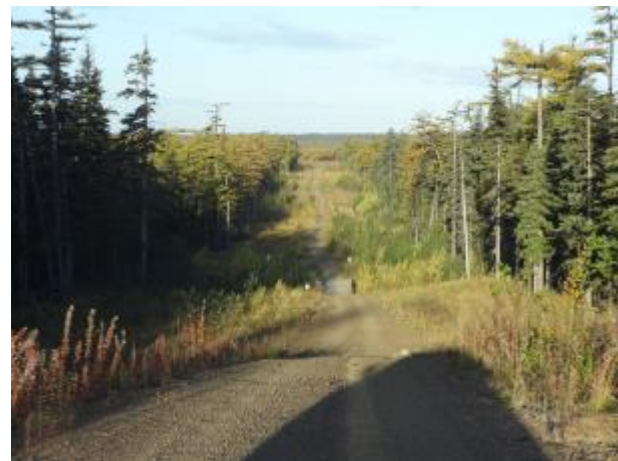
Photo 2 – View north along the RoW showing good vegetation cover and growth of trees

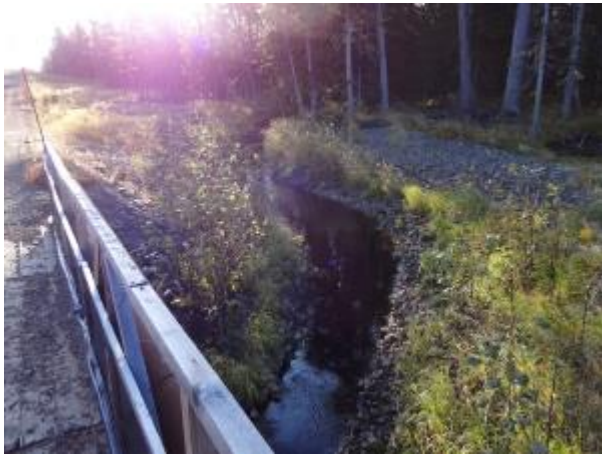
Photo 3 – View of bridge and protected drainage with riprap.

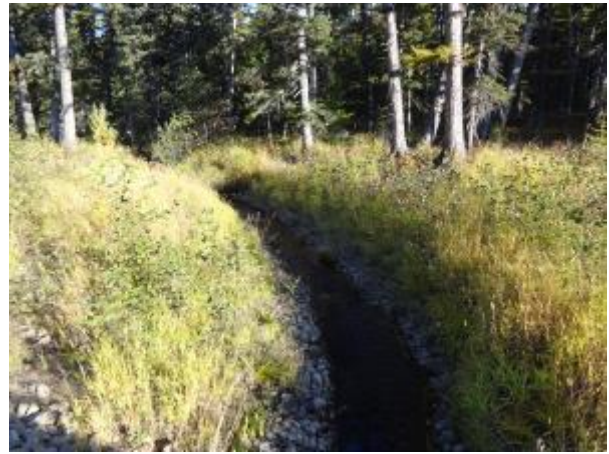
Photo 4 – View of protected drainage with riprap and good vegetation cover

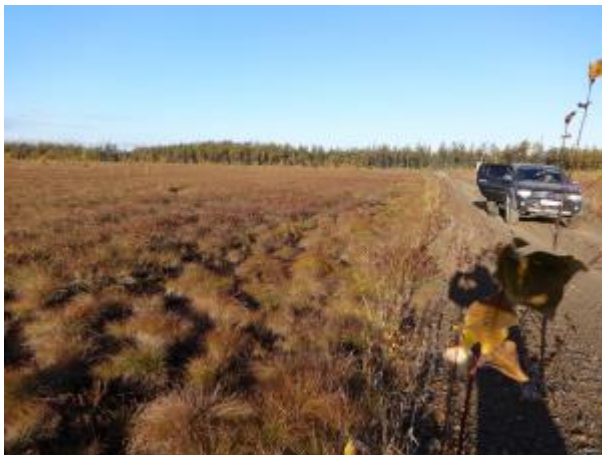
Photo 5 – View of the wetland east of NOB 24

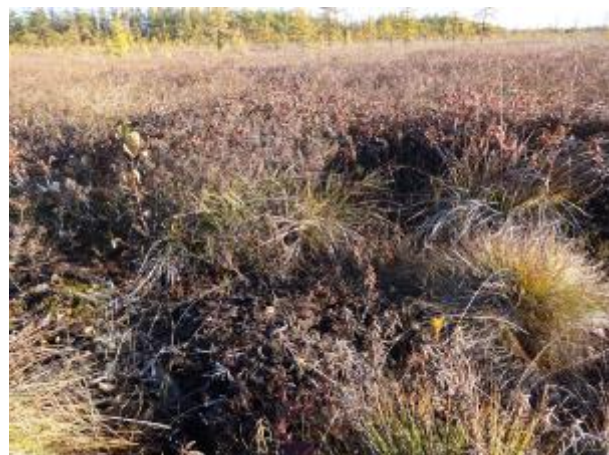
Photo 6 – View of wetland boundary east of NOB 24

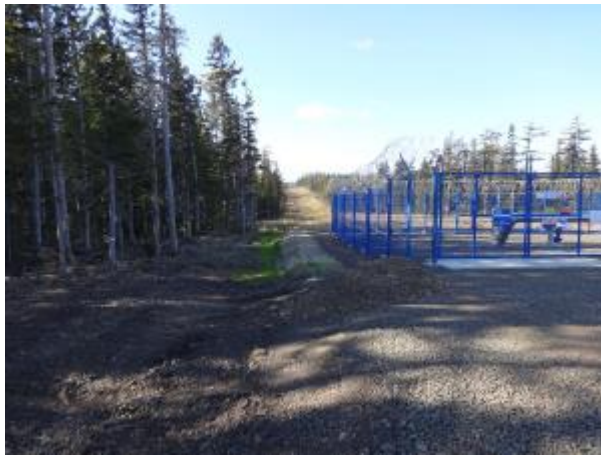
The Sakhalin-3 Tie-In is located at KP 0 near the OPF. The installation of the Tie-In was completed within the last year and reinstatement of the RoW on all sides is pending (Photos 1 and 2)). We understand that the Sakhalin-3 operator was responsible for final reinstatement of the area, but that this was not fully undertaken. We further understand that Sakhalin Energy now plans to complete these reinstatement works itself in 2015.

Photo 1 – View north of the east side of the Tie-In

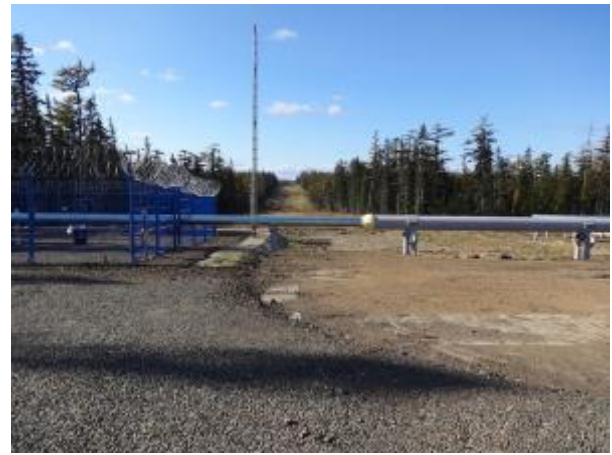
Photo 2 – View north of the west side of the Tie-In

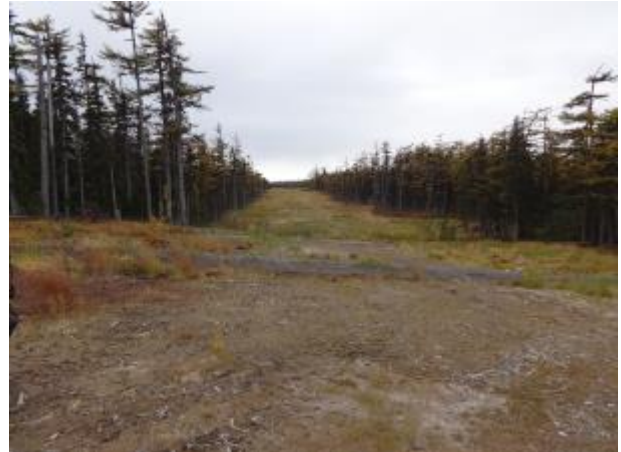
Photo 4 – View north from KP 3 showing running track with marginal vegetation cover

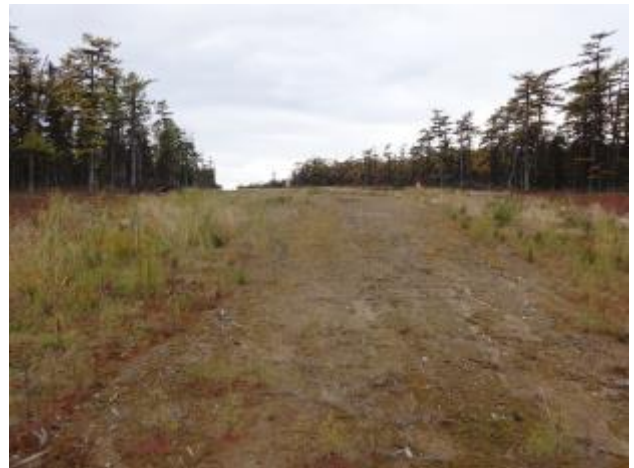
Photo 6 – View of RoW at approximate KP 4.5

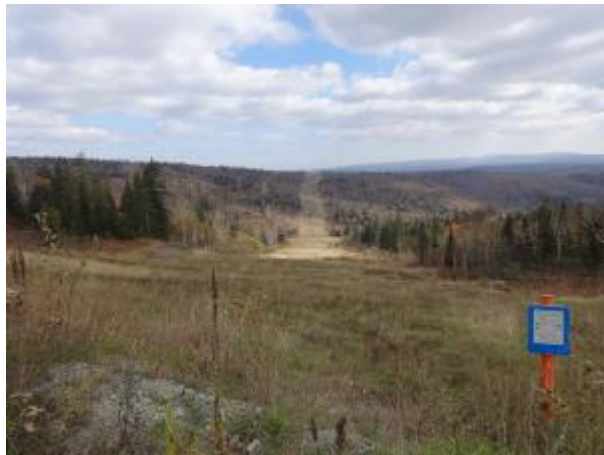
The RoW in this area is in undulating terrain with some steep slopes. The slopes are protected with slope breakers and with good vegetation cover (Photos 1 and 2).

Photo 1 – View north along the RoW

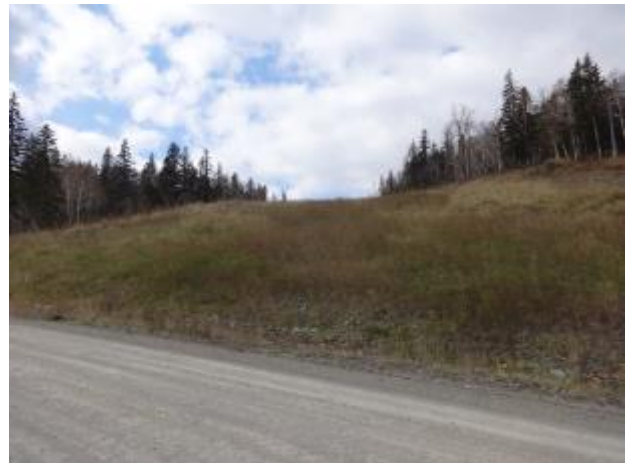
Photo 2 – View south along the RoW

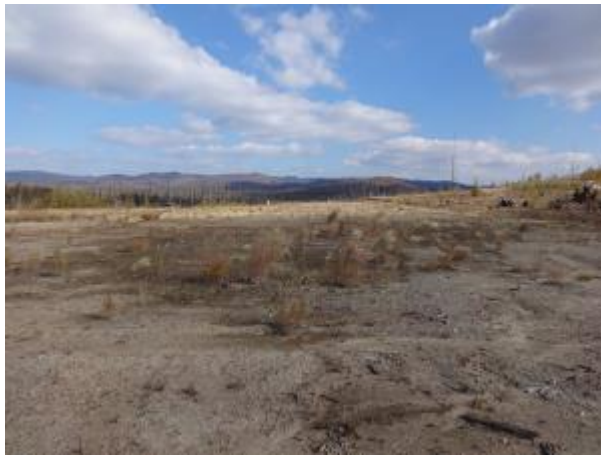
The RoW in this area (KP 54) is poorly vegetated. However, further south vegetation cover is better and in some areas exhibits wetlands flora (Photos 1, 2 and 4). The slope on the southern end of the valley has poor vegetation cover and includes erosion in the central portion (Photo 4) in spite of the fact that it has slope breakers. It is recommended that erosion control on the slope should be re-evaluated and additional seeding be done.

Photo 1 – View north along the RoW showing sparse ground cover.

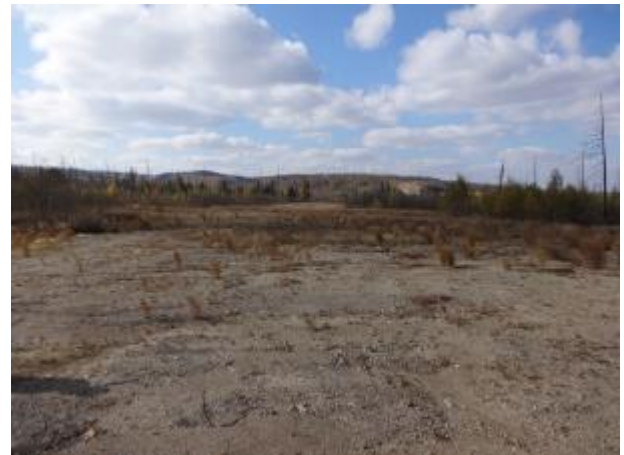
Photo 2 – View south along the RoW showing sparse ground cover.

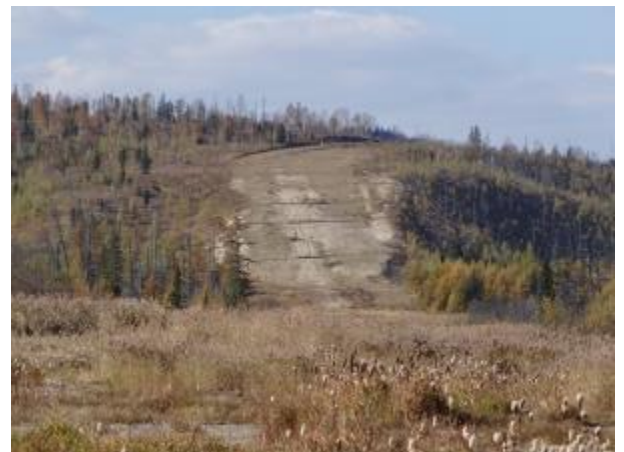
Photo 4 – View south showing RoW slope with slope breakers and erosion. Also wetland fauna in the foreground.

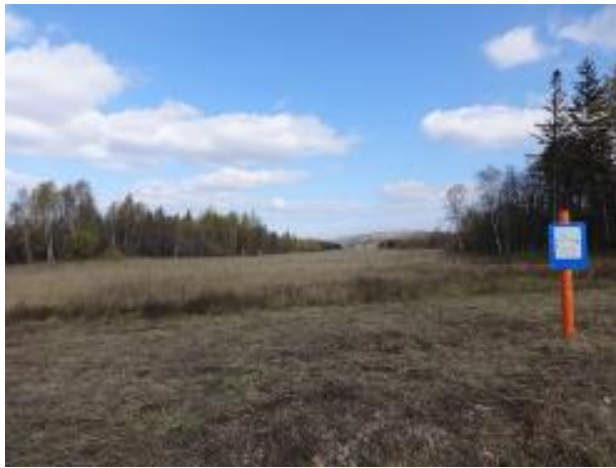
The RoW at this road crossing has a very good grassy ground cover (Photo 1).

Photo 1 – View north showing a very good grass cover on the RoW.

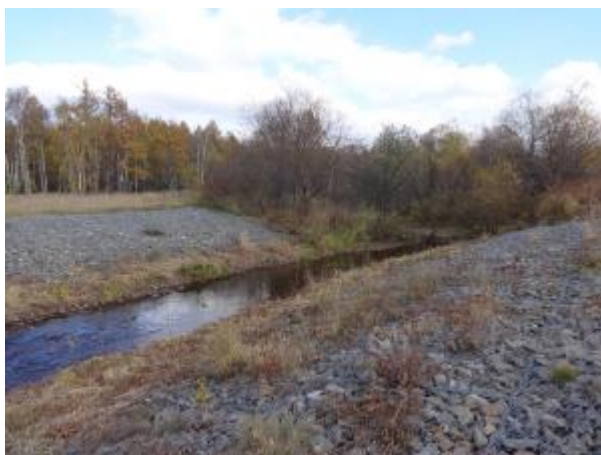
The RoW north and south of the river has good vegetation cover (Photos 1 and 2). The riverbanks are well protected by reno matting and have grass cover on the lower portions by water level (Photos 3 and 4).

Photo 3 – View to the upstream showing reno matting on the riverbanks

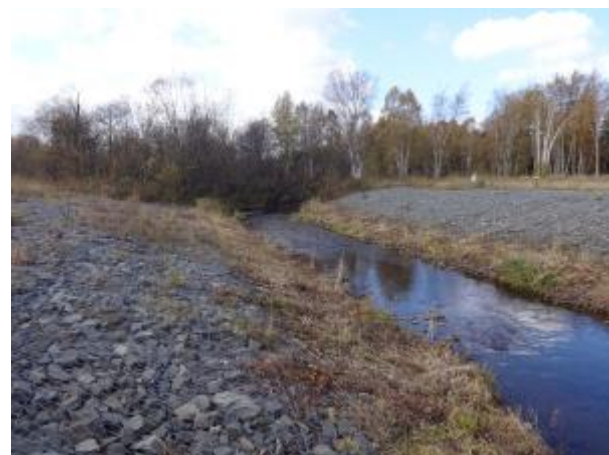
Photo 4 – View to the downstream showing reno matting on the riverbanks

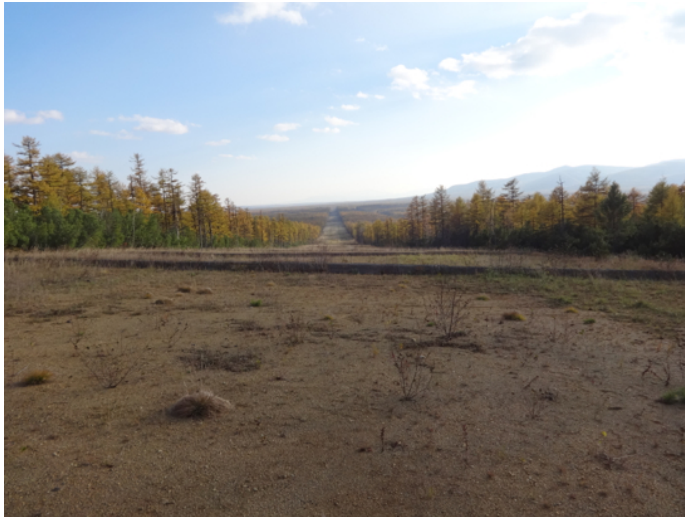
The RoW in this area crosses an undulating hilly terrain with sandy lithology. There was no appreciable change since last year's visit. The RoW has good vegetation cover, good slope breakers and the slopes appear stable. The area on the RoW just south to the access road has sparse vegetation and will need to be improved in time.

Photo 1 – View south showing good slope breakers and good vegetation along the slope but sparse vegetation on top by the access road.

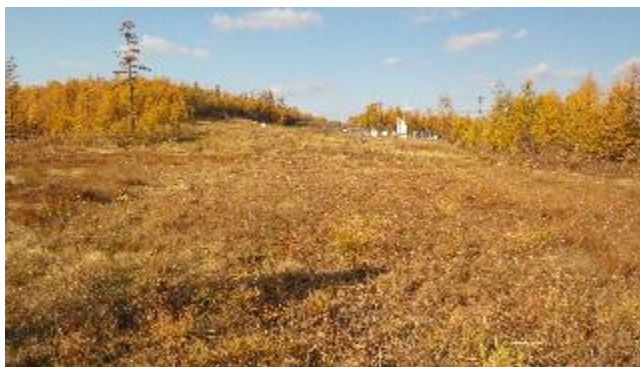
Photo 1 – Grass dominated revegetation of RoW

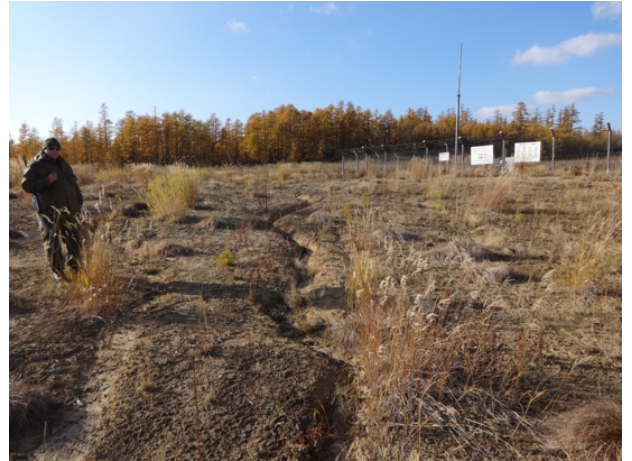
Photo 4 – Area adjacent to the block valve shows poor ground cover and erosion

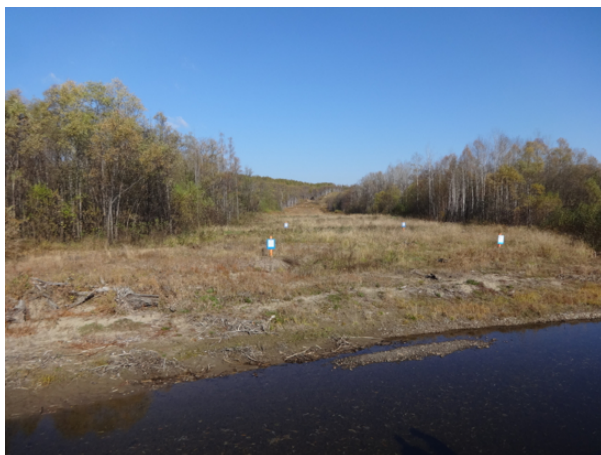
The RoW on both sides of the river has good vegetation cover and the slope on the south side is protected with slope breakers (Photos 3 and 4).

Photo 3 – View north across the river at the RoW

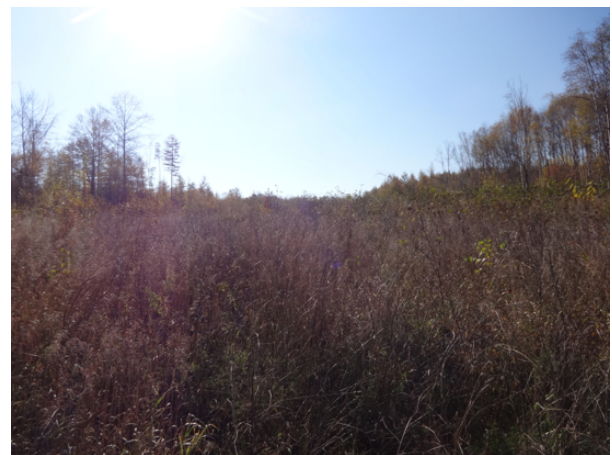
Photo 4 – View south at the vegetated slope of the RoW.

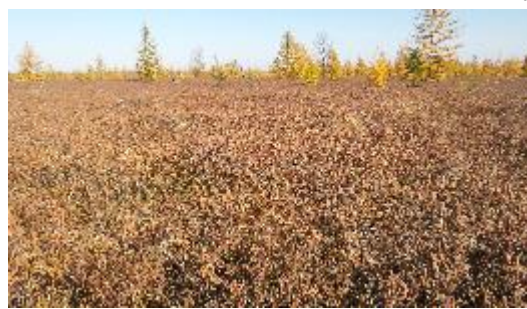
Unlike the other wetlands visited, this wetland is showing signs of dewatering, both on the RoW and also in the wider area to the east of the RoW. The cause of the dewatering appears to be two-fold. The retained access track to the block valve appears to be acting as a barrier to hydrological connectivity between the western and eastern sections of wetland.

Photo 4 Wetland east of RoW that is drying

As a result of the factors described above, the RoW is barely vegetated with only occasional ephemeral grasses. No wetland plants are present. In order to address the issues identified, the ditch and berm should be filled in and fully removed. Additionally, approximately five small culverts should be installed under the access track approximately every 200m between KP 230 and KP 231.

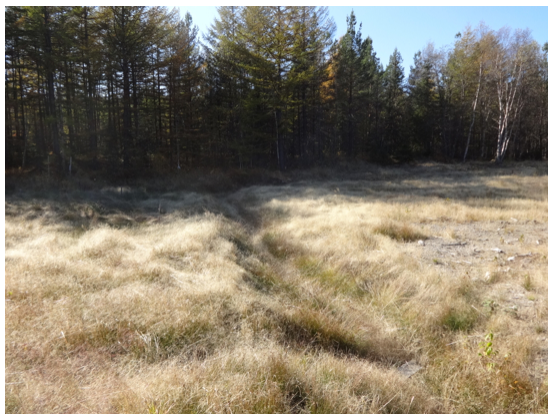
Photo 3 – View of a crossing drainage with vegetation cover on the banks.

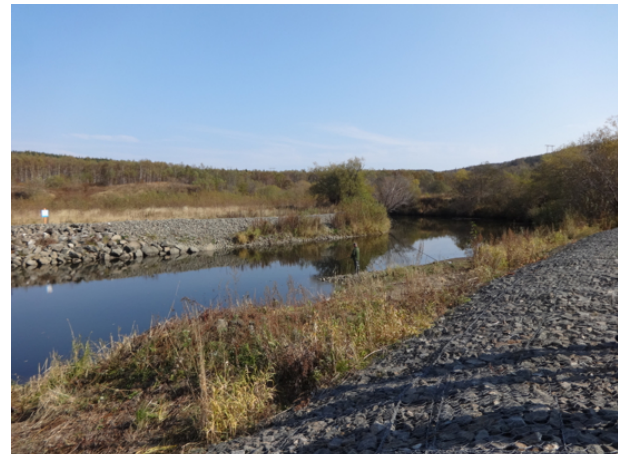
The Pugachevo River crossing appears stable. The south bank is protected with reno matting, with some grass growing through the matting. The north bank is protected with large riprap and also has vegetation coming through the rocks (Photos 1 and 2). The RoW on both sides of the river has good vegetation cover (Photo 3). The slope on the southern edge of the river valley is protected well by slope breakers (Photo 4).

Photo 2 – View downstream showing reno matting and riprap

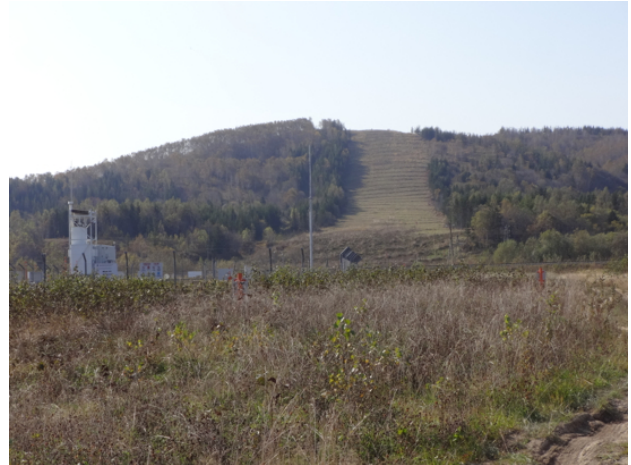
Photo 4 – View south showing well protected slope.

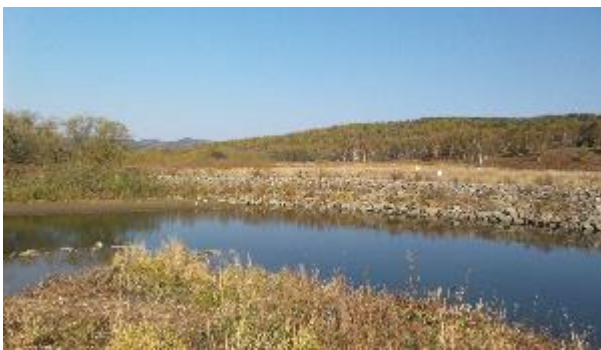
Photo 7 View north from ox bow lake showing river crossing and grassy wetland beyond

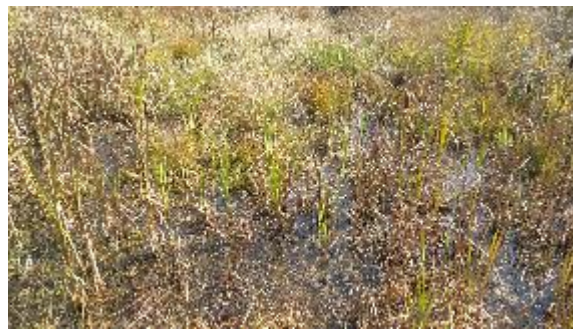
Photo 4 Tall emergent vegetation in wetter central part of RoW

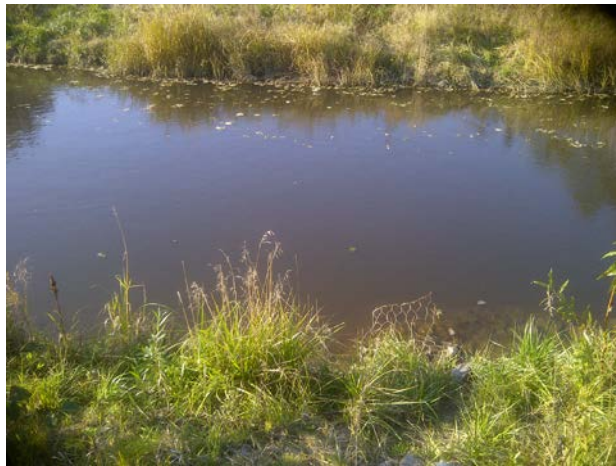
The Mereya River is crossed with two separated RoWs, one for the oil pipe and one for the gas pipe (Photo 1). Both crossings are protected with Reno matting. Significant vegetation growth has come up through the matting and the banks appear to be stable.

Photo 1 – Riverbank re-vegetation on the gas line crossing

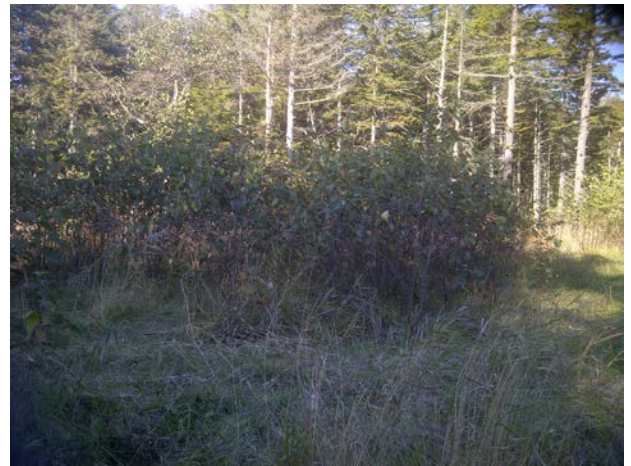
The RoW on adjacent to both river crossings is re-vegetating well (Photo 3), although significant tree growth was identified south of the river that needs to be removed.

Photo 2 – Tree growth on the RoW south of the gas line crossing
