Lenders' Independent Environmental Consultant Site Visit Report: September 2008 Sakhalin II (Phase 2) Project

Report to Sakhalin II (Phase 2) Project Finance Parties

Restricted – Commercial
AEAT/ENV/R/2704 Issue 2
October 2008

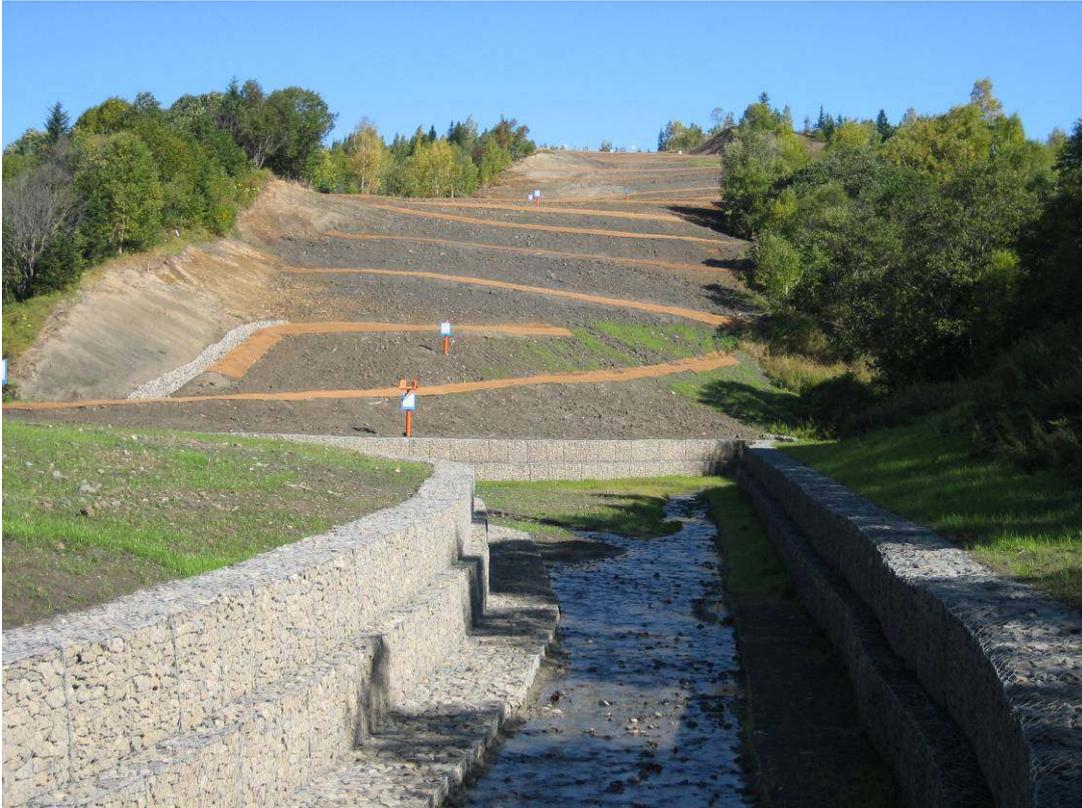
- The frequency of spacing of slope breakers was generally found to be adequate (e.g. see Picture 1). However, a number of locations were identified where additional slopes breakers would be beneficial to both reduce rilling on the slopes and reduce the volume/energy of runoff water handled by the slope breakers (e.g. the north slope of the R. Kirpinchnaya, R. Korsakovka and KP458 – see Picture 2). These are not of significant concern at the current time and can be readily rectified.

- The majority of drainage controls were identified as being armoured by either geotextile (for slope breakers – e.g. see Picture 1) or rip-rap (for spoon and French drains – e.g. see Picture 3).

Picture 1 Well-spaced slope breakers (protected with geotextile) in the Varvarka Valley

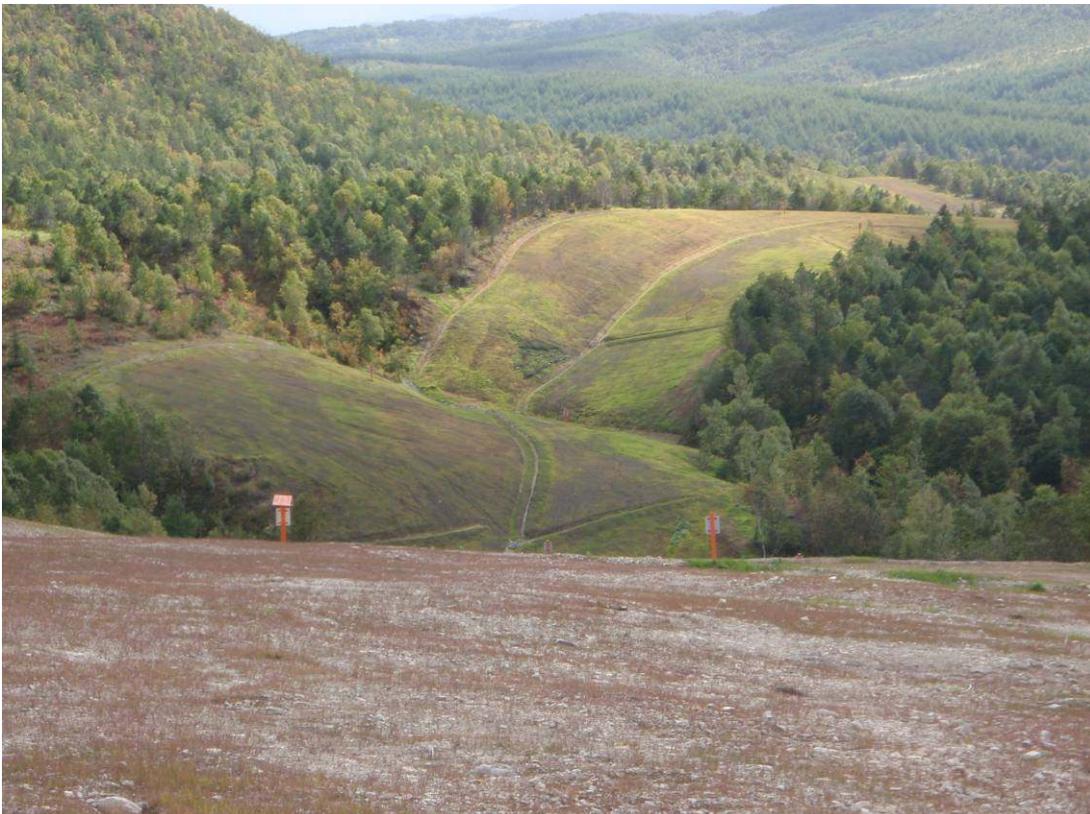
- In many areas slope breakers have been installed across the RoW and are designed to be drivable where they cross the running track (in some areas the geotextile is temporarily rolled back from the running tracking to allow access while not damaging the textile). This represents an important improvement over practices previously witnessed by AEA, although in some areas drainage controls will need to be extended across the entire width of the RoW once the running track is removed (e.g. see Picture 2).

Picture 2 Slopes around KP458 requiring additional slope breakers

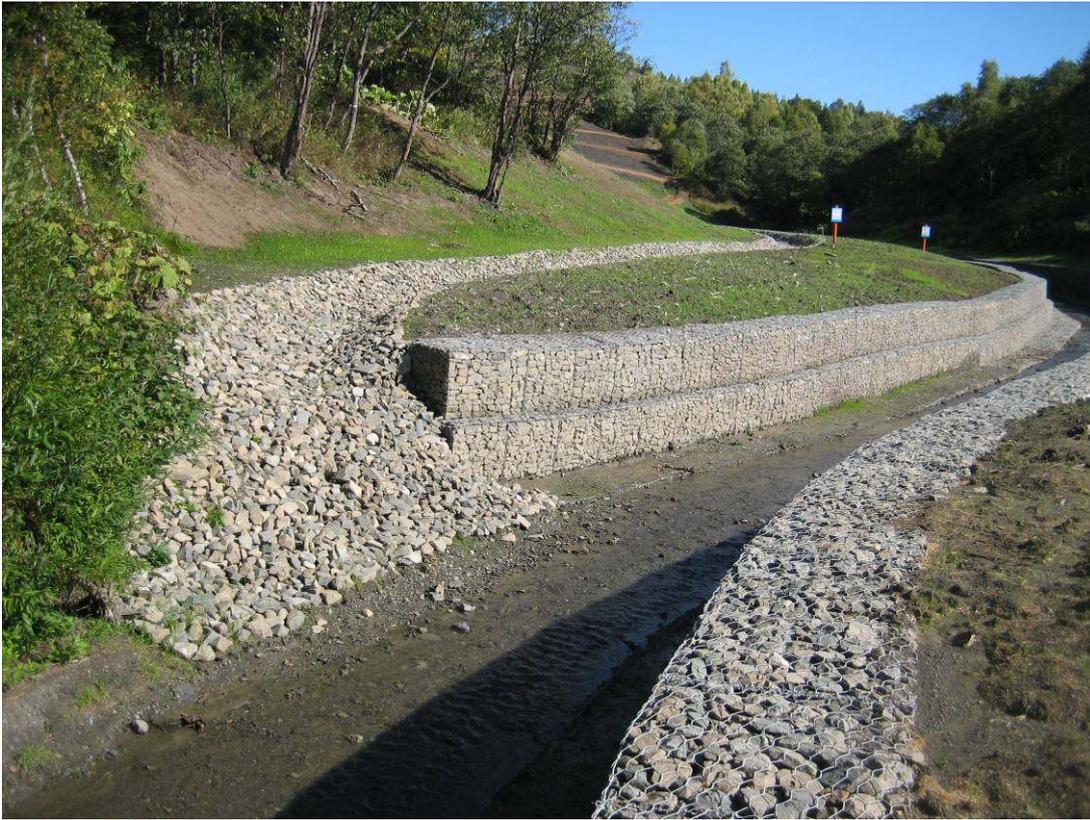
Picture 3 French drain and gabion wall constructed in the Varvarka Valley

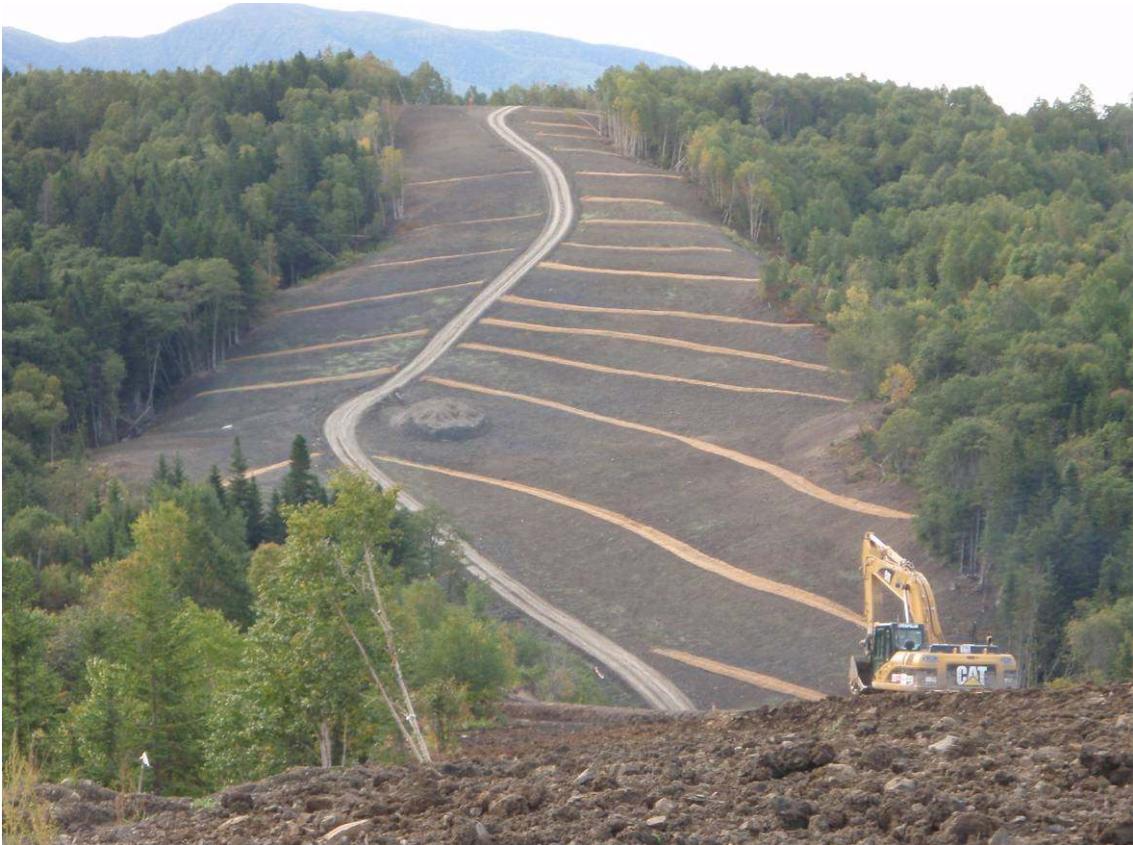
- The depth and gradient of the slope breakers is typically much improved in order to direct water off the RoW in a suitably low-energy state (e.g. Picture 1). However, some exceptions were identified where the existing drainage controls have been designed rather steeply (e.g.

see Picture 4) and these require re-design for final reinstatement in order to avoid erosion at the drainage outlets.

Picture 4 Slope adjacent to a tributary to R. Sedlets where slopes breakers are too steep and need to be extended across the running track

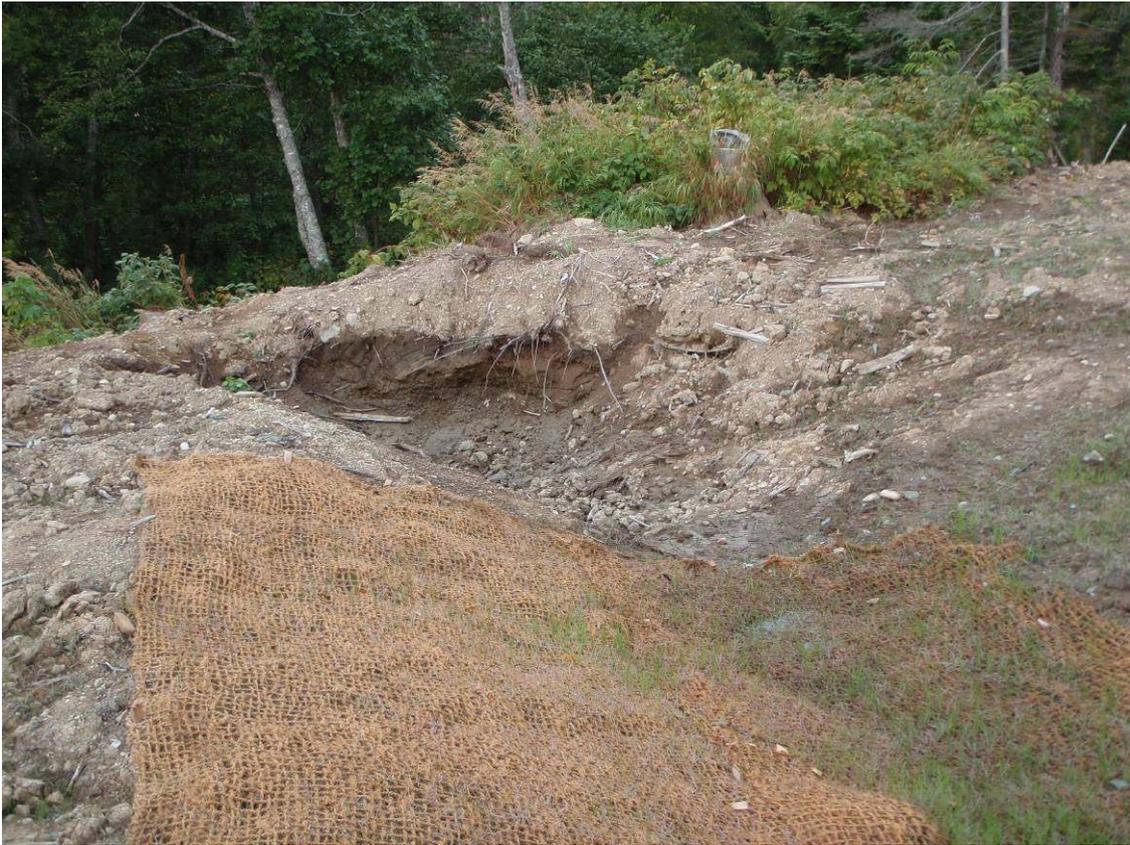
- The location and design of drainage outfalls were identified to be generally adequate, although a number of locations were noted where further engineering is required to minimise the risks of erosion into the RoW, especially where drainage channels are directed towards steep slopes at the side of the RoW. Examples of this include the southern slopes of the R. Kormovaya, where, although riprap has been installed at the outfall, additional engineering may be required, and near the R. Pegus, where the lack of energy-dissipation at the end of some drainage channels is leading to minor erosion (see Picture 5).

Picture 5 Erosion forming at the end of a drainage channel near R. Pegus

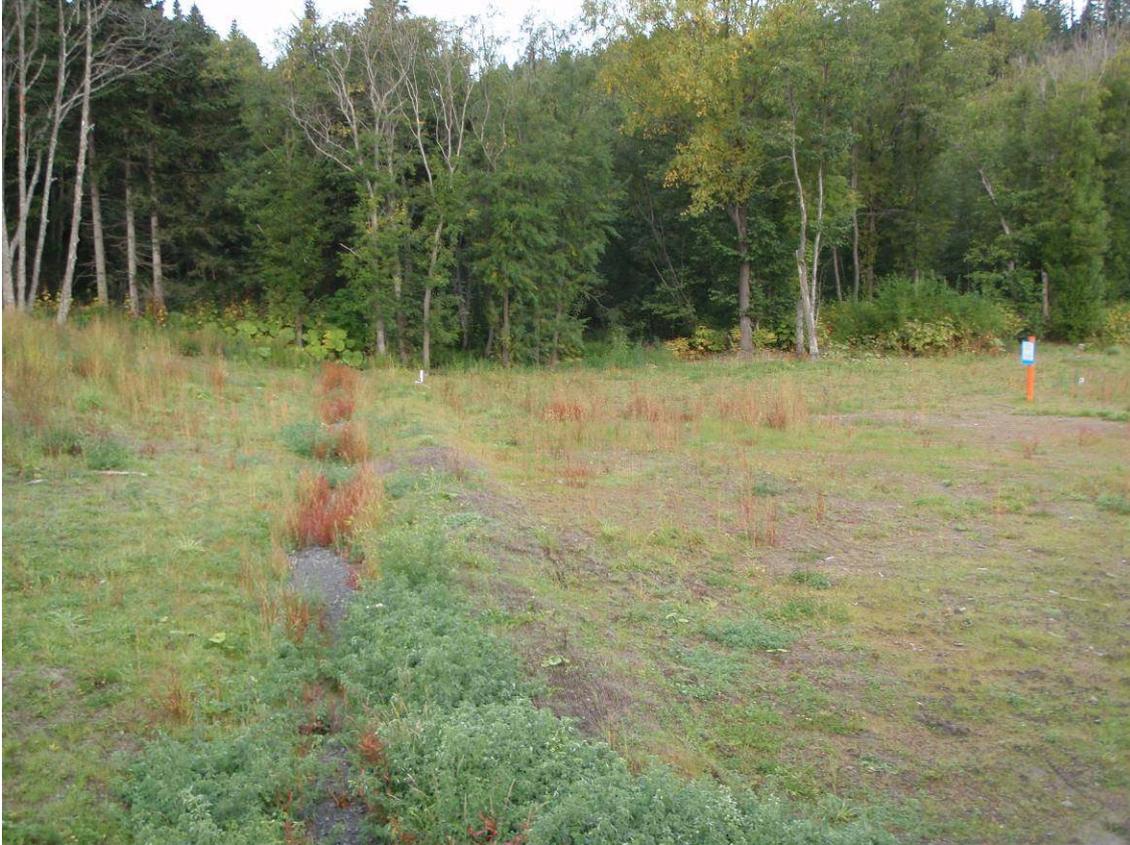
Picture 6 Natural re-vegetation of the RoW around KP 372

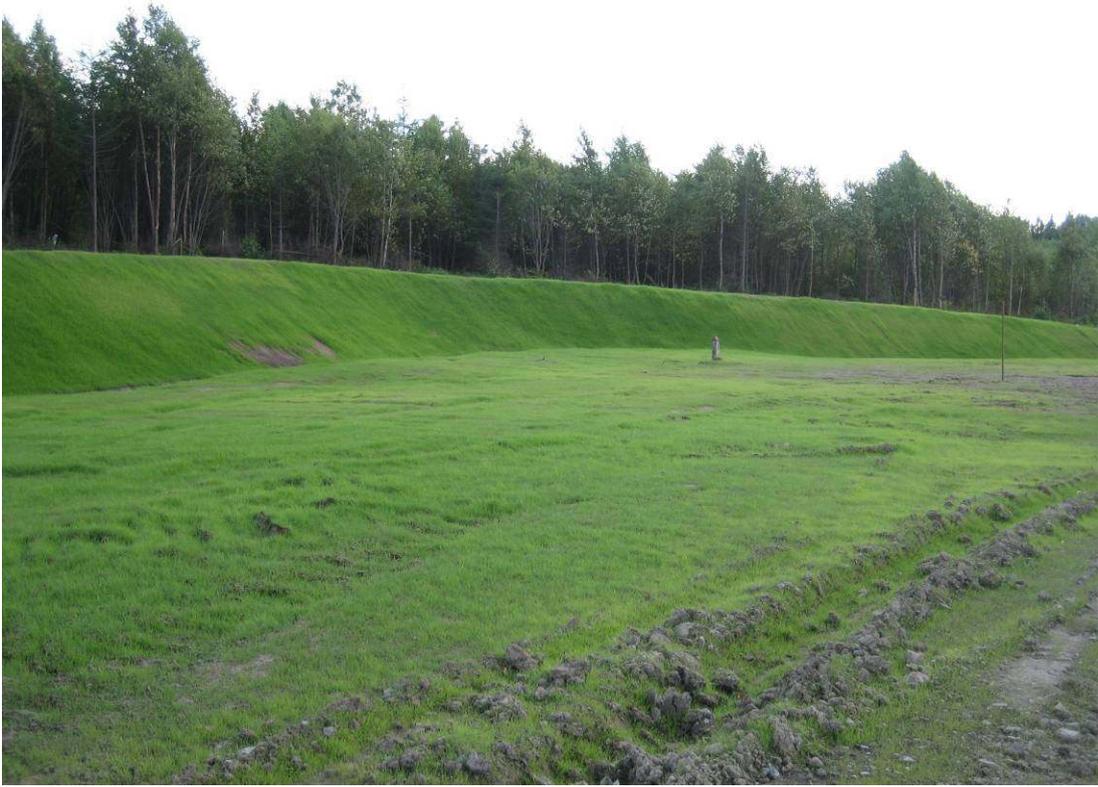
Picture 7 Successful hydroseeding at Fault Crossing near KP302

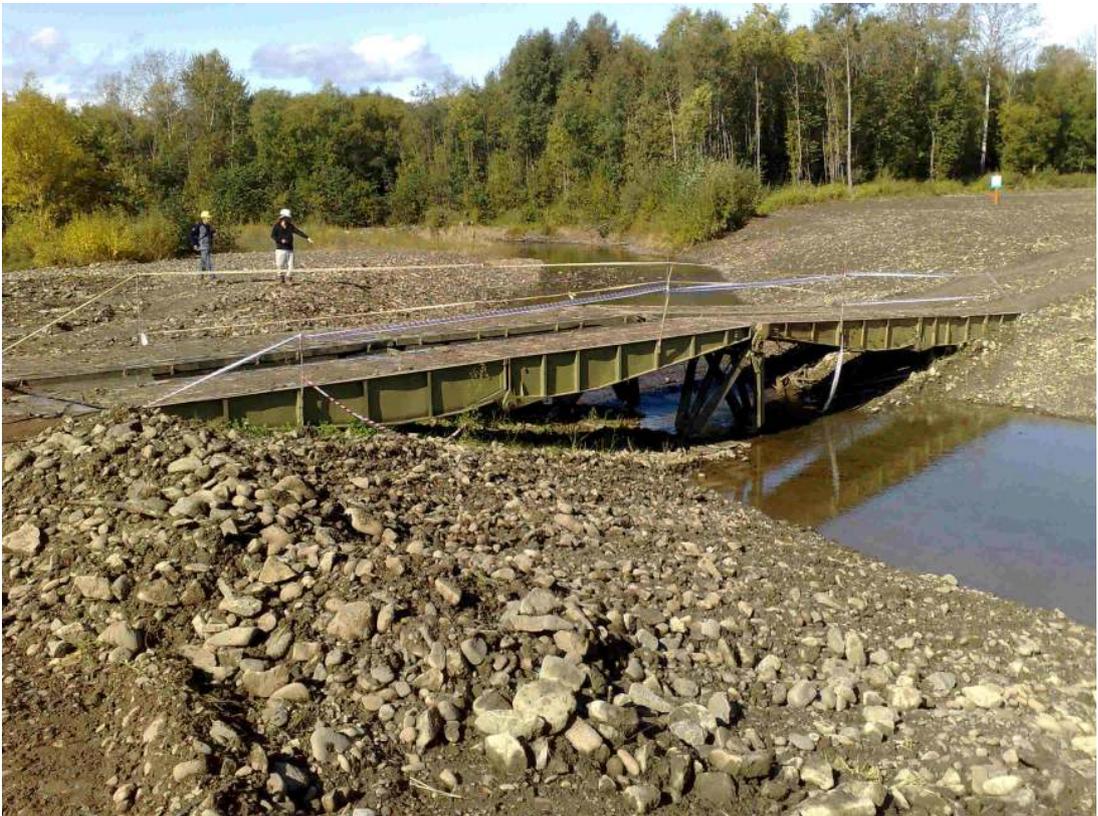
Permanent reinstatement works on riverbanks have been ongoing in 2008, with all engineering works required under the water use licences (WULs) needing to be completed before first oil in the pipe². This has been completed in the northern pipeline sections where gas was in the pipe at the time of the site visit in preparation for the introduction of oil. First oil in the pipeline is due by mid-October 2008 and hence remaining riverbank reinstatement is to be completed by that time. The standard of engineering works undertaken on riverbanks is somewhat variable between the different subcontractors. In some areas work performed by specialist contractors to install Reno mattresses and gabion defences on eroding riverbanks has been identified as being of a high standard (numerous examples of good work include those at the R. Pegus, R. Madera, R. Pobedinka, R. Pulka and R. Varvarka – see also Picture 3). Elsewhere Reno mattress construction by non-specialist contractors is of a sometimes lower quality (e.g. inadequate toe-in with the riverbank), although we note inspection by Sakhalin Energy's geotechnical specialists will be undertaken prior to final sign-off. In many instances the need for hard-reinstatement of riverbanks is questionable from a technical viewpoint, but necessary under the conditions of the WULs. In some instances naturally re-vegetated and stabilised riverbanks are being re-worked, with resultant re-disturbance of the river in order to meet the WUL requirements for Reno mattress protection. AEA views this as unfortunate but recognises that this is a permit requirement. Some care is required in the programming of the works in order to minimise the time between the removal of temporary riverbank protection and the installation of permanent protection, particularly at a time of year when heavy rainfall can be expected (see Picture 8).

Picture 8 R. Leonidovka (south channel) awaiting installation of permanent bank protection

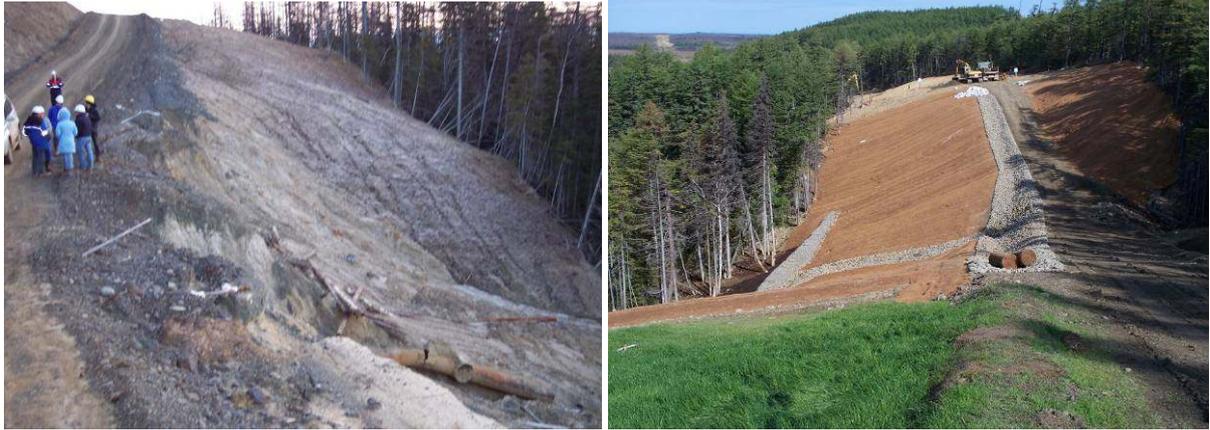
During previous site visits to this area (e.g. May 2006 and November 2007) AEA identified concerns with erosion of the side of the RoW that, if not rectified, could pose a risk to the pipeline. During the September 2008 site visit we found that the area has been subject to significant geo-technical engineering and biological reinstatement works, including

The works appeared from visual inspection to be of good quality (although ongoing monitoring of the performance of the geotechnical solutions will need to be undertaken by SAKHALIN ENERGY – see Section 2.2 below). The greatly improved status of the site in September 2008 is contrasted with the situation viewed by AEA in November 2007 in Picture 9.

Picture 9 Comparison of RoW at KP 101.5 (Section 1B) between November 2007 (left) and September 2008 (right)

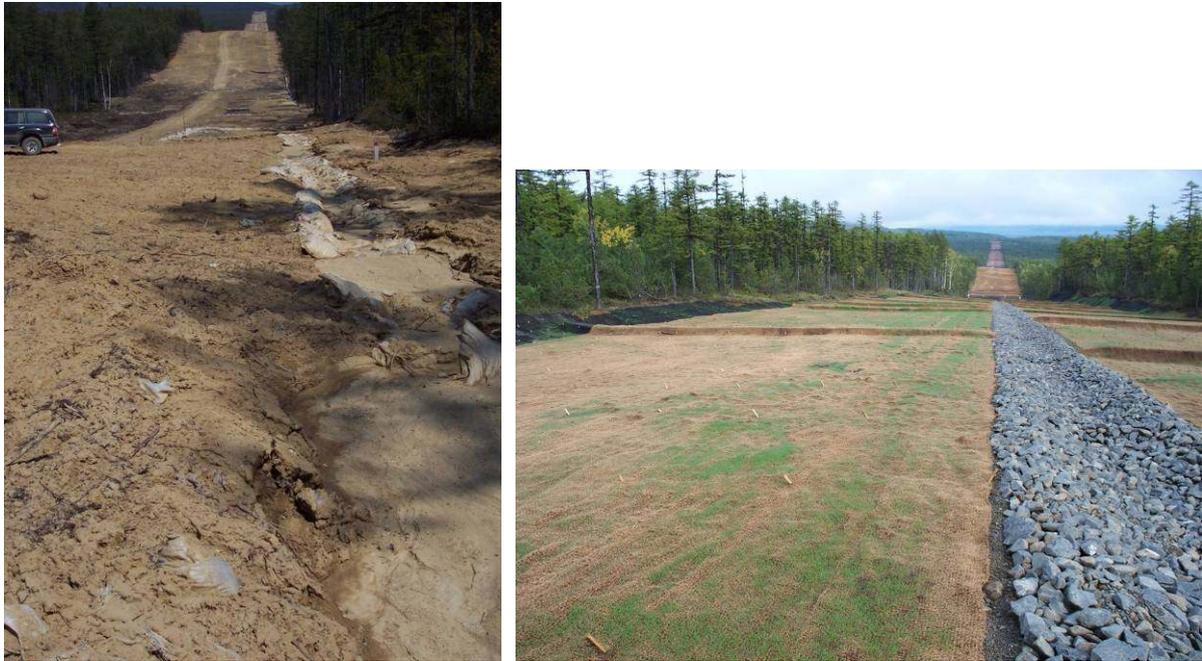
The area around KP127 in Section 2 is characterised by rolling slopes and sandy soils of low fertility. The lack of preservation of the thin topsoil layers during construction means that biological reinstatement is problematic. In addition, AEA identified concerns over erosion controls (e.g. lack of slope breakers and poor drainage controls leading to visible sediment flows) in the area during previous site visits, for example during 2007. Significant improvements were identified during the September 2008 site visit. A comparison of the site status between May 2007 and September 2008 is shown in Picture 10 and illustrates improvements to drainage controls (avoiding the sediment flows seen in May 2007), the installation of slope breakers, stabilisation of side cuts and the use of geotextile with seeding to promote re-vegetation.

Picture 10 Comparison of RoW at KP 127 (Section 2) between May 2007 (left) and September 2008 (right)

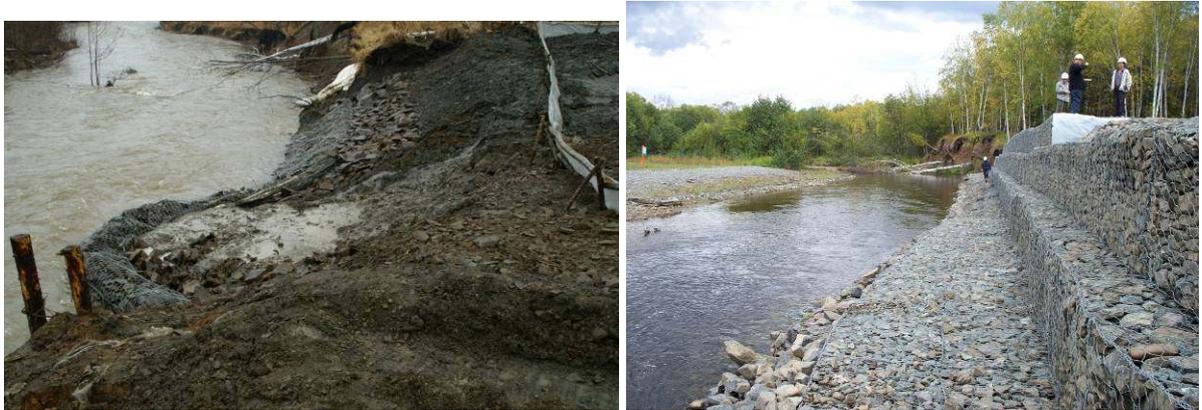
Picture 11 Comparison of Riverbank reinstatement at R. Pobedinka between May 2006 (left) and September 2008 (right)

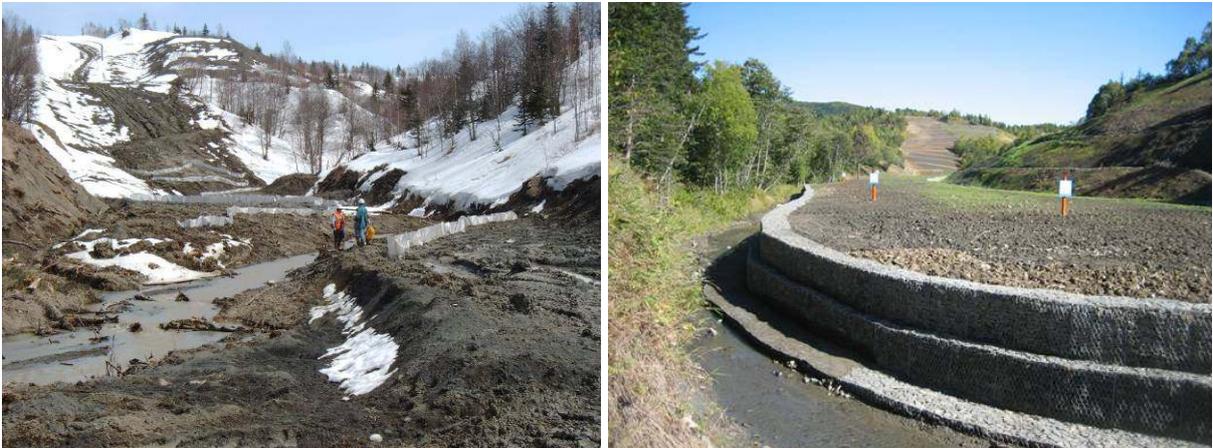
In the Varvarka valley the R. Varvarka and its tributaries run adjacent to and across the RoW. This results in a number of geological complications, including potential stream erosion into the side of the RoW and stability of side-cuts within the valley. During previous site visits AEA has raised concerns over the management of these risks. However, by the time of the September 2008 site visit significant engineering works had been performed in the valley based on detailed designs. These include the application of slope breakers (with geotextile protection), gabion channelling of the river and tributary streams to prevent erosion into the RoW, terracing and drainage control on side cuts, and seeding. Examples of these works are shown in Picture 1 and Picture 3, with a comparison of the current status with previous site visits being shown in Picture 13.

Picture 13 Comparison of the RoW in the Varvarka valley between May 2006 (left) and September 2008 (right)

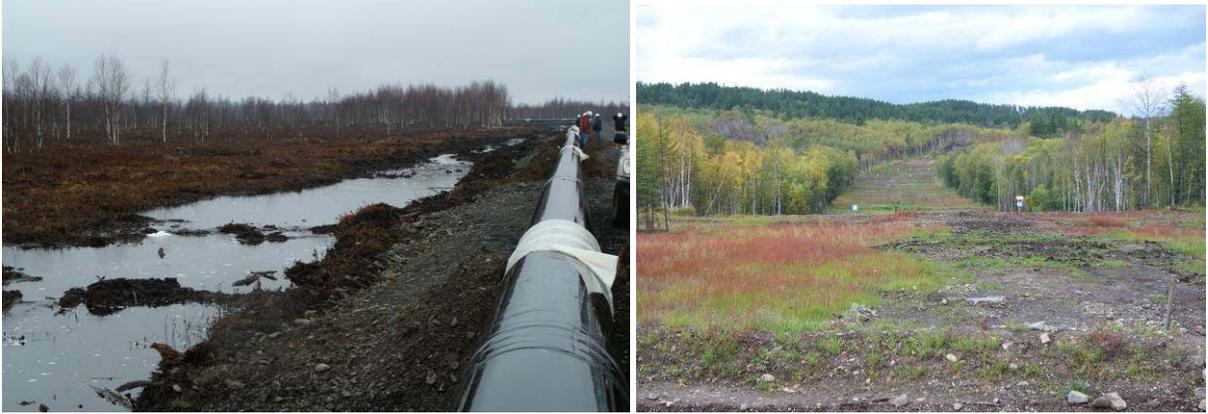
These sites were also identified for remedial works in the RemAP. In winter 2007/08, remedial works were undertaken in the area KP212-220 to remove the running track. During the September 2008 visit, access to the entire area was not possible due to ground conditions. However, in the areas accessible (in the north portions), AEA found the wetlands to be recovering well, suggesting that the remedial works had been successful. In particular, the previously identified pooling was no longer visible and this change is illustrated in Picture 14, which shows the area as photographed in May 2006 and in September 2008.

Picture 14 Comparison of the wetland around KP212 between May 2006 (left) and September 2008 (right)

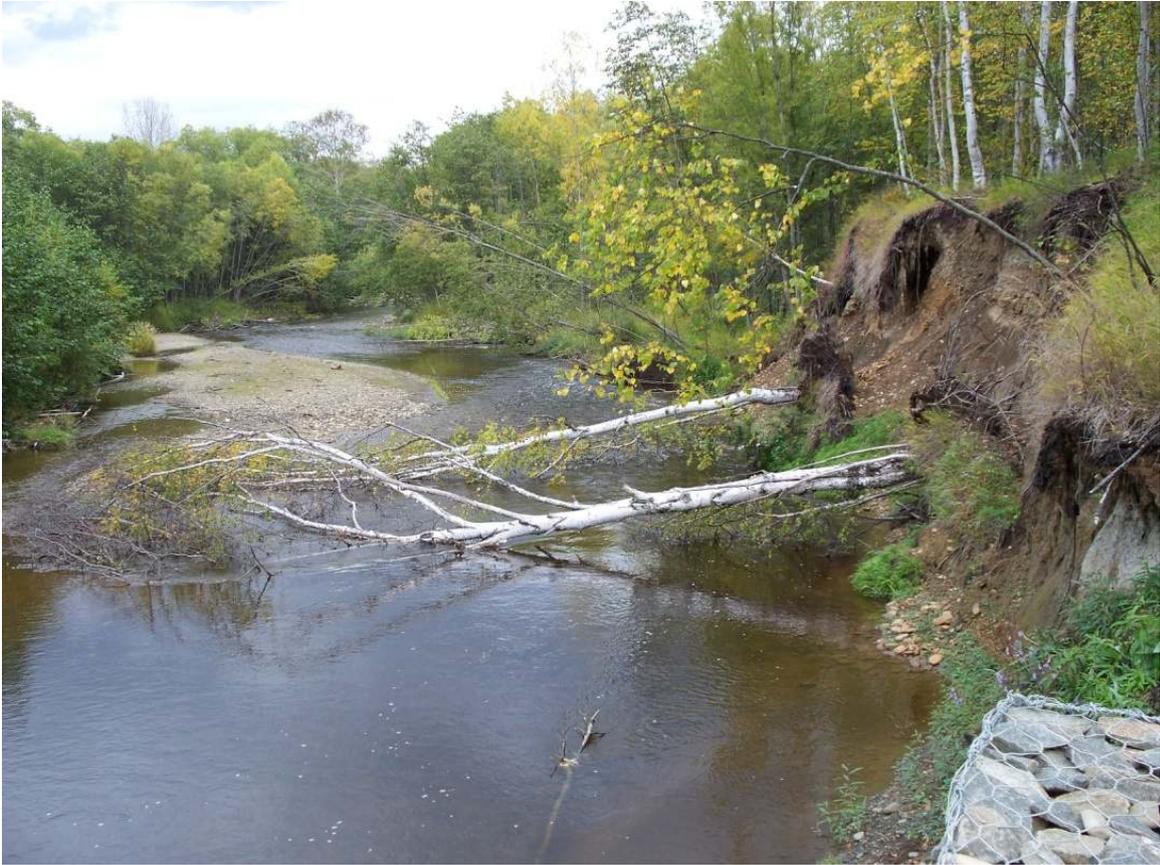
- Rivers where significantly eroding banks lie immediately outside of the RoW with the risk that the river erodes behind the existing engineering within the RoW. Examples of where this may occur include the R. Pobedinka (see Picture 15), R. Nitui and the R. Kirpichnaya (see Picture 16). In such instances we recommend that Sakhalin Energy continue to monitor the channel erosion and, if necessary, consider the need to seek additional land allocation to enable installation of engineering outside of the current RoW.

Picture 15 Riverbank erosion outside of the RoW at the R. Pobedinka

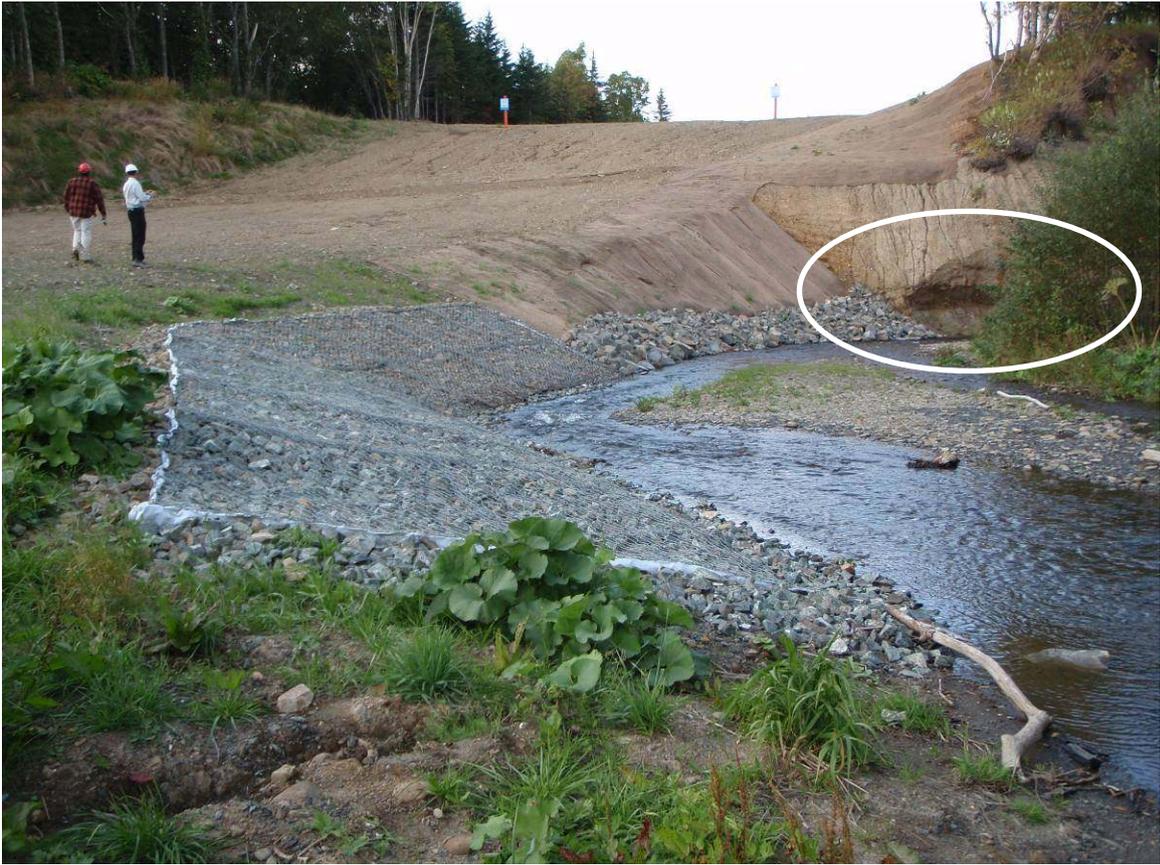
Picture 16 Riverbank erosion outside of the RoW at the R. Kirpichnaya

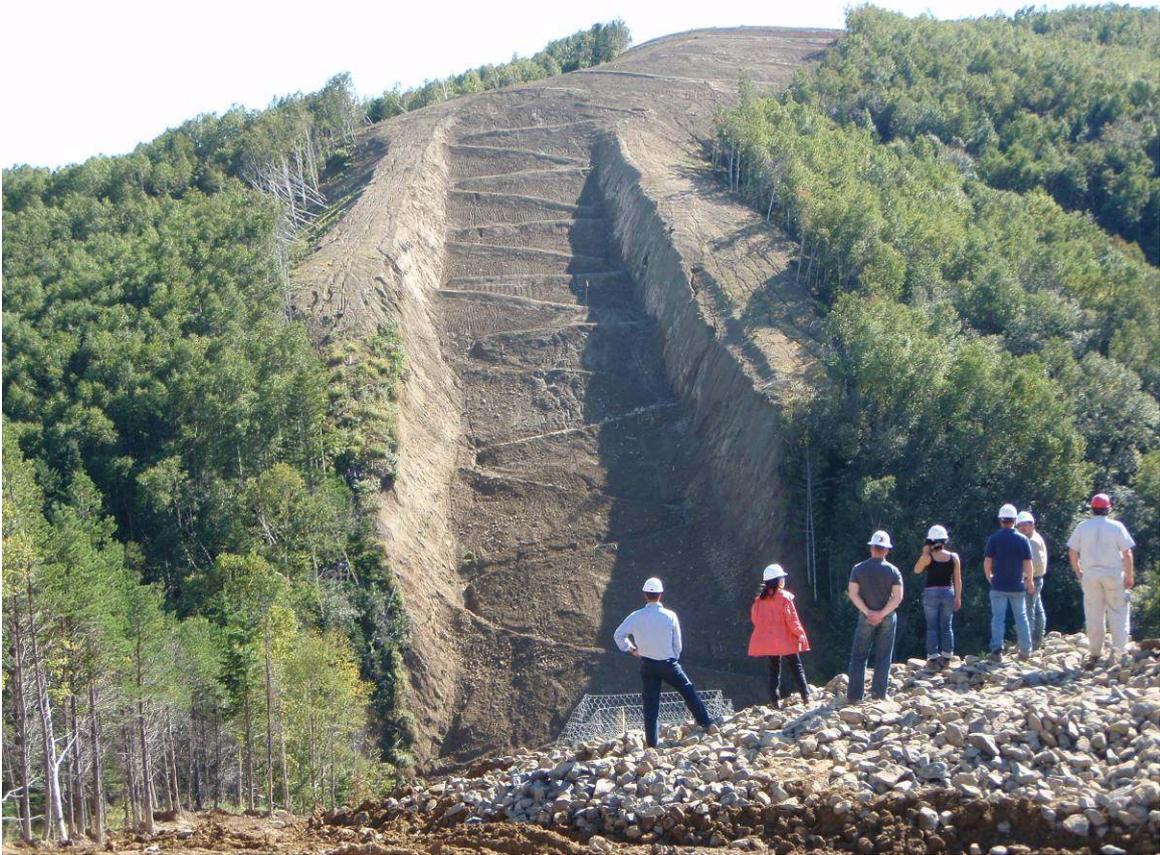
Picture 17 Slope adjacent to the R. Gar showing step side cuts

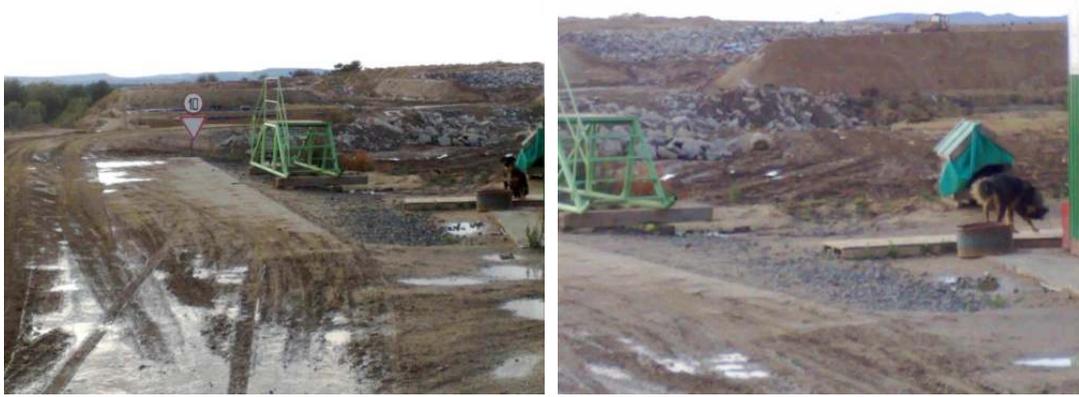
Only a general view of Nogliki Landfill could be gained as the site was closing for the day. The site is fully fenced and has security, there are lined cells and the correct compaction and spreading equipment is in use. In general the site seemed tidy and well run (see Picture 18). It is understood that the original cell was increased in size through the addition of a lined bund to the original construction. This has had the effect of increasing the height of the waste mass which, while not ideal, is still better than the previous practices observed at the site in the past.

Picture 18 Nogliki landfill entrance (left) and active cell (right)

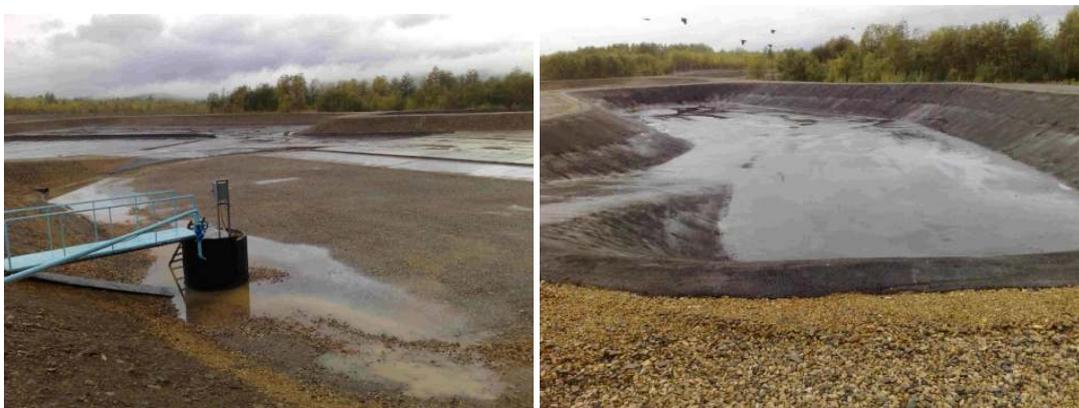
This is one of the up-graded landfills constructed by Sakhalin Energy in 2006 and replaced the former facility 2km away. There has now been an additional oily wastes handling area constructed at the site. This consists of a lined temporary holding cell and a large bio-remediation area equipped with a groundwater monitoring and pumping well that can extract the oily water and run it through an on-site treatment plant (see Picture 19). It was not clear from the site visit exactly how the system was

Picture 19 Smirnikh bioremediation cell (left) and oily waste holding area (right)

Waste management	<p>We have concerns as to the proposed treatment of oily wastes at Smirnikh and recommend that other treatments should be assessed in addition to this process, such as thermal desorption, in-vessel bio-remediation, encapsulation etc.</p> <p>It was observed that waste was being disposed of (seemingly without being covered) in the area of the initial cell constructed at the new Smirnikh landfill site. It is unclear if this initial cell is still intended to be operated or if it is supposed to be closed. We recommend that the status of this cell be clarified by Sakhalin Energy and appropriate acts (e.g. cover or removal of visible wastes) undertaken.</p> <p>Care should be taken that where any of the non-upgraded landfills/dumpsites are to be closed that an alternative waste facility is available within a reasonable distance. We note for example that Sakhalin Energy intends to assist with the closure of a waste dump at Val, but it is unclear whether an alternative facility exists (or is to be developed).</p>

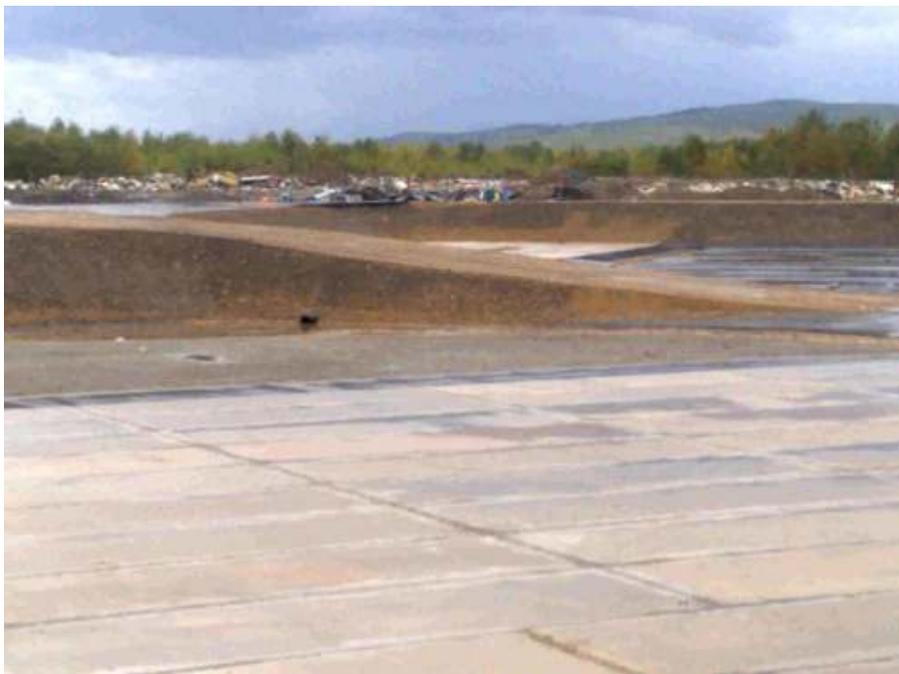
Another area of potential concern for the site is the current waste operation procedures. It was observed that waste was being disposed of (seemingly without being covered) of in the area of the initial cell constructed at the site (see Picture 20). It is unclear if this initial cell is still intended to be operated or if it is supposed to be closed. We recommend that the status of this cell be clarified by Sakhalin Energy and appropriate acts (e.g. cover or removal of visible wastes) undertaken.

Picture 20 On-going landfill operations on the initial cell at Smirnikh

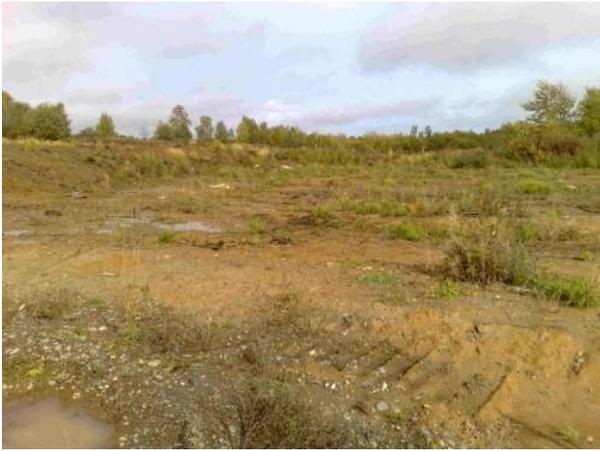
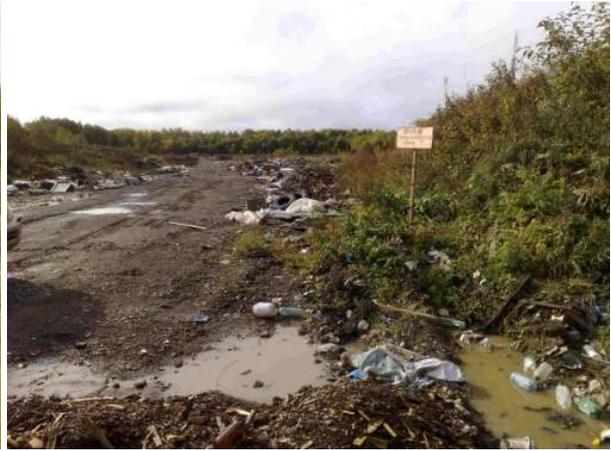
This is one of the non up-graded landfills that Sakhalin Energy has undertaken to close and reinstate. A total of 35,000m³ clean spoil material was brought here from Fault 3 to act as cover material. The tipped material present at the site was bulldozed into one area then covered with the clean spoil to a depth of 1m and then seeded. A trench was then dug across the entrance to prevent further unauthorised tipping. However, during the visit it was noted that the trench had been backfilled and fresh tipping of domestic waste had resumed (see Picture 21). There is potential here for the Sakhalin Energy social program to assist the local administration with an education program for the local community in responsible waste disposal.

Picture 21 Views of the Yasnore waste tip showing new covered tip area (left) and recently tipped waste (right)

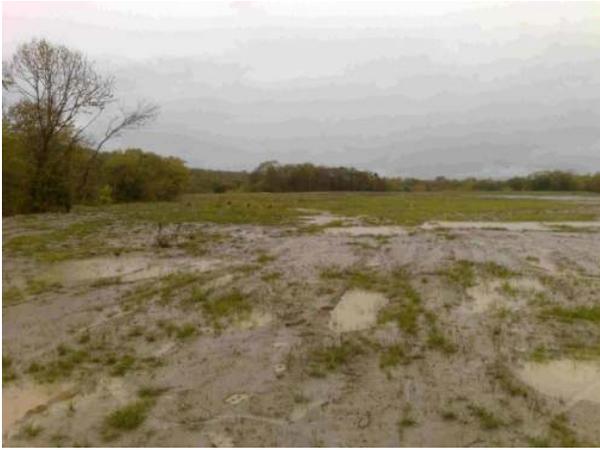
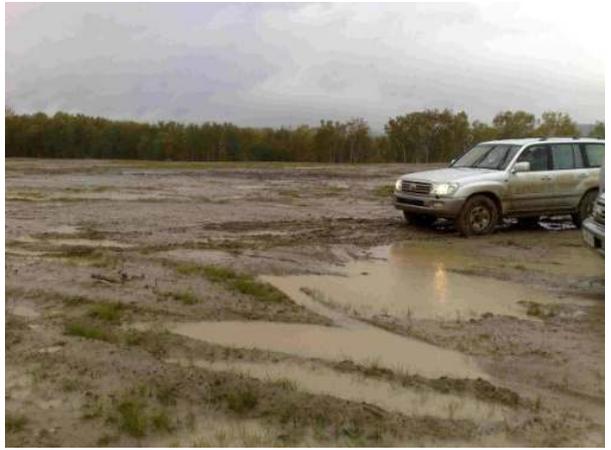
This is another non up-graded landfill that Sakhalin Energy have helped close. At this site a total of 200,000m³ of spoil from Fault 8 has been brought into the site to act as final cover material and to seal the site (see Picture 22). Seeding has also been carried out in patches across the site. As at Yasnoye it was noted that some fly tipping at the site had occurred since closure in spite of the fact that the new fully lined site is open 2km away. Some education of the local community is required, and there may be an opportunity for Sakhalin Energy social programs to assist the local authorities in this.

Picture 22 Views of cover material over the former Smirnikh landfill
