Intended for  
**Sakhalin Energy Investment Company Limited**

Date  
**March 2018**

Project Number  
**UK22-17081**

# **SAKHALIN-2 PHASE 2 LENDERS' ENVIRONMENTAL CONSULTANT MONITORING REPORT SEPTEMBER 2017**

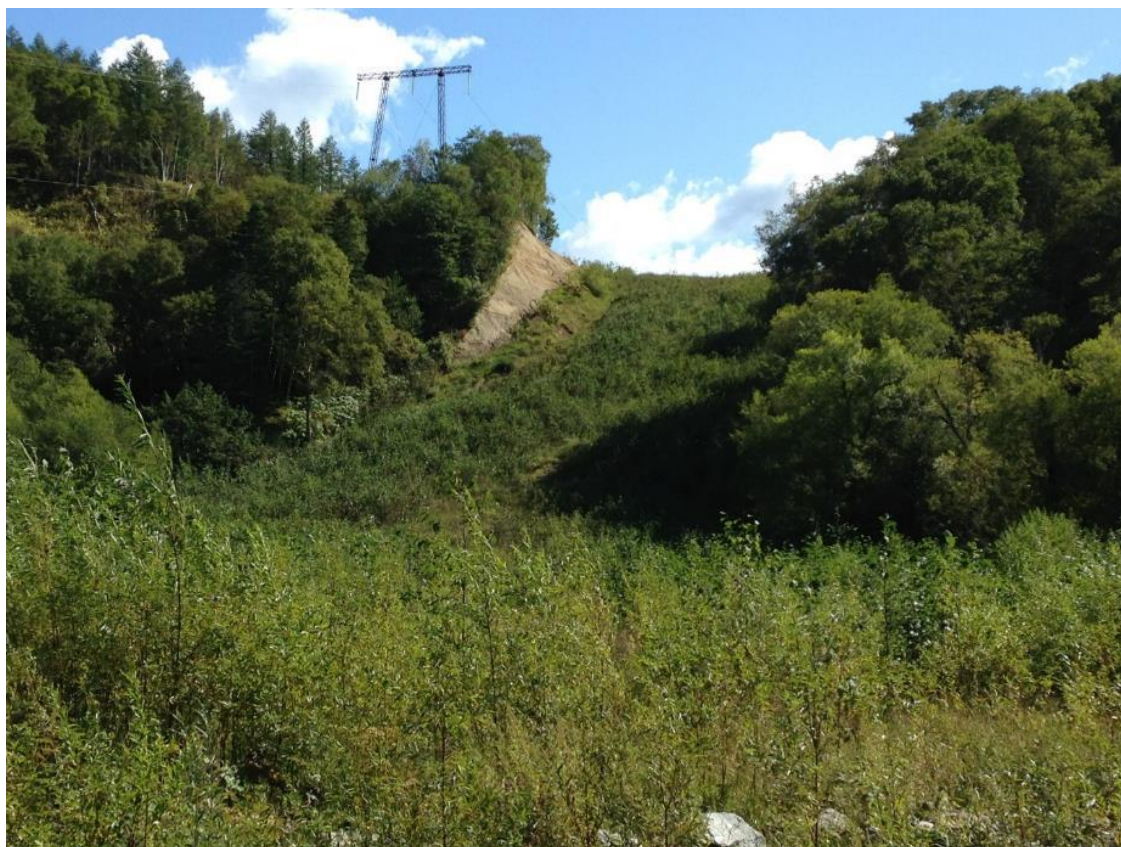
No specific visits were made to sites featuring steep slopes, however a number of steep slopes were observed incidentally while travelling along the RoW. All appeared from a distance to be well vegetated and no obvious signs of erosion were spotted. A number of instances of steep slopes having been created during construction immediately adjacent to the RoW from cuttings through hill side were observed; Photo 1 shows one example. It is understood that this and a number of other sites are being actively monitored by Sakhalin Energy for erosion or landslips via a geotechnical risk register.

**Photo 1 – En-route to KP499, steep slope on side of hill cutting**

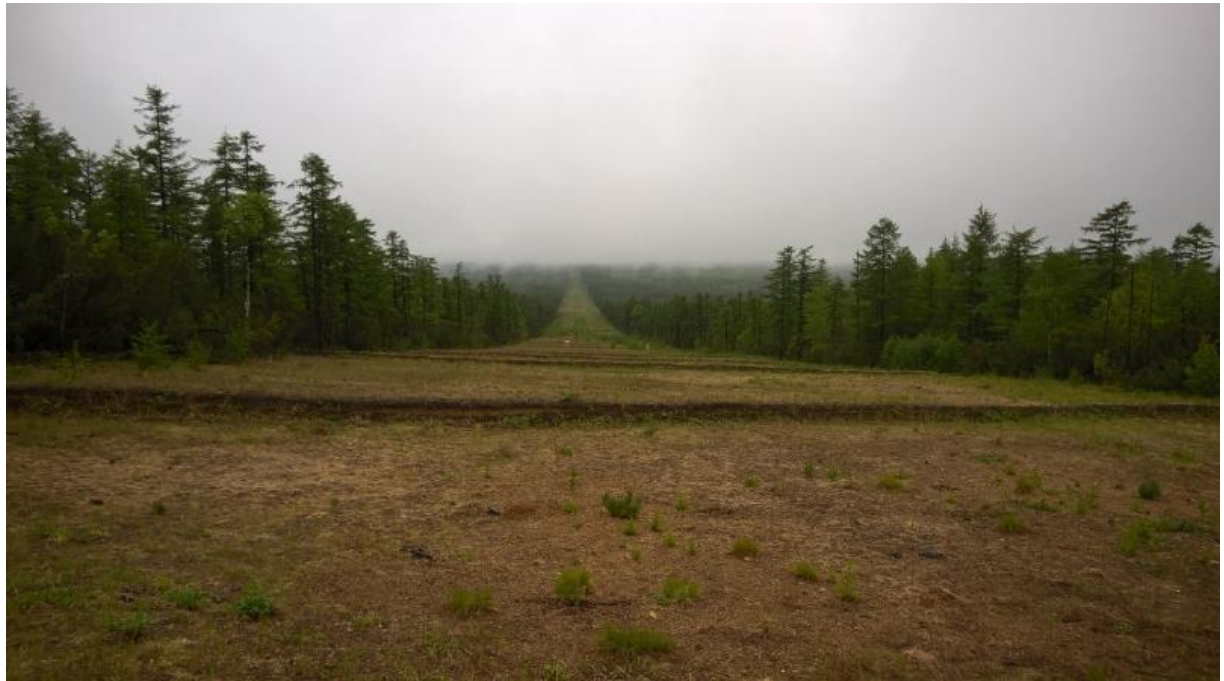
Another sandy slope was observed at Fault Crossing #1ALT (see Appendix 4). No erosion was observed at this location and the slopes have been protected through the installation of slope breakers and geo-textile. However, additional specialist ecological restoration may be required to restore natural vegetation at this location. The very low-nutrient sandy soils at this location naturally support fragile lichen mats and biogenic crusts. These vegetation types are not easy to restore and are likely to take some years. The difficulty of restoration of this and a number of other locations along the RoW are likely to have been exacerbated through the lack of preservation of the vulnerable topsoils along with their seedbanks during construction. This issue is being tracked as Finding LAND.16.

**Photo 2 - Recently restored sandy slope (June 2016)**

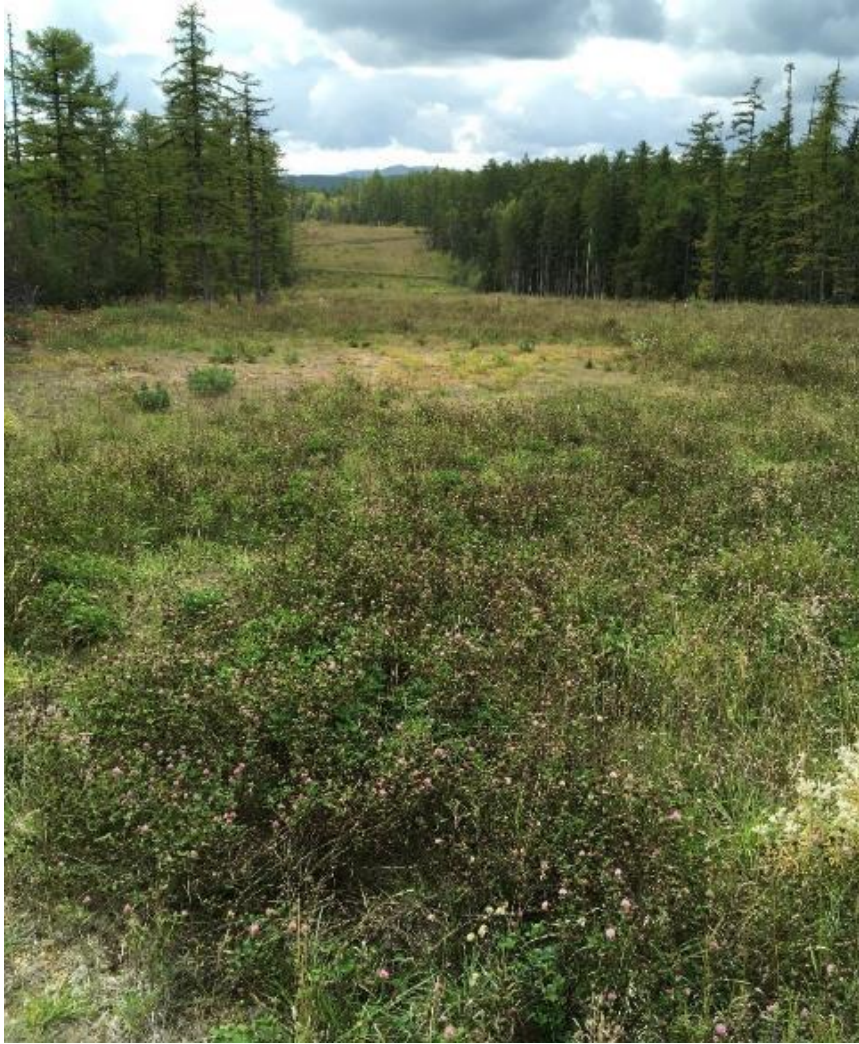
**Photo 3 - Similar location, pictured during this visit (September 2017)**

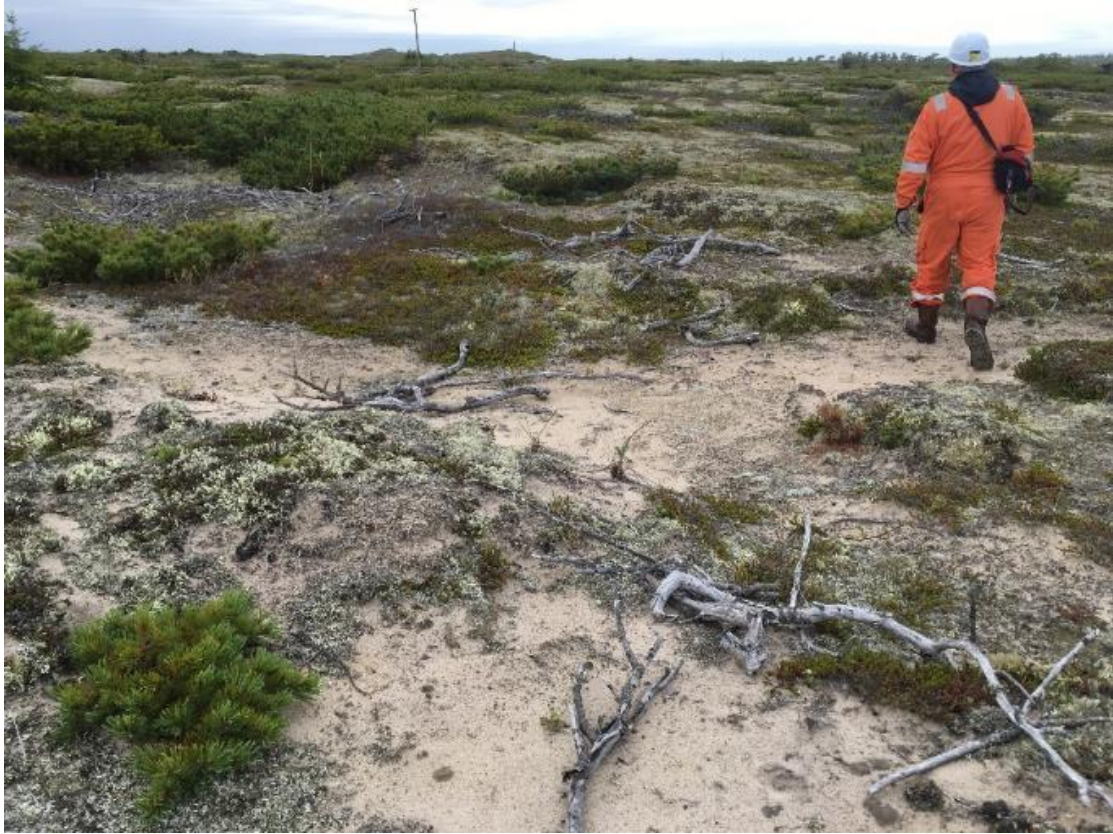
The beach landfall of the pipeline from the Lunskeye-A platform (Lun-A) to the OPF was visited. The area of dune vegetation immediately adjacent to the sandy beach has restored rapidly following construction due to the colonising ability of Marram in this naturally unstable sandy habitat. However, the vegetation on the more stable dune areas immediately inland has not restored (Photo 4 and Photo 5) and bare sand is still present. The plant community of stable dunes is relatively complex and includes biogenic crusts and lichen beds. Restoration of this natural habitat in the RoW will likely require a tailored ecological restoration programme, such as the local collection of seed and propagation of plants for transplantation.

**Photo 4 - KP 14 (Lun-A landfall), mature stable dune habitat adjacent to the RoW**

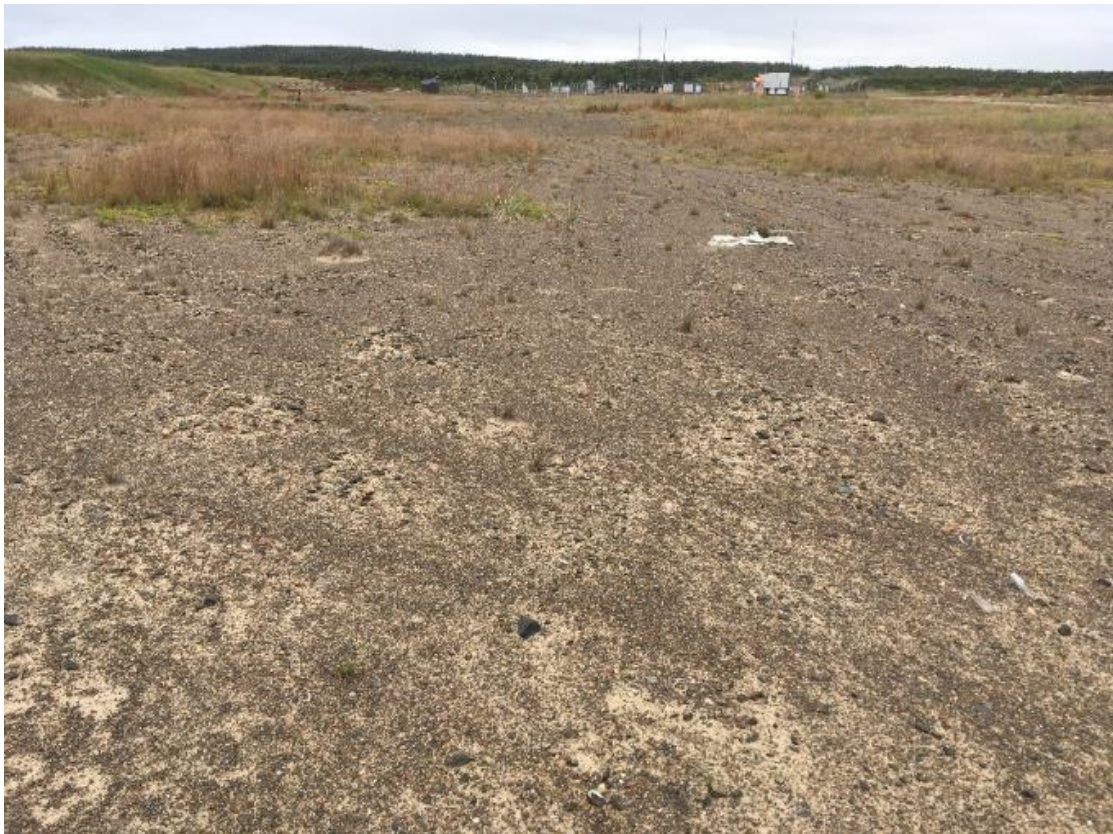
**Photo 5 - RoW at KP 14 showing areas of bare sand**

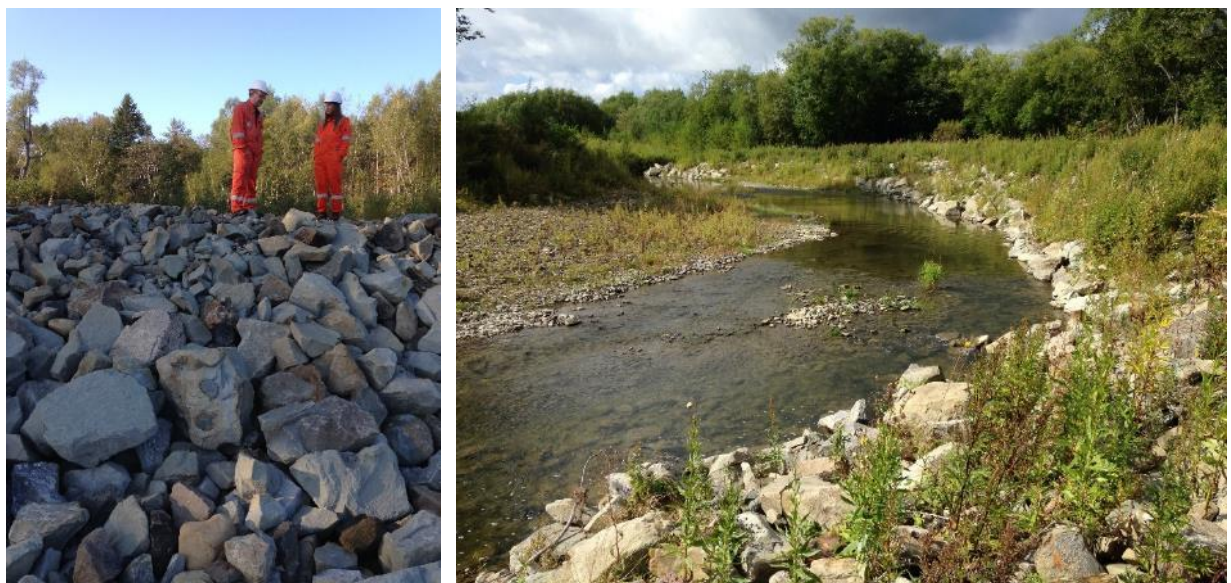
Five river crossings were visited by Ramboll Environ during the site visit. This included sites subject to restoration work over a number of years. The majority of sites have had protective stone rip-rap installed on the banks to prevent erosion during 'high erosion potential' river flows, especially after snow melt in the spring. To prevent erosion from undercutting either the pipes or the restored banks, protective stone has had to be installed to areas *outside* of the RoW. It is understood that the permitting process for works outside of the RoW has a long lead-time. This is being managed through a proactive restoration programme that attempts to address erosion before it becomes a significant issue. All of the rip-rap observed looked to be in good condition, and by year four following installation has well-established vegetation growing in the cracks between the stones. This vegetation is likely to aid the stabilisation of the banks and improve the overall natural appearance of the stone banks (compare examples in Photo 6 below).

**Photo 6 - Recently installed rip-rap, lacking vegetation (left)**

**Four year old rip-rap with good vegetation establishment (right)**

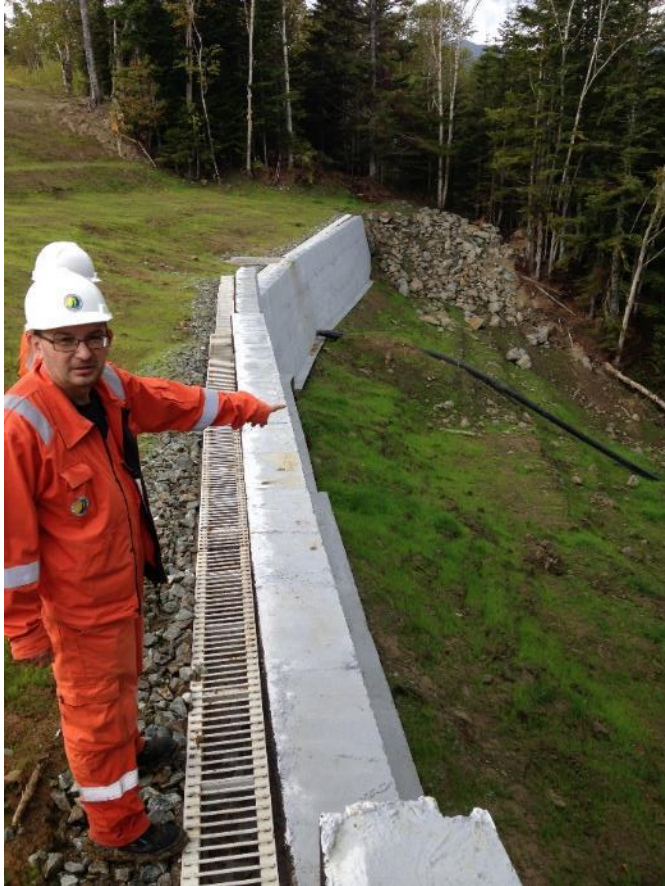
Three locations of geotechnical repair were visited during September 2017. Two previously completed Category 3 repair sites (KP382.5 and KP383.4) provide examples of specialist engineering design including the installation of large hard retaining structures (Photo 7). The third location (KP420) shows an example of where proactive restoration has possibly prevented a worsening landslide problem through the installation of “softer” engineering solutions (e.g. ground anchors and netting as shown in Photo 8).

**Photo 7 - Reinforced concrete retaining wall recently installed at KP 383.4**

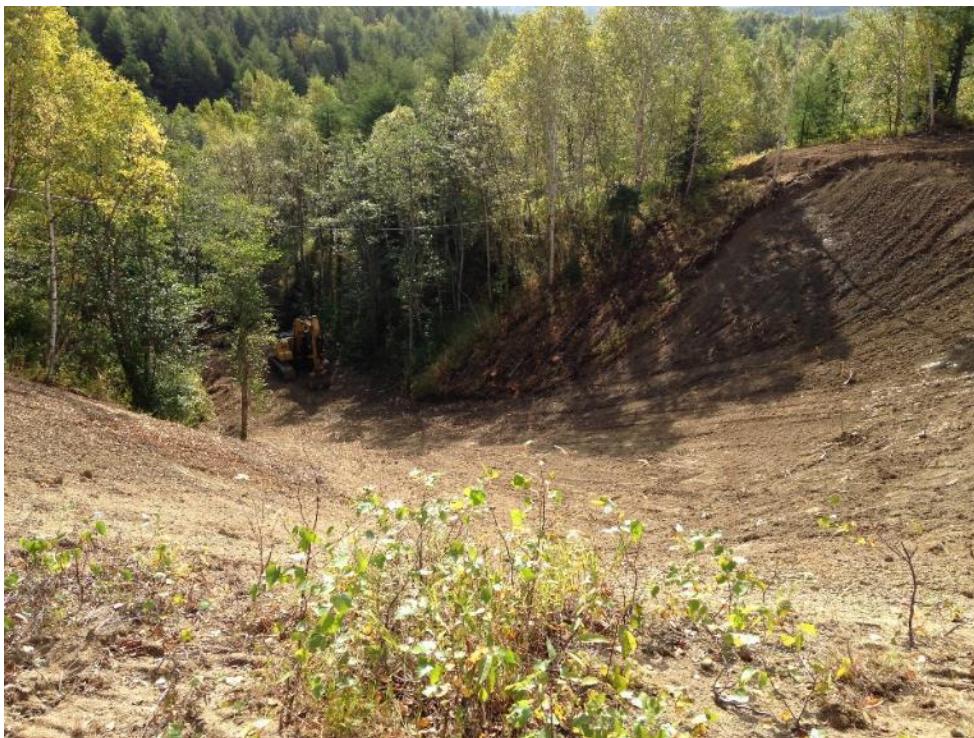
**Photo 8 - KP 449 Restored slope in preparation of installation of ground anchors and netting**

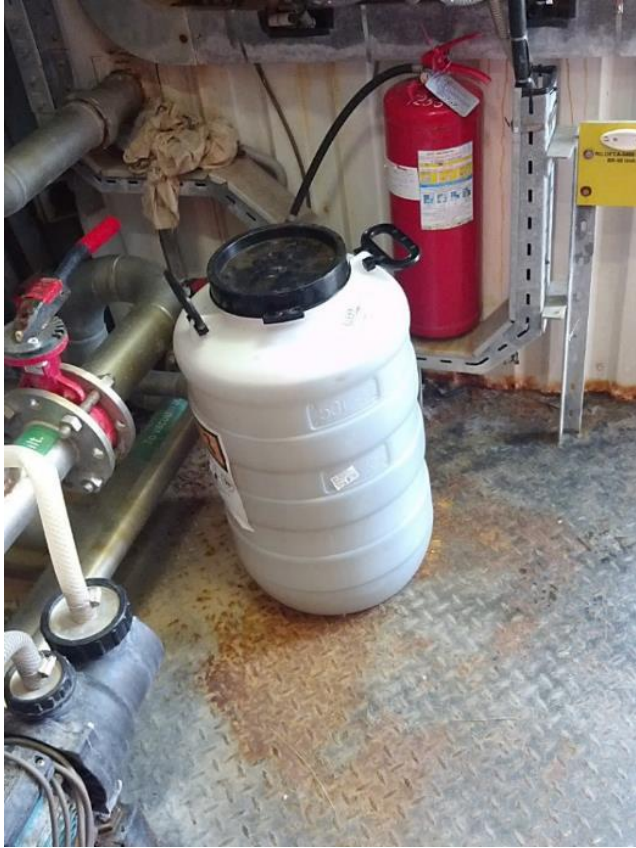
**Photo 9 – Drum of polyaluminium chloride with no trip tray in the STP**

**Opportunity for Improvement:** It is recommended that refresher training on the requirements of the materials management manual is provided to warehouse staff. In particular, it should cover the procedures on acceptance of damaged chemical drums.

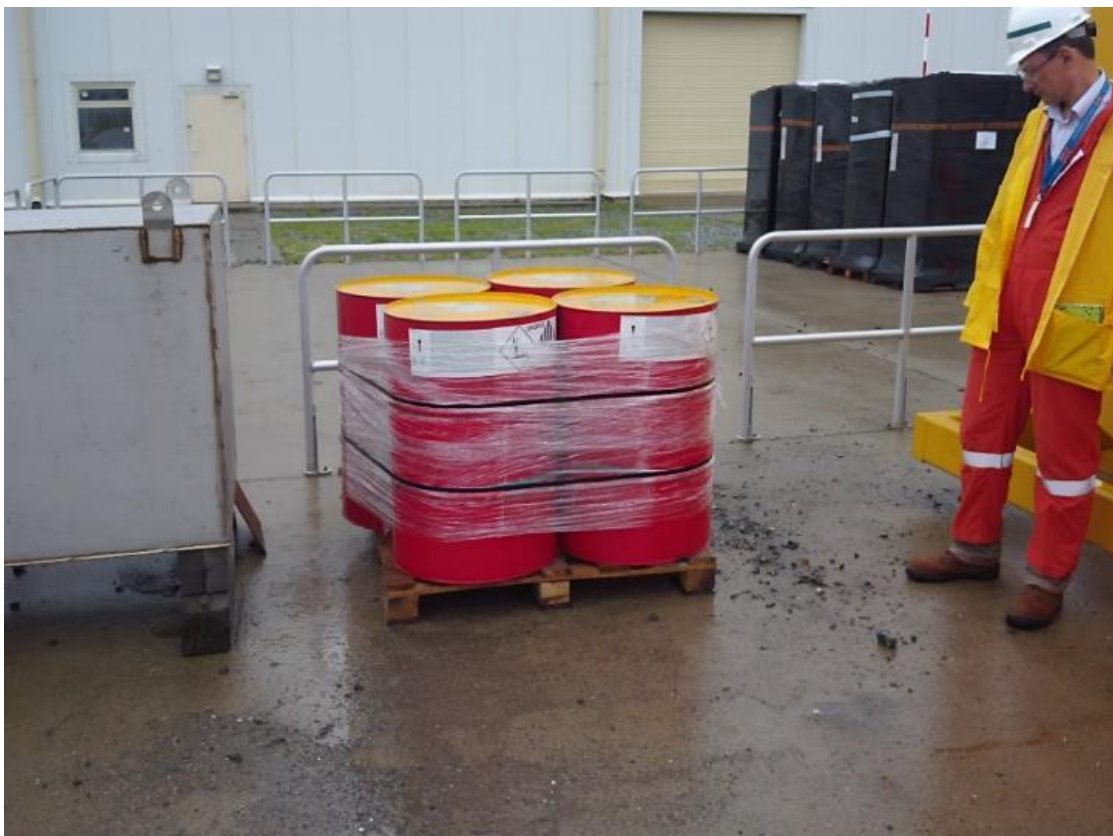
**Photo 10 – Four drums of oil with no secondary containment**

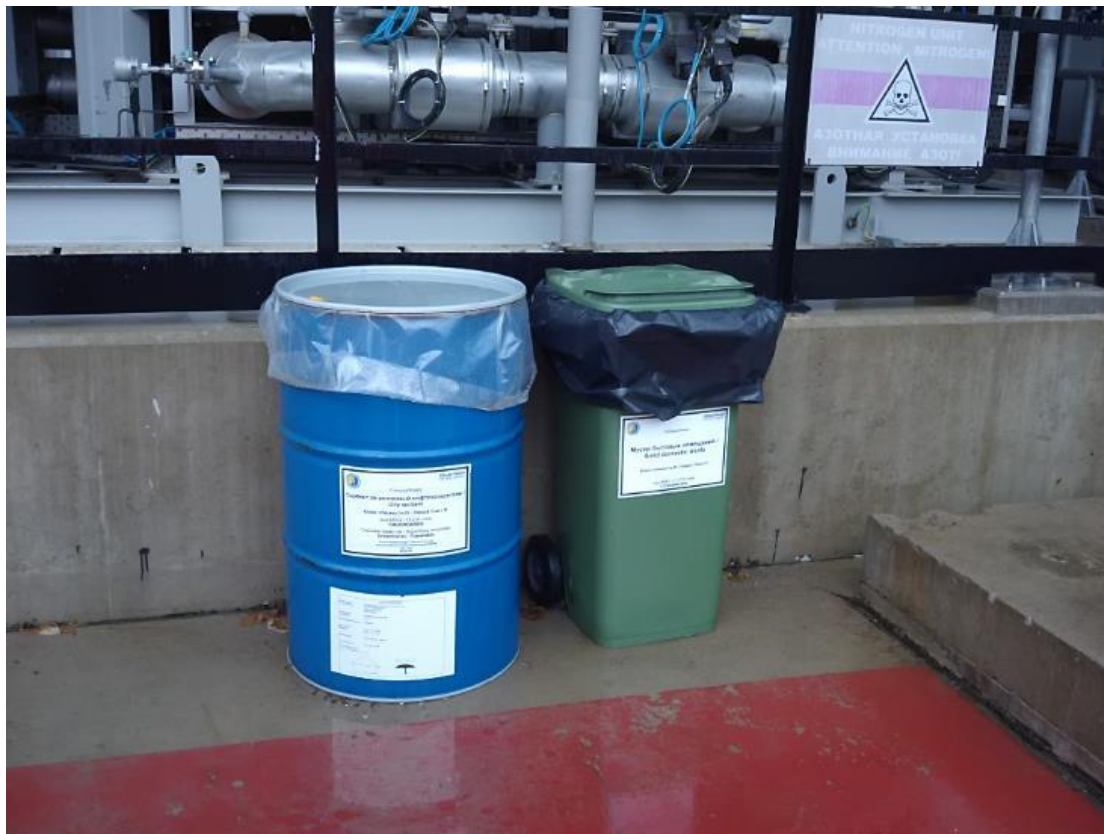
The facility has implemented several waste minimisation measures, including diverting grass cuttings from landfill to a local farmer, as recommended in the 2015 IEC audit report. In addition, plastic, cardboard and paper are now segregated for off-site recycling.

**Photo 11 – Waste stored in secure containers with clear labelling**

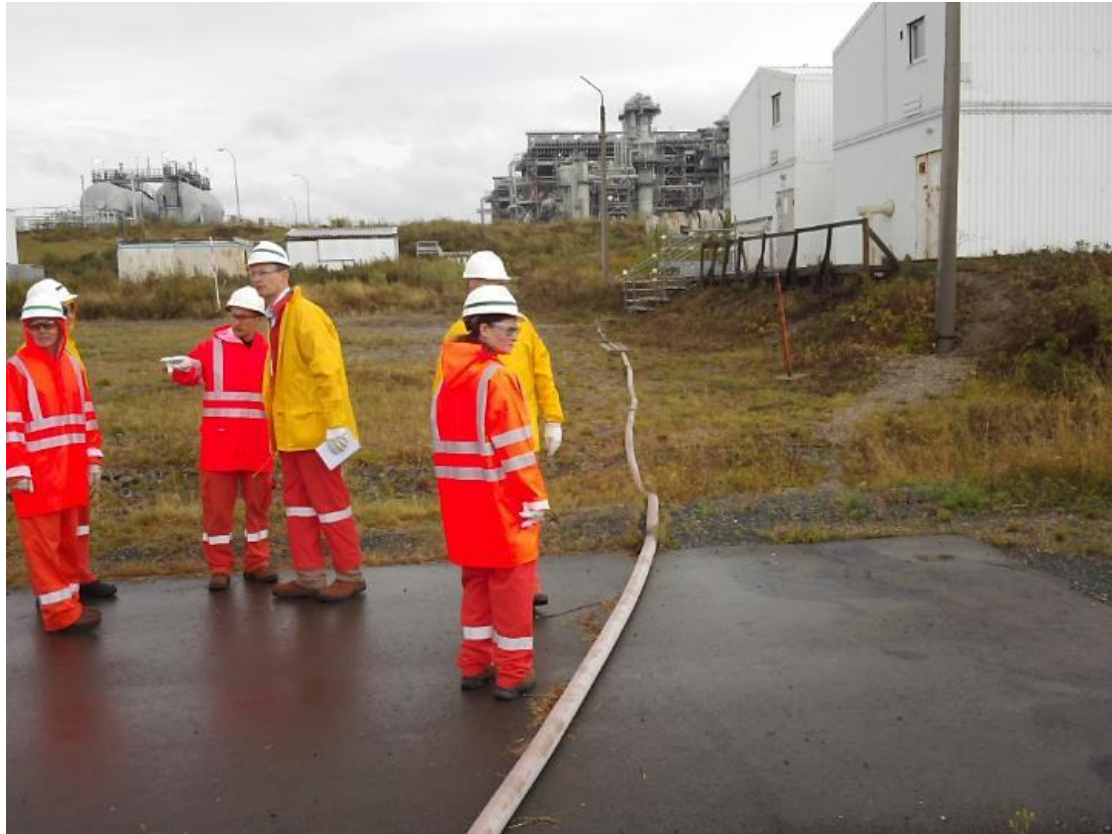
- Several sections of the temporary aboveground hose connecting the on-site sewage treatment plant (STP) to the older BR-200 water treatment units have been replaced (the need for such had been identified in previous IEC monitoring visits) and it currently appears in good condition. It is understood that the current STP, BR-200 treatment units and surrounding unused buildings will be demolished and replaced with a larger STP in around 2020, as part of the Train 3 Project.

**Photo 12 – Temporary hose near the STP**

It is understood that the current STP, the older BR-200 treatment units and surrounding unused buildings will be demolished and replaced with a larger STP in around 2020, as part of the Train 3 Project.

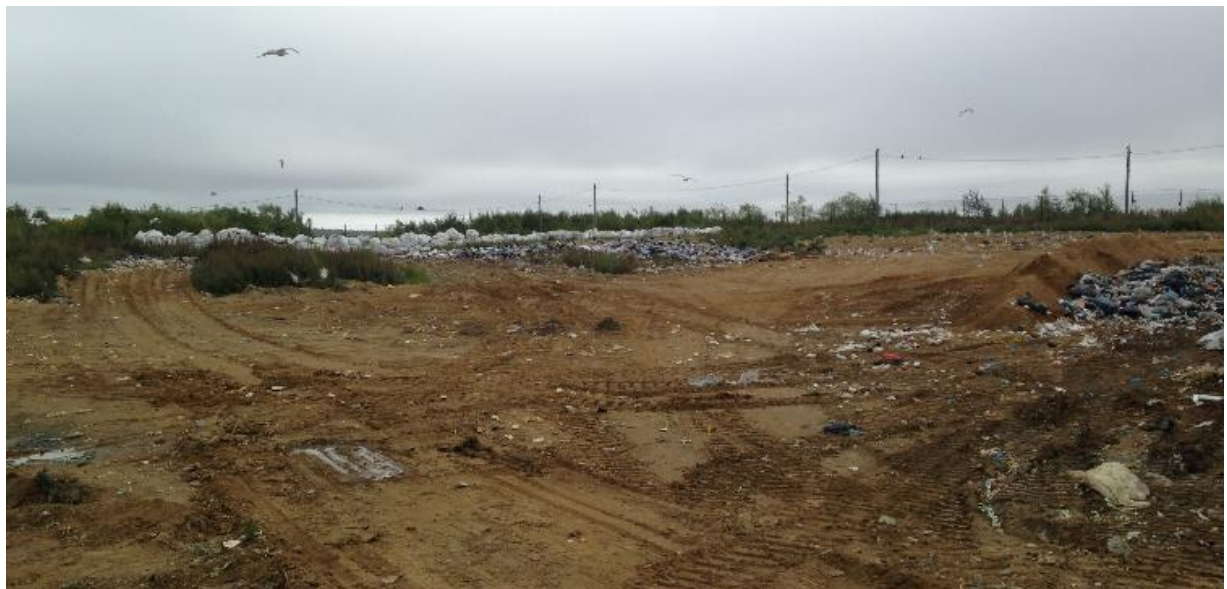
**Photo 13 - General view of Sakhalin Energy cell**

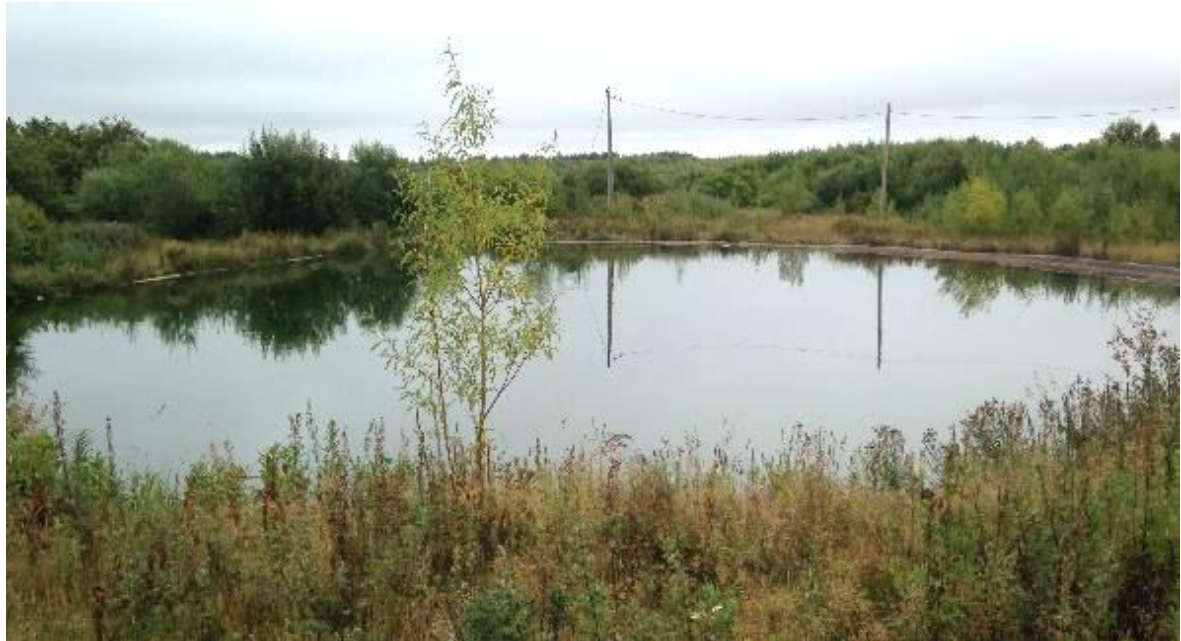
**Photo 14 - Leachate pond associated with Sakhalin Energy cell**

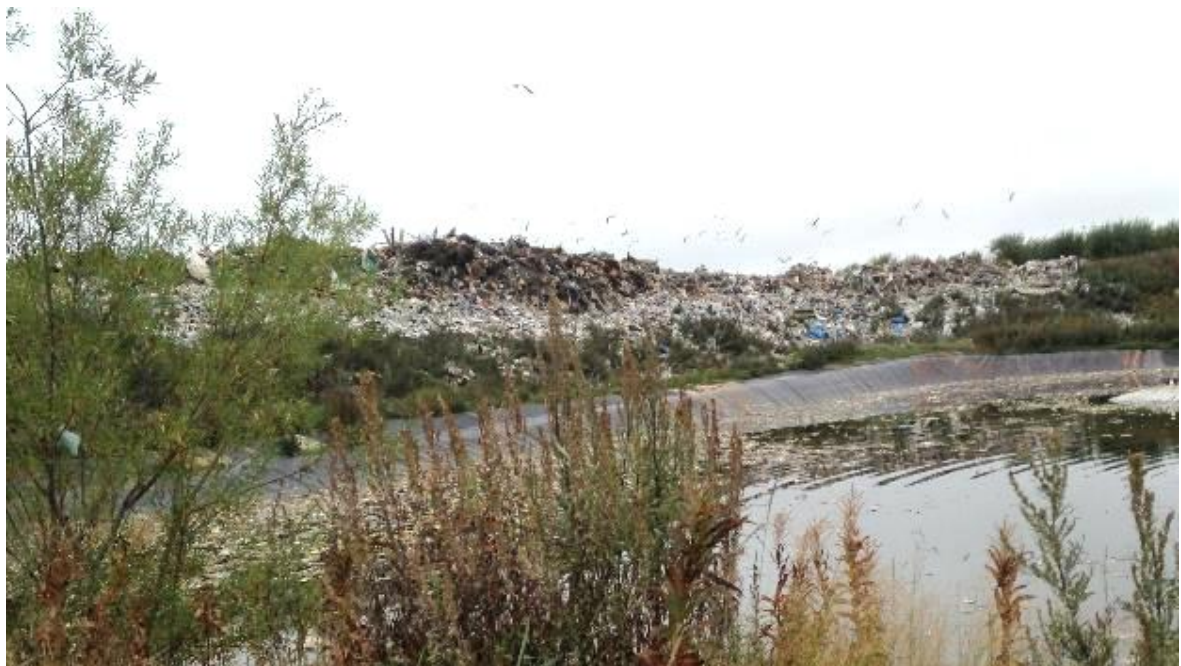
**Photo 15 - Municipal cell and associated pond**

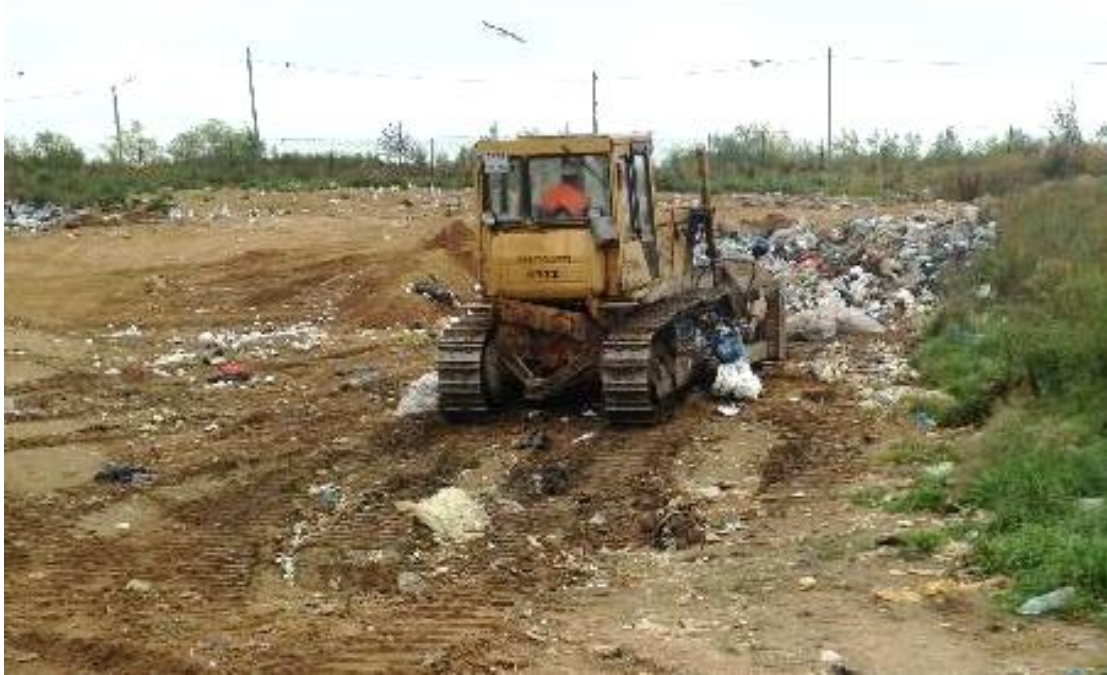
**Photo 16 - Compaction and covering operations at Sakhalin Energy cell**

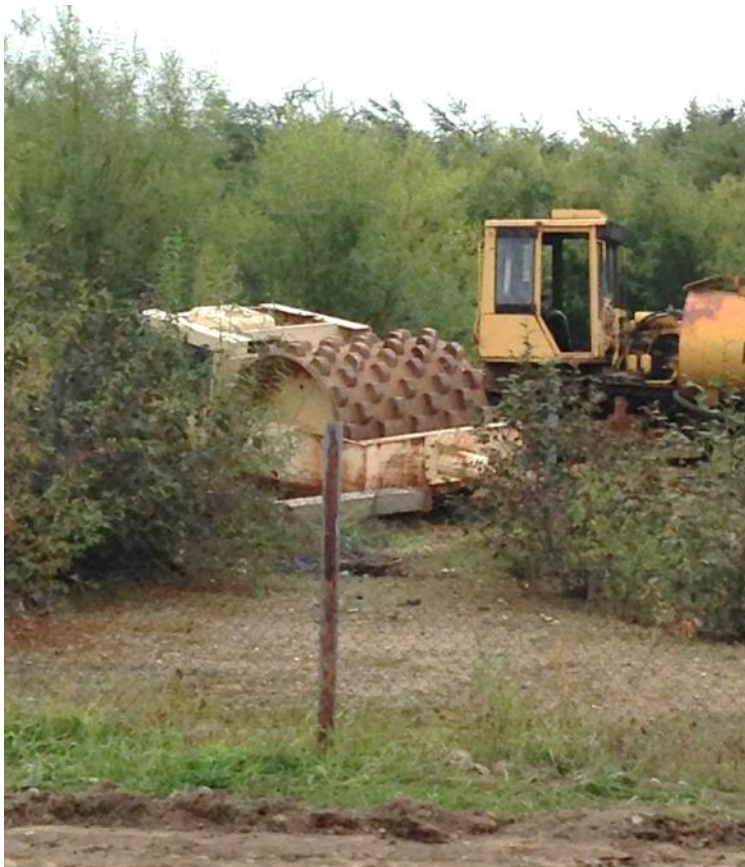
**Photo 17 - Non-operational studded roller - to be replaced**

**Opportunity for Improvement:** Sakhalin Energy should seek confirmation from the operator of its intention to replace the studded roller and should use its influence to ensure a replacement is put into operation at the Sakhalin Energy Cell in a timely manner.

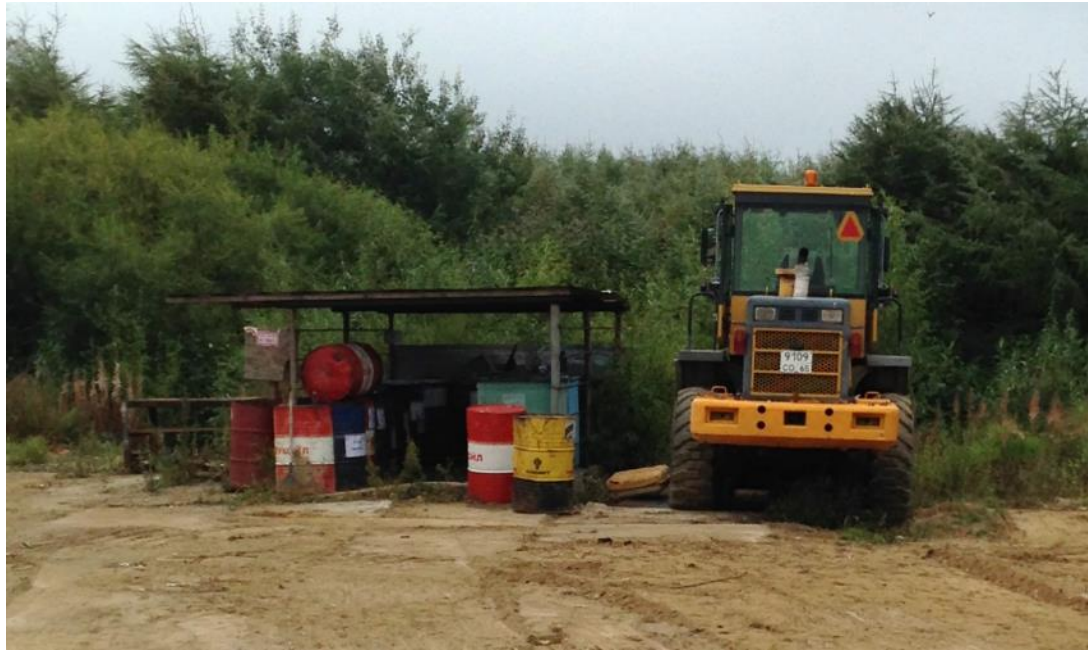
The Nogliki landfill facility includes a small storage shed containing engine oil, lubricants and waste oils associated with the maintenance of site vehicles. While it was reported that the storage facility had been upgraded at the Company's request in recent years (i.e. concrete paving had been installed), the store was still observed to be poorly managed and well below the standards of housekeeping and secondary containment applied at Company assets.

**Photo 18 - Oil store**

**Opportunity for Improvement:** Sakhalin Energy should seek to use its influence to achieve improvements in the general standard of housekeeping applied in the facility's oil store, and improve the secondary containment up to a level commensurate with HSESAP requirements.

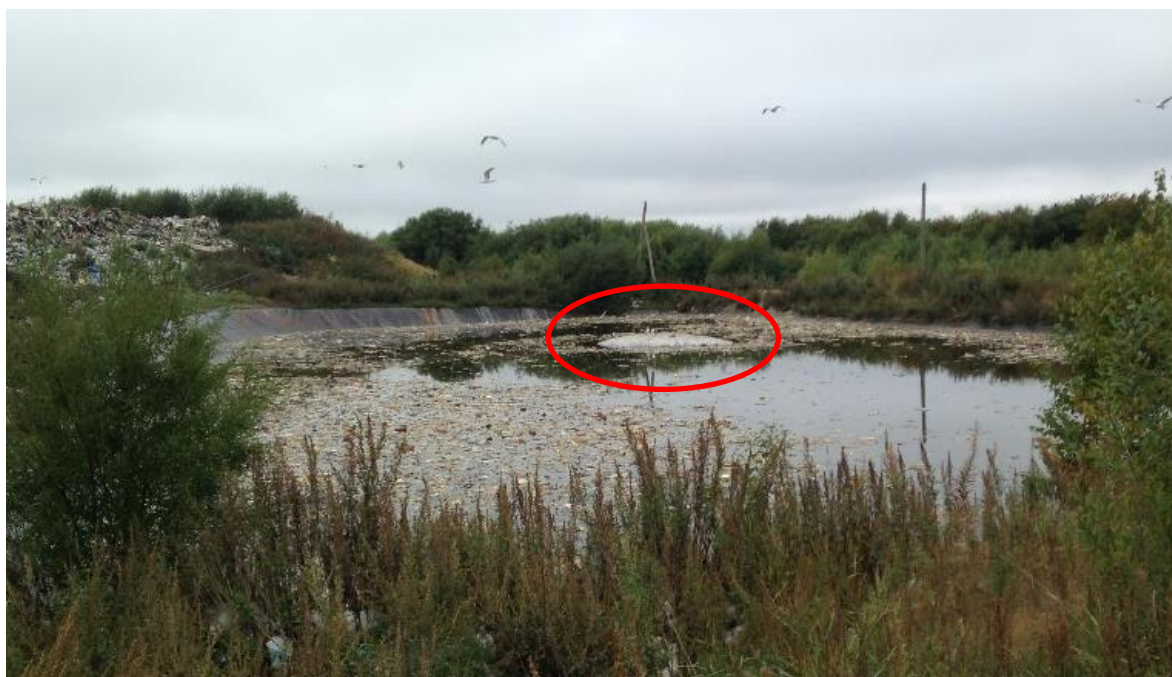
In response, Sakhalin Energy funded a study into the likely causes of the 'bubble' and potential remedial measures (although it was agreed that responsibility for corrective actions remained with the landfill operator). Then in October 2014 and subsequent to that study, Ramboll Environ noted that the 'bubble' had significantly reduced in size. Sakhalin Energy representatives and site management reported that the 'bubble' reduced naturally, without any physical intervention. During 2015 and then 2016, when Sakhalin Energy were unable to use the landfill whilst its GRORO registration was pending, it appears no further progress was made to definitively identify the root cause or implement the recommended remedial measures. During the latest visit by Ramboll Environ, it was observed that the 'bubble' was present and was approximately the same size as observed in 2014.

**Photo 19 - Methane gas 'bubble' in centre of municipal cell leachate pond**

**Opportunity for Improvement:** Sakhalin Energy should use its influence to ensure that the operating company re-initiates its investigation into this issue and designs and implements a permanent solution to the problem in a timely manner. In the meantime, Sakhalin Energy should closely monitor the extent of the 'bubble' and record it during each periodic monitoring visit to the site.

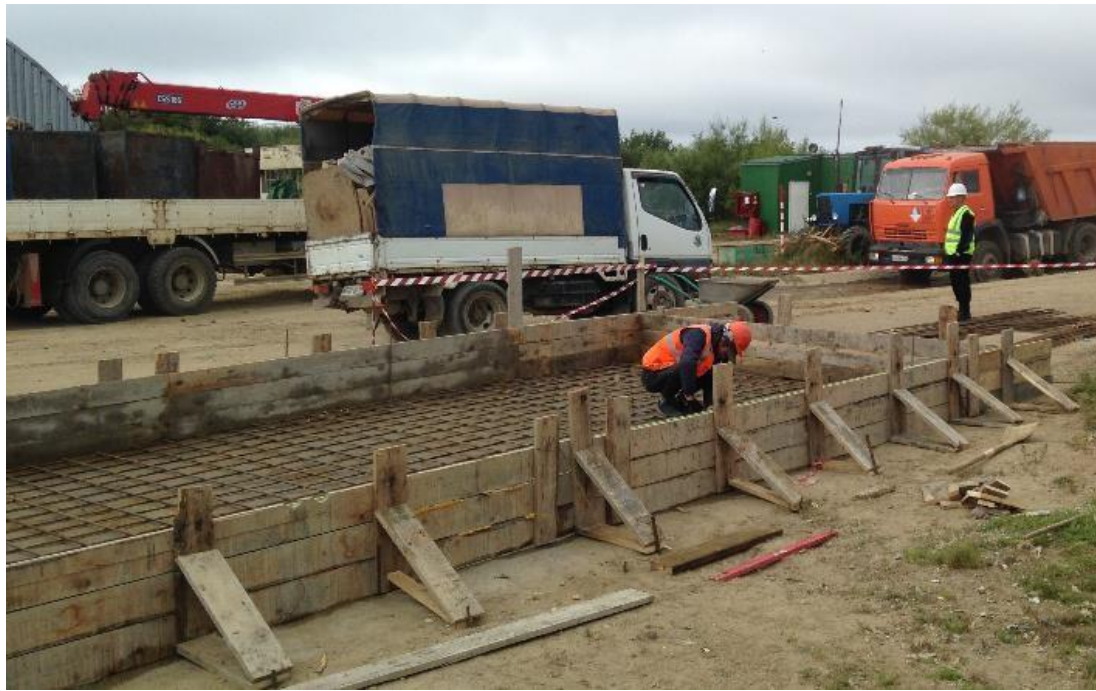
**Photo 20 - New weighbridge under construction**

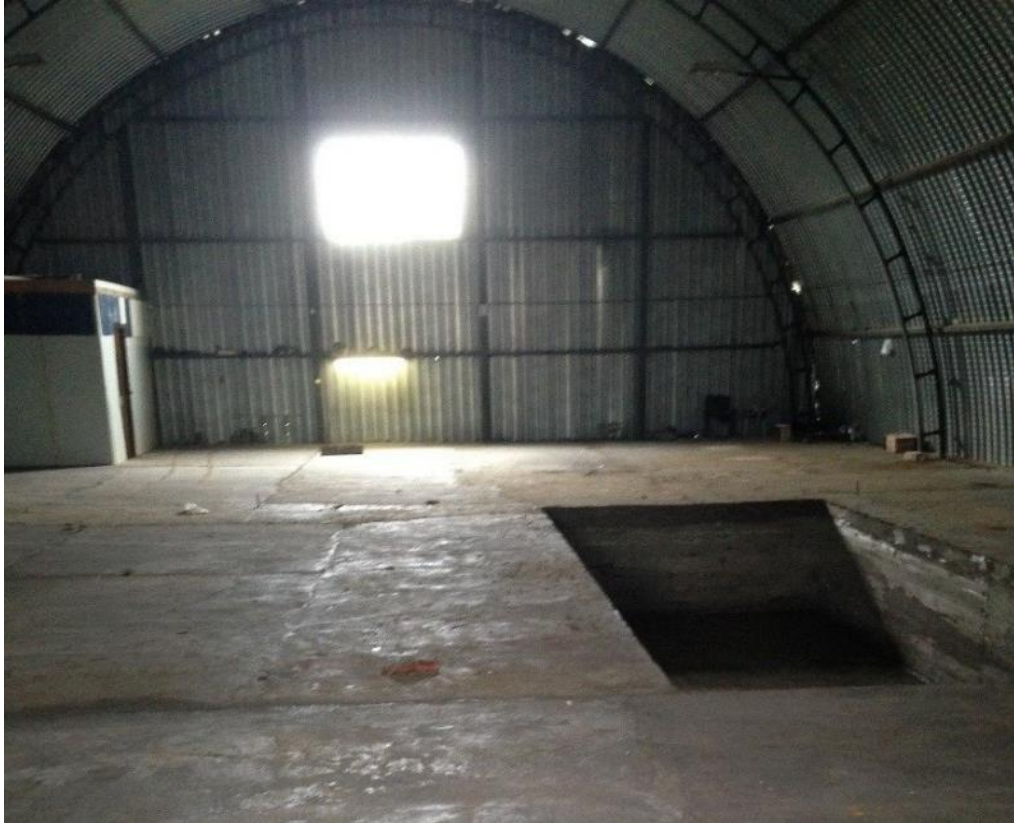
**Photo 21 - Recently refurbished storage shed ready for installation of MRF equipment**

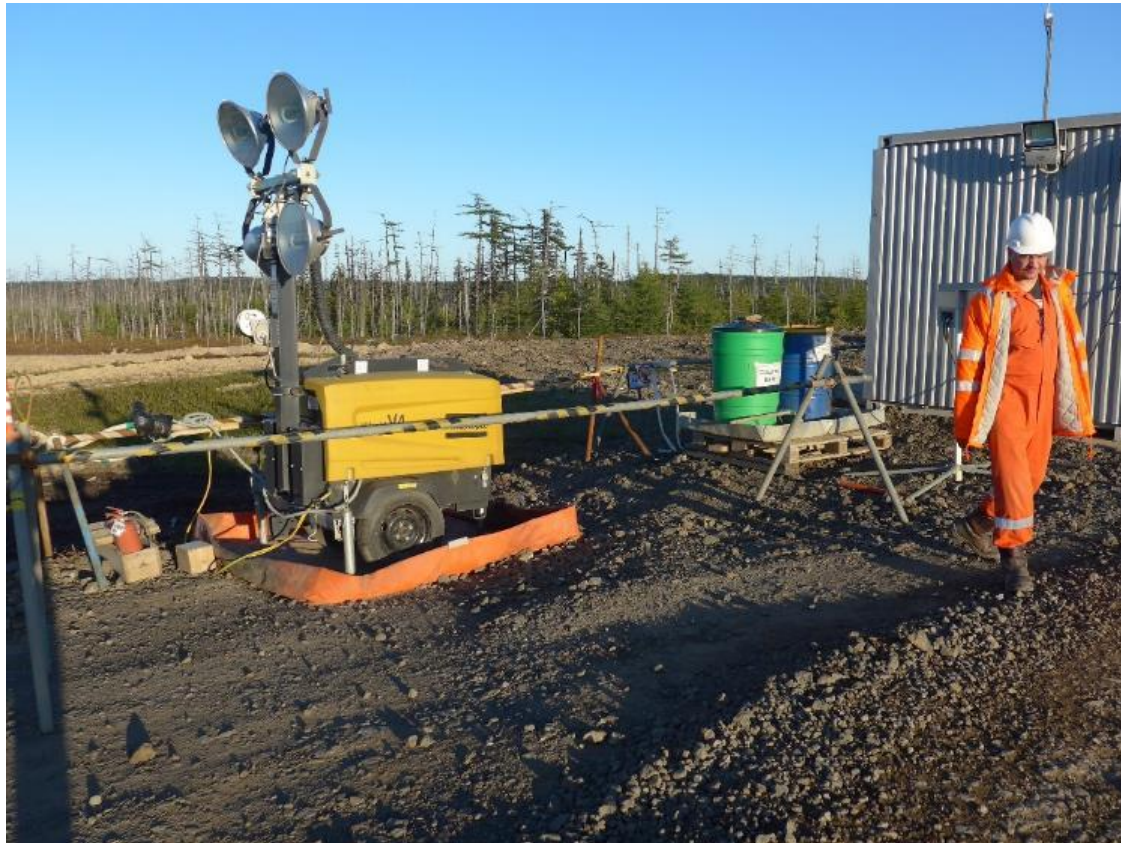
Generally, oil and chemicals are stored securely around the OPF-C construction site. In particular almost every storage drum and all plant and equipment inspected had a drip tray (Photo 22). However, there are some opportunities for improvement.

**Photo 22 – Example of secondary containment for a generator and oil drums**

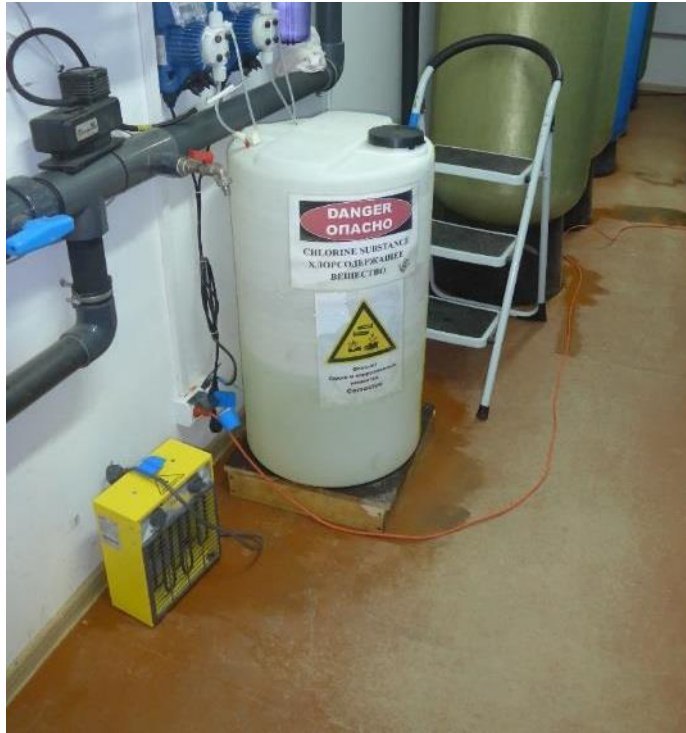
**Photo 23 – Drum of hypochlorite without secondary containment**

It is recommended that metal bunds are tested for water-tightness and repaired or replaced where necessary and that all portable plastic bunds are inspected daily.

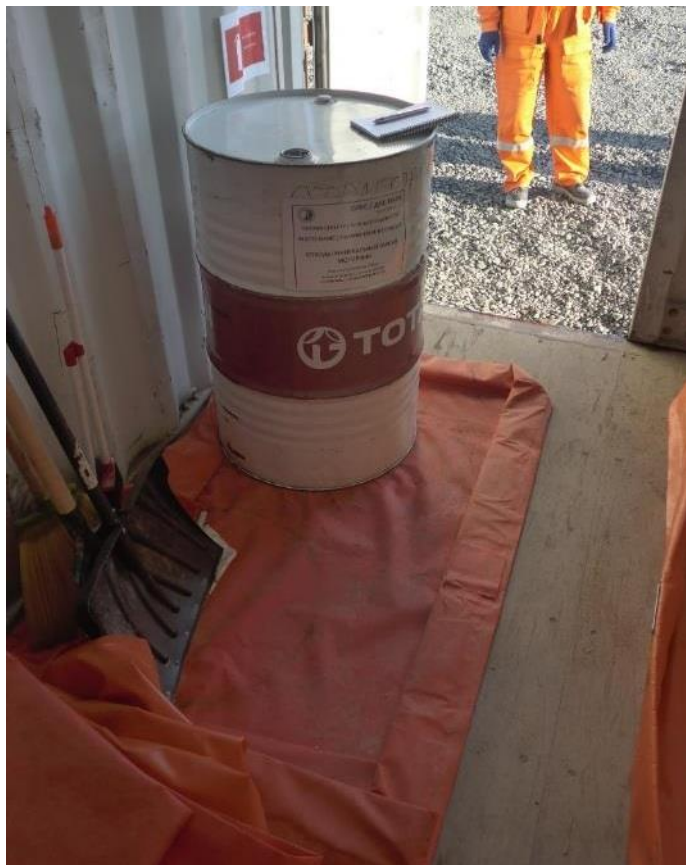
**Photo 24 – Fully collapsed portable bund around a waste oil drum**

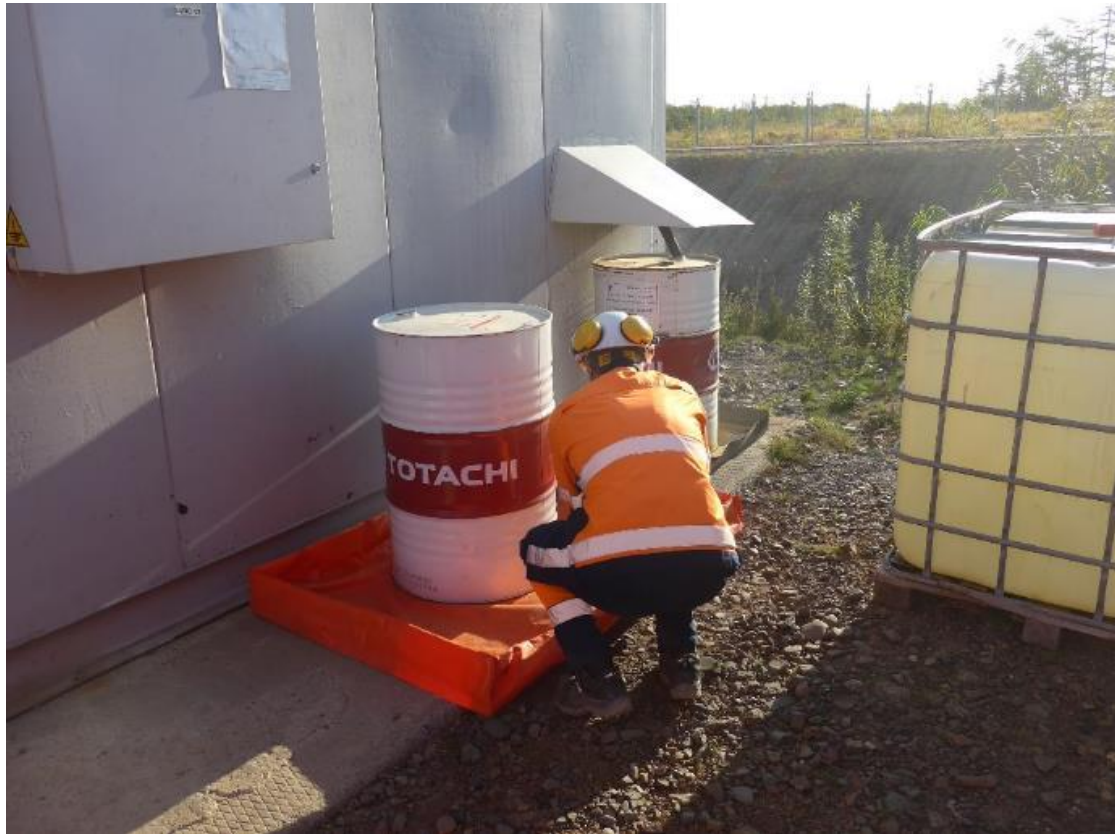
**Photo 25 – Waste oil drum in a partially collapsed portable bund (it was being repaired when the photo was taken, after the auditor highlighted the issue)**
