Intended for  
**Sakhalin Energy Investment Company Limited**

Date  
**March 2018**

Project Number  
**UK22-17081**

# **SAKHALIN-2 PHASE 2 LENDERS' ENVIRONMENTAL CONSULTANT MONITORING REPORT SEPTEMBER 2017**

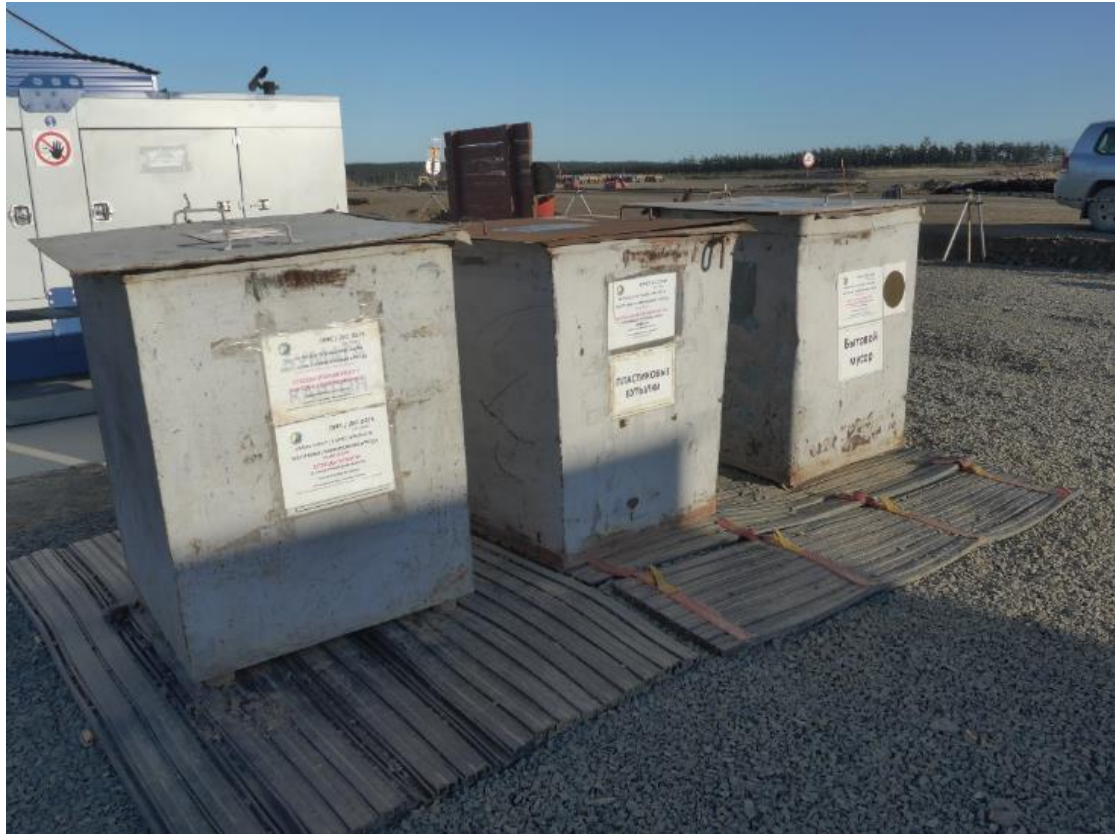
Photo 26 – Clearly labelled non-hazardous waste storage containers

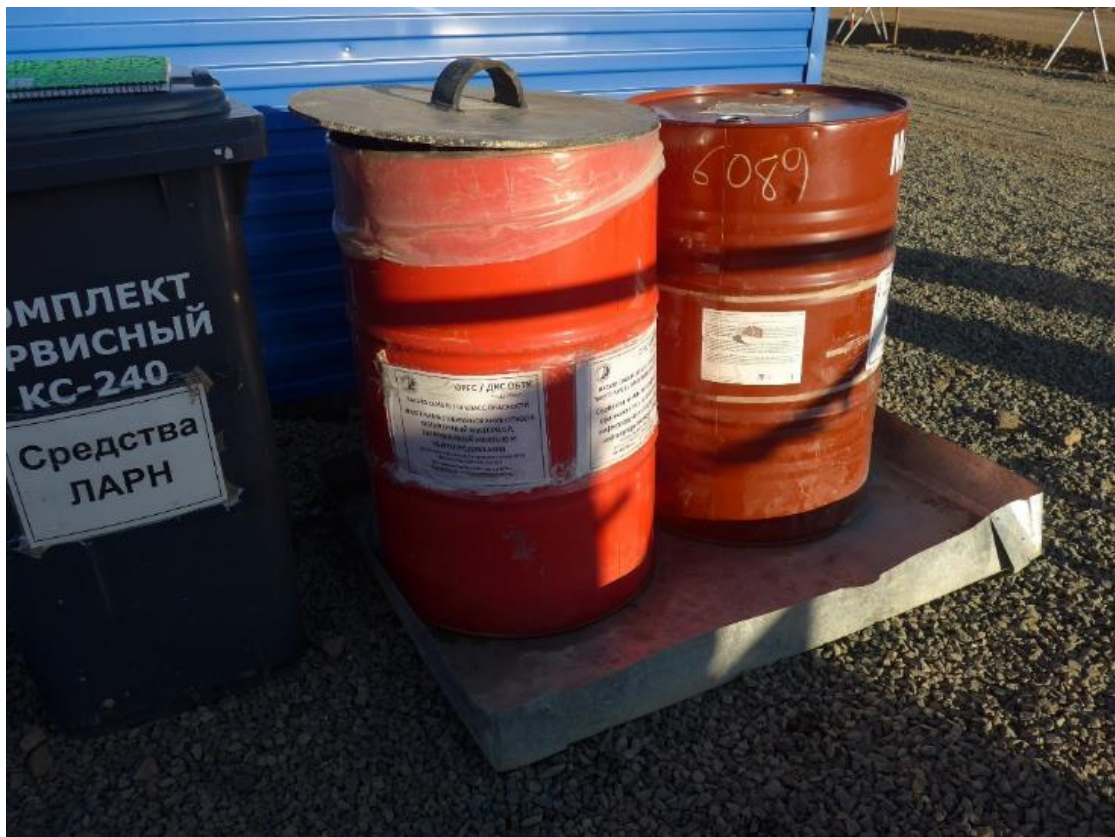
Photo 27 – Clearly labelled waste oil / oily rags storage containers

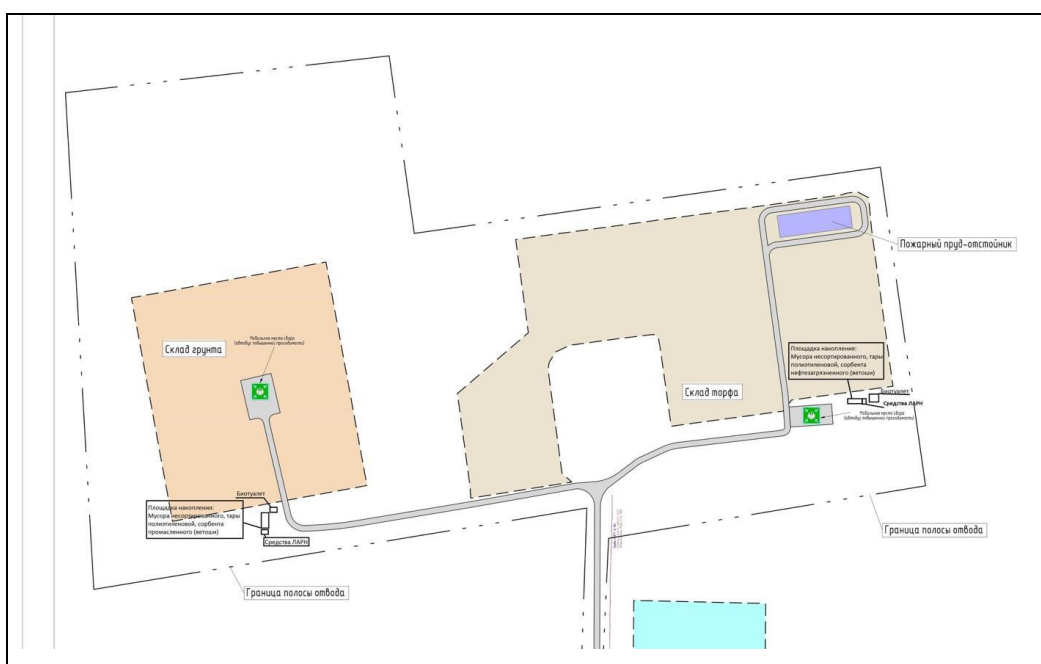
Soil and peat excavated from the construction site has been stockpiled in an area to the north of the construction worker accommodation camp. The peat storage area is located on a north facing gentle slope, in an area that according to the ESHIA, previously supported shrub-cotton grass-moss bog (similar to the remaining surrounding habitat). This is a natural habitat as defined by IFC PS6. The peat is being piled in a series of long windrows, 3-4 metres high (Photo 28). Each windrow has a drainage ditch excavated either side, which collects water run-off and transports it to a settling pond at the northern end of the area, shown in purple in Figure 5). The settling pond discharges into an unnamed creek, which ultimately forms a tributary of the Vatung River.

**Figure 5 - Soil and peat storage areas**

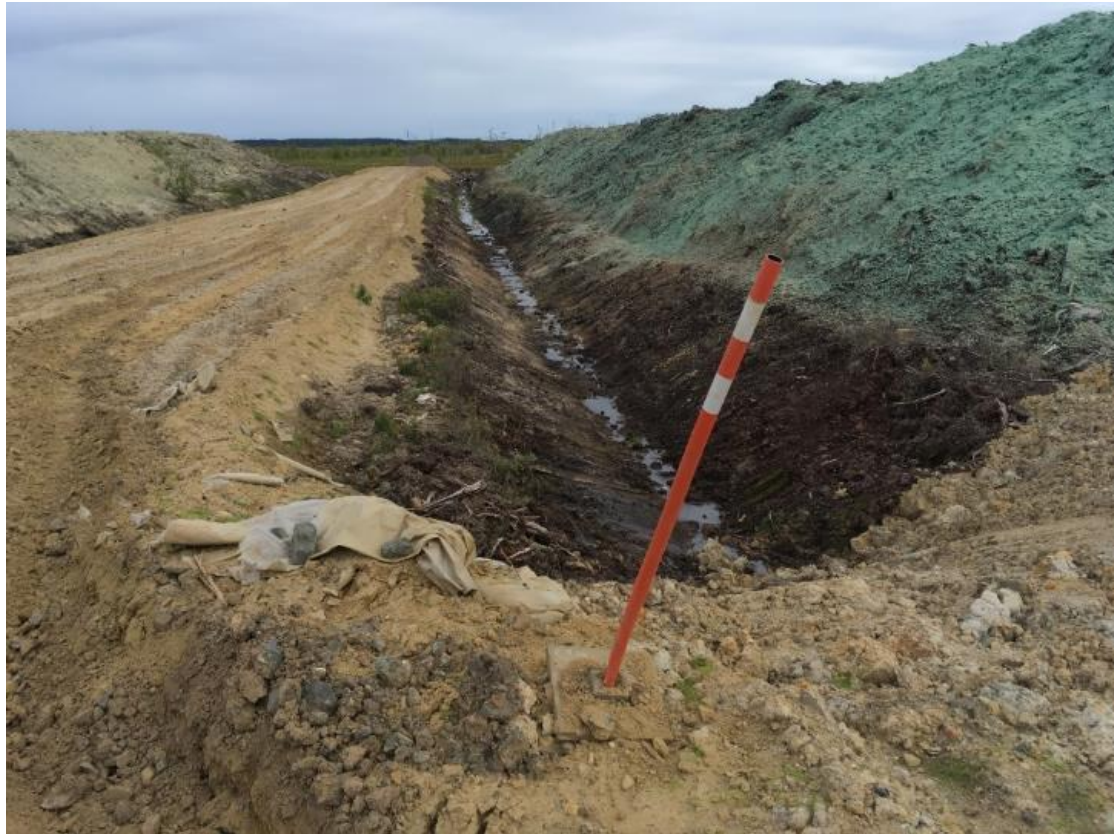
Ramboll Environ also has concerns over the peat storage design. Peat is formed when wet conditions create abiotic conditions, leading to incomplete decomposition of plant material (especially wetland plant species such as sphagnum moss). Because of the wet conditions and the lack of decomposition, it is naturally stored and gradually accumulates over long periods of time. If peat is allowed to dry out, it allows oxygen to enter the soil and decomposition to start, releasing CO<sub>2</sub> to the atmosphere. Therefore, if the aim of the peat storage is to preserve it for later use, it needs to be stored in wet conditions or in a way that ensures the air cannot come into contact with the soil and cause aerobic decomposition of the humus. The use of windrows and drainage is likely to cause peat drying and decomposition.

**Photo 28 – Peat Storage Windrow and Adjacent Drainage Ditch**

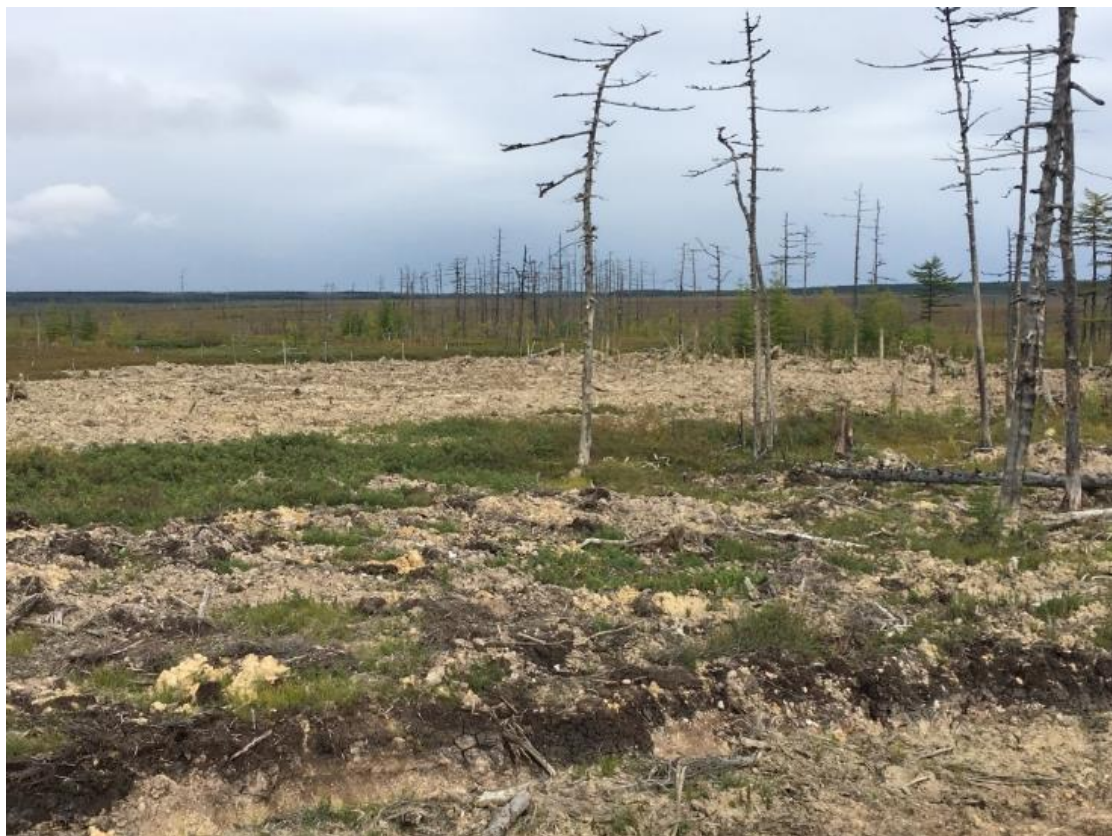
**Photo 29 – Sub-soil that has been deposited beyond the active construction zone**

According to Sakhalin Energy HSE staff, the existing damaged areas are due for restoration at the end of construction in 2020. It is recommended that habitat restoration would be more effective and easier to implement if conducted much sooner. Restoration should include the removal of excess sediments from the vegetation surface.

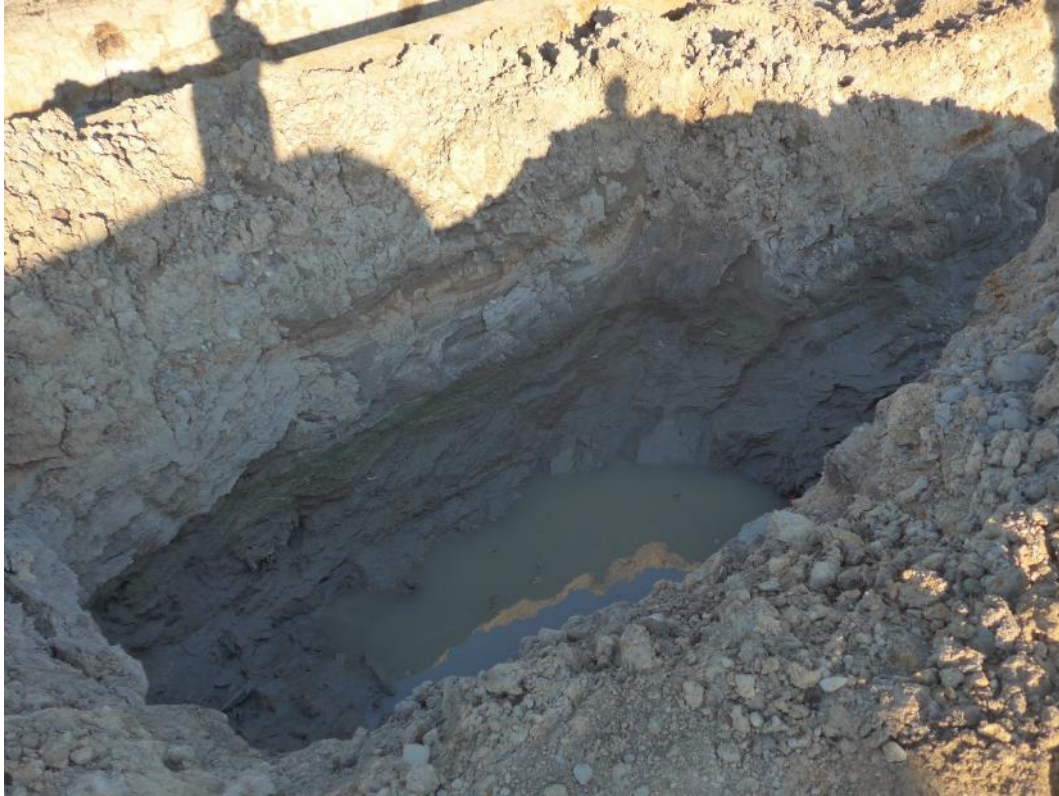
**Photo 30 – Stormwater retention pit in the north of the OPF-C site**

**Opportunity for Improvement:** Sakhalin Energy should ensure that stormwater runoff ditches are installed to a standard equivalent to those at the existing OPF site and that sediment and erosion control measures are incorporated into the design. Where damage to habitats has occurred from excess sediment run-off, it is recommended that these areas are restored as soon practicable.

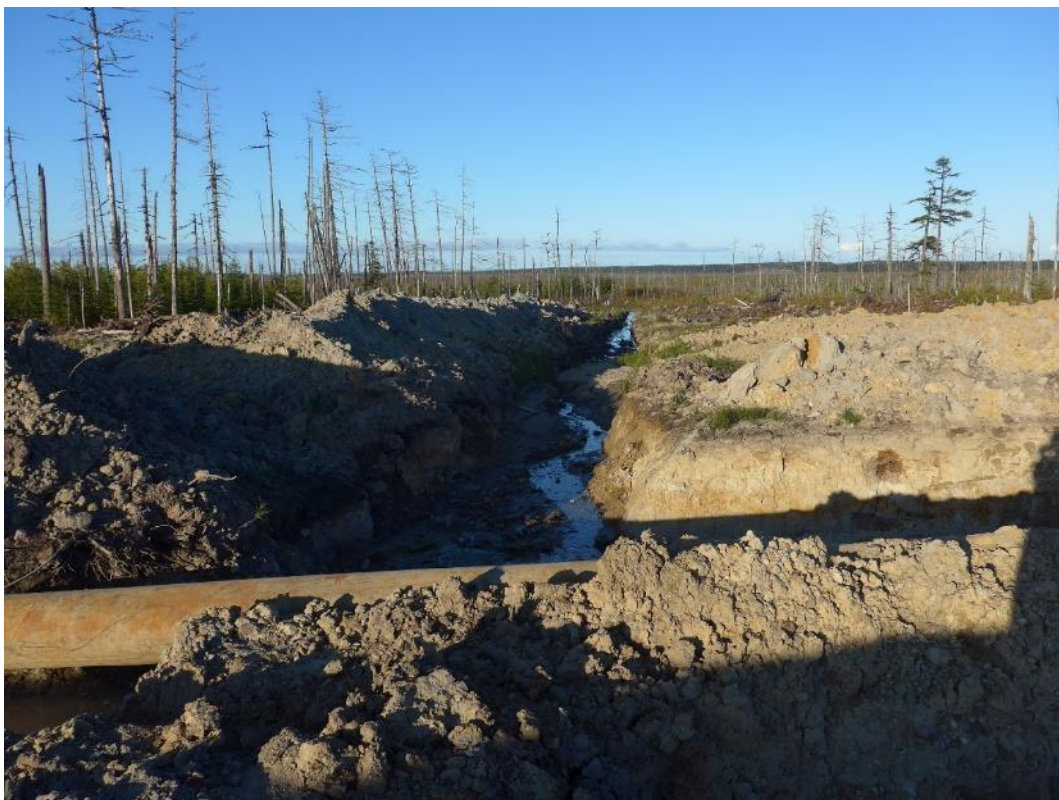
**Photo 31 – Ditch adjacent to stormwater retention pit in the north of the OPF-C site**

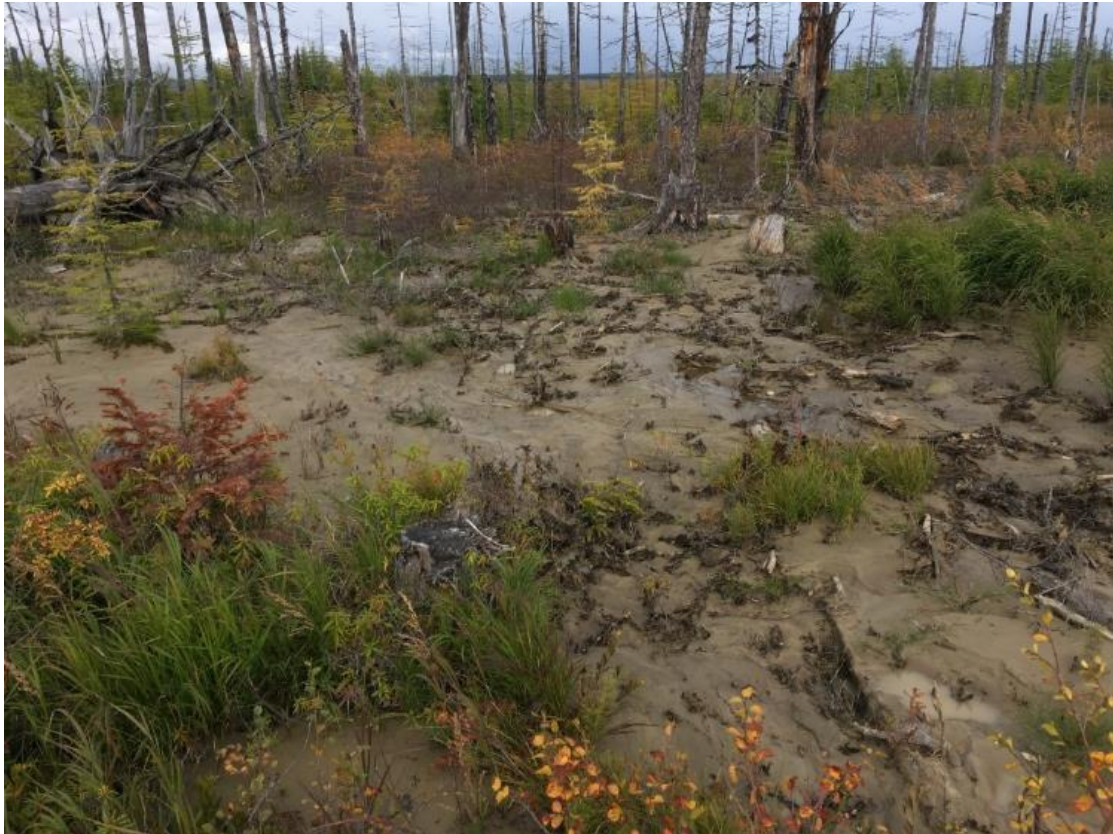
**Photo 32 – Sediment run-off into surrounding natural habitat**

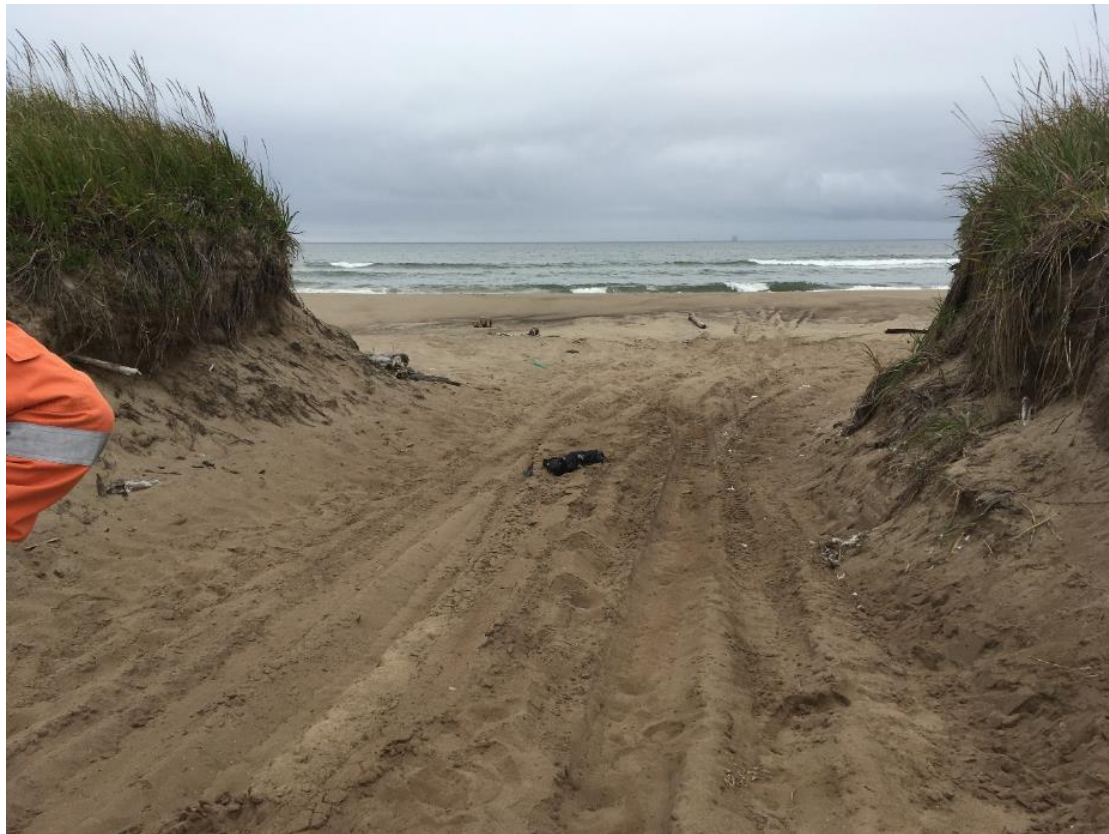
A gap in the dunes was made during the construction of the original OPF beach landing facility (Photo 33). It is understood that it is planned to re-use the same opening for the OPF-C, although it may require widening. The opening appears to be being used by illegal fishermen to access the beach.

**Photo 33 - Gap in the Dunes**

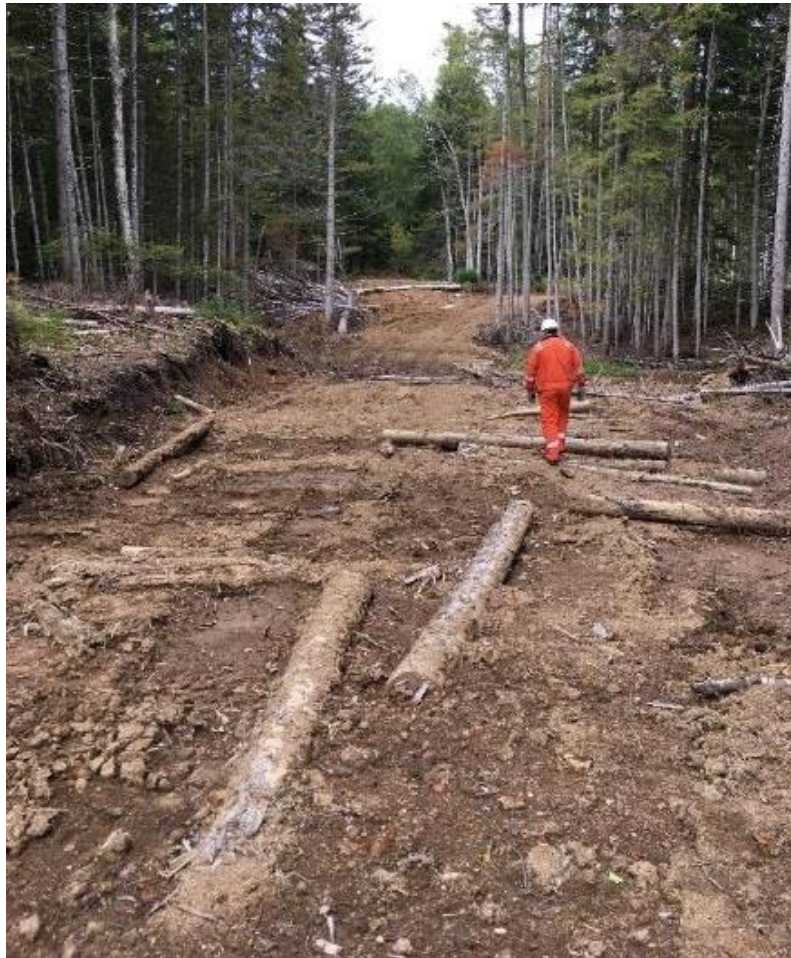
A visit to the proposed site of BS3 was made during the RoW inspection. A new access track has been cleared through the forest from the RoW to the proposed site (Photo 34). The track has not been reinforced with hardcore and comprises loose soil, limiting vehicular access to the proposed site. The track crosses a number of small streams that have not been culverted under the track at the current time.

**Photo 34 - Access track to BS3**

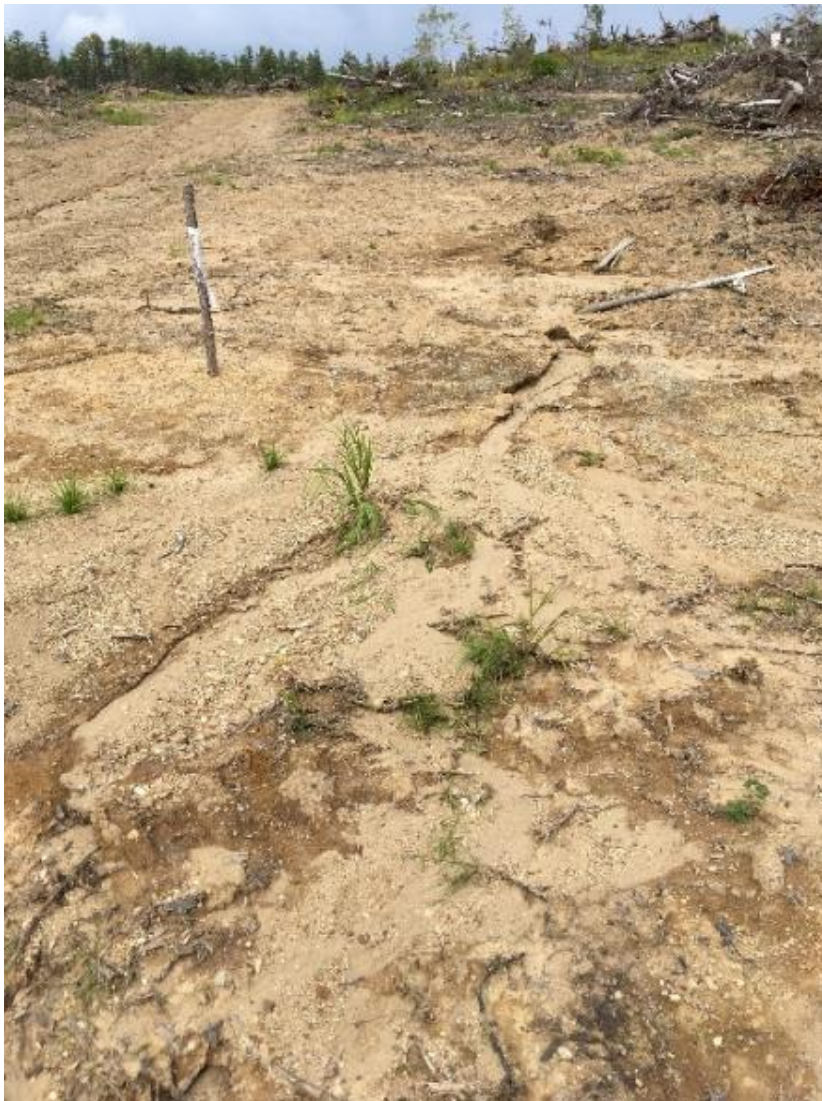
This risk will be much higher during construction as the large site will require significant cut and fill of the hillside to create a level site.

**Photo 35 - Soil erosion within the proposed BS3 site**

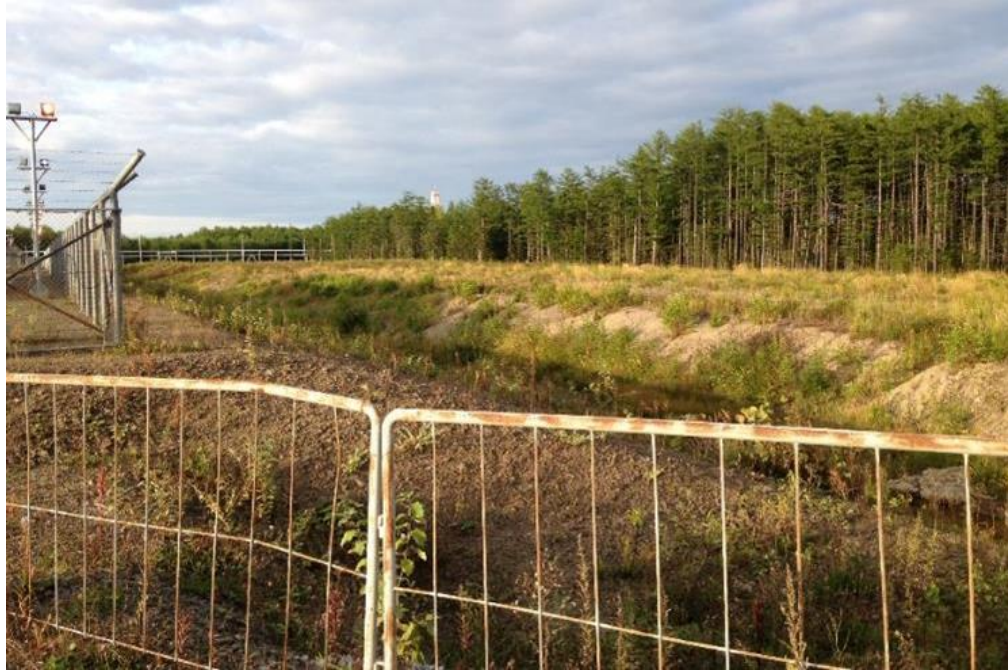
A very brief visit was made to BS2 during the RoW inspection. It is understood that as part of the Train 3 Project, additional plant will be installed within the existing footprint of the site. The BS2 site is situated within an area of previously cleared forest and it is understood that no additional tree clearance will be required for the main Train 3 related works at BS2 (Photo 36).

**Photo 36 - Edge of BS2, showing cleared buffer area and forest**

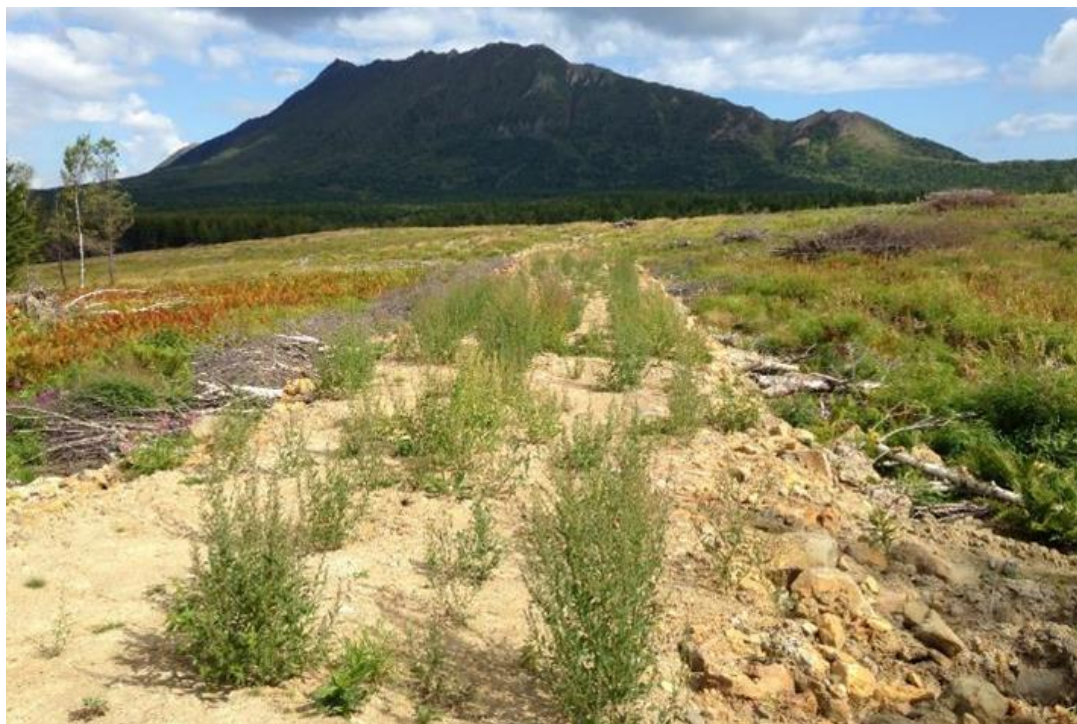
The proposed site for BS4 was also visited during the RoW inspection. As with BS3, the site has been recently clear-felled and the timber stacked in piles on-site (Photo 37). The cleared site has incurred less damage during the forestry operations than at BS3, and a relatively intact vegetation cover remains. However, soil erosion and sediment run-off will be a significant risk during construction. Due to the large size of the site and the slopes present, it is likely that significant cut and fill will be required to create a level site.

**Photo 37 - Part of the cleared site for BS4**

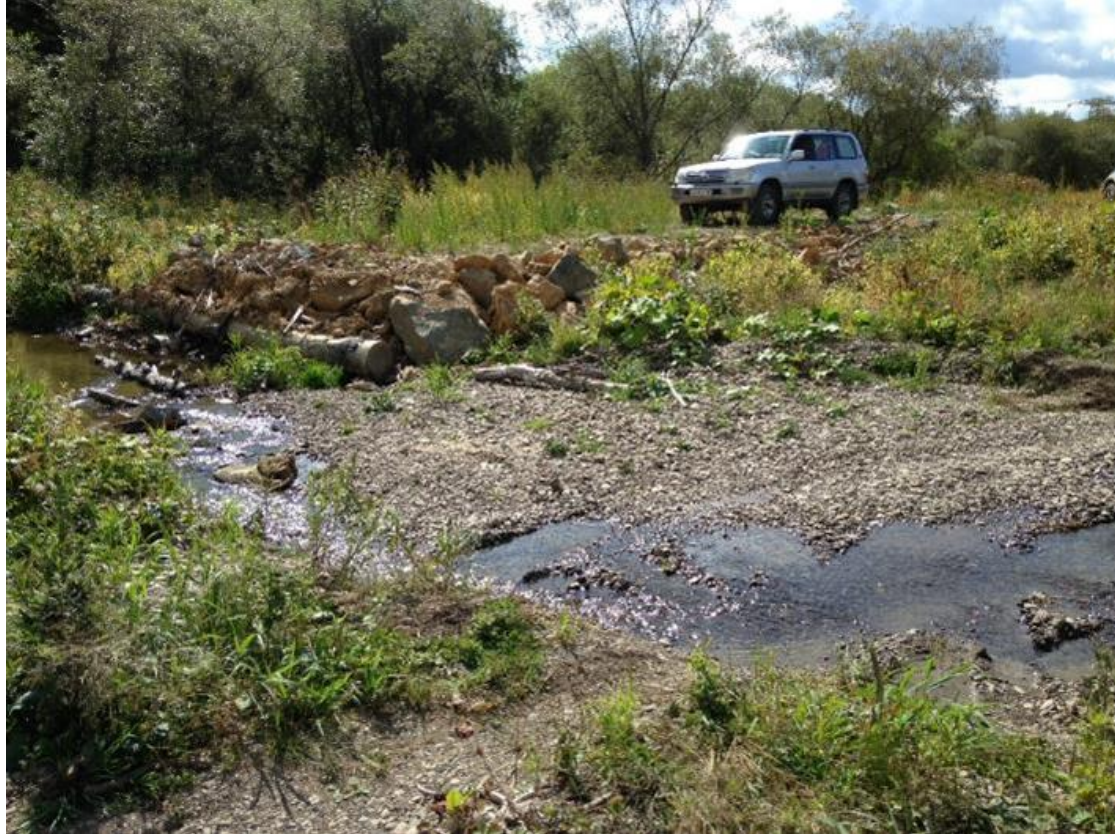
An access track has been created to the proposed BS4 site. This has required some tree felling in places and stone fill appears to have been imported to create a temporary road surface. The access track crosses a water course, which has yet to be culverted and forms a barrier that limits vehicular access to the site (Photo 38).

**Photo 38 - Small watercourse crossing on access track to BS4**

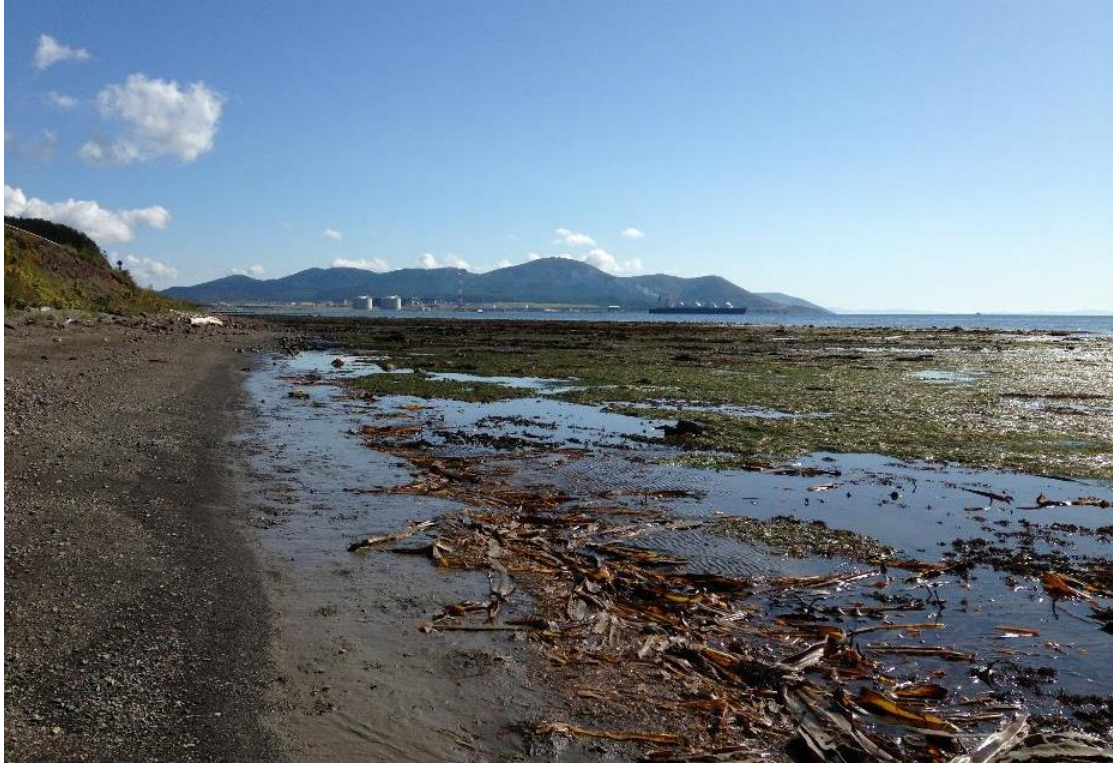
**Photo 39 - Wave-cut rocky platform, site of environmental monitoring location**

The majority of the shoreline within 3 kilometres of the LNG facility comprises a mixture of sandy beaches and rocky wave-cut platforms (Photo 39). These are largely unsuitable to provide migratory stop-over feeding habitats for large numbers of wading bird species. However, the rocky shoreline areas are suitable for species such as harlequin duck *Histrionicus histrionicus*. Possibly more significant in terms of the Aniva Bay Important Bird Area is the small Mereya lagoon close to the LNG facility. It is understood that on occasion this does support larger numbers of migratory shorebird species. A number of red-necked grebe *Podiceps grisegena* were viewed offshore, and it is important that the ESHIA assesses the value of the bay for migratory and wintering grebes, divers and sea duck.

**Opportunity for Improvement:** With respect to the environmental monitoring programme, it is understood that one of the sample locations is the rocky shore shown in Photo 39. A transect of survey points is made down the shore profile between high and low tide. Given the local use by people for harvesting seafood, any colonisation of the area by non-native invasive species introduced by ballast water could cause significant impacts. Therefore, it is recommended that a large area of the rocky shoreline is monitored for signs of alien invasive species as part of the monitoring programme.

26	Train 3 - Monitoring of Invasive Species	With respect to the environmental monitoring programme, it is understood that one of the sample locations is the rocky shore shown in Photo 39. A transect of survey points is made down the shore profile between high and low tide. Given the local use by people for harvesting seafood, any colonisation of the area by non-native invasive species introduced by ballast water could cause significant impacts. Therefore, it is recommended that a large area of the rocky shoreline is monitored for signs of alien invasive species as part of the monitoring programme.	SE	Accepted Q1 2019
27	Train 3 - Monitoring of Invasive Species	A similar observation to the above OFI is made in relation to the existing jetty. A single monitoring location is used on the jetty (albeit with multiple sampling points in the water profile). Given the large size of the jetty, invasive species could colonise and	SE	Accepted Q1 2019
