Sakhalin-2 Phase 2 Project Environmental Audit of LNG Plant

Prepared for:
Sakhalin-2 (Phase 2) Project Finance Parties

Prepared by:
ENVIRON
Manchester, UK

Date:
October 2011

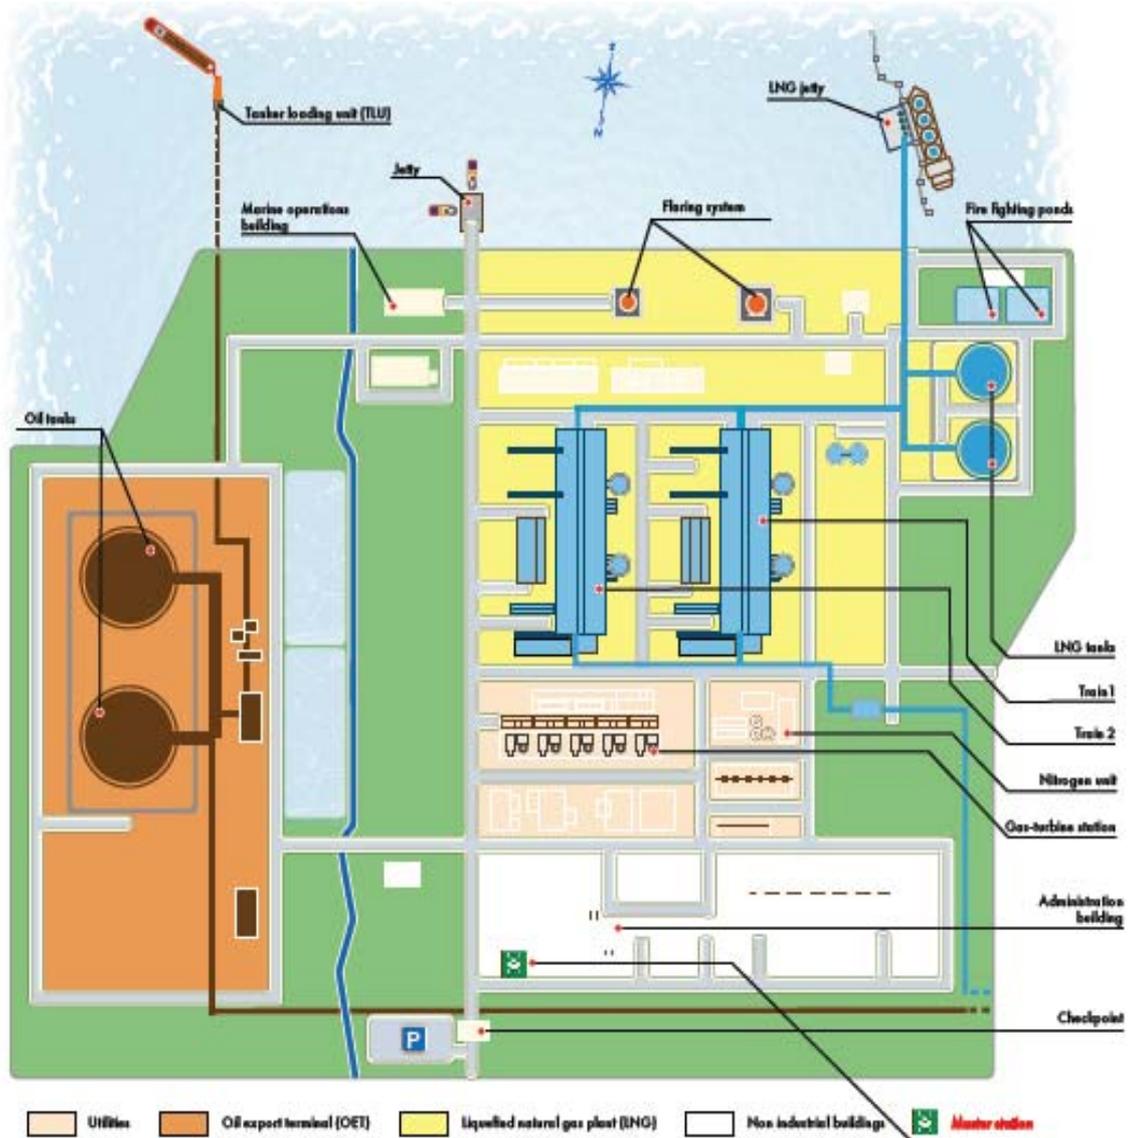
Figure 1 – Layout of LNG Plant

Figure 1 shows the layout of the site and Figure 2 illustrates the overall process flow.

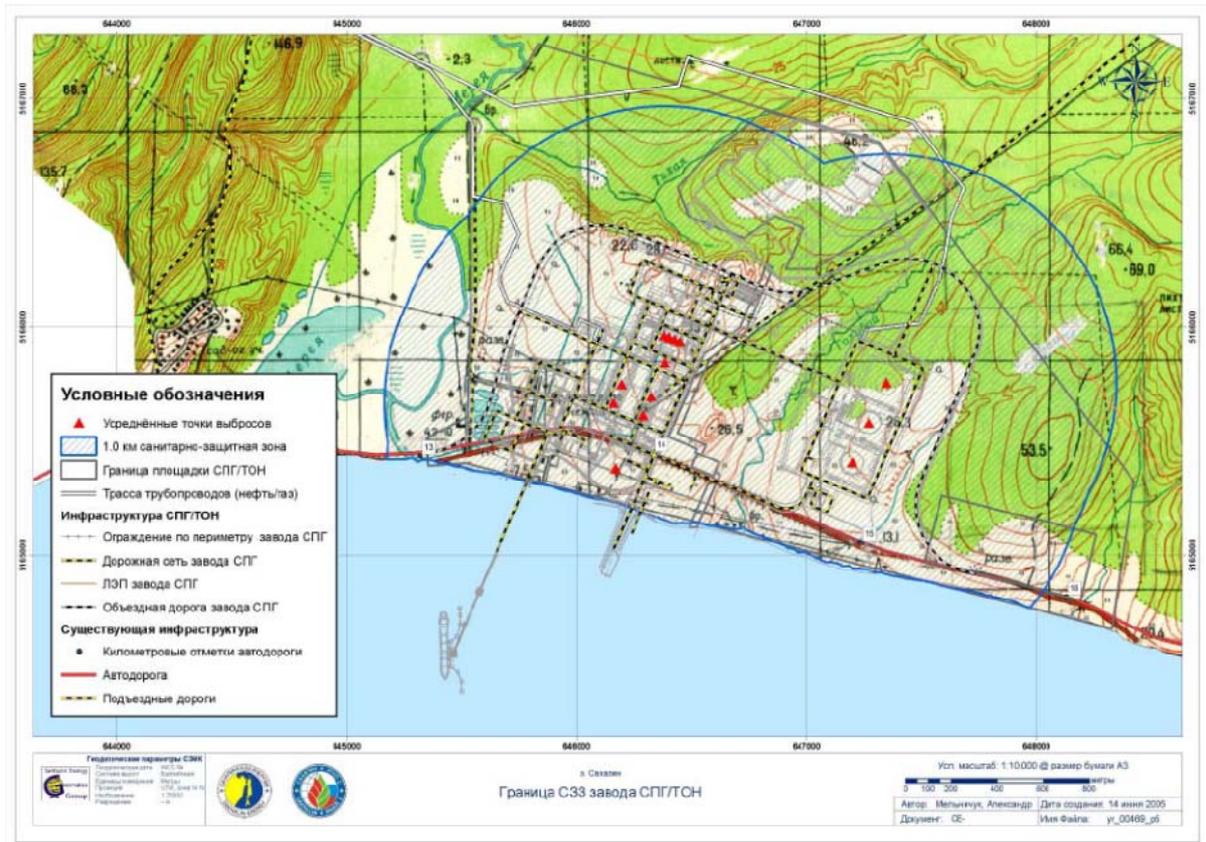
Figure 3 – Sanitary Protection Zone Around LNG Plant

There is a formal Sanitary Protection Zone (SPZ) around the plant. This zone extends 1,000 metres from the perimeter fence in all directions. A map showing the Sanitary Protection Zone around the site is shown in Figure 3.

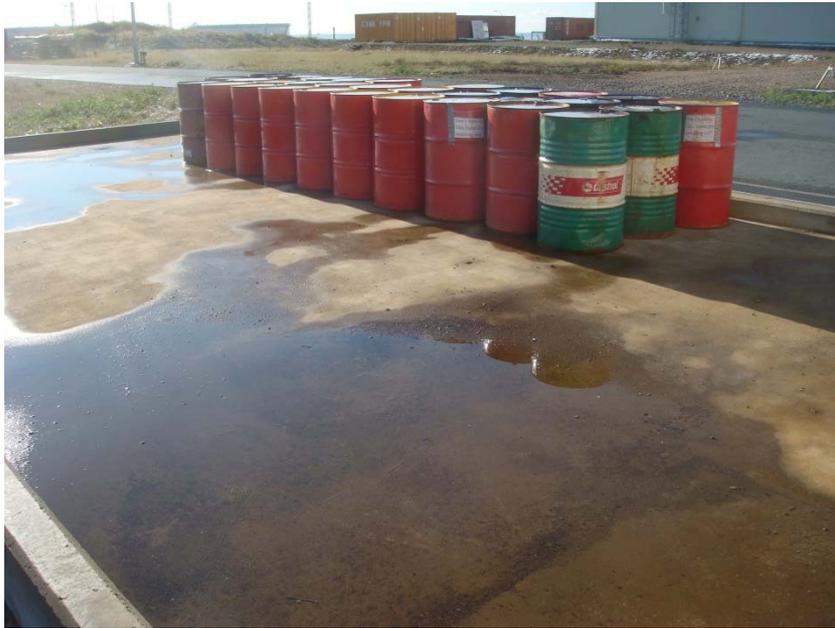
- Waste management and minimisation
 - There is inadequate secondary containment in the overflow waste storage area outside Building 10 (there is a hole in the bund wall). This issue was also highlighted in the last IEC monitoring visit report, dated April 2010.

Photo 1: Overflow waste storage area outside Building 10

- Provision of a low ramp would allow vehicle access to the waste storage area outside Building 10, whilst retaining adequate secondary containment. This would allow faster and easier access, minimising manual handling risks.
- Provision of a roof over the waste storage area outside Building 10 would minimise the volume of potentially contaminated runoff requiring treatment and disposal.
- Although the use of R22 in domestic-sized equipment is permitted by Sakhalin Energy it is recommended that alternatives are considered (R417A is a drop-in replacement for R22 and has an ODP of zero).

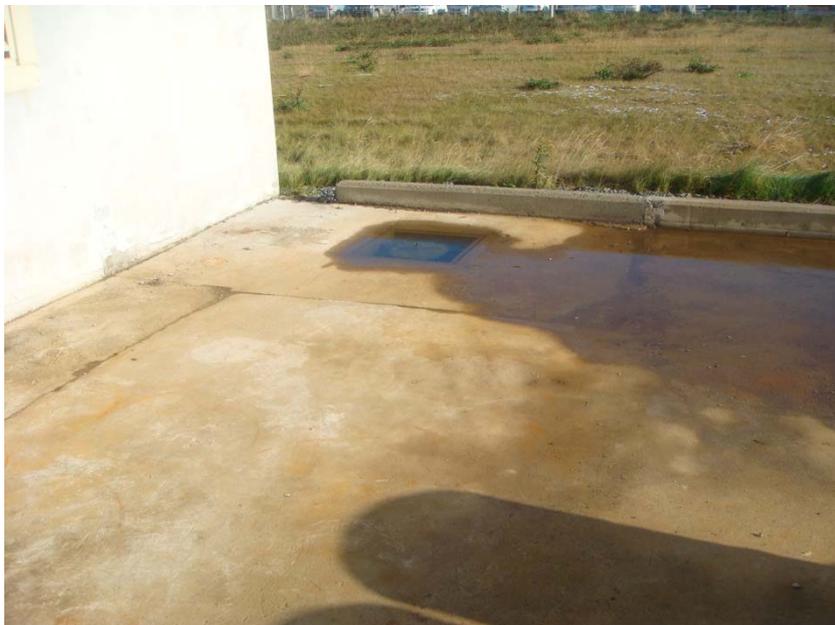
Finding: There is a hole in the bund wall around the external waste storage area (Photo 2). This issue was noted in the last Independent Environmental Consultant (IEC) monitoring visit report, dated April 2010, and no action has been taken. This is a non-compliance against Clause 3k of the Approved Waste Storage and Accumulation Facilities Specification, forming

Photo 2: Hole in bund wall around external waste compound

- There is no vehicle access to the external bunded area. It is recommended that consideration is given to installing a low ramp to allow easy access, whilst retaining the integrity of the bund.
- The outside area has no roof so large volumes of COC runoff can be generated. It is recommended that consideration is given to erecting a roof over this compound.

Findings Log								
Ref	Rank	Status	Date	Topic	HSESAP Ref:	Finding	Action Progress Review	Action
	Low Amber (E2)	New	20/10/2011	Water Use	0000-S-90-04-O-0255-00-E Appendix 1	In July 2011 the Federal Service for Supervision of Natural Resources wrote to Sakhalin Energy (Ruling No. ЯШ - 01 - 005/2011), informing the company that it will be fined RUR 300,000 for breaches of permit requirements (license IOCX 00338 ВЭ) including over abstraction, use of faulty water flow meters, and inadequate water quality sampling.	Action: Investigate the root cause of the non-compliance and implement appropriate corrective and preventative measures.	
	Red (E3)	Ongoing	20/10/2011	Waste Management	0000-S-90-04-O-0258-00-E Appendix 8	There is a hole in the bund wall around the external waste storage area. At the time of the audit this area only contained empty drums but the facility is used to accommodate liquid wastes when Building 10 is full. There is a risk of contamination of the ground immediately outside the breached bund wall. This issue was noted in the last Independent Environmental Consultant (IEC) monitoring visit report, dated April 2010, and no action has been taken. This issue has therefore been classified as E3 due to the "frequent exceedance of statutory or other prescribed limit".	Action: Immediately repair the bund wall.

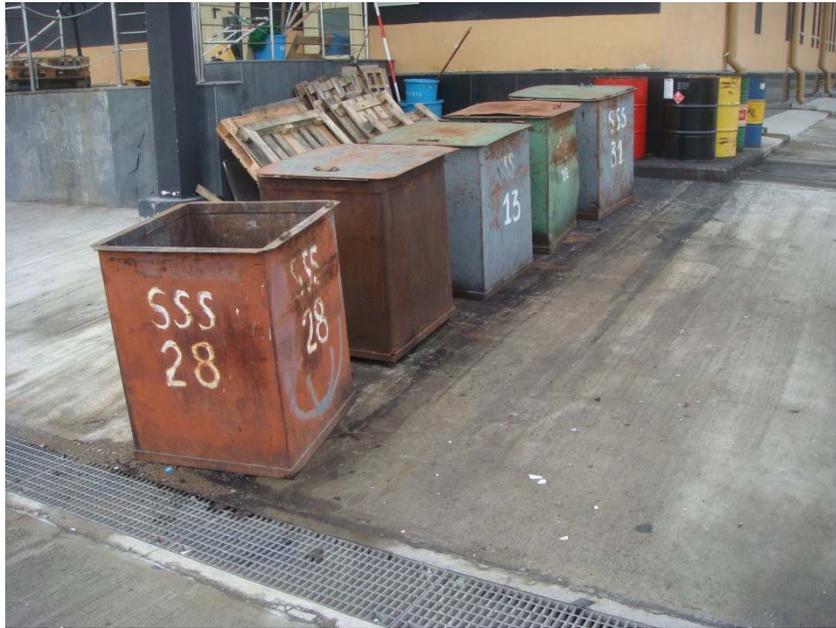
- Labelling was non-existent or poor on several waste containers holding solid and liquid wastes outside the site canteen.
 - Containment of general waste and waste cooking oil outside the canteen does not meet HSESAP requirements (a general waste bin had no cover, and concrete staining indicates leakage from the drums of waste oil).

Photo 3: Unlabelled waste containers outside site canteen (the nearest bin has no lid)

Low Amber (E2)	New	20/10/2011	Waste Management	0000-S-90-04-O-0258-00-E Appendix 10	Inadequate waste labelling was observed outside the canteen: <ul style="list-style-type: none"> labelling of four metal bins containing general waste was non-existent ; a metal bin labelled for oily rags actually contained only cardboard; and waste cooking oil was stored in unlabelled drums. 	Action: Ensure that all waste bins are appropriately labelled. It is understood that a request has already been submitted to the maintenance department for refurbishment of waste containers (cleaning, repainting, repair and labelling).

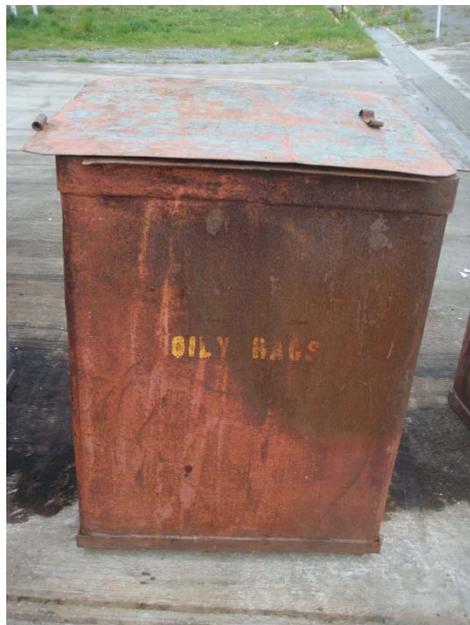
Photo 4: Oily waste container full of cardboard

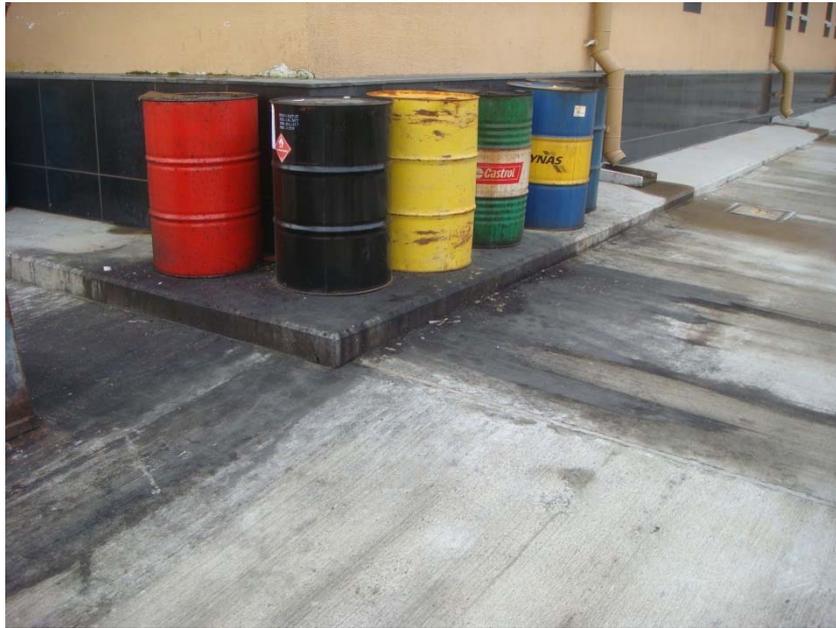
- Clause 3k of the Approved Waste Storage and Accumulation Facilities Specification, forming part of the Waste Management Standard (0000-S-90-04-O-0258-00-E), requires “*spill containment for liquid wastes such as oil and chemicals*”. However, concrete staining indicates that leaks of cooking oil have occurred (Photo 5).

Photo 5: Concrete staining around unlabelled drums containing waste cooking oil

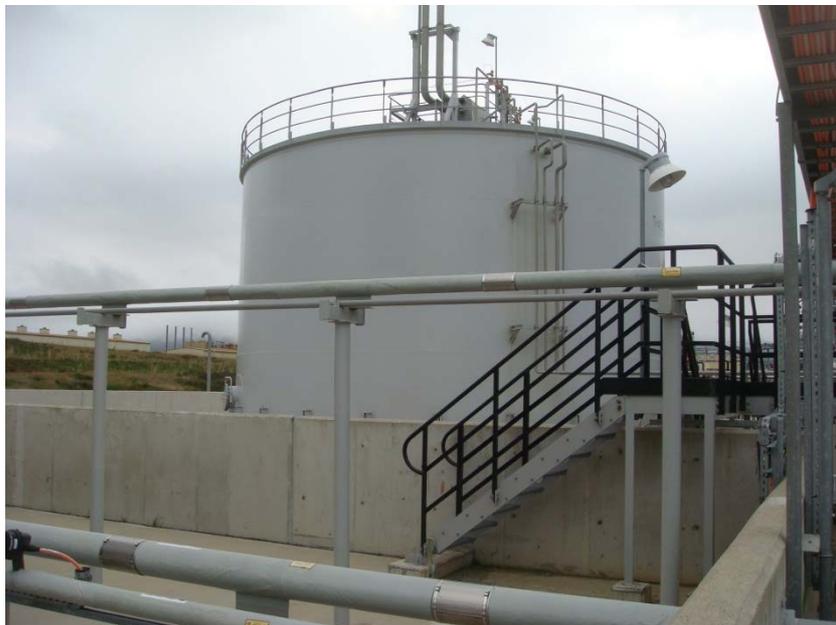
Photo 6: Diesel storage

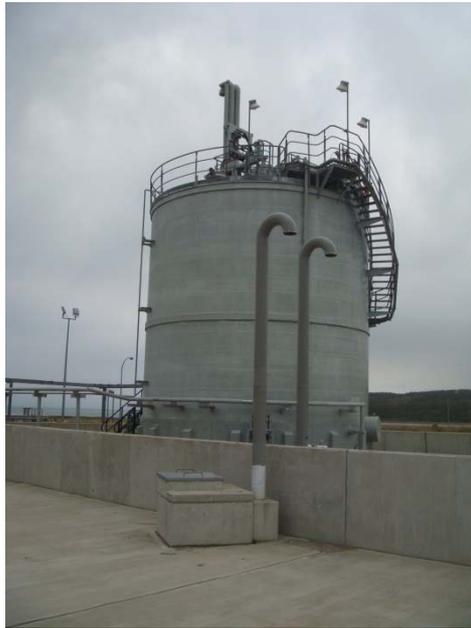
Adjacent to the diesel tank is an above ground tank containing heat transfer liquid (Photo 7). The diesel and heat transfer fluid bulk storage tanks have adequate bunding. The concrete bund walls and floor are in an excellent condition and there is no visible evidence of contamination from leaks or spills. Runoff generated within the bunded areas is collected in a COC sump.

Photo 7: Heat transfer fluid storage

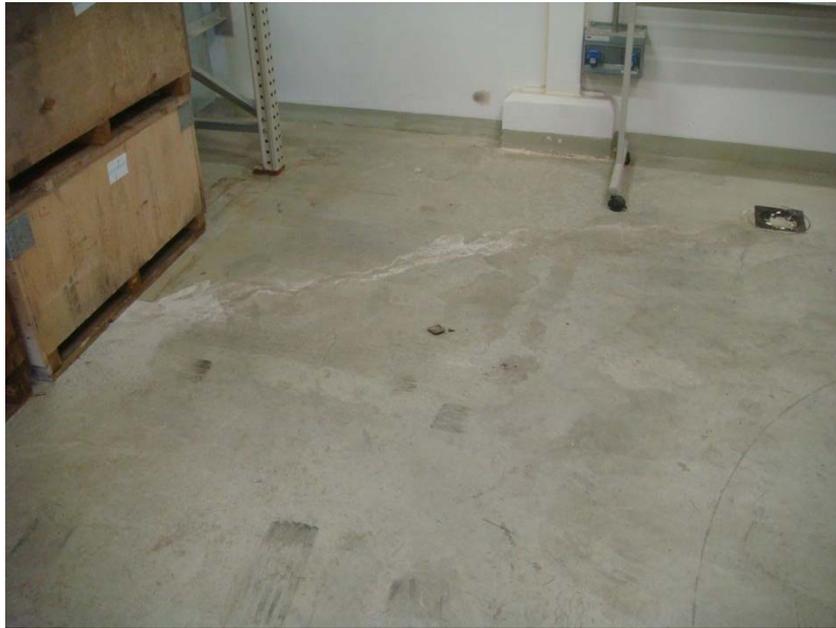
Concrete staining indicates that leaks have occurred in the C104 area (Photo 9). However, the risk to the environment from leaks in this location is minimal as any spillages are captured in the COC drainage system.

Photo 9: Concrete staining in the alkaline store

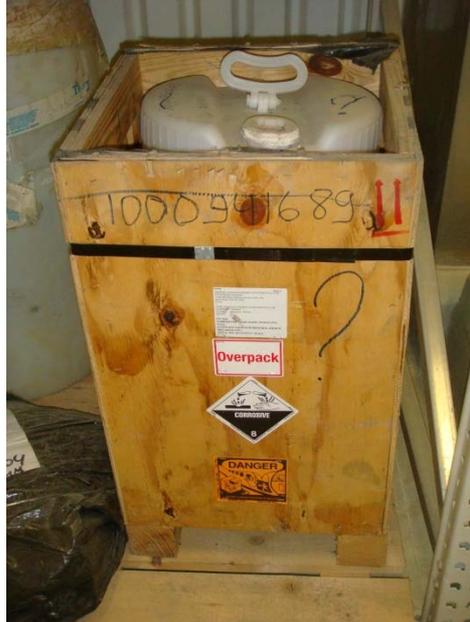
Photo 10: Drum of unknown liquid with incorrect stock code in C104

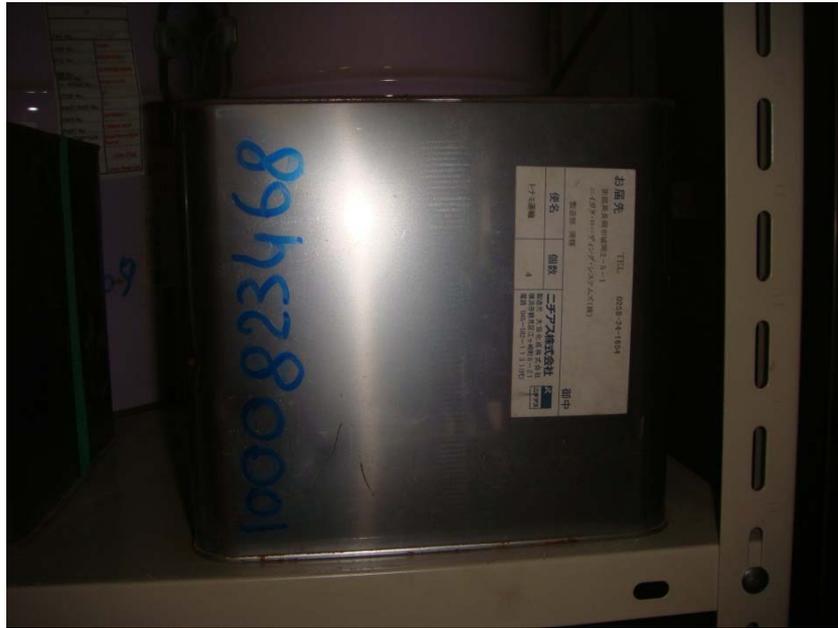
- Two metal drums of liquid were noted in C107 that had labels in Japanese only (Photo 11). The stock codes (1000823468 and 1000823469) could not be tracked to MSDS in the chemical store. However, the auditors later confirmed, via the SAP system, that this material was delivered during the construction phase in 2007.

Photo 11: Poorly labelled chemical containers in C107

Findings Log								
Ref	Rank	Status	Date	Topic	HSESAP Ref:	Finding	Action Progress Review	Action
						in Russian.		
	Blue (E0)	New	20/10/2011	Storage of Hazardous Materials	0000-S-90-04-O-0270-00-E Appendix 9	<p>Clause 6a of the Chemicals Management Specification, forming part of the Occupational Health and Hygiene Standard requires that "chemicals are appropriately labelled". The following deficiencies were identified:</p> <ul style="list-style-type: none"> • A drum of liquid in C104 is stored in a box with an incorrect stock code (the MSDS with the corresponding stock code - 1000941689 - was for High-density polyethylene (HDPE)). • Two metal drums of liquid were noted in C107 that had labels in Japanese only. • Five 205 litre drums and three smaller drums were noted outside C107. The drums were full but the contents unknown as there were no labels. 	Action: Ensure that all chemical containers have adequate labelling.. Periodically check labels, for example during audits and inspections.

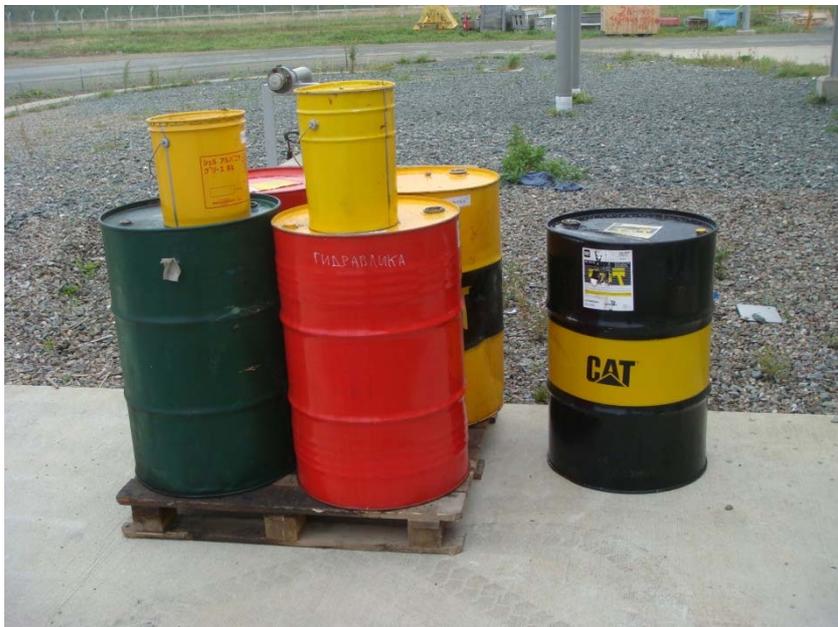
- Five 205 litre drums and three smaller drums were noted outside C107 (Photo 12). The drums were full but the contents unknown as there were no labels. The drums were stored on hardstanding adjacent to gravel and no secondary containment was provided. The lack of secondary containment is also non-compliant with Clause 1b of the Soil and Groundwater Industrial Controls Specification, which forms part of the Soil and Groundwater Standard (0000-S-90-

Photo 12: Unbanded, unlabelled drums of unknown liquids outside C107

Low Amber (E2)	New	20/10/2011	Storage of Hazardous Materials	0000-S-90-04—O-0018-00-E	<p>Five 205 litre drums and three smaller drums were noted outside C107 on hardstanding adjacent to gravel. No secondary containment was provided. The lack of secondary containment is non-compliant with Clause 1b of the Soil and Groundwater Industrial Controls Specification, forming part of the Soil and Groundwater Standard , which requires that "there shall be an appropriate use of bunded areas to provide spill containment of 110% of the largest stored vessel or double skinned tanks" and "where bunded areas are not</p>	Action: Investigate the root cause of the non-compliance and implement appropriate corrective and preventative measures.
