Sakhalin-2 Phase 2 Lenders' Independent Environmental Consultant

Monitoring and Audit Report

October 2013

Prepared by: **ENVIRON UK**

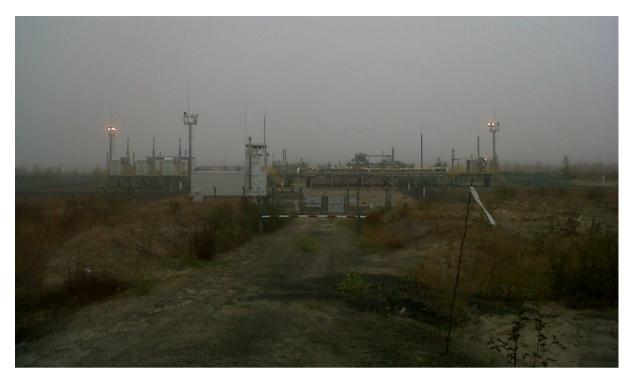
Photo 5: Northern Gas Transfer Terminal near Boatasino

In the IEC's previous site visit report (2012), ENVIRON noted the concern expressed by a representative of the local community in Val with respect to ensuring the security of the Northern Gas Transfer Terminal (GTT). Since then, the Company has advised that an additional clarification was provided to the local community about the security measures and supervision of the facility by the designated contractor. Photo 5 shows the fully automated Northern GTT facility located near Boatasino, approximately 12 km from Val.

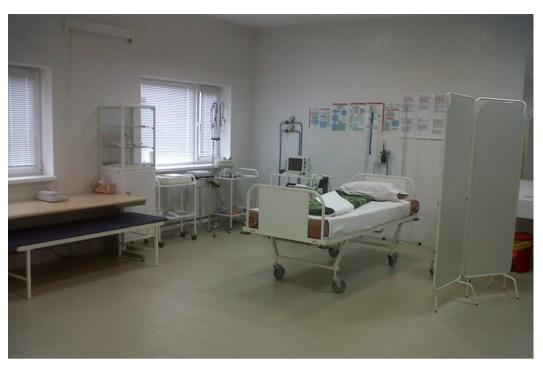
Photo 7: Intensive care unit at the OPF on-site clinic

The existing clinic at the OPF site is intended for the OPF operations personnel. It is well organised and coordinated and follows the required procedures. In addition to a general ward (two beds), the clinic has an intensive care unit (two beds, as shown in Photo 7) and a fully equipped isolation ward (one bed). In an emergency, the clinic will perform the following main functions: sorting of the injured in accordance with the type/urgency of medical aid required, stabilisation and preparation for transportation to the designated hospital.

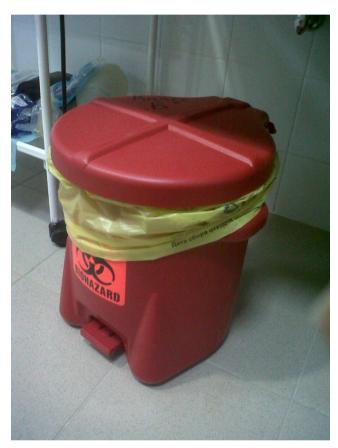
The clinic allows the collection and disinfection of clinical waste on-site (collection and transfer containers are shown in Photos 9 and 10 below). The temporary storage of disinfected clinical waste before removal does not currently represent a major issue due to the small volumes of this type of waste generated on-site ¹⁵. However, this aspect will need to be revised to account for the additional construction personnel and the establishment of a designated storage facility for medical waste might need to be considered. ENVIRON also suggests that Sakhalin Energy continues to ensure safety during the movement of disinfected clinical waste and we recommend that it verifies/assesses third party facilities for the final removal (incineration) of such wastes as part of the forthcoming ISOS audit.

Photo 9: Clinical waste temporary collection container (prior to disinfection)

- The clinical waste incineration facility used by medical services provider International SOS (ISOS) has not been inspected by Sakhalin Energy and we recommend that the incinerator facility is audited by Sakhalin Energy as part of its next audit of ISOS.

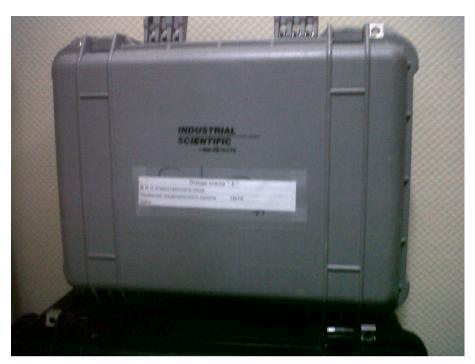
Photo 10: Sealed container for removal of disinfected clinical waste

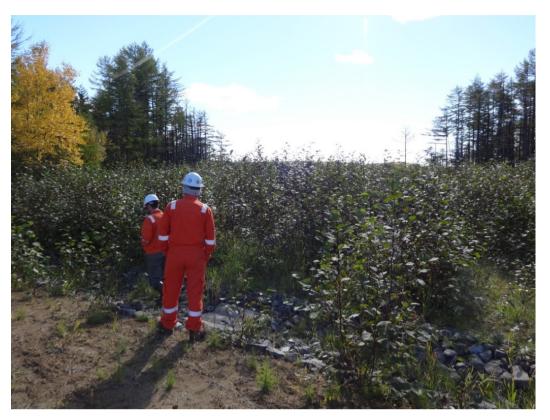
Tree growth on the RoW was first identified as an important issue during the October 2011 monitoring visit. Following the 2011 visit, Sakhalin Energy implemented a programme to fell trees / saplings on the RoW. Observations during the September 2012 site visit and the latest October 2013 site visit found that significant tree clearance efforts have been made at a number of locations (further details below). Nonetheless, the overall impression from ENVIRON's observation of sample locations along the RoW is that year-on-year the tree / sapling cover has typically become more widespread and denser, and that the trees are taller and with thicker trunks. The site-by-site status of tree growth is shown in Appendix 4, and an example of tree growth from the October 2013 site visit is shown in Photo 11 below.

Photo 11: Tree growth on the RoW north of the Djimdan River

We recommend that Sakhalin Energy re-evaluates and reconsiders the methods that are currently in use for long term effectiveness and also their impact on existing biological reinstatement. Alternative means of tree eradication should be reviewed (in the first instance by literature review); such alternative methods could include pulling of roots for smaller saplings (as opposed to simply cutting above the roots) and ring-barking for larger trees.

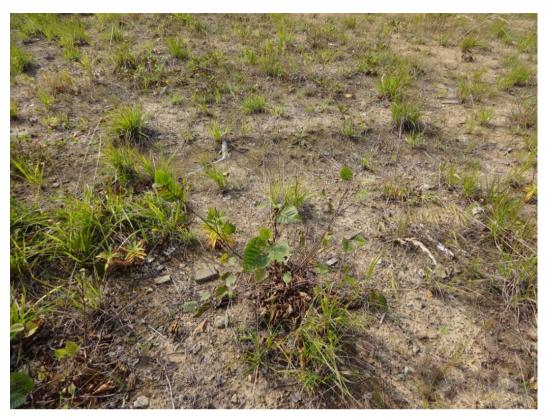
Multiple areas were visited were manual cutting had taken place. In these areas the trees / saplings were observed to have been cut at the main trunk about 10 to 20 cm above ground level. This method leaves the roots untouched and may not be effective in the long term. In several cases side branch re-growth (including leaf production) below the cut was evident (Photo 12).

Photo 12: Sapling regeneration after cutting of main trunk

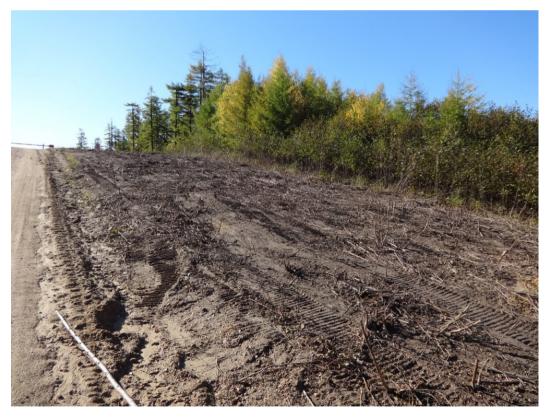
The second (mechanical) method was seen to have resulted in the cutting/ripping of the trees / saplings at about 30 cm above ground. This method also leaves the root system in place. Since this was the first year that this method was implemented, no side branch regeneration was observed but this is likely to occur next spring. However, as Photos 13 and 14 show, an additional result of the mechanised tree removal is heavy disturbance of the soil on the RoW and damage to other vegetation including grass and other plants.

Photo 13: RoW after mechanical tree felling near KP 63

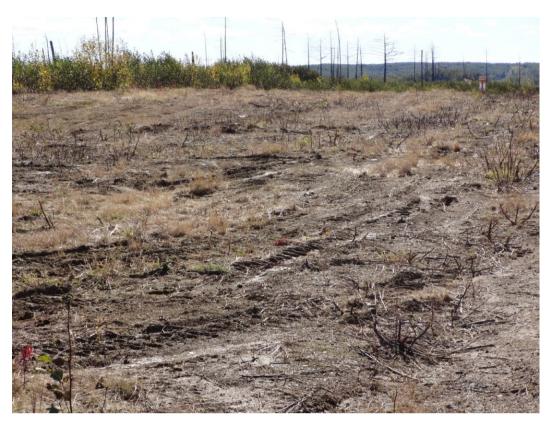
Photo 14: RoW after mechanical tree felling near KP 82

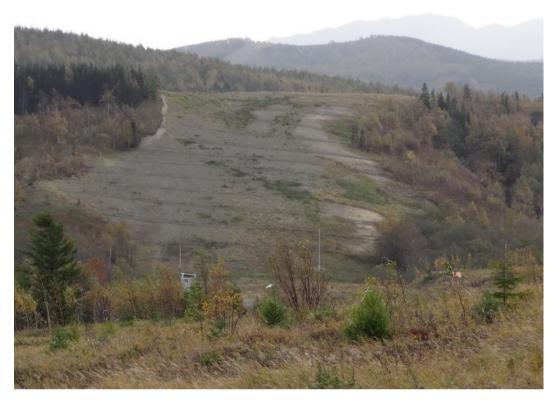
Photo 15: Steep slope at KP 419.5 showing poor vegetation cover

be identified to ensure successful re-vegetation. It likely that such techniques will be sitespecific and additional specialist advice may be required.

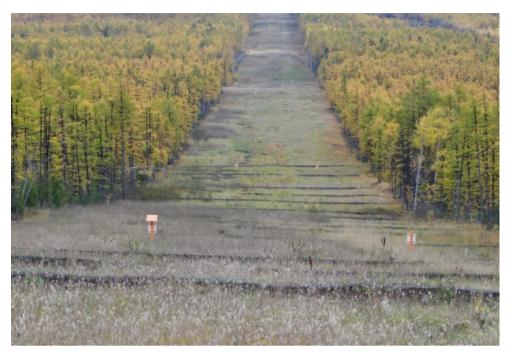
Photo 16: Sandy slope at KP 128 showing good vegetation cover

Notwithstanding the general improvement in the re-vegetation of sandy areas, continued efforts are still required to ensure that all such areas are adequately reinstated.

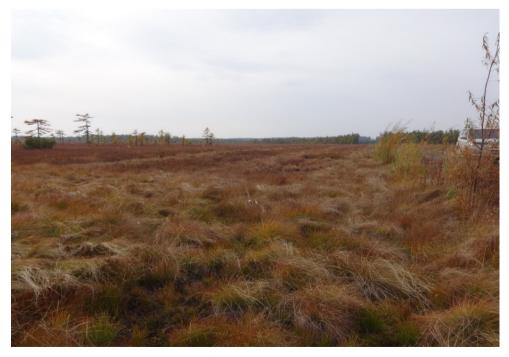
A number of wetlands areas were viewed during the October 2013 site visit, however due to access and schedule constraints, the number of wetland areas visited was limited and could only be viewed from a distance. Nonetheless, general impressions of wetland recovery indicated that while some wetlands showed generally good recovery (e.g. KP 149 area, Photo 17), other locations were found to be recovering much more slowly.

Photo 17: View of wetland around KP 149

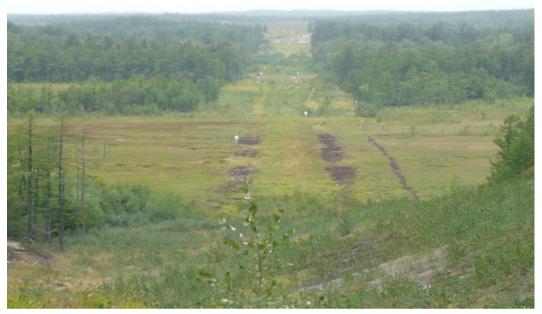
An example of a poorly recovering wetland is shown in Photos 18 and 19 below from the Dagi River Valley. The photographs provide a comparative view of the state of recovery of this wetland area in September 2012 (Photo 18) and in October 2013 (Photo 19). It is clear from comparison of the photographs that very little improvement took place in the intervening year.

Photo 18: View of the Dagi Valley September 2012

We recommend that Sakhalin Energy conducts detailed assessments of all poorly regenerated wetland areas to identify all factors impeding re-vegetation. In the case of sites where importation of materials and/or depressions are identified as key drivers for poor re-vegetation, ENVIRON recognises that measures to remove any remaining imported materials and to infill depressions would require the use of heavy equipment, which in turn may result in damage to recovering areas as they access the wetland. Nonetheless, if continued poor rates of recovery are identified by future monitoring at these specific sites, then it is recommended such measures may need to be considered in these areas.

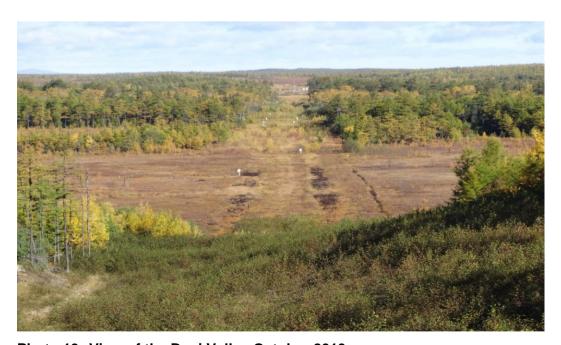
Photo 19: View of the Dagi Valley October 2013

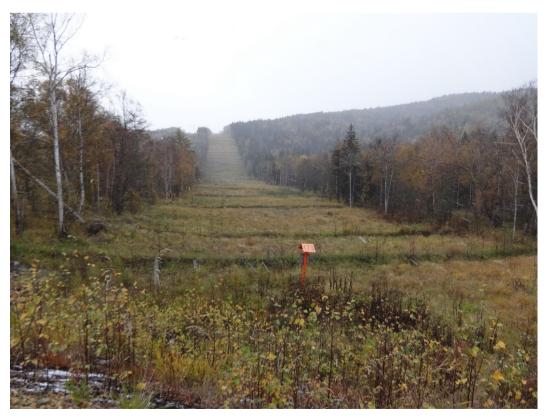
Slope breakers play an important part in managing slope drainage and erosion control. During the October 2013 visit slope breakers were found to be in mostly good condition at the RoW locations inspected. An example can be seen in Photo 20, taken from KP 178 north of the Devyataya River.

Photo 20: KP 178 Slope with good slope breakers protection

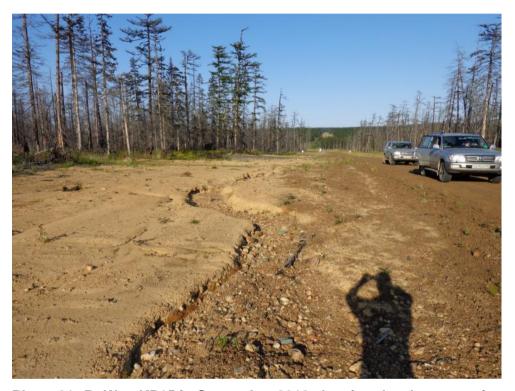
The vast majority of slope breakers were well positioned and in good condition. However, there were a few sites where additional slope breakers could improve drainage. An example is the RoW slope at approximately KP 15 that exhibits erosion on the slope due to a lack of surface stabilisation from slope breakers and/or vegetation. Photos 21 and 22 show the condition of this site in September 2012 and October 2013 respectively. While the exact viewpoints are different between the two photographs, they nonetheless demonstrate that even a mild slope which has no (or poorly constructed) slope breakers and poor/no vegetation can develop deep erosion.

Photo 21: RoW at KP15 in September 2012 showing development of erosion

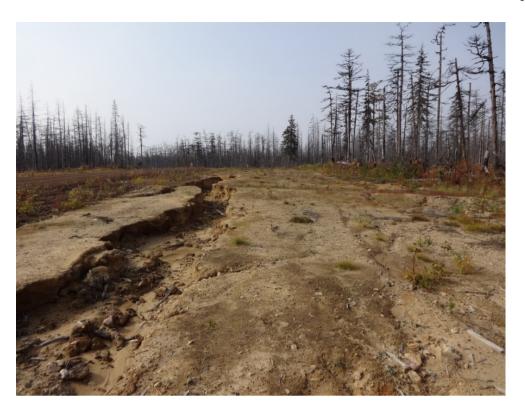
Photo 22: RoW at KP15 in October 2013 showing increased development of erosion

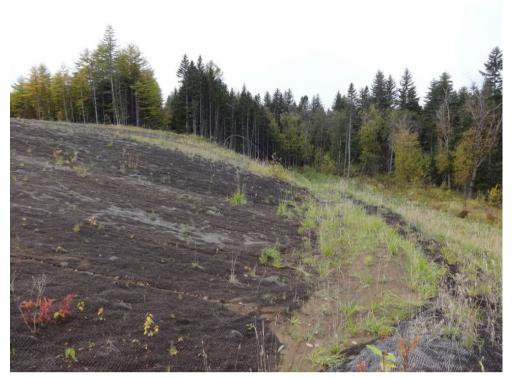
However, there are other locations where geojute and/or coco matting have been installed and not yet degraded, but nonetheless re-vegetation efforts have yet to be successful. ENVIRON suggests that such locations be re-evaluated by Sakhalin Energy and that reseeding and the potential use of fertilizer be considered (where it is not prohibited). Examples of such locations include the RoW near KP 180 (Photo 24), which has side slopes that have been covered with geojute but nonetheless remain poorly vegetated.

Photo 24: RoW slopes leading to an access on the at KP 180

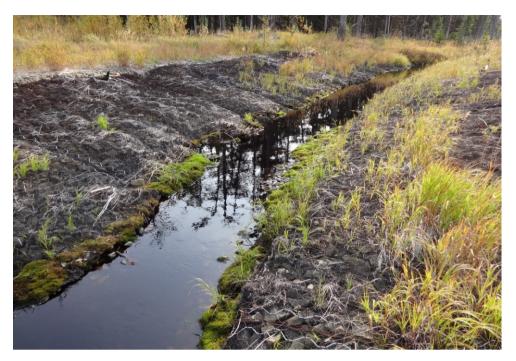
During the October 2013 site visit, good use of Enkamat type geotextile was observed at a range of locations, including the Vatung and Pilenga River banks (KP 19 and 15). In both cases the Enkamat was placed within the Reno matting and will help to trap soil particles and encourage vegetation growth on the mats (Photo 25).

Photo 25: Use of Enkamat within Reno matting at the Vatung River

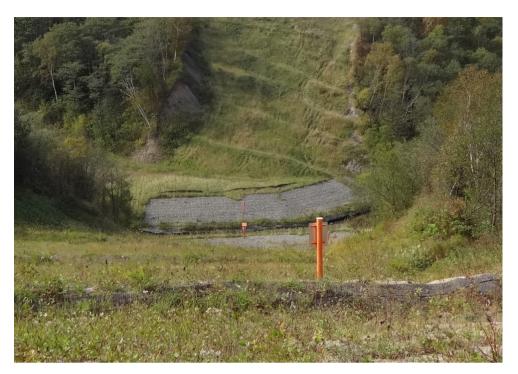
Photo 26: R. Krinka with good re-vegetation and redundant silt fence visible

ENVIRON suggests that Sakhalin Energy continues its on-going programme of conducting a site-specific evaluation of whether to continue the use of silt fencing. If the continuing presence of silt fencing in a specific location is no longer needed, then it should be removed (e.g. the silt fence above the bank of the Krinka River – the bank and slope are fully vegetated and there is no longer need for the silt fence as shown in Photo 26). Conversely, if the silt fencing still proves useful it should be kept in good repair.

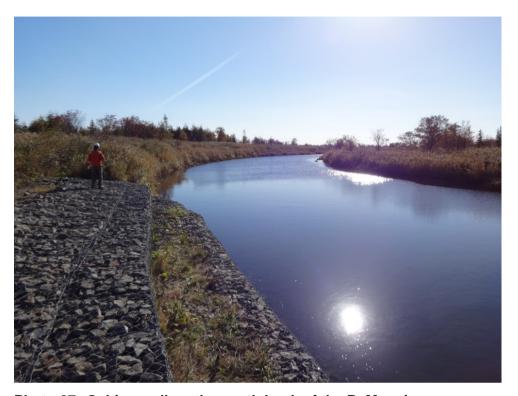
and in many cases in conjunction with reno matting. At locations inspected during the October 2013 site visit the use of gabions on river crossings was seen to be successful.

Photo 27: Gabion wall on the south bank of the R. Manui

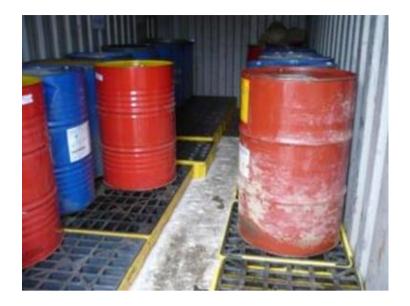
Photo 28: Waste liquid storage 2012 Monitoring visit

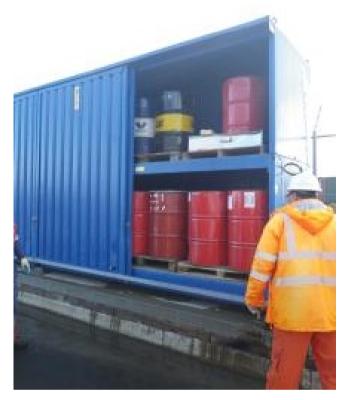
This monitoring visit confirmed that the number of drums stored upon these drip trays had been reduced and that new drum storage, comprising a series of containers, had been installed in the external yard area of the PMD. These containers had a metal mesh shelf (allowing drums to be stored over two levels) and incorporated a spill lip into their base, providing a secondary containment area. However, it was unclear whether these secondary containment areas were sufficient to retain the volume required by the Sakhalin Energy *Soil and Groundwater Industrial Controls* specification (Photo 30).

Photo 30: External drummed storage at the OPF PMD

It is suggested that calculations are made to confirm the maximum number of drums that may be stored within the external containers in accordance with the above HSESAP specification.

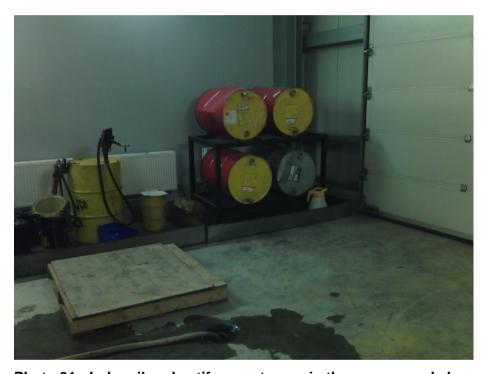
It is understood that Sakhalin Energy has dedicated a lot of effort towards providing adequate secondary containment of oil drums at the LNG facility, including the provision of awareness training and drip trays. The storage of lube oil and antifreeze in the garage workshops was noted to be much improved since the 2011 audit of the LNG facility as shown in Photo 31 below.

Photo 31: Lube oil and antifreeze storage in the garage workshop

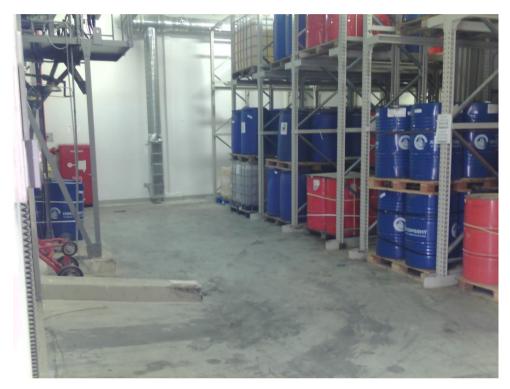
In all areas inspected the secondary containment was observed to be more than adequate, with environmental controls adequate to the types of materials stored within. Full sets of MSDS were observed in both Russian and English as required by the HSESAP *Chemicals Management* Specification.

Photo 32: Lube oil storage building showing ramp down into secondary containment area

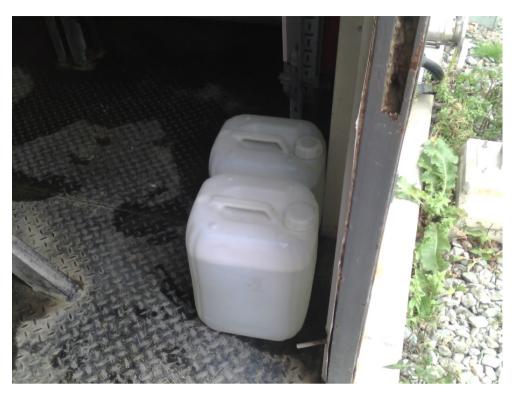
Only one example of no secondary containment was noted in the water treatment plant area – two plastic 25-litre containers of an unknown liquid were not stored on a drip tray. Furthermore, there were no accompanying MSDS for the containers.

Photo 33: Containers of an unknown substance at the wastewater treatment plant with no secondary containment or MSDS

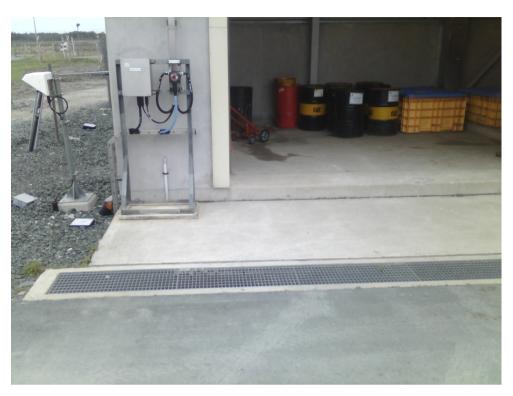
Storage areas for general waste categories 4 and 5 were very clean and organised at the LNG facility. The purpose-built main waste storage building is locked and each waste type is stored within an appropriate metal or plastic container. Furthermore, all waste containers were covered and labelled in both Russian and English with the type of waste and hazard class. Inspection of the contents suggested that these were being used appropriately. Wastes of hazard classes 1 to 3 (e.g. mercury and fluorescent lamps) are stored in plastic crates within the waste storage building. The concrete floor of the waste storage building is sloped towards the rear of the building, ensuring that leaks or spills would be directed to a sealed drainage sump.

Photo 34: View of entrance to waste storage building

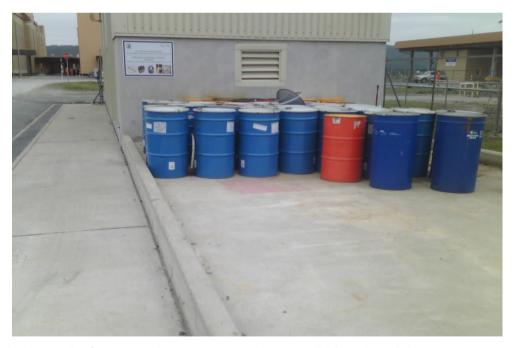
Furthermore, the bunded compound for waste empty metal drums adjacent to the waste storage building which noted to be in poor condition during the 2011 LNG audit was observed to have been repaired.

Photo 35: Storage of empty waste drums within a bunded area

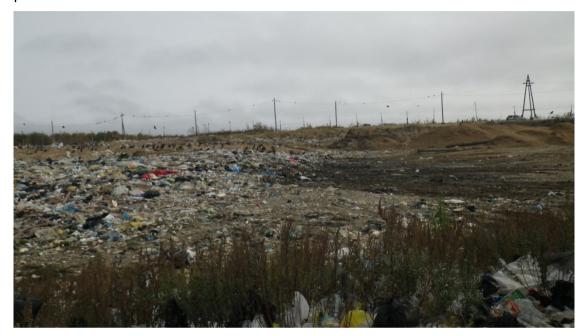
1. Daily cover of waste is inadequate at the cell used for Sakhalin Energy waste (Photo 36) and is non-existent at the other two cells. The lack of daily waste cover has resulted in the entire site being covered in windblown waste, including the leachate ponds.

Photo 36: Inadequate daily cover at the Sakhalin Energy waste cell

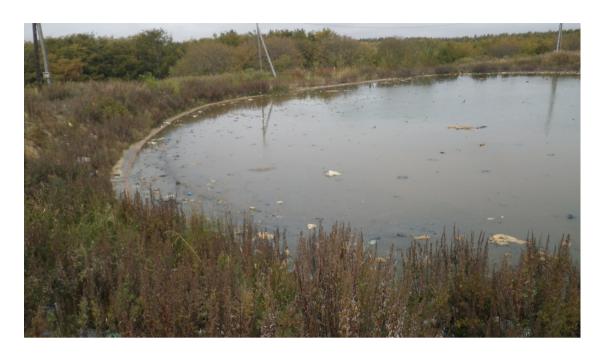
Photo 37: Overflow leachate pond at the Sakhalin Energy waste cell

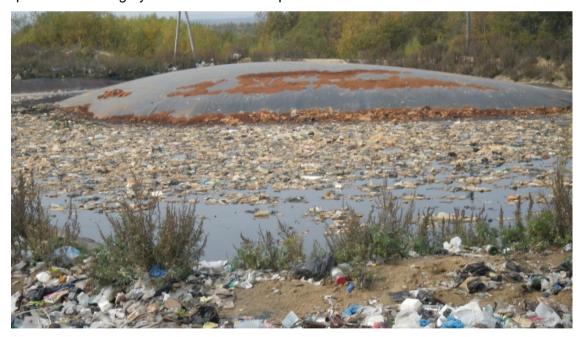
3. A large bubble had developed in the municipal waste leachate pond (Photo 38). ENVIRON suggests that this is likely to be formed by methane that has transported underneath the leachate pond; it is not possible to determine whether the source of this is from the municipal waste cell, the nearby Sakhalin Energy waste cell or elsewhere. This represents a significant health and safety risk at the site and also draws into question the integrity of all cells/leachate ponds at the site.

Photo 38: Bubble formed at municipal waste leachate pond

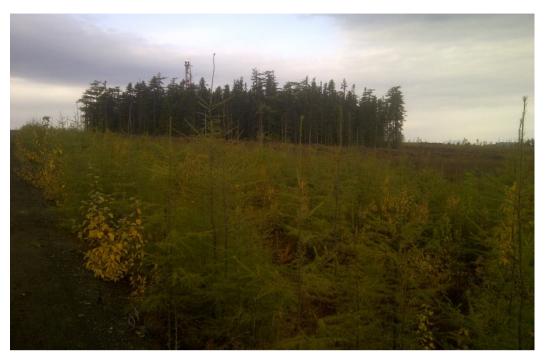
Photo 39: Un-felled trees comprising lichen habitats adjacent to the OPF Compression Project site

- Impacts on lichen should include consideration of air quality and nitrogen deposition impacts in addition to direct physical impacts;
- During early works tree clearance, a small section of trees where lichen growth was identified was left intact (Photo 39). The ESHIA should consider the long-term viability of this mitigation and in particular 'edge effects' on this set aside area;

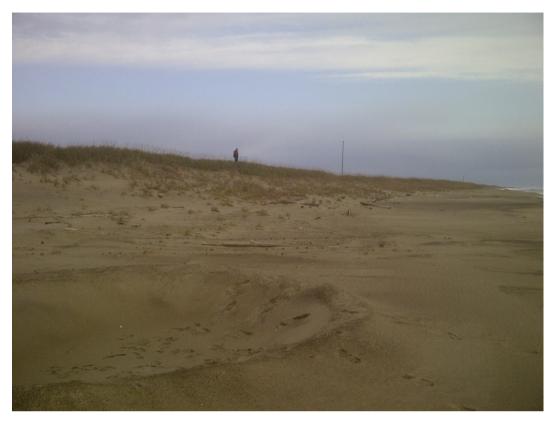
Photo 40: View to the north from the beach landing area towards the pipeline landfall location

A temporary beach landing facility will be required during the construction of the OPF Compression Project in order to import large modules and other construction items. The proposed beach landing facility will be in the same location and of similar design to that used during the original OPF construction phase. The area for the beach landing facility was visually inspected during the October 2013 site visit, and the beach and dune areas were found to have recovered well following removal of the original landing facilities used during the original construction of the OPF (Photo 40). This augurs well for the reinstatement of the

new landing facility following completion of the OPF Compression Project construction provided that similar construction and reinstatement techniques are used.

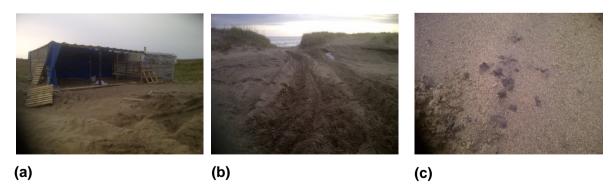
The beach landing area is reached from the OPF site via a beach access road that was installed during the original OPF construction phase. There was clear evidence of informal fishing at the beach landing area (Photo 41(a)), which has accessed by local fishermen via the beach access road. In addition to potential impacts on fish stocks, this informal fishing activity has resulted in damage to the dunes (Photo 41(b)) and visible hydrocarbon contamination of sands immediately behind the dunes (Photo 41(c)). ENVIRON also notes that uncontrolled use of the beach access road by fishermen has the potential to lead to disturbance of Steller's sea eagle nests in the vicinity of the road.

Photo 41: (a) Evidence of informal fishing at the beach landing area including temporary facilities, (b) damage to the dunes and (c) localised contamination
