Intended for
Sakhalin Energy Investment Company Limited

Date
February 2016

Project Number
UK22-17081

SAKHALIN-2 PHASE 2 LENDERS' INDEPENDENT ENVIRONMENTAL CONSULTANT LEVEL 1 AUDIT: PRIGORODNOYE PRODUCTION COMPLEX

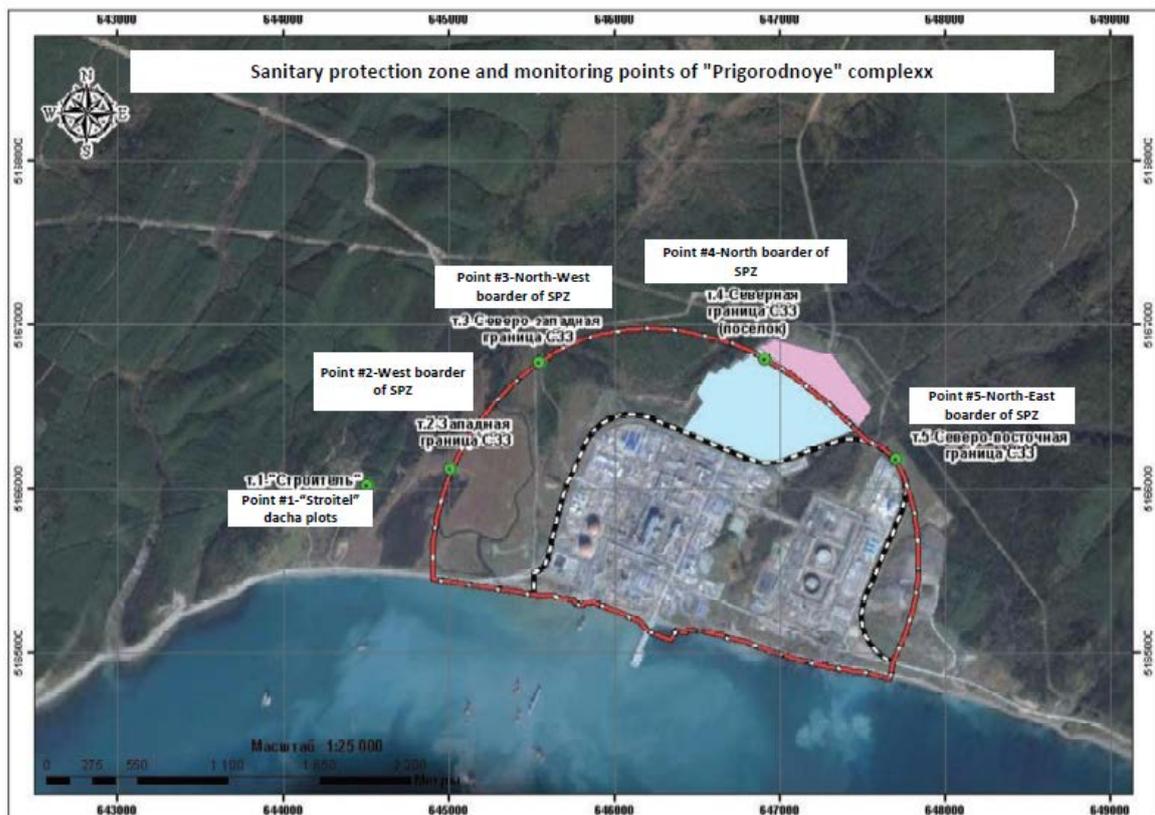
Figure 1 - Sanitary Protection Zone around the Prigorodnoye Production Complex

There is a formal Sanitary Protection Zone (SPZ) around the plant. This zone extends 800 m from the perimeter road in all directions. A map showing the Sanitary Protection Zone around the site (red contour line) is shown in Figure 1.

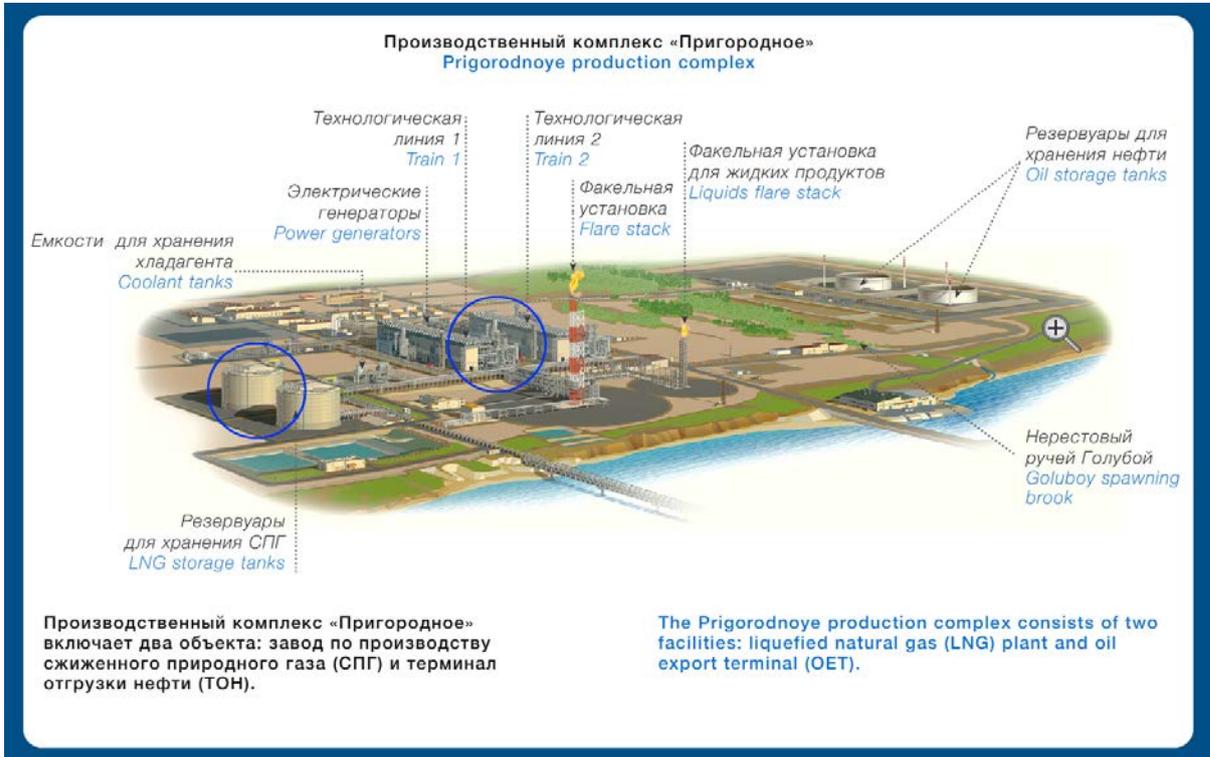
Figure 2 - Layout of Prigorodnoye Production Complex (from Sakhalin Energy website)

The total fenced area of the Prigorodnoye site is 4.2 km², and is divided by the Goluboy Stream (and surrounding undeveloped buffer zone); the LNG plant is located in the western part of the site, and the eastern part is occupied by the OET.

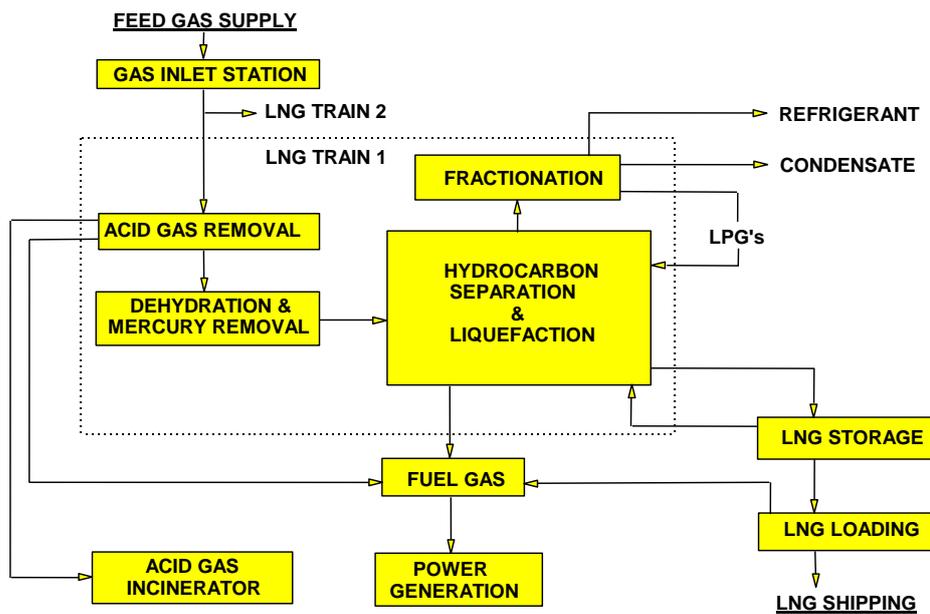
Figure 3 - LNG Plant block flow diagram

Feed gas arriving from the OPF is metered before being split into two parallel LNG trains. Each train comprises:

- An acid gas removal unit (Sulfinol-D and Active MDEA processes) to remove acid gases (mainly carbon dioxide (CO₂) with trace amounts of hydrogen sulphide (H₂S)) from feed gas. The removed acid gas, containing some hydrocarbons co-absorbed by the solvent is routed to an incinerator.
- A molecular sieve unit to dehydrate the feed gas.
- A guard bed of sulphur-impregnated activated carbon to remove any mercury that may be present in the feed gas.
- A Double Mixed Refrigerant Liquefaction Unit to liquefy the gas using two separate mixed refrigerant cooling cycles. One cycle is for pre-cooling of the gas to approximately -50°C (PMR cycle), and the other for final cooling and liquefaction (MR cycle) to below -160°C.
- A fractionation unit to produce refrigerant grade ethane and stabilised condensate.

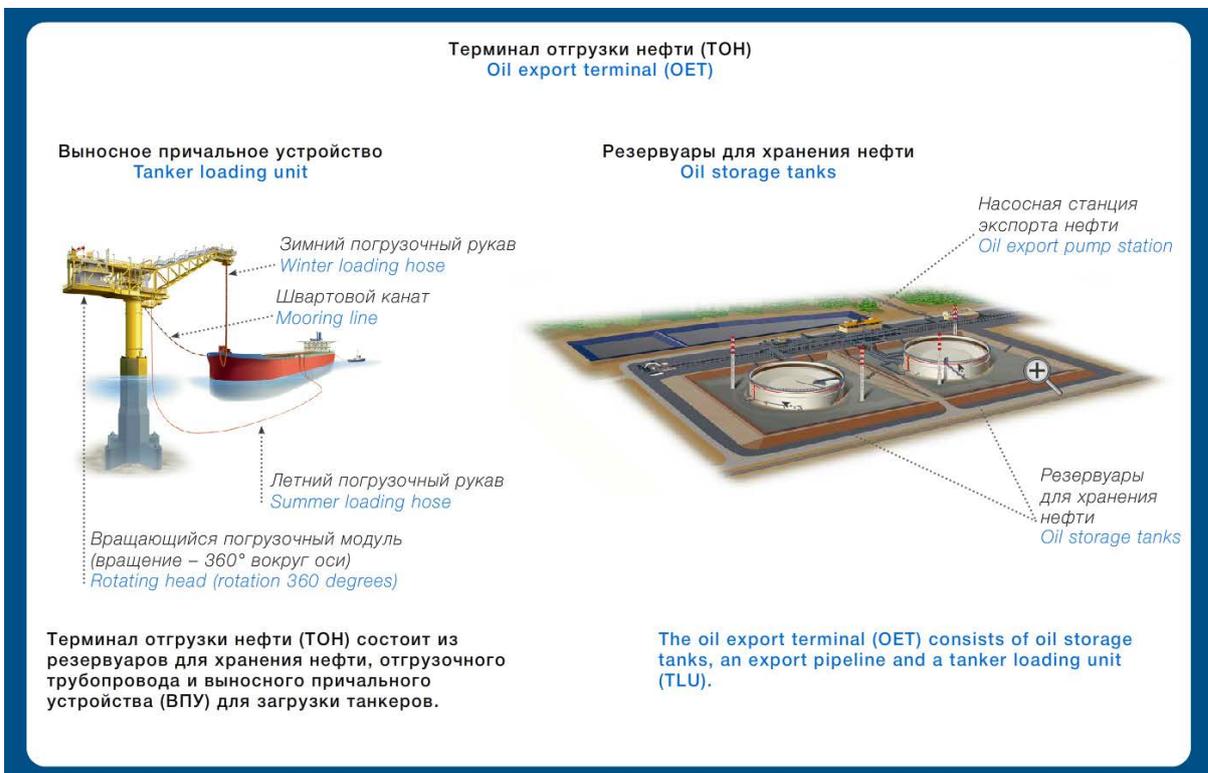
Figure 4 - Pictorial Description of OET (from Sakhalin Energy website)

The OET comprises oil storage facilities, oil export pump station, underground/subsea export pipeline and a tanker loading unit (TLU). The terminal receives stabilised oil from the PA field in the north of the island (following treatment and separation from associated gas on the PA-A and PA-B platforms) via a single-phase pipeline transportation system. The small amounts of condensate recovered by the LNG plant are blended with the oil at the OET.

Oil is stored at the OET in two floating roofed tanks, each with a capacity of 95,000 m³. It is then transferred to the TLU, a 74 m high structure located 4.8 km offshore in waters approximately 30 m deep, through the export pipeline where it is offloaded to oil tankers for export.

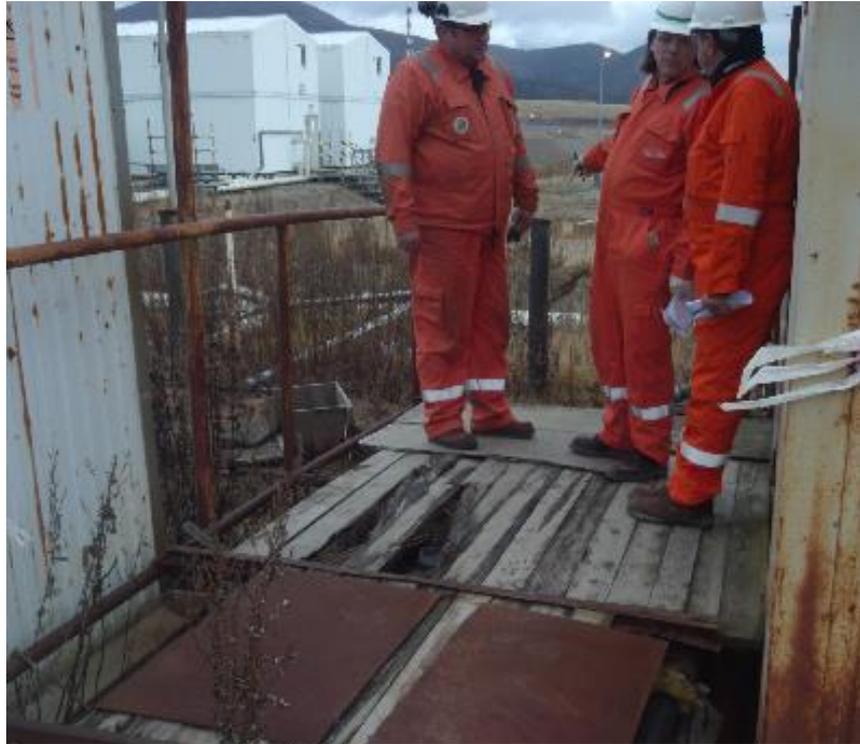
Photo 1. Derelict structures in close proximity to operation STP facilities

Opportunity for Improvement: A number of redundant buildings / infrastructure associated with defunct sewage treatment facilities used during the construction phase are still present in close proximity to the operational STP. The derelict condition of these structures (see Photo 1) poses a potential health and safety risk to personnel working in the area and we recommend that they be removed and the site area restored.

- A number of redundant buildings / infrastructure associated with defunct sewage treatment facilities used during the construction phase are still present in close proximity to the operational STP. The derelict condition of these structures poses a potential health and safety risk to personnel working in the area and we recommend that they be removed and the site area restored.

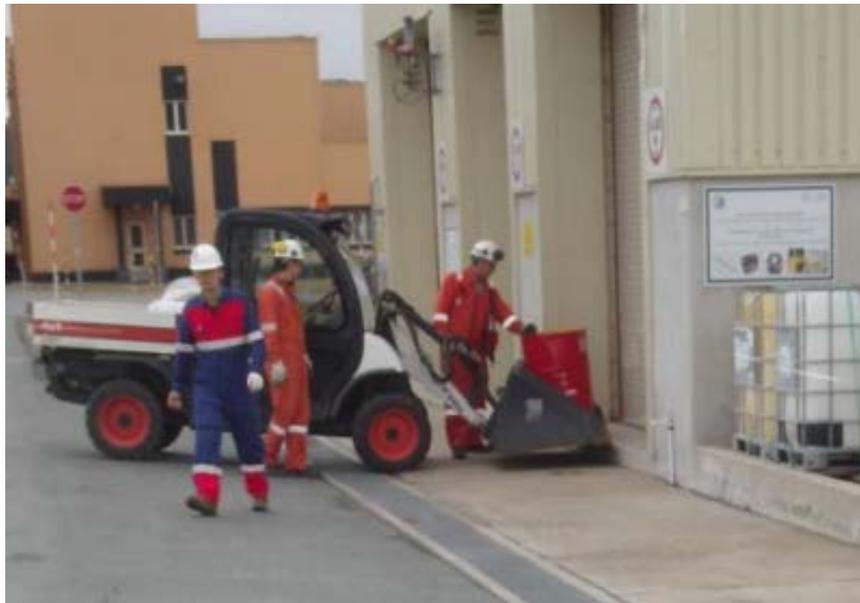
Photo 2. Waste oil drum transported by Bobcat – unsecured – outside Building 10 (over storm water drain)

Opportunity for Improvement: The Auditors observed a 205 litre drum of waste oil being delivered to Building 10 during the audit (see Photo 2). The drum was being transported in the bucket of a Bobcat vehicle without any form of strapping/device to secure the load. Furthermore, the slotted drain over which the vehicle was parked, whilst the drum was offloaded, was identified as a storm drain that discharges directly to a natural drainage ditch. Given the hazardous waste transfer activities that take place in this area, it is recommended that the

- The Auditors observed a 205 litre drum of waste oil being delivered to Building 10 during the audit. The drum was being transported in the bucket of a Bobcat vehicle without any form of strapping/device to secure the load. Furthermore, the slotted drain over which the vehicle was parked, whilst the drum was offloaded, was identified as a storm drain that discharges directly to a natural drainage ditch. Given the hazardous waste transfer activities that take place in this area, it is recommended that the Company gives consideration to installing a pen-stock valve so that the drain can be isolated in the event of a spill.

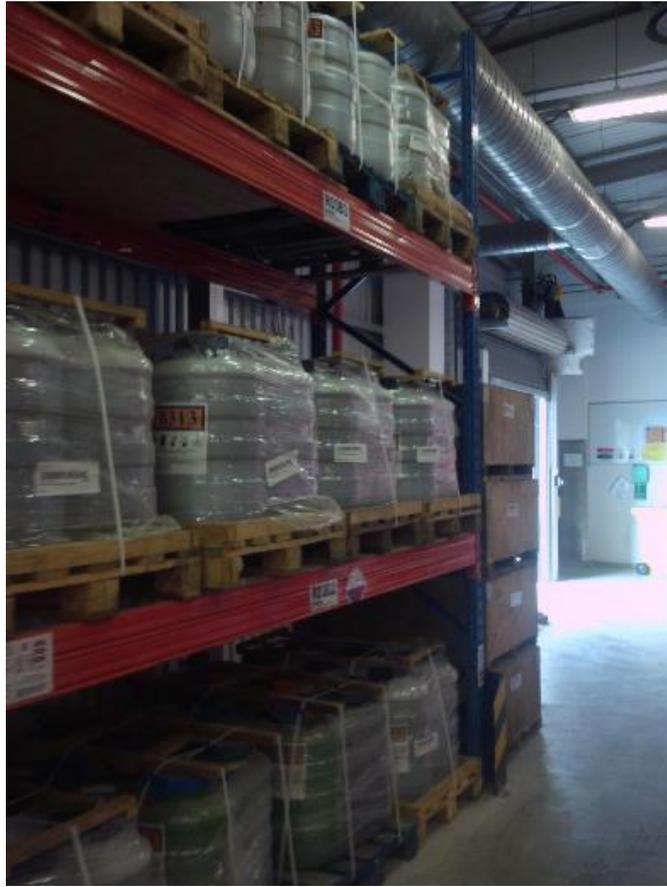
Photo 3. Storage of liquid hazardous chemicals in Room 101 (not designed for such storage)

- Storage Room R101, which contained a large number of chemical drums, did not appear to have been designed for such a use (i.e. no sump or lip across the door). It appears that the room was originally designed for dry storage but ended up as mostly liquid chemical storage. The Company should pursue possible mitigation measures to bring it up to standard for liquid chemical storage. As a minimum, chemical drums should be stored further from the entrance.
