## APPENDIX 4: RIGHT OF WAY REPORT

<b>Title:</b> Photographic Log – Right of Way	<b>Client:</b> Sakhalin-2 Phase 2 Lenders
<b>Site:</b> Sakhalin Energy Investment Company	<b>Date:</b> September 2017

## ROW FROM CHAIVO LANDFALL TO OPF

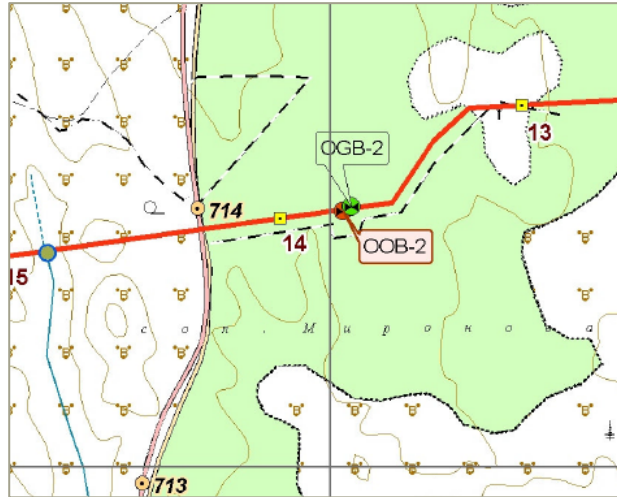
The crossing has a number of detailed engineering design features to reduce the risk of seismic movements causing damage to the two pipelines. At the surface, the soil is quite sandy and only very sporadic vegetation and grass has established despite seeding. However, no signs of erosion were evident and erosion protection features such as slope breakers and geojute matting has been installed in part of the section (Photo 1).

The slow establishment of vegetation may be attributable to the sandy nature of the soil and a probable low nutrient status, combined with the harsh climate. It is likely that any topsoil previously present was mixed with sub-soil. An indication of the difficulty of establishing a natural vegetation can be gained from inspection of the vegetation adjacent to the RoW. The forest is quite sparse in this area and the forest floor comprises a mixture of low woody shrubs, interspersed with mats of lichen mats and what appear to be biogenic crusts. Biogenic crusts are typically a few millimetres thick where the soil surface held together by combinations of microphytic communities such as mosses, lichens, soil algae, bacteria and fungi (Photos 2 and 3). These vegetation types are very fragile and easily damaged but play an important role in reducing erosion from wind and water. They can also take a long time to re-establish post disturbance. It is unlikely that there is much that Sakhalin Energy can do to speed up the natural regeneration of these natural vegetation types.

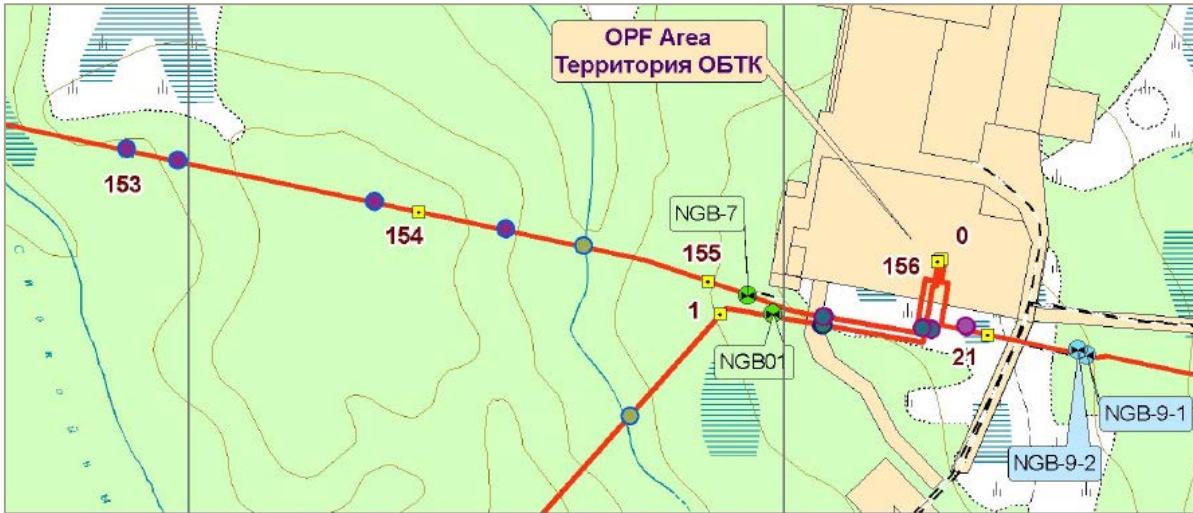
A brief visit was made to inspect the bridge repairs at KP154. Steel supporting structures are routinely used by Sakhalin Energy for maintaining river crossings for access tracks within the RoW. The steel supports are decked with timber, which require routine replacing once they become decayed or damaged.

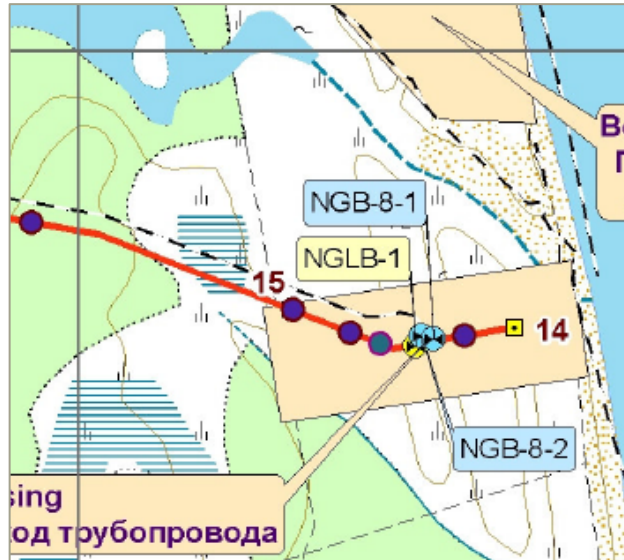
The RoW vegetation has been damaged in this vicinity by fishermen driving from the beach landed facility access road to an illegal camp located to the south. An abandoned fisherman camp is also located immediately adjacent to the RoW, and the remains of temporary shelter, rubbish and a tracked excavator are present. Better security and control of the beach access facility access road is required to prevent the damage caused by this induced access.

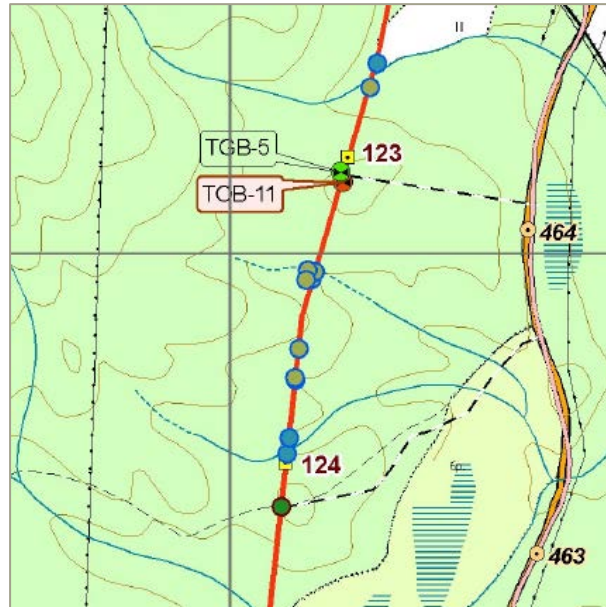
**Photo 1.** June 2016

The sandy slopes have shown a large improvement in vegetation cover since June 2016 (compare Photos 1 and 2). The sown seed mixture of grass and legumes has established well, probably assisted by the legume’s ability to fix nitrogen into the naturally low-nutrient soil. The vegetation within the RoW will assist in the prevention of soil erosion, but does not match the naturally occurring forest floor vegetation present either side of the RoW (Photo 3). This in part is likely to be due to the loss or mixing of the very shallow topsoil along with its seedbank during construction. It may take decades for a more authentic forest floor vegetation to restore within the RoW as the soil profile matures and seeds spread from its edges.

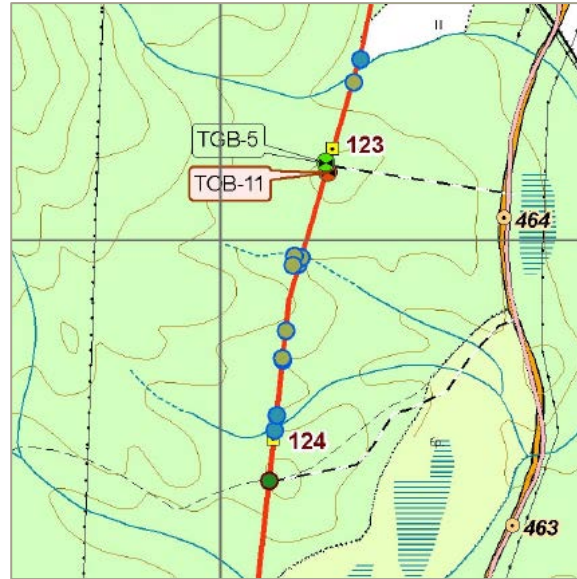
A visit to the proposed site of BS3 was made during the RoW inspection. A new access track has been cleared through the forest from the RoW to the proposed site (Photo 1). The track has not been reinforced with hardcore and comprises loose soil, limiting vehicular access to the proposed site. The track crosses a number of small streams that have not been culverted under the track at the current time.

**Photo 1.** Recently created access track to BS3

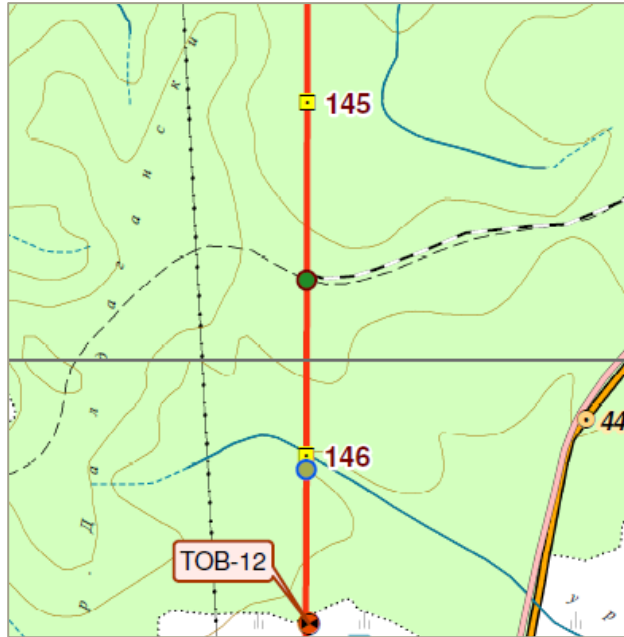
Stone rip-rap has been installed on one bank of the river that was suffering erosion (Photo 1). The rip-rap has been installed along the bank extending either side of the RoW to protect the full extent of the bankside vulnerable to erosion. Based on discussions with Sakhalin Energy, it is understood that the permitting process for works outside of the RoW is relatively complicated and requires a long-lead time. It is understood that river restoration works are completed during low-flow winter periods, outside of the salmon spawning season.

**Photo 1.** Stone rip-rap erosion protection

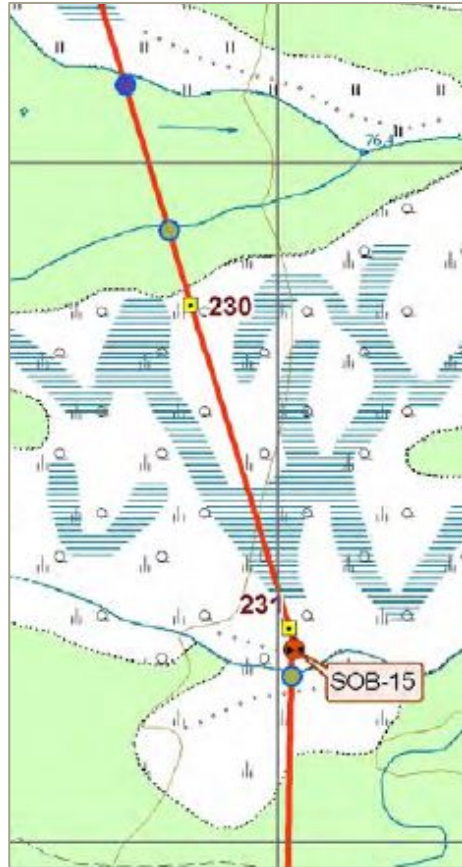
Since the last IEC monitoring visit in June 2016, additional culverts have been installed across the RoW as recommended in the previous monitoring visit report (Photo 1). In addition, shallow ditches and low bunds have been installed to assist water flow to and away from the culverts. Unfortunately, the monitoring visit took place in a period of low rainfall and no water was present to gauge the efficacy of the newly installed works.

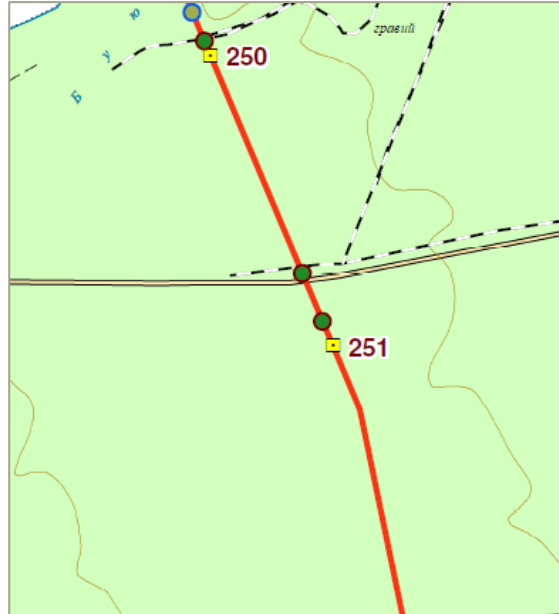
Stone rip-rap has been installed on both banks of River Corssing #2 as both were suffering erosion. In particular, the steep bank to the west of the RoW visible in Photo 1 was eroding, posing a risk of undermining the pipelines that are only buried to 1.5 metres deep at river crossing points. This has required installation of rip-rap beyond the RoW boundaries.

**Photo 1.** River Crossing #2 with stone rip-rap installed on both banks of river

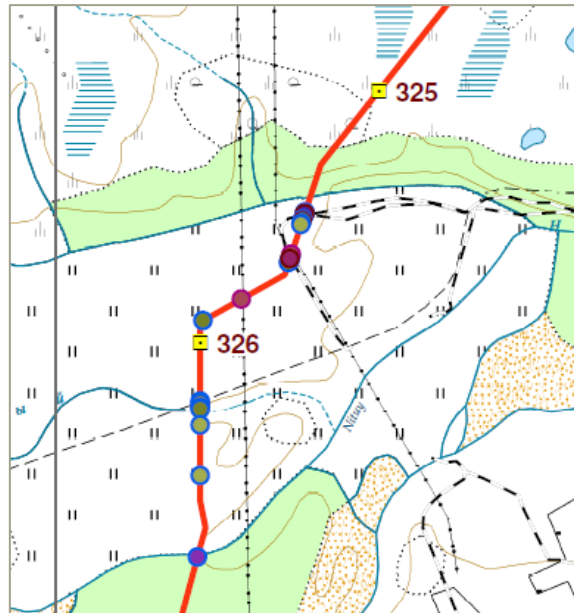
Where rip-rap was installed four years ago, the cracks between stones have become colonised by vegetation and have become much more natural in appearance (Photo 1). No signs of damage to the rip-rap was observed from high water flows.

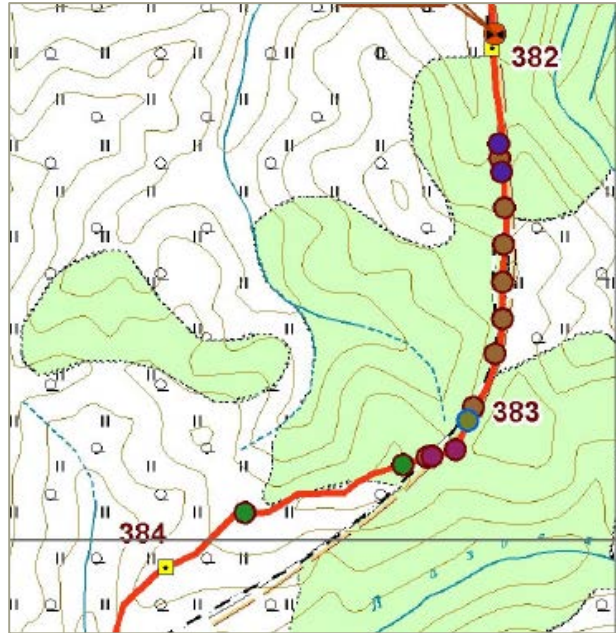
Repairs to this landslide were inspected. The repairs have included the installation of stone-filled gabion walls combined with an extensive network of drains to prevent the build-up of water. The replaced soil slope has been reseeded and has established very successfully (Photo 1). It is understood that Sakhalin Energy is undertaking a proactive monitoring approach to areas vulnerable to landslips to assess when pre-emptive works are required in an attempt to reduce landslides in the future, along with the need for significant engineering works to restore the damage.

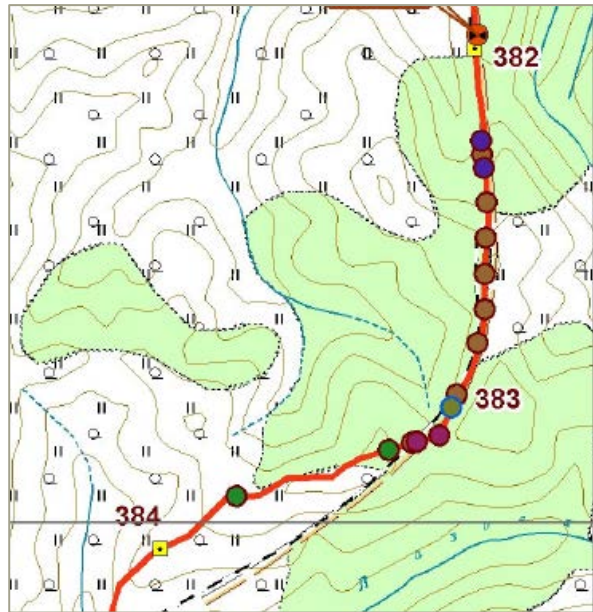
The landslide at this location presented significant engineering challenges to restore the slope. This has included re-enforced concrete piles to support a large retaining wall. Underground drains have been installed and water is collected at a central location and removed by a pipe lain over ground (Photo 1). The works have been completed recently, and the reseeded surface is still establishing itself.

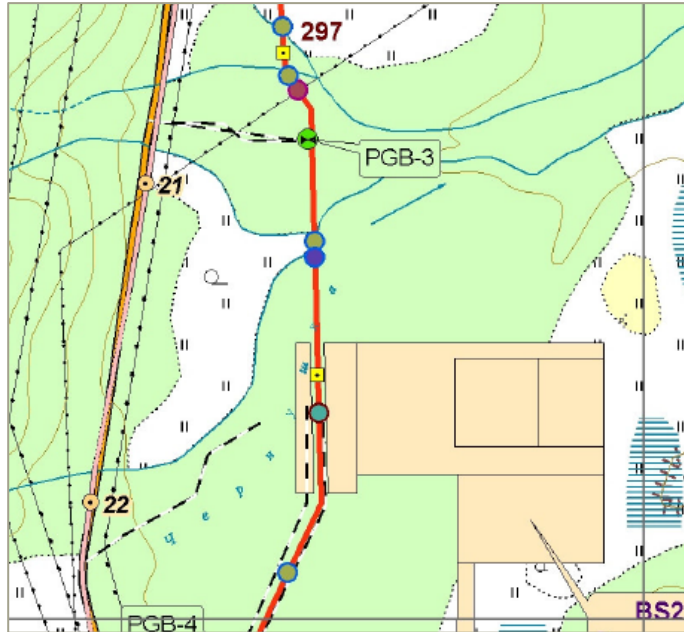
A very brief visit was made to BS2 during the RoW inspection. It is understood that as part of the Train 3 Project, additional plant will be installed within the existing footprint of the site. The BS2 site is situated within an area of previously cleared forest and it is understood that no additional tree clearance will be required for the main train 3 related works at BS2 (Photo 1).

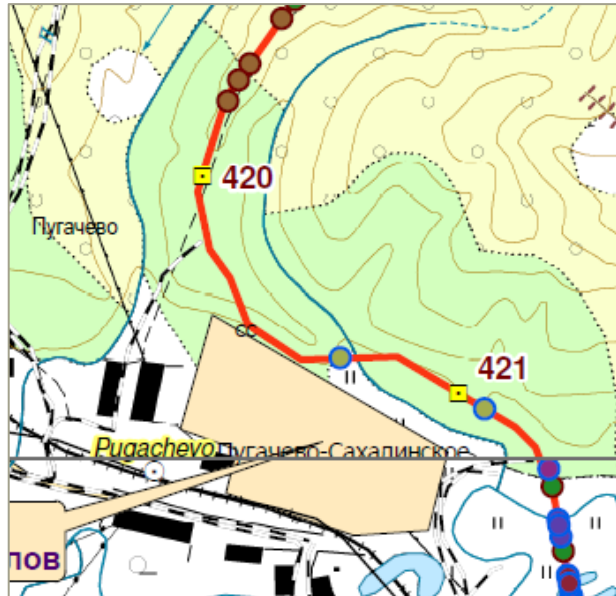
At the time of the visit, it is undertsood that the slope reprofiling at been completed (Photo 1) in preparation for the installation of surface netting and ground anchors. The area had yet to be reseeded due to ongoing construction.

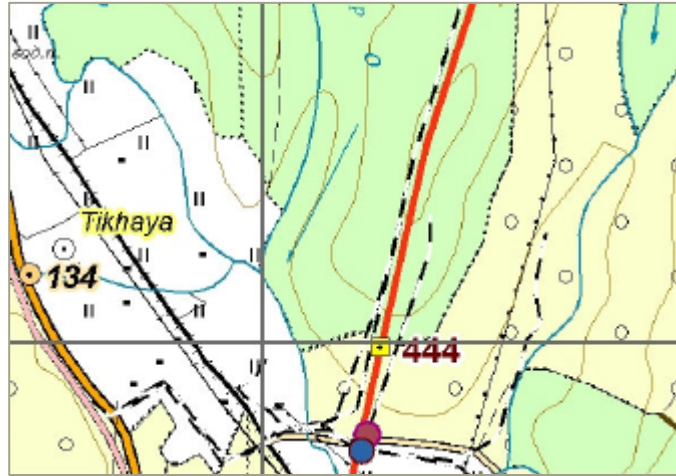
The proposed site for BS4 was visited during the RoW inspection. As with BS3, the site has been recently clear-felled and the timber stacked in piles on-site (Photo 1). The cleared site has incurred less damage during the forestry operations than at BS3, and a relatively intact vegetation cover remains. However, soil erosion and sediment run-off will be a significant risk during construction. Due to the large size of the site and the slopes present, it is likely that significant cut and fill will be required to create a level site.

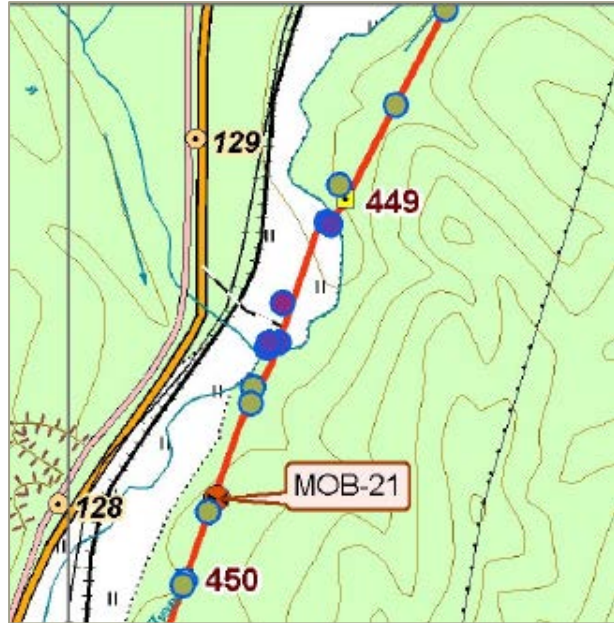
A brief visit was made to the Duet River crossing at KP 449. The river banks at this location are still protected by reno mats that have been left in situ (Photo 1). Vegetation has grown up through the mesh of the reno mats, providing further protection against erosion.

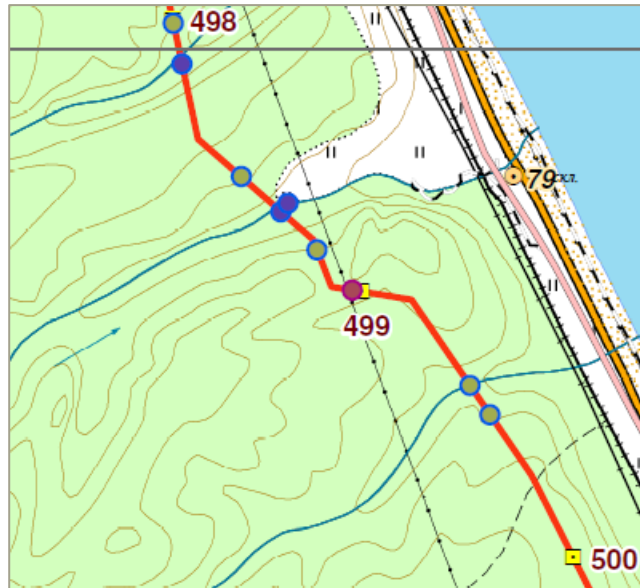
The River crossing at this location has been reinforced with stone rip-rap. The works were completed four years ago and vegetation has established itself well amongst the large stones, providing a more natural appearance.

No signs of erosion of the protected banks were evident.
