## **Annex D: Individual RoW Descriptions**

### Fault Crossing 1 and adjacent RoW – KP 12 to 14

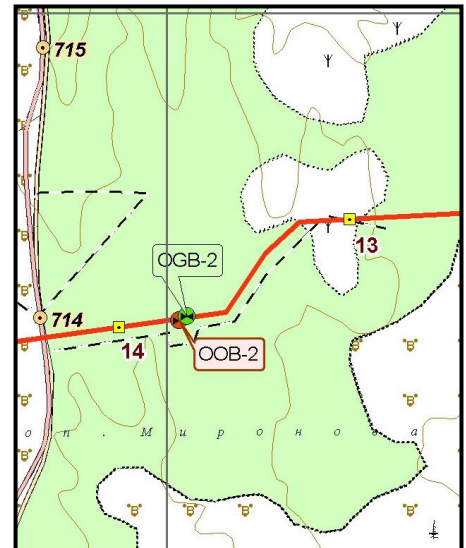
The drainage in Fault Crossing 1 was recently repaired at several locations by adding slope breakers and drainage channels surfaced with riprap. There is a marked difference between the south and north facing side cuts along the RoW. The south slope facing side cuts show good vegetation cover while the north facing side cuts have very poor cover. The north slopes are surfaced with geonetting which shows failure across the slope. This is usually the case when the geonetting is placed horizontally instead of vertically. It is recommended that the netting will be placed according to the manufacturers specifications. The RoW north of the Fault crossing shows good vegetation cover while the RoW cover south of the crossing is minimal and patchy.

**Photo 1** – View south showing repaired erosion control and re-seeding.

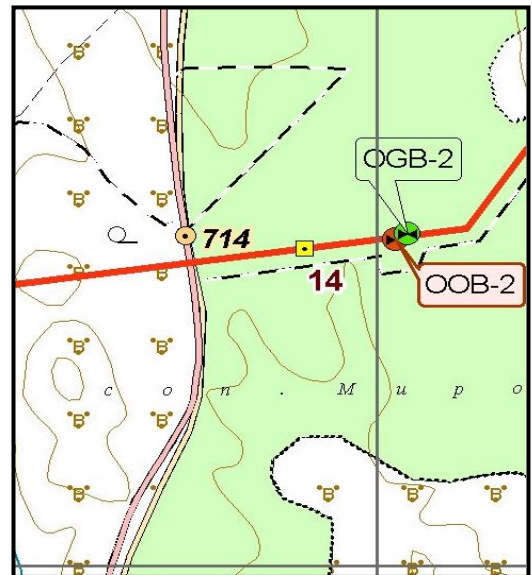
**Photo 2** – View north toward the Federal Highway road crossing, showing a vegetated RoW with grass and small trees.

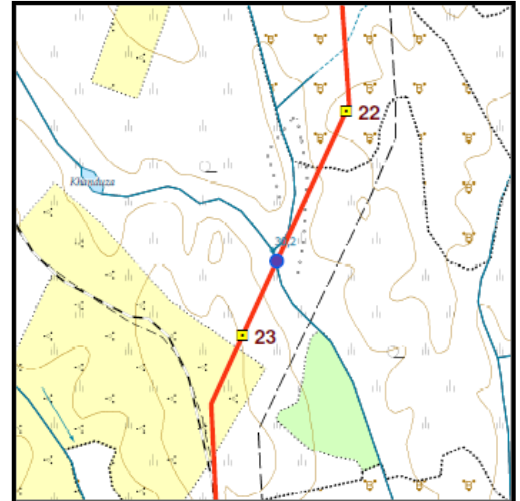
**Photo 1** – View to the south across the river showing heavily vegetated valley and slope breakers on the steep slopes in the background.

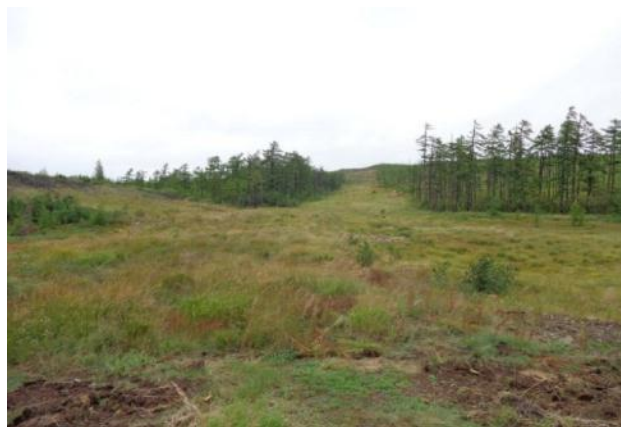
A sand borrow area on the upstream side of the RoW is well protected by Enkamat and shows good vegetation cover (Photo 2). The river banks are heavily vegetated (Photo 1).

**Photo 2** – View of the river valley and reinstated sand borrow area upstream of the RoW.

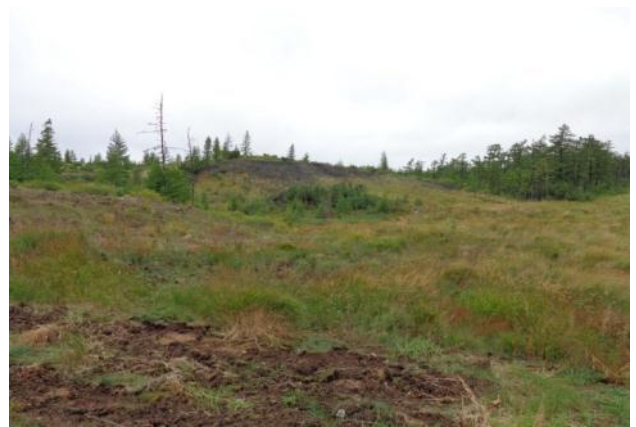
The Khandusa River south slope is very well vegetated and the slope breakers on the steeper part are well preserved. The area north of the north bank is also very well vegetated by thick grass cover in the river flood plain. The slope further north was recently repaired and is currently fortified by Enkamat cover at the lower elevation. There is some vegetation already establishing through the Enkamat (Photo 3). One slope breaker was repaired and fortified, the rest are holding well and are partly vegetated.

**Photo 3 (left)** – View to the south from the north slope showing fortified northern slope and a repaired slope breaker.

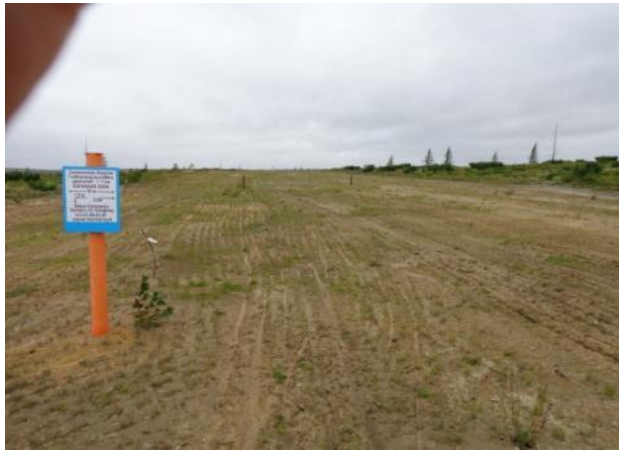
**Photo 2** – View of moderately well vegetated RoW on gentle sandy slope.

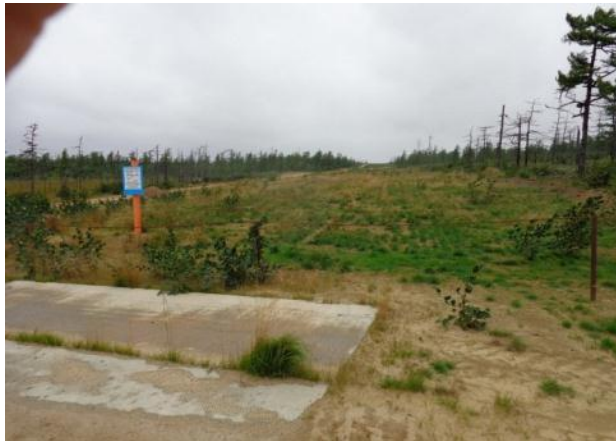
**Photo 2** – View of undulating RoW with good vegetation cover and slope protection.

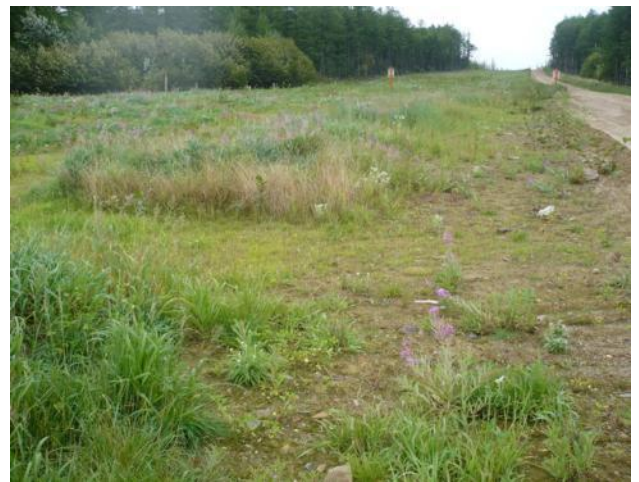
**Photo 3** – View of RoW south of BVS, showing good vegetation cover and tree saplings.

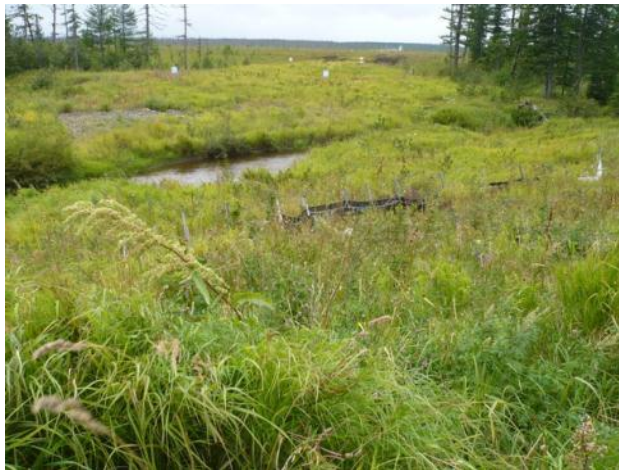
**Photo 2** – View of the slope south of the river crossing with thick vegetation cover.

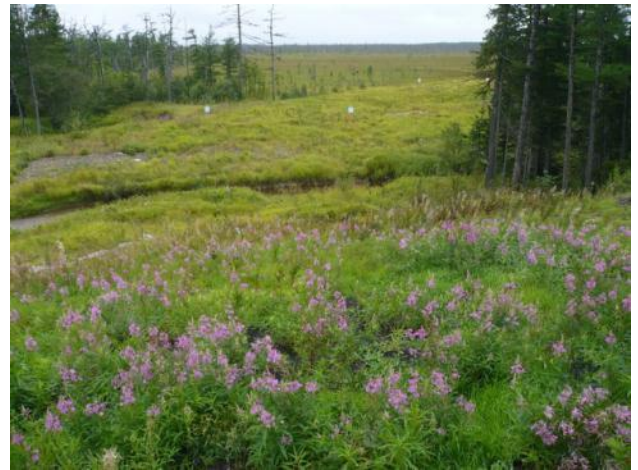
**Photo 3** – View to the north showing the wetland valley with partially vegetated RoW.

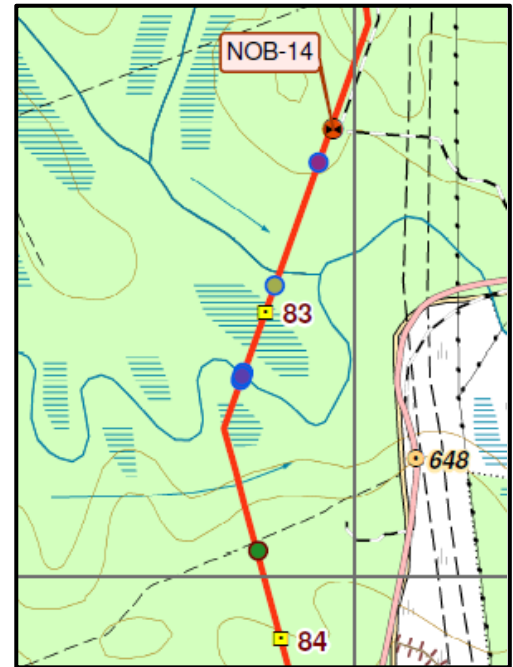
The river crossing is situated in a broad wetland valley with a long steep slope on the south end. The slope is well protected with slope breakers and good vegetation including saplings of Elder (Photo 1) in an improvement since last year when vegetation on the slope was sparse.

**Photo 1** – View to the south showing the slope south of the crossing with slope breakers and good vegetation cover.

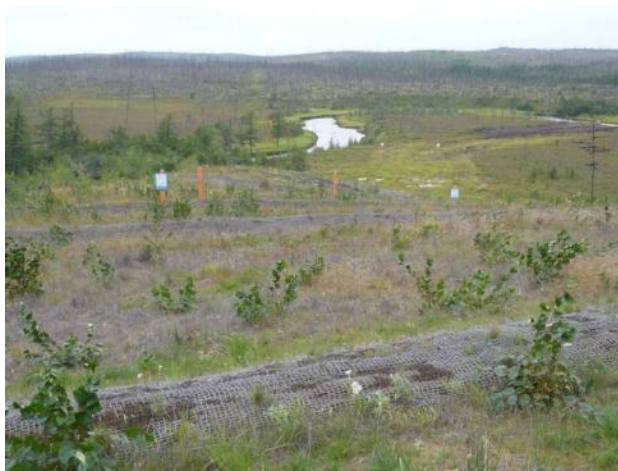
The wetland in the immediate vicinity of the crossing is showing poor regeneration of vegetation (Photo 2). However, further away the wetland is much better vegetated (Photo 3). Photo 3 also shows a well vegetated slope on the north side of Bolshoi Veni.

**Photo 2** – View to the north showing the wetland on both side of the crossing with poor vegetation cover on both sides.

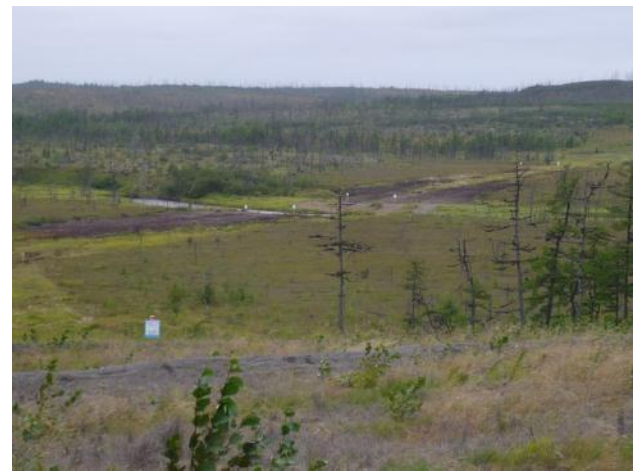
**Photo 3 (left)** – View to the north showing the Bolshoi Veni in the background at the base of the slope. Also note the mostly well vegetated valley between the two river crossings.

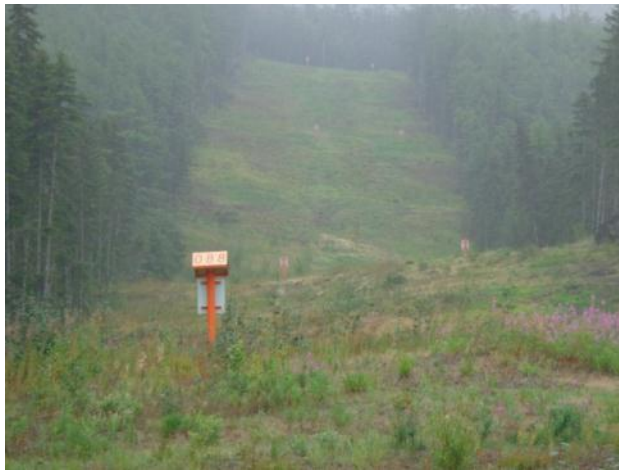
**Photo 2** – View south of well protected slopes with good vegetation cover.

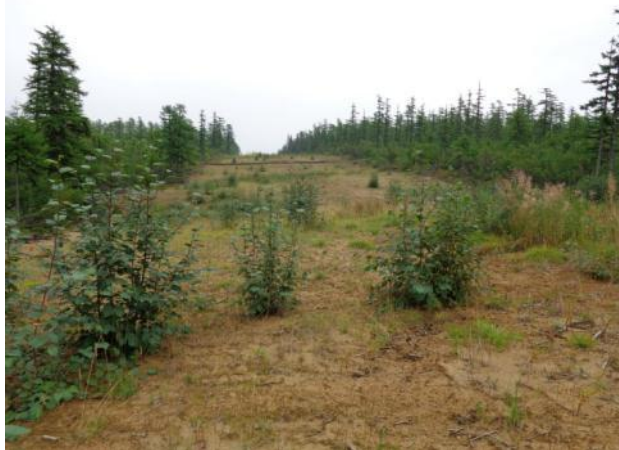
**Photo 2** – View of well vegetated RoW

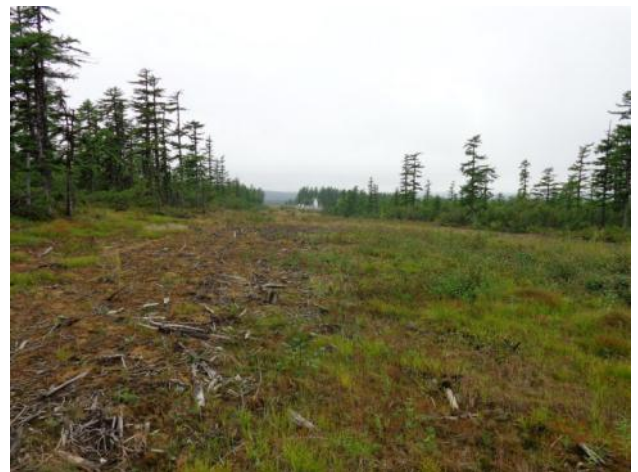
**Photo 3 (left)** – View towards the road and railroad crossing showing good vegetation cover. Along the access road to the BVS there is thick growth of tree saplings.

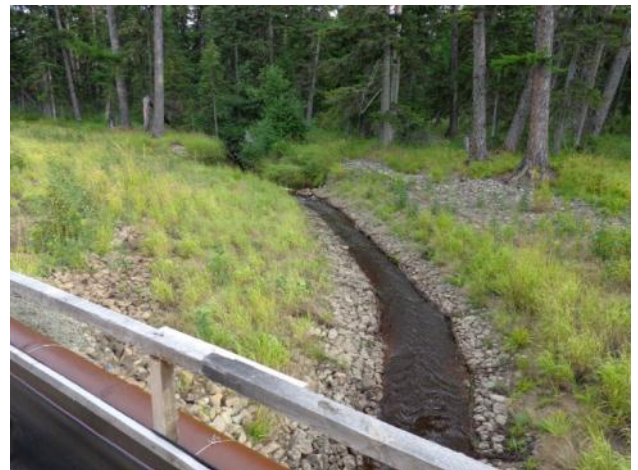
**Photo 3** – View of Spokoyney River crossing showing good bank protection and upgraded temporary bridge.

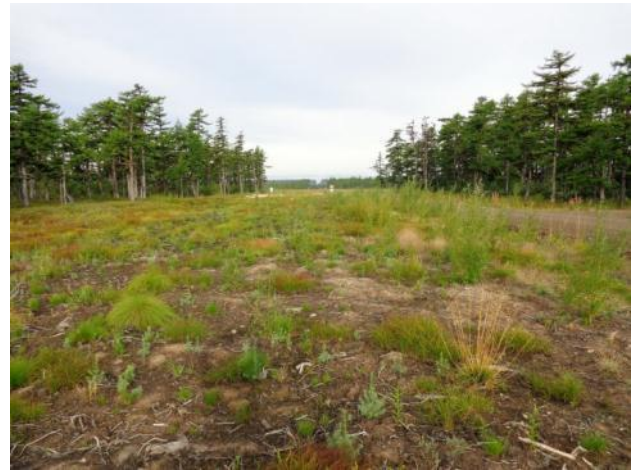
**Photo 5** – View to south showing recovered wetland

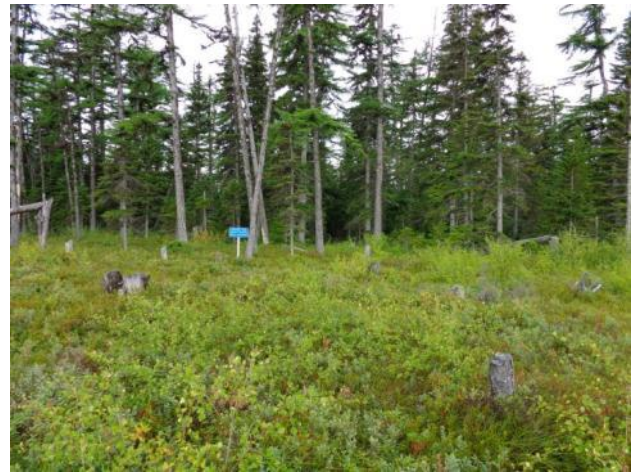
The wetlands which start at approximately KP 152.7 are well recovered (Photos 4 and 5). The section ends at the Block Valve Station NOB 24 where the pipes are HDDed below an area of archaeological significance within the forested area. The area is identified with several warning signs (Photo 6).

**Photo 6** – View to the north showing the archaeological area next to NOB 24

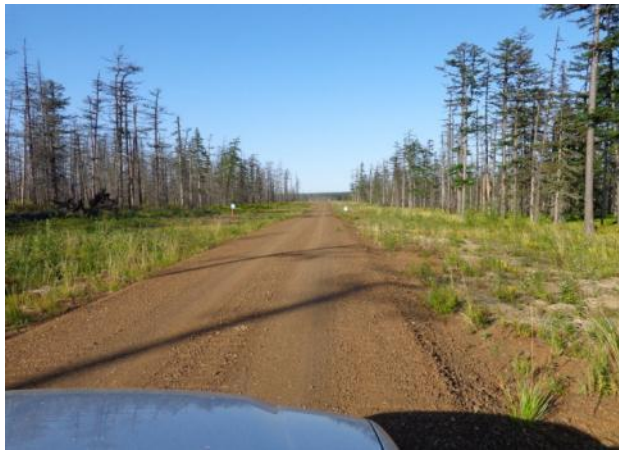
The river was accessed by a long access road starting at KP 21 and ending at KP 15 at the river crossing and at Block Valve stations NOB 01 and NGB 02. The RoW between KP 21 and KP 18 (approx.) is well vegetated (Photo 1). However, between KP 18 and 15 (approx.) the RoW is sparsely vegetated and in some location lacking all vegetation and showing erosional channels (Photo 2).

**Photo 1** – View to the south showing well vegetated RoW at the area of KP 18 to 21

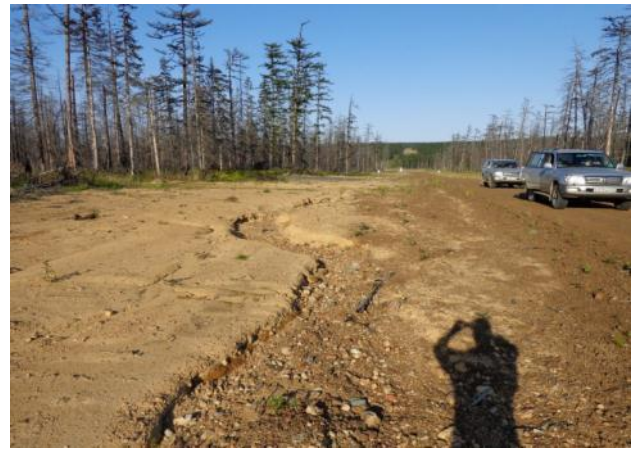
**Photo 2** – View of a RoW section in the area of KP 15 to 16 showing poor vegetation cover and a development of erosion channels.

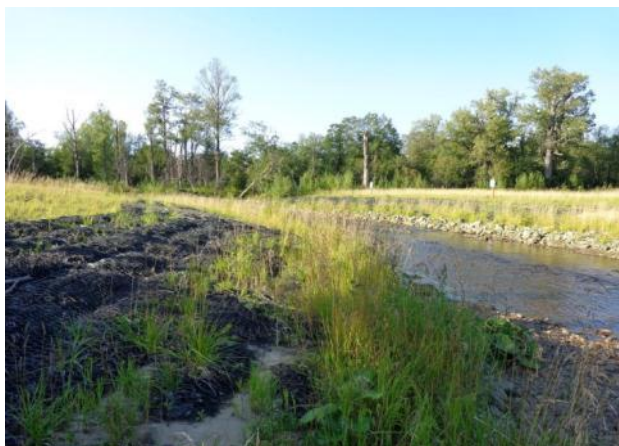
Pleleyarna River banks are well protected with Reno mats and vegetation is starting to break through the mats.

**Photo 3** - View to the upstream showing protected banks and vegetation coming through the Reno mats

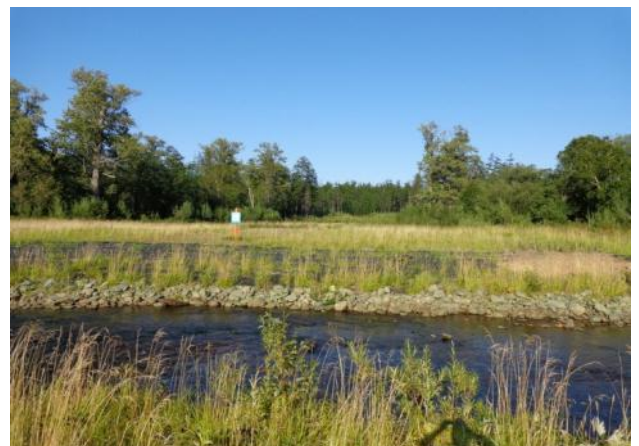
**Photo 4** – View across the river to the south Showing well protected river bank with riprap and Reno mats.

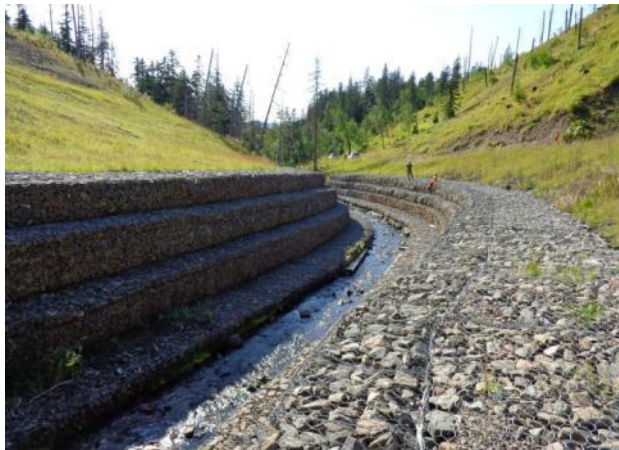
The Vstrechny River has fully engineered gabion protected channel with both banks covered by gabion walls (Photos 1). The slope to the east is well vegetated and protected with slope breakers (Photo 2). The slope to the west is partially vegetated (Photo 3). The toe of the gabion wall towards the incoming flow at the upstream is holding well. The bottom Reno matt is partially above the flow with some undercutting below it (Photo 4) and should be monitored.

**Photo 1** – View to the downstream showing gabion banks and vegetated slopes

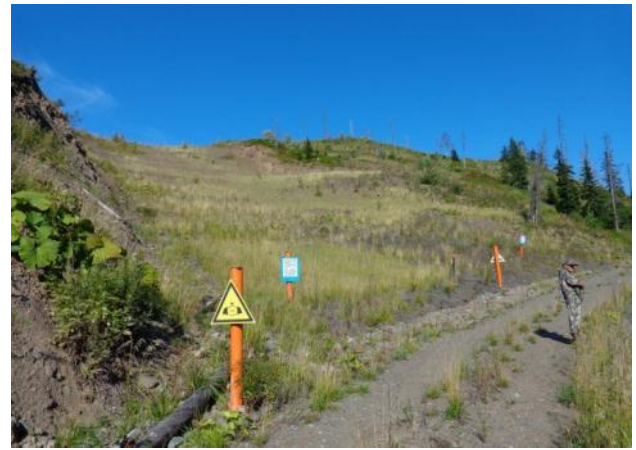
**Photo 2** – View to east showing steep vegetated slope with slope breakers

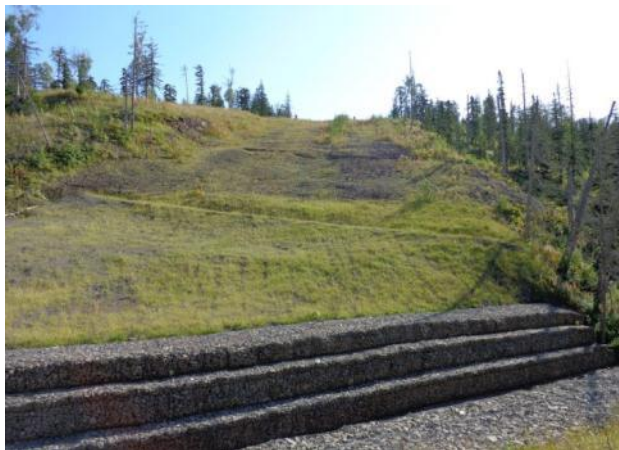
**Photo 3** – View to the west showing partially vegetated steep slope.

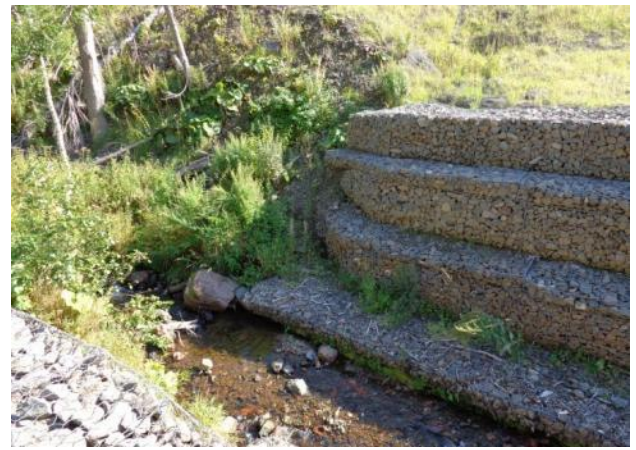
**Photo 4** – View to the upstream showing the toe of the gabion wall at the impact point of the stream.

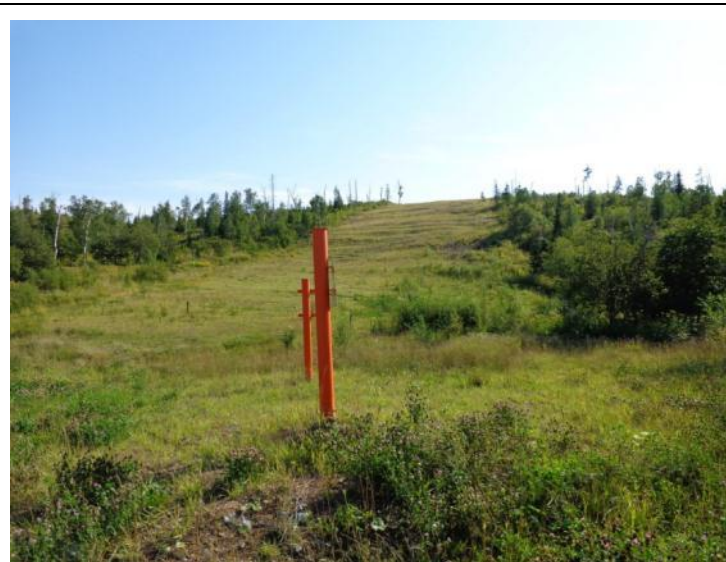
The RoW at the road crossing shows good vegetation cover and well protected slopes with slope breakers.

**Photo 1** – View to the south showing the RoW with a well vegetated and protected with slope breakers.

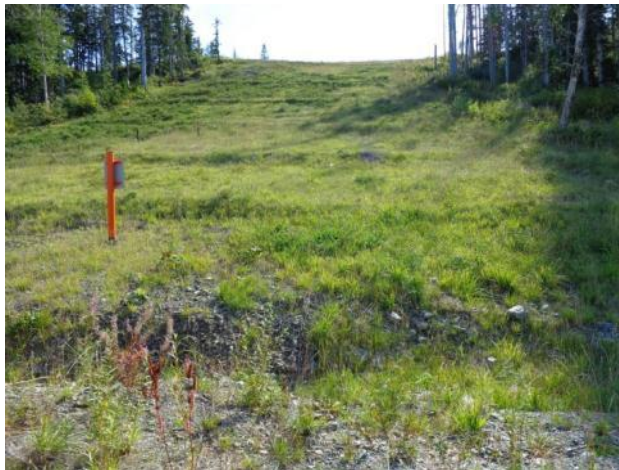
**Photo 1** – View of the west slope showing good vegetation and slope breakers.

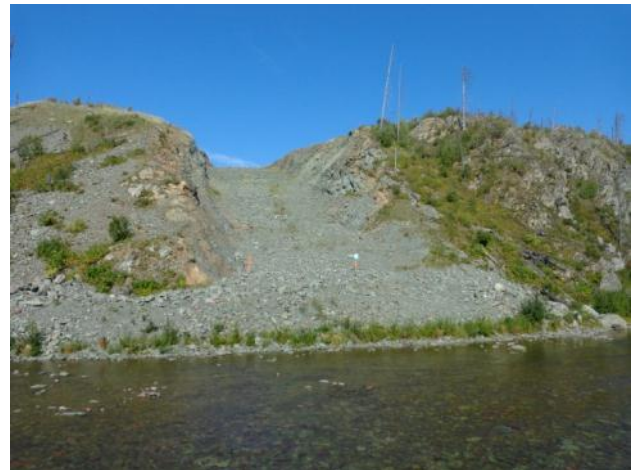
The Nabil River crossing has two steep slopes. The east slope RoW was blasted through rock (Photo 1) and is currently exposed rock with no vegetation. The western slope is well vegetated and protected with slope breakers. The river banks are protected with heavy riprap on the western bank of the river and rock in place on the eastern bank (Photos 2, 3 and 4).

**Photo 2** – View of the east bank showing blasted rocky RoW in stable condition.

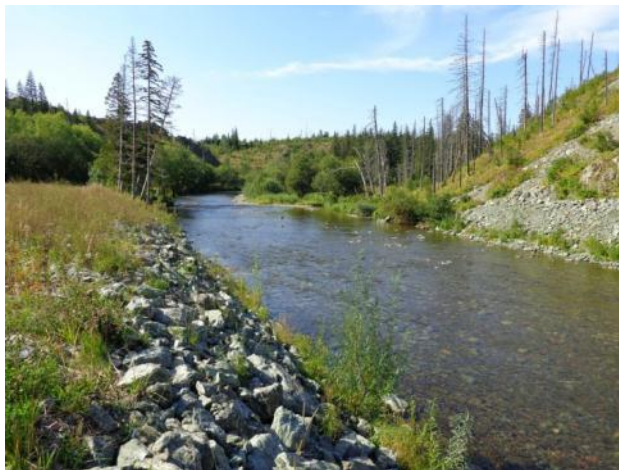
**Photo 3** – View downstream showing well protected banks with heavy riprap on the west bank.

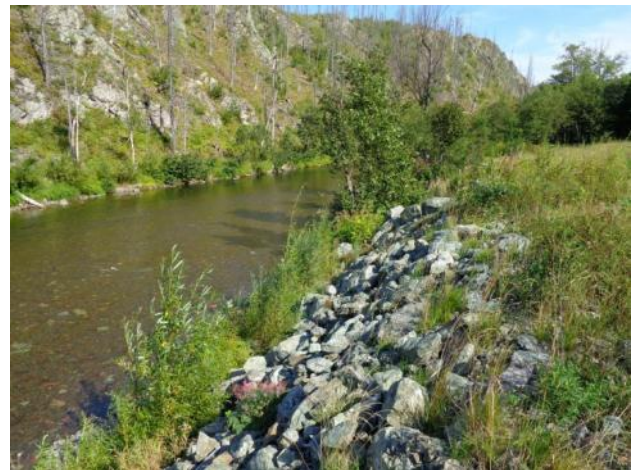
**Photo 4** – View to upstream showing riprap and vegetation growing on the bank and through the rocks.

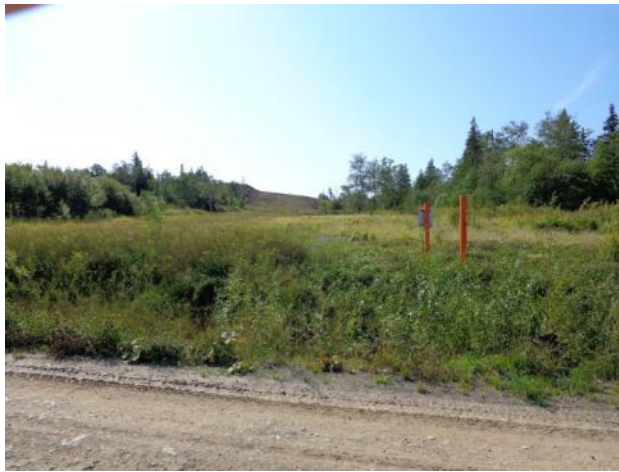
The RoW at road crossing at KP 44.8 shows good vegetation growth on both sides to the distance. The RoW to the west of the road has a short slope in the distance with a slope breaker.

**Photo 1** – View of the RoW to west of the road showing good re-vegetation and slope protection

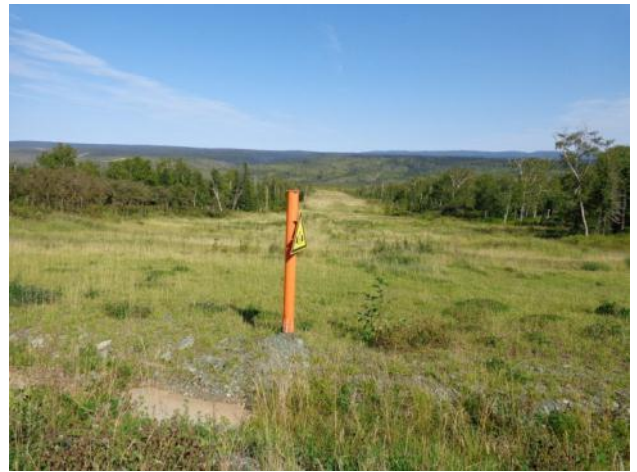
**Photo 2** – View east of the road showing good re-vegetation.

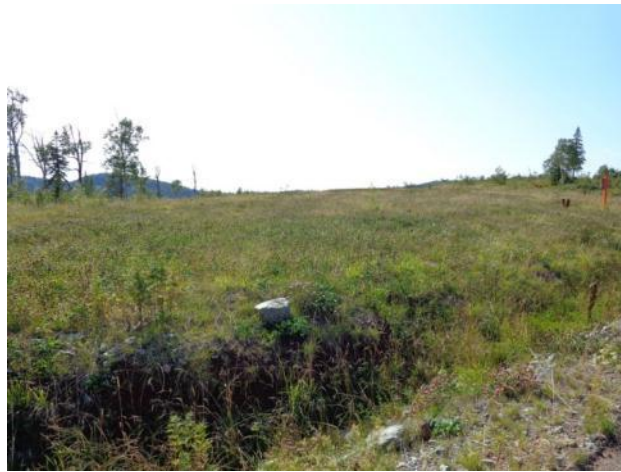
The RoW at KP 45.6 was observed from a road crossing. The RoW on both sides has very good vegetation cover – grass east of the road and clover west of the road on a gentle slope.

**Photo 1** – View to west at a gentle slope on the RoW with good vegetation cover – clover in this case.

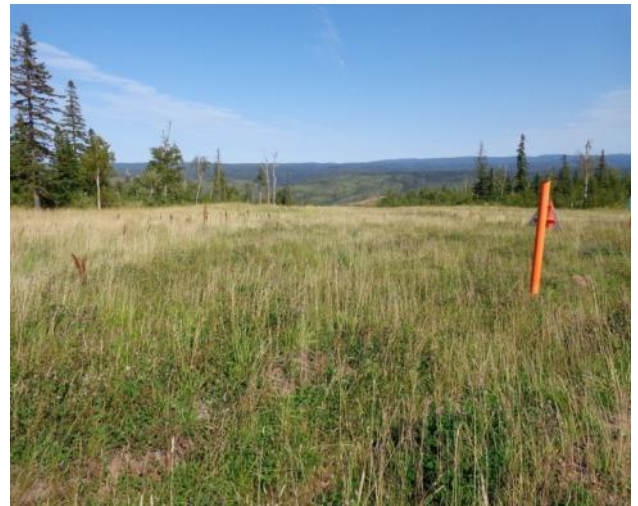
**Photo 2** – View to the east at mostly flat RoW with good grass cover.

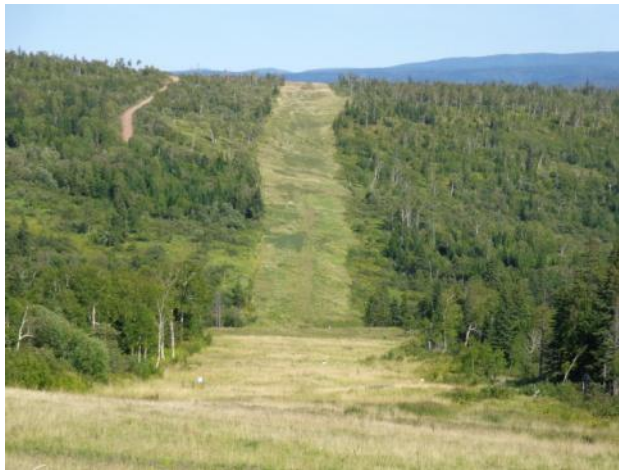
The RoW was observed from a road crossing with an extensive view to the east showing well vegetated RoW and slopes protected with slope breakers (Photo 1).

**Photo 1** – View of slopes to the east of the crossing. Showing good recovery and slope protection

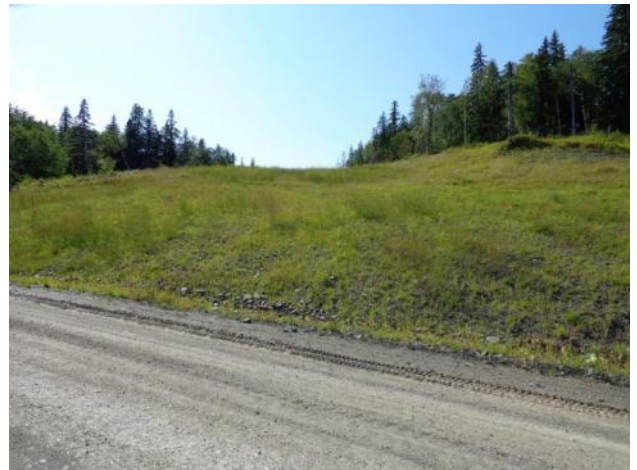
To the west the visible slope was well vegetated (Photo 2)

**Photo 2** – View of the slope to the west showing good vegetation cover.

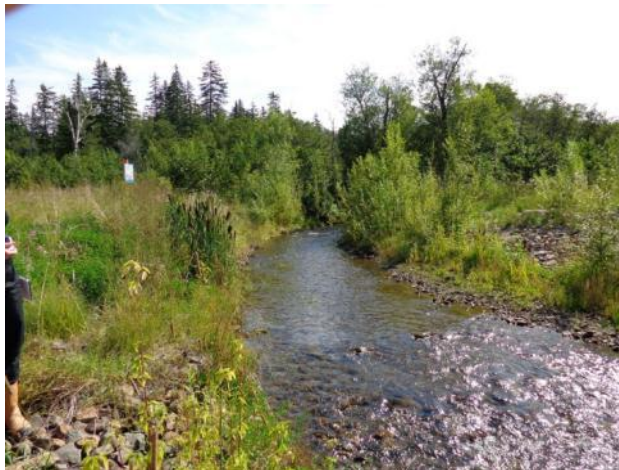
The Svetly Stream crossing is situated between two gentle slopes. The river banks are well protected with riprap and show good vegetation growth through the riprap including grass and willows (Photos 1 and 2).

**Photo 1** – View to the upstream showing riprap and vegetation on banks.

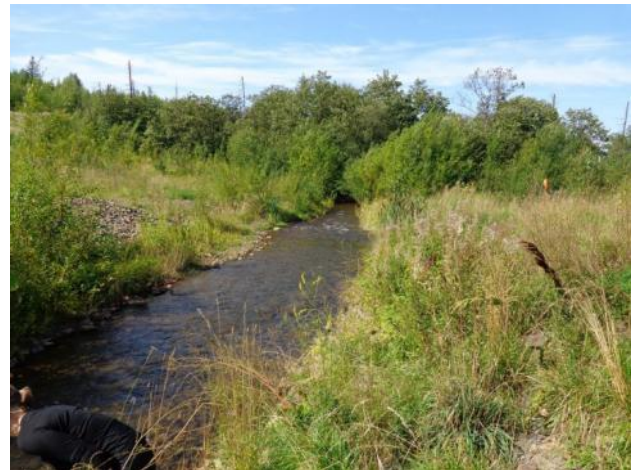
**Photo 2** – View to the downstream showing riprap and vegetation on banks.

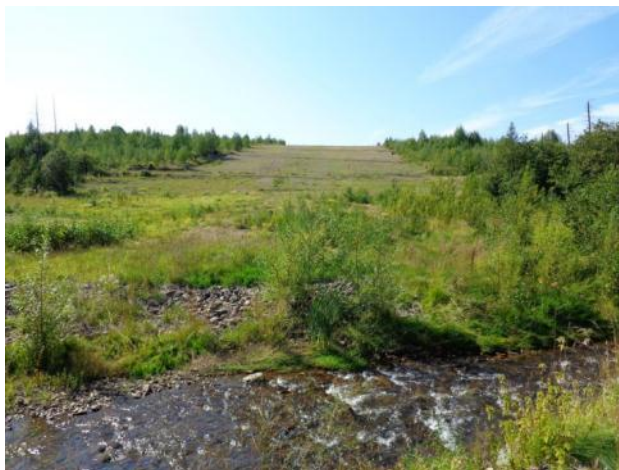
The slopes on both sides of the stream have slope protection and vegetation cover (Photos 3 and 4).

**Photo 3** – View to west showing slope protection and vegetation cover.

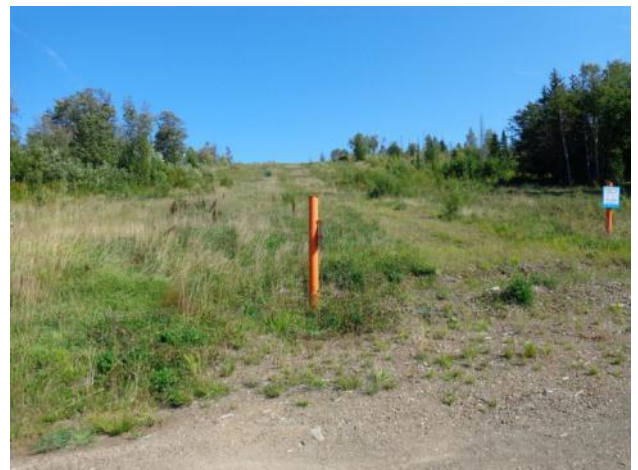
**Photo 4** – View to the east showing slope protection and vegetation cover.

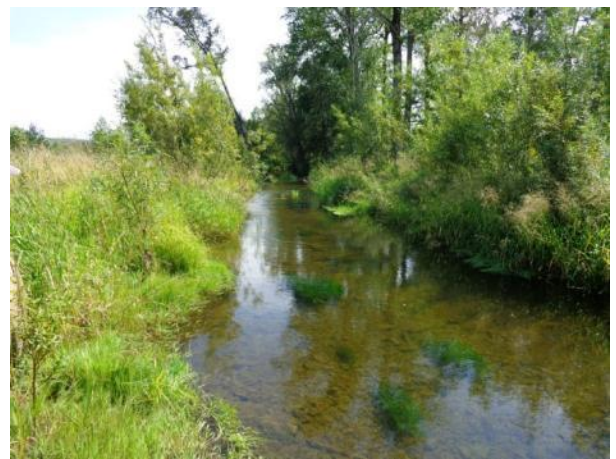
The Pilenga River crossing and RoW is situated in a mostly flat area near Block Valve station TGB 01 and TOB 01. The river banks are well protected with thick grass and small willow trees (Photo 1)

**Photo 1** (right) – View of the river with stable banks and thick vegetation cover including grass and willow trees.

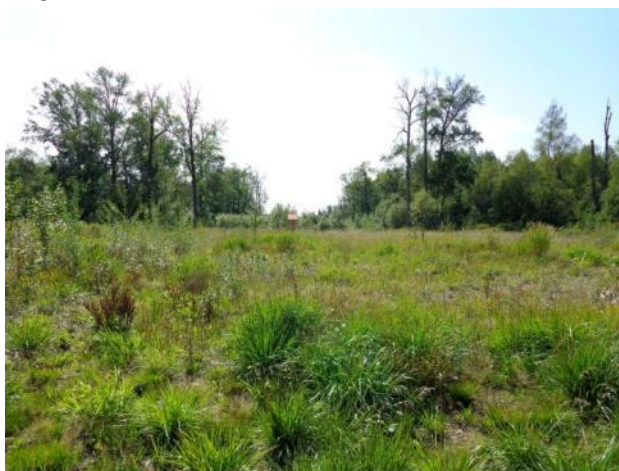
The RoW to the north has thick vegetation cover and small willows and the RoW to the south shows good ground cover (Photos 2 and 3).

**Photo 2** – View to the north showing thick vegetation cover on the RoW

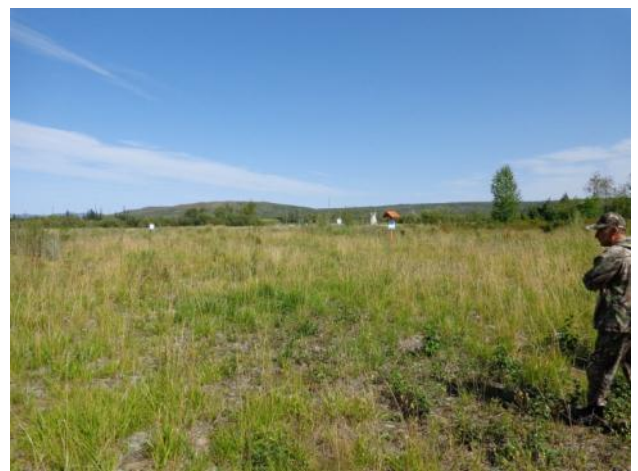
**Photo 3** – View to the south showing well recovered RoW.

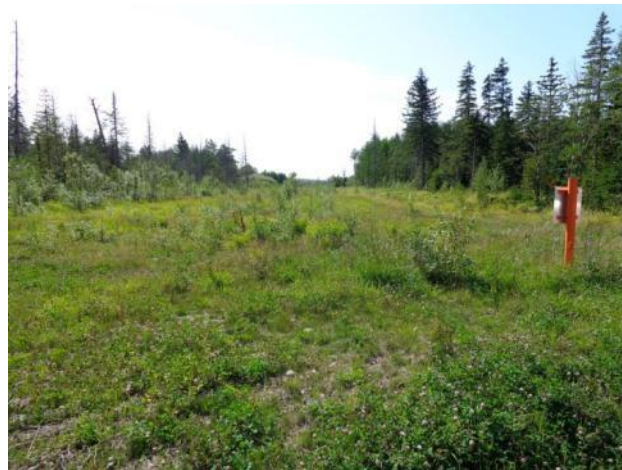
The RoW road crossing is situated south of the Pilenga River crossing at a high point between the Pilenga and the stream to the south of it. The RoW in both directions shows a good vegetation cover of grass to the northeast and grass and tree saplings to the southwest.

**Photo 1** – View to the southwest showing well vegetated RoW with grass and small saplings.

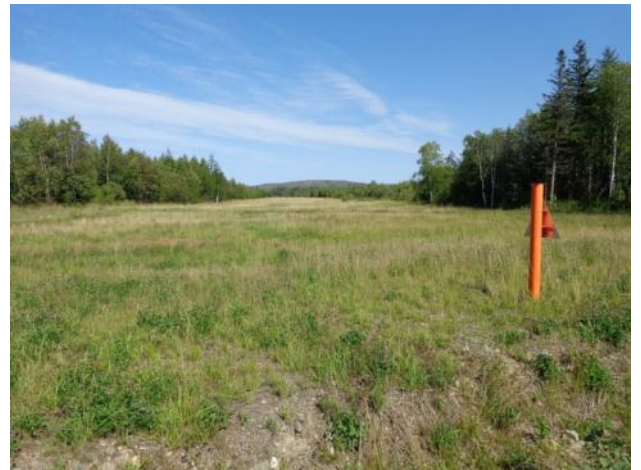
**Photo 2** – View to the northeast showing RoW with good grass cover.

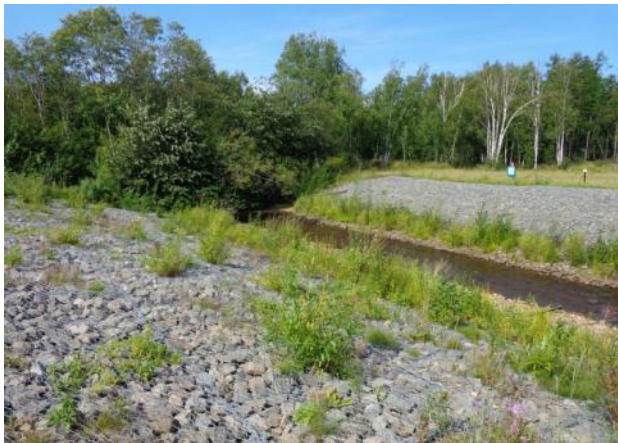
**Photo 2** – View to upstream showing banks protected with Reno mats and vegetation.

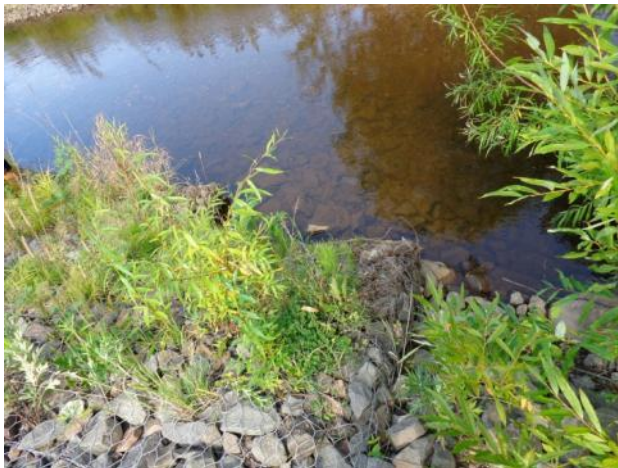
The RoW on both side of the river is showing good grass coverage, with much grass now going to seed (Photo 4)

**Photo 4** – View of the RoW leading to the river with good vegetation cover.

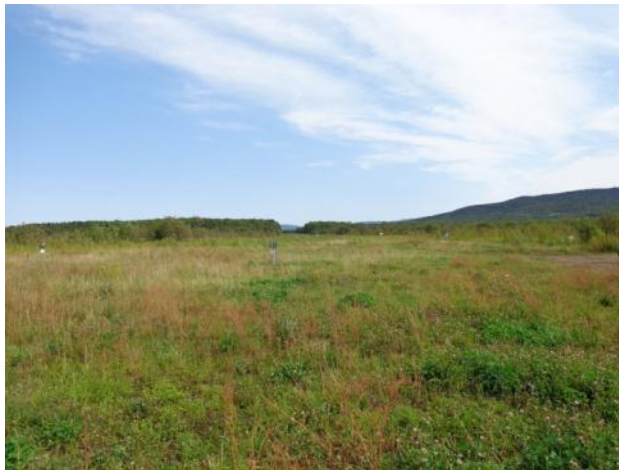
**Photo 2** – View of the HDD site.

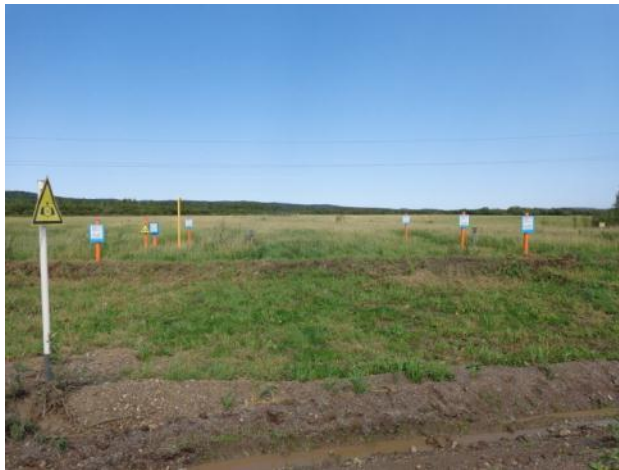
**Photo 2** – View to the south toward the Tym river crossing showing RoW with good vegetation.

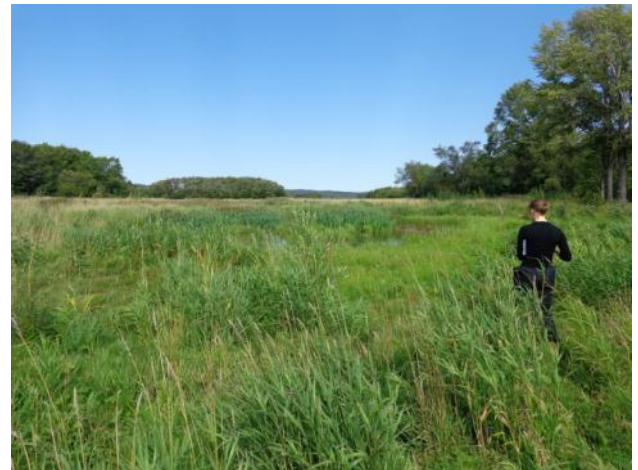
The RoW leading to the river from the north has thick vegetation cover (Photos 2 to 4). An area of standing water in a depression on the RoW was noted (Photo 3).

**Photo 3** – View to north showing a depressed area on the RoW with standing water.

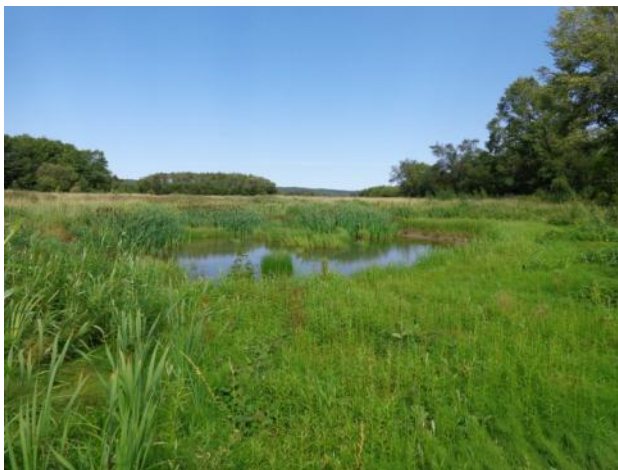
**Photo 4** – View the RoW north of the crossing showing good vegetation cover.

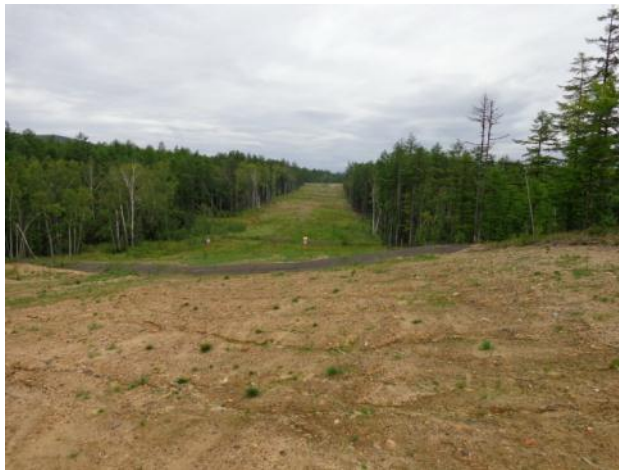
**Photo 2** – View of poor vegetation cover and a misaligned slope breaker with erosion rills parallel to the breaker.

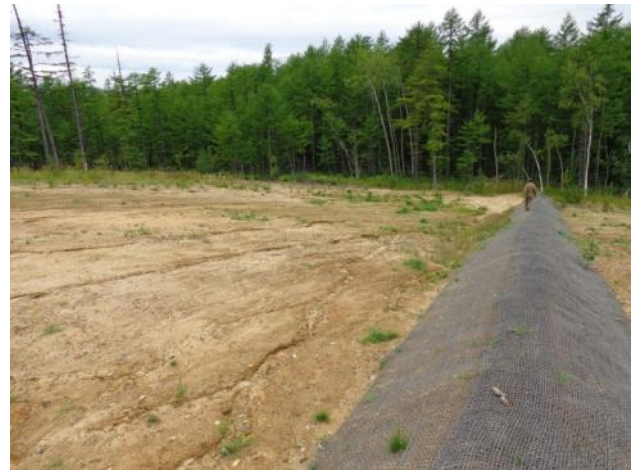
**Photo 3 (right)** – View to the south showing partially vegetated RoW with poor coverage on the upper elevations and better coverage on the lower elevation.

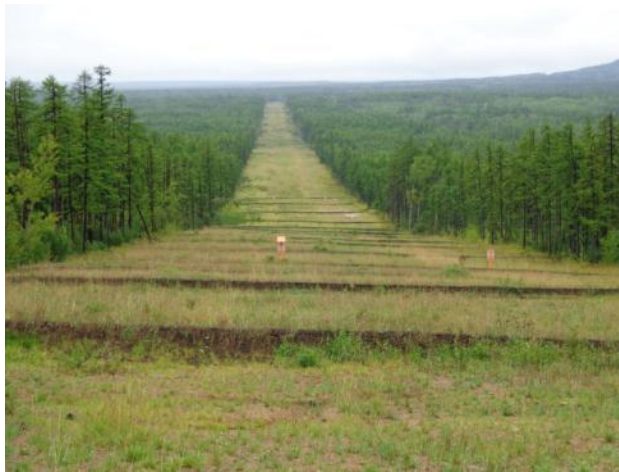
The sandy slopes in this area show general improvement over previous years. To the north from the road crossing the RoW shows good vegetation cover and good slope protection. To the south the vegetation coverage away from the road crossing is spotty and needs to be improved. The final slope south of the crossing shows good vegetation growth.

**Photo 2** – View to the south showing sandy slopes with partial coverage.

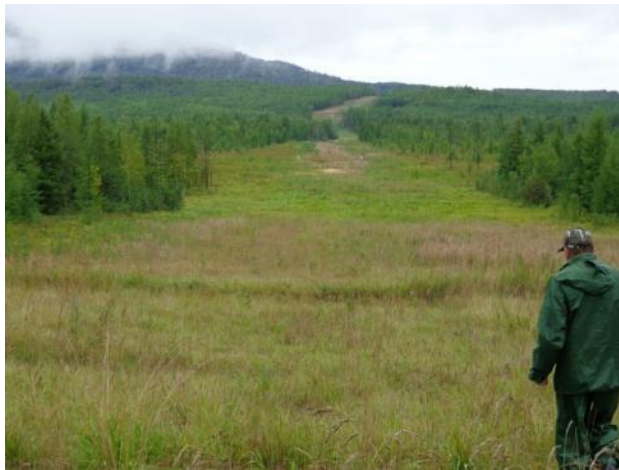
**Photo 2** – View to the north showing well vegetated slope above the wetland.

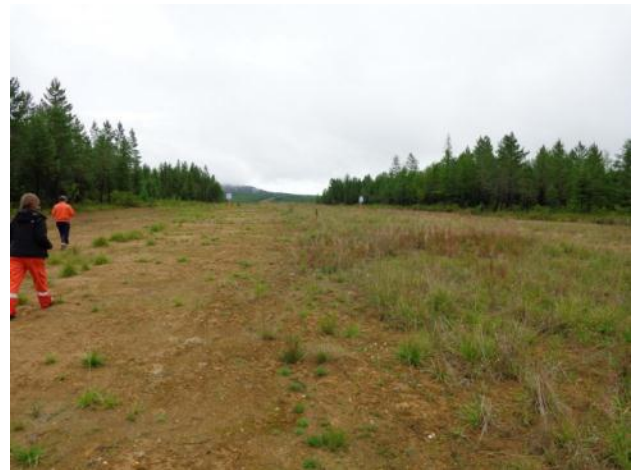
**Photo 3** – View to the south showing thick grass cover on the RoW.

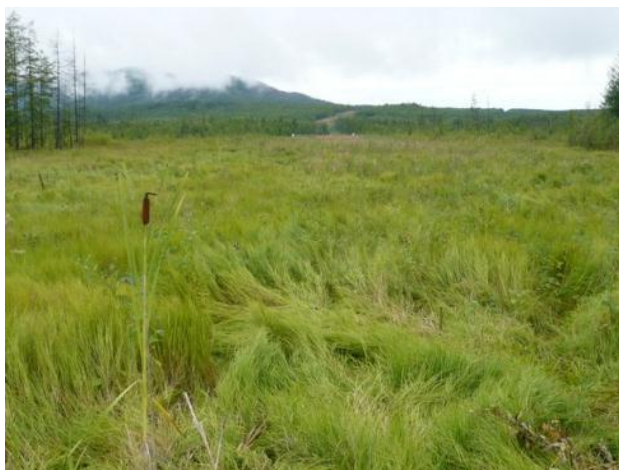
The Taulan River valley is approximately 2 km in width and is mostly a wetland. From the north the RoW slope leading to valley is well vegetated and protected with slope breakers (Photo 1). The valley floor is covered with thick growth of grass (Photos 2 and 3). In the wetland section of the valley the vegetation recovery is quite good with the exception of few bold spots above the pipe trench (Photo 4)

**Photo 4** – View to the north along the wetland in the river valley showing mostly well recovered vegetation with few bare spots.

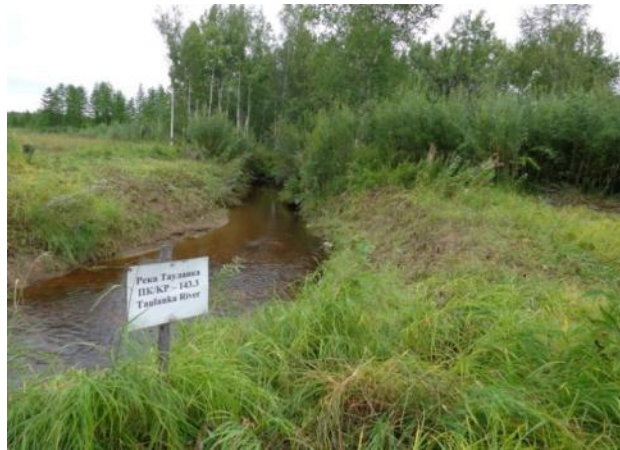
**Photo 2** – View to upstream showing good vegetation cover on the banks and with cut willow trees.

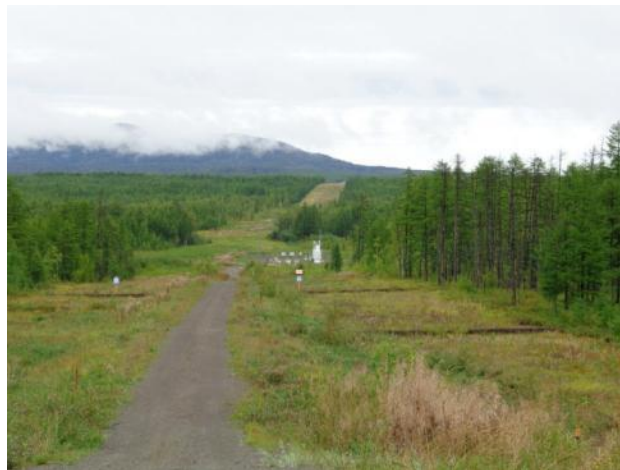
**Photo 4** – View of the valley floor showing good vegetation cover.

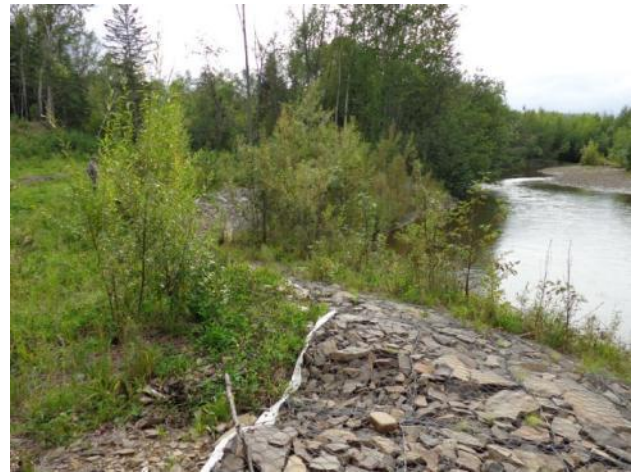
The slope on the south side of the crossing is somewhat stony and not well vegetated. The RoW further to the south has good vegetation cover (Photo 3 and 4).

**Photo 3** – View to the north across the river from the access road. The RoW on both sides of the river is well vegetated with the exception of the stony slope. Both slopes are protected by slope breakers.

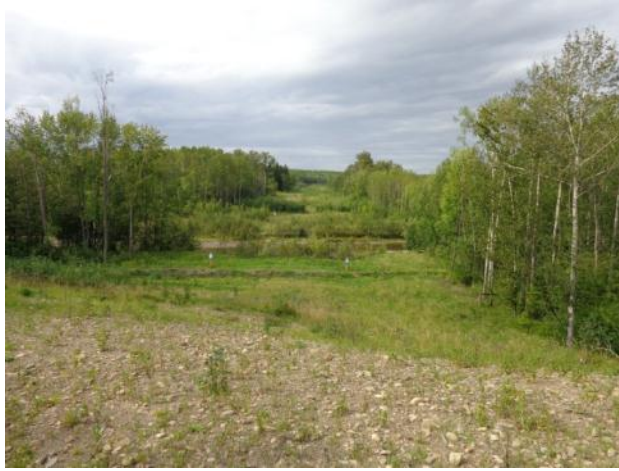
**Photo 4** – View to the south from the access road showing moderately vegetated RoW.

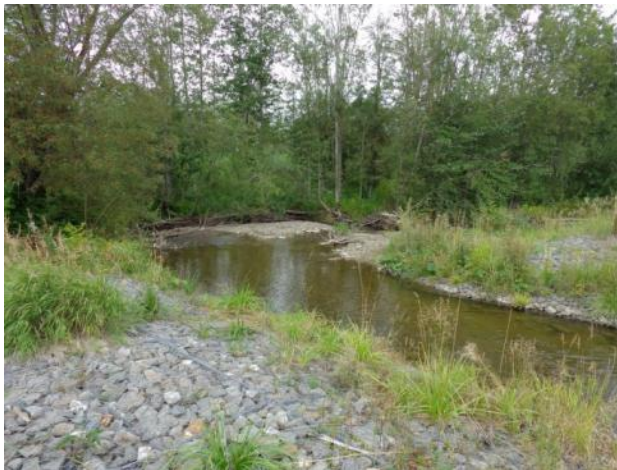
**Photo 2** – View to the upstream showing banks covered with Reno mats and some vegetation.

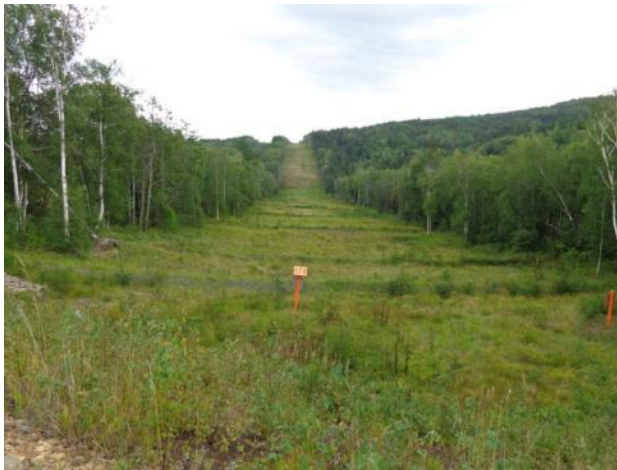
The RoW at the Devyataya River crossing has a very good ground cover on the level areas along the access road and on the slopes leading to the river. The slopes on each side of the river are protected with well-placed slope breakers (Photos 1 to 3).

**Photo 1** – View south showing Devyataya valley with very good vegetation cover on the RoW and good slope protection.
