## **Annex D: Individual RoW Descriptions**

### Fault Crossing 1 and adjacent RoW – KP 12 to 14

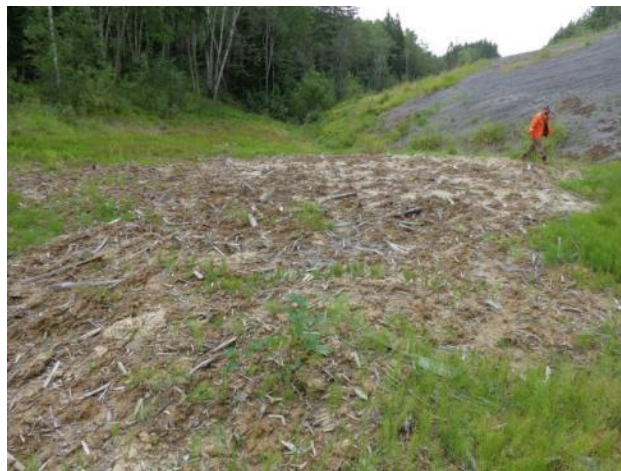
A pipe inspection/repair dig-up was observed at KP 182.2. The inspection/repair was reportedly one of about a dozen which were performed during the last year. The site was clearly visible since no reinstatement was performed at the surface following the completion of the work (Photo 1). It is recommended that a procedure be formulated for such maintenance activities.

**Photo 1** – View of the dig-up site.

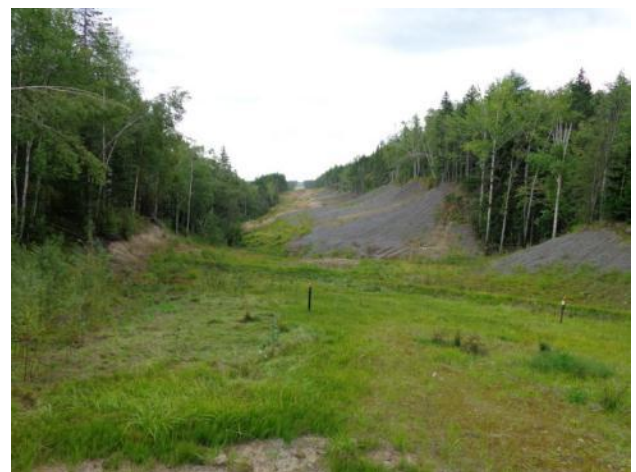
The RoW in the area of the dig-up was very well vegetated at the level surfaces (Photo 2). However, the RoW at this area has steep side slopes (not side cuts) which are protected by geojute (Photo 3). The vegetation on these side slopes is poor and it is recommended that steps are taken to improve the vegetation cover. The geojute has provided stability up to now, but with time it will degrade and the slope will not be protected from erosion unless vegetation takes hold.

**Photo 3 (right)** – View to the south from KP 182 showing the side slopes with geojute and no vegetation cover.

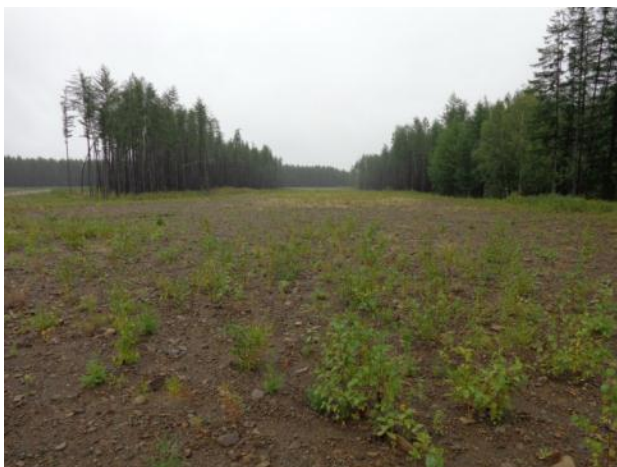
The section which is approximately 500 metres long was reforested during the 2011 planting season. The progress to date is shown in Photo 3.

**Photo 3 (left)** – View to the north showing the abandoned portion of the RoW by the fault crossing and the progress of the reforestation.

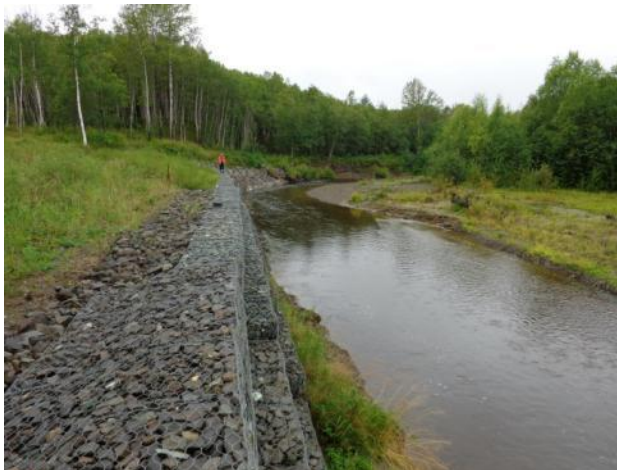
The Pobedinka River is a high energy river that required a strong fortification of the outside bank (the southern bank). Currently the southern bank has multi-level gabion wall protection and heavy riprap bank protection that is placed upstream of the crossing at the high impact point of the stream (Photos 1 and 2). The gabion wall shows signs of wear and tear and should be monitored.

**Photo 1** – View to the upstream of the south bank of the river, showing multi-level gabion wall.

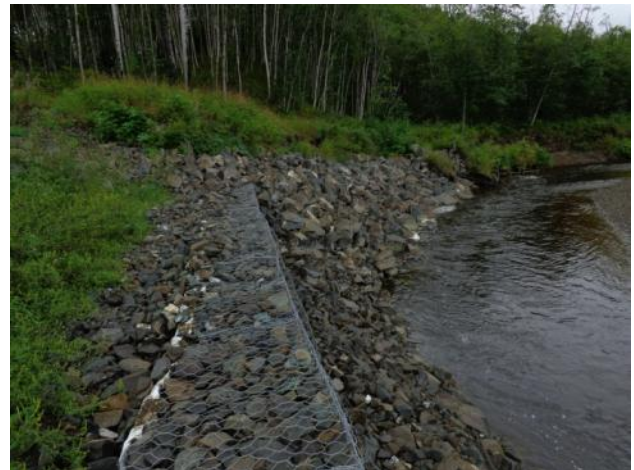
**Photo 2** – View to upstream showing the heavy riprap protection at the leading edge of the crossing.

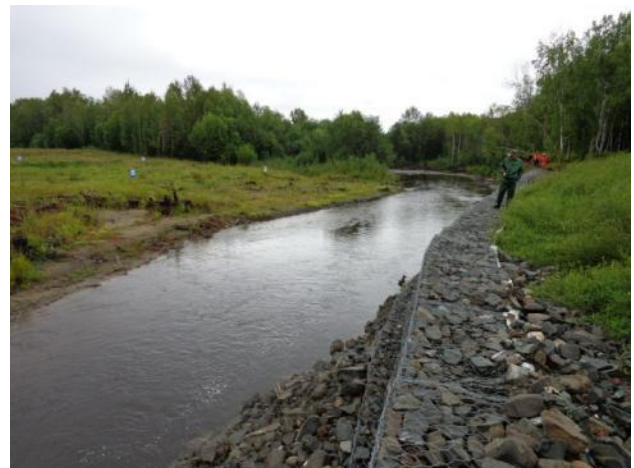
**Photo 4** – View to the downstream direction showing the fortified south bank and silted and overgrown north bank.

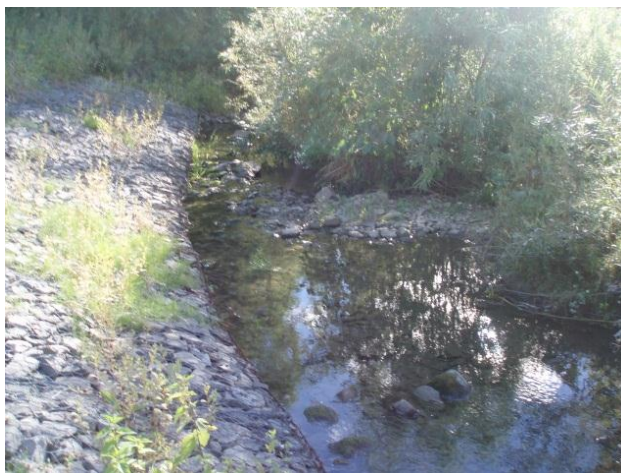
The Gastellovka river is a high energy braided river with multiple channels. The bank of the northern channel (currently the minor channel) is well fortified against the RoW to the north with Reno mattings which are in good condition (Photo 1). Further south the larger main channel is also fortified with Reno matting that was found to be in good condition (Photo 2).

**Photo 1** – View of the Reno mats on the north bank of the northern channel.

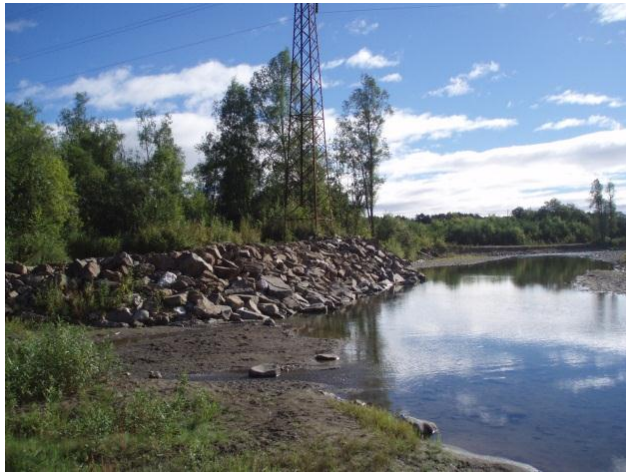
Downstream of the crossing location on main southern channel, the erosion has occurred in the vicinity of a municipal power line pylon and riprap protection has been installed to help prevent further erosion (we understand that this was installed by Sakhalin Energy (Photo 3).

**Photo 3** – Riprap protection around power pylon

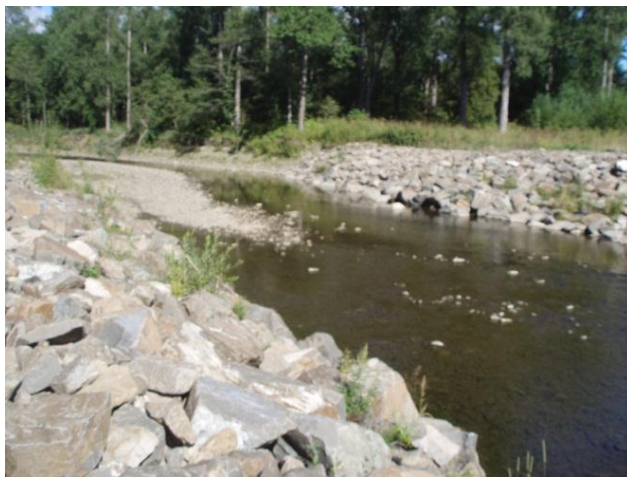
The Nitui River is a high energy, multi channel braided river. During the September 2012 visit the main southern and central channels were viewed. The southern channel was protected with good size riprap which was found to be in good condition (Photo 1). The central stream is comprised of braiding channels (Photo 2) and good condition riprap is installed on the northern bank (Photo 3). Downstream vehicle tracks were evident on the river bank leading into the stream, which are most probably evidence of salmon poaching.

**Photo 1** – Riprap on southern channel

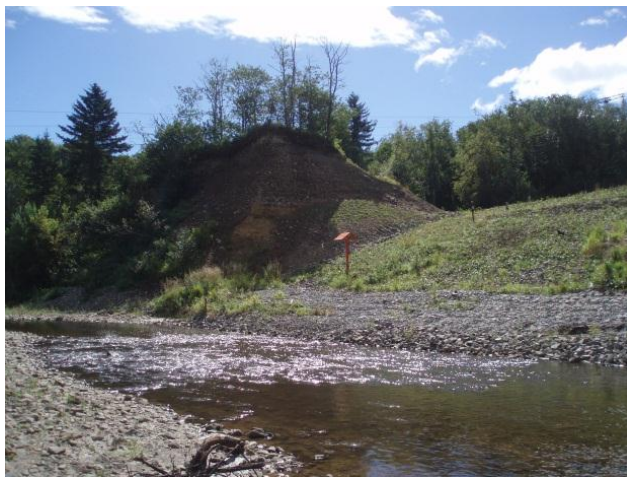
The Turkovka River is at the foot of a steep slope to the south that was the subject of significant erosion control issues during the construction period. At the time of the site visit moderate re-vegetation was observed on the south slope (Photo 1). However, vegetation of side cuts near the riverbank showed very limited vegetation (Photo 1) and some erosion was evident on and around drainage on either side of the RoW (Photo 2) and it was likely that this would lead to sediment discharge into the river in the event of heavy rainfall. The south riverbank was protected with reno matting in reasonable condition. The northern riverbank had riprap set back from the channel (Photo 3), presumably to provide protection during high flow periods. Spawning salmon were visible in the river.

**Photo 1** – Moderate re-vegetation on slope to south of river. Note un-vegetated side cut

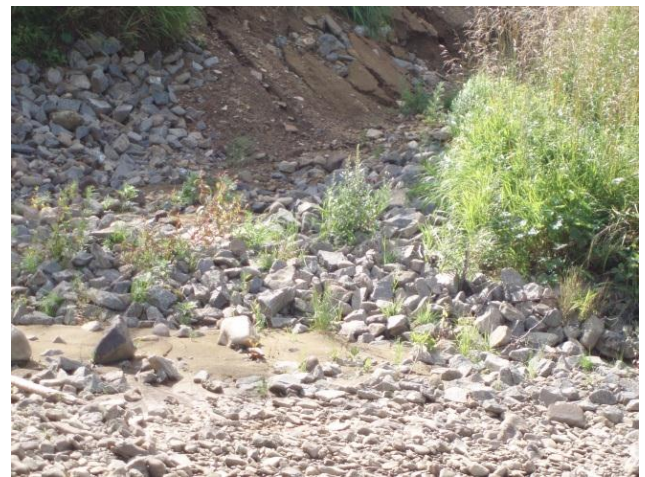
**Photo 2** – Erosion around drainage channel on southern bank

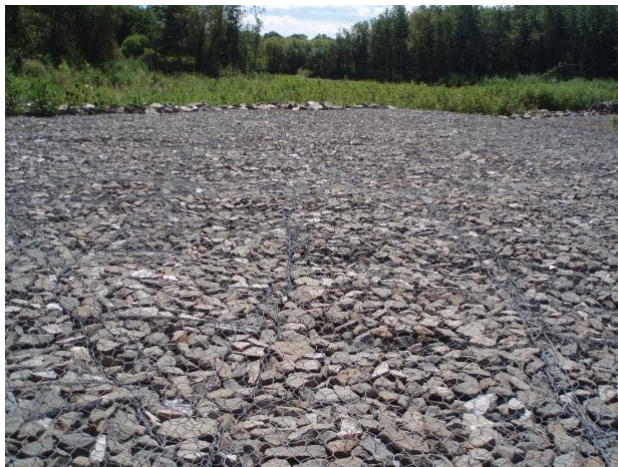
Since then, a fortified overflow channel was constructed across the RoW (Photos 1 and 2).

**Photo 1** – View of the overflow channel

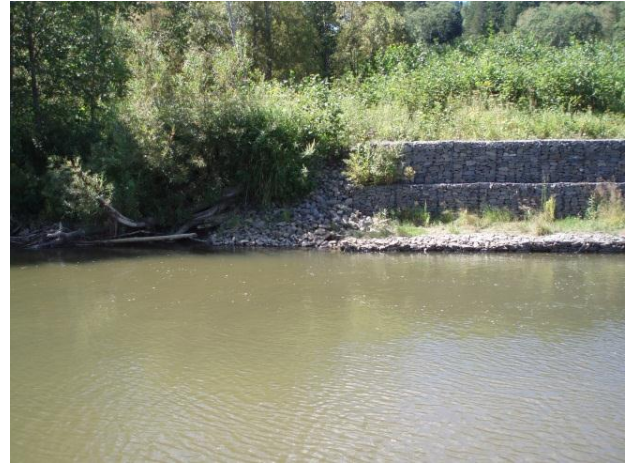
The crossing itself appears intact and the south bank is protected by a gabion wall (Photo 3), which was found to be in generally good condition, although minor damage on the downstream edge of the wall was observed (Photo 4). During the current visit significant re-vegetation on the RoW was observed (Photo 3), but this included significant tree (alder) sampling growth that needs to be removed.

**Photo 4** – Minor damage to downstream portion of gabion wall

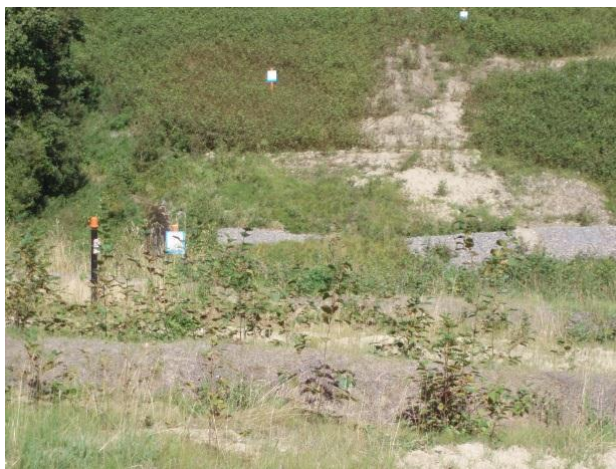
The Vidnaya River has a very long and steep southern slope of poorly consolidated material. The slopes adjacent to river show moderate re-vegetation with some areas of only sparse growth on sandy soils (Photos 1 to 2).

Significant tree sapling growth was evident along the RoW between the Vidnaya and the Gar rivers and this needs to be removed.

**Photo 1** – View of the river crossing, showing moderate vegetation, including tree sapling growth.

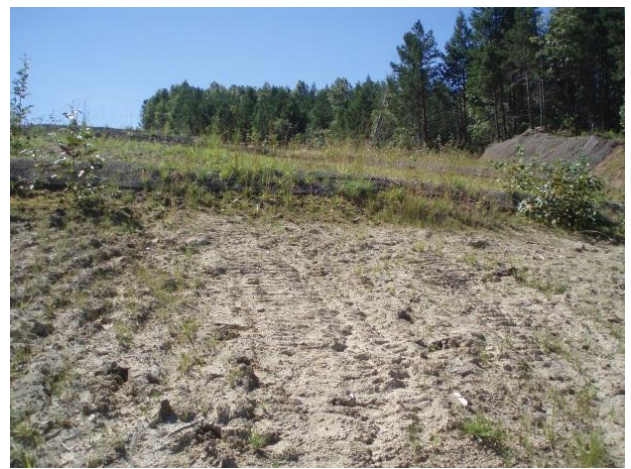
**Photo 2** – Sparse re-vegetation on southern slope

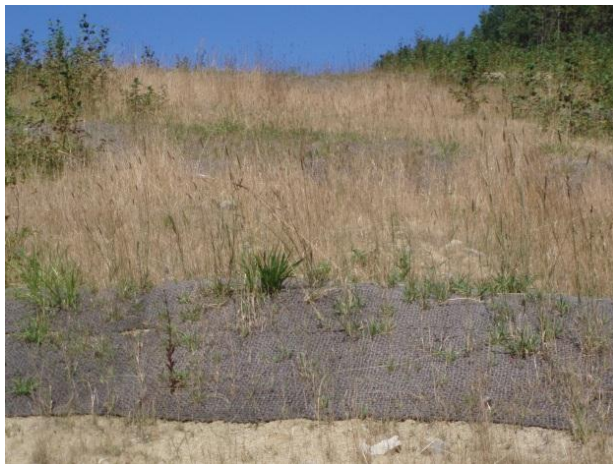
The Gar River slopes were observed from the north. The north Slope appeared to be in good condition. Good quality slope breakers, protected with geojute, were present on the northern slope. This combined with a reasonable level of re-vegetation afford a good level of slope stabilisation (Photo 1).

**Photo 1** – View northern slope with vegetated RoW with fortified slope breakers.

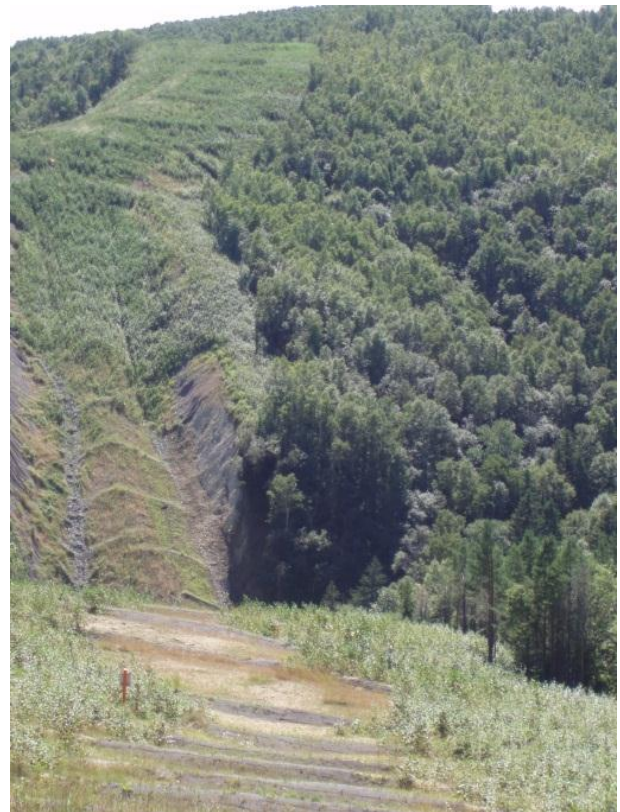
On the southern bank, improved vegetation was visible compared to 2011, especially on the upper portions of the slope (Photo 2). However, the lower portions of the southern slope remain only partially vegetated and there is a need to continue seeding slope and seeding and protecting the side cuts (Photo 3).

**Photo 2** – View of southern slope showing good re-vegetation on upper portions of slope

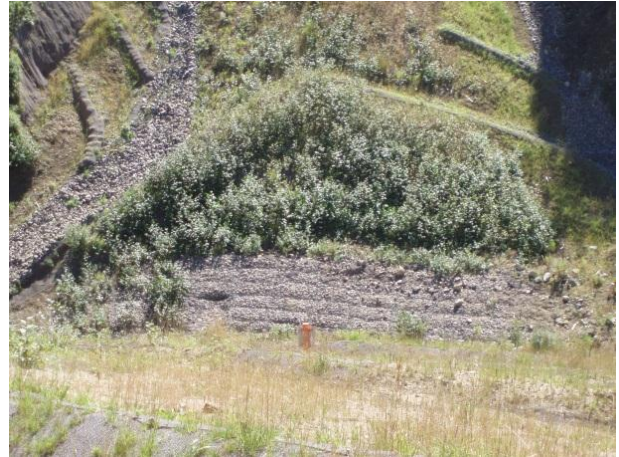
Drainage channels at the side of the RoW on the southern slope are armoured with rock, but some wash-out was observed on the eastern side and there was also evidence of minor collapse of reno matting on the southern riverbank (Photo 4).

**Photo 4** – View of southern slope showing tree growth above reno matting and also minor failure of the reno

Control of tree sapling growth is required in the area immediately above the reno matting (Photo 4).

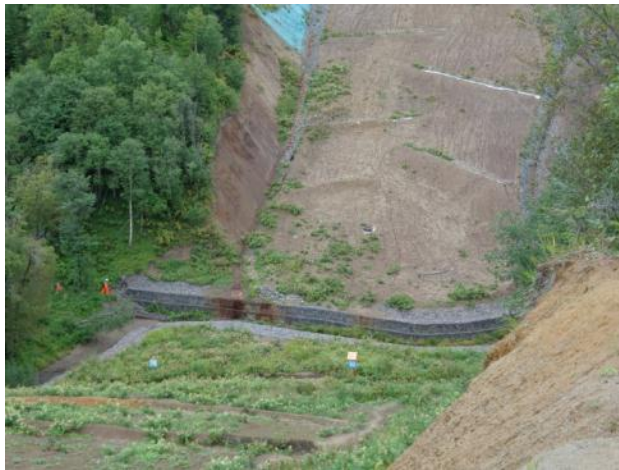
The Kormovaya River crossing has two very steep slopes on its banks. The northern slope is mostly bare and more effort is needed in providing ground cover (Photo 1). The southern slope has some ground cover on the bottom part right above the gabion wall, poor vegetation at the centre part and very good vegetation in the top third of the slope (Photos 2 to 4). The river banks are fortified with gabion walls (Photos 1 and 2) and appear to be holding.

**Photo 2** – View of southern slope with spotty vegetation at the bottom part and with slope breakers.

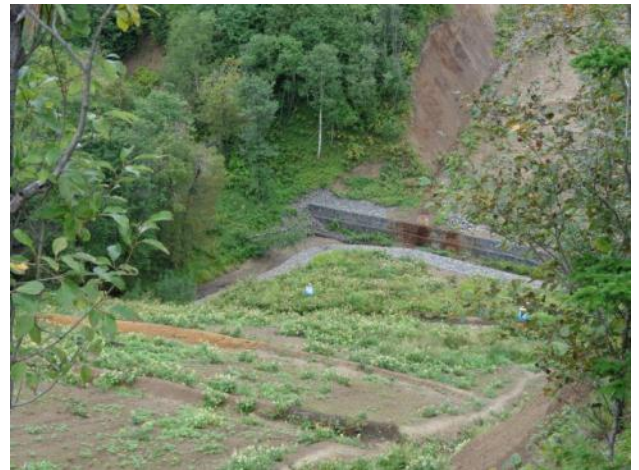
**Photo 3** – View of the central portion of the southern slope shows area of recent repair with new slope breakers.

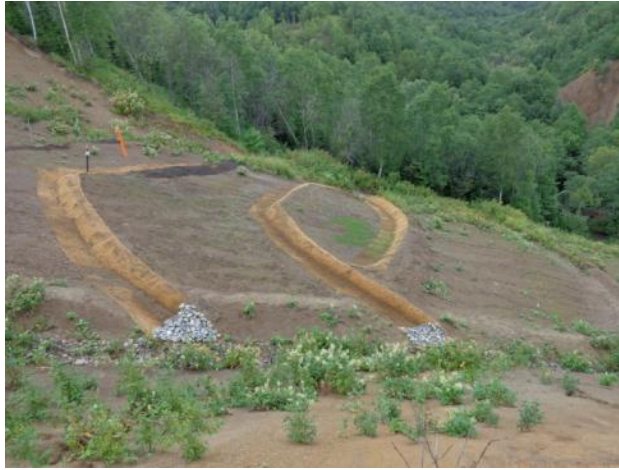
**Photo 4** – View of the upper part of the southern slope (in the foreground) showing good vegetation and tree saplings.

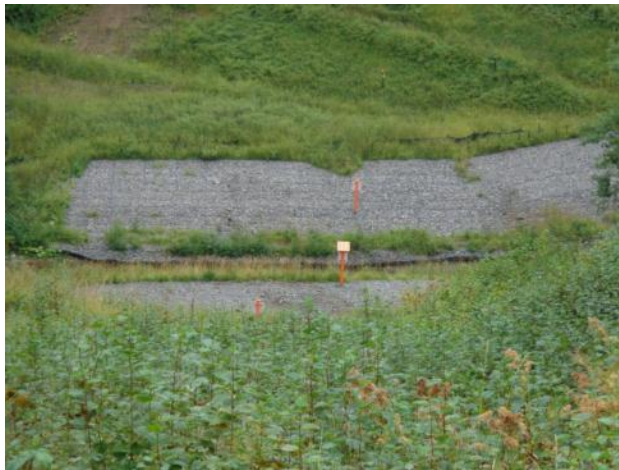
The Krinka River banks at the crossing are well protected with an extensive Reno mats and some vegetation is coming through the mats (Photo 1). The slopes are well protected with slope breakers and with dense vegetation (Photos 2 and 3). The northern slope also has many Elder saplings, some almost 2 metres tall.

**Photo 1** – View to south showing Reno mats on both banks with some vegetation coming through. Very good vegetation cover on slopes

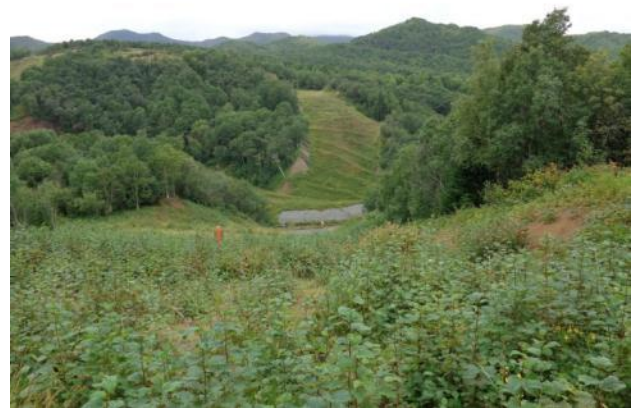
**Photo 2** – View to the south showing both slopes with good slope protection and many tree saplings.

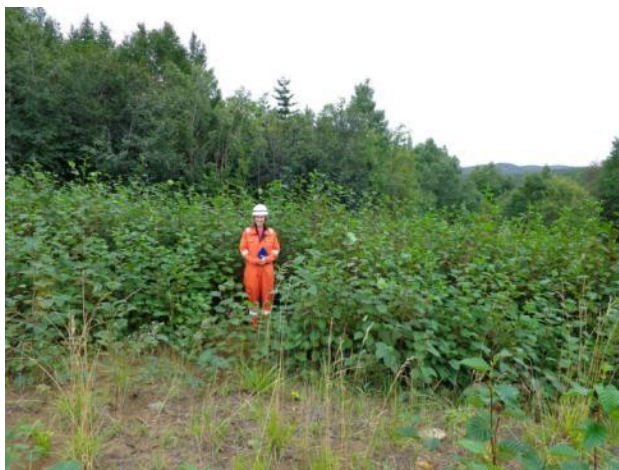
**Photo 3 (left)** – View of tall tree saplings – photo taken at the top of the slope to the north of the crossing.

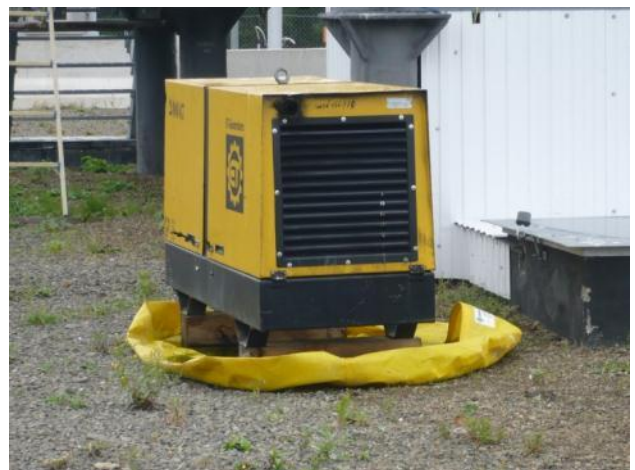
An old generator was observed at the BVS MOB-6. It had been placed on plastic sheeting to help protect groundwater from fuel leaks. It did not appear to be in use and no additional fuel tanks were observed, so the groundwater protection in this instance was deemed adequate.

**Photo 4** – Groundwater protection – generator at MOB-6

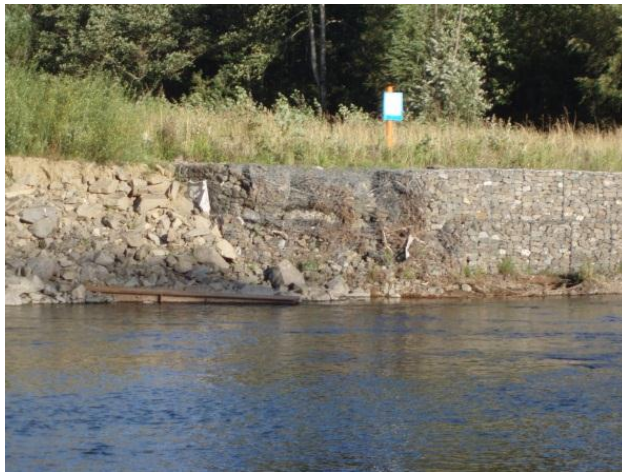
The Makarovka River is a wide high energy river which during heavy rains and the thaw season flows with high volume. The river banks are protected by gabion walls. The north bank gabion is short on the western side with erosion and damage visible – similar damage was identified in the October 2011 IEC site visit and requires attention (Photo 1). There is also some metal debris (possibly from the construction bridge, on the northern bank that should be removed (Photo 1). The south bank gabion wall is intact (Photo 2) and silt fence above the wall is damaged but is in fact no longer required and should be removed (Photo 3).

**Photo 1** – View to upstream showing damage to the north bank gabion wall and good vegetation behind.

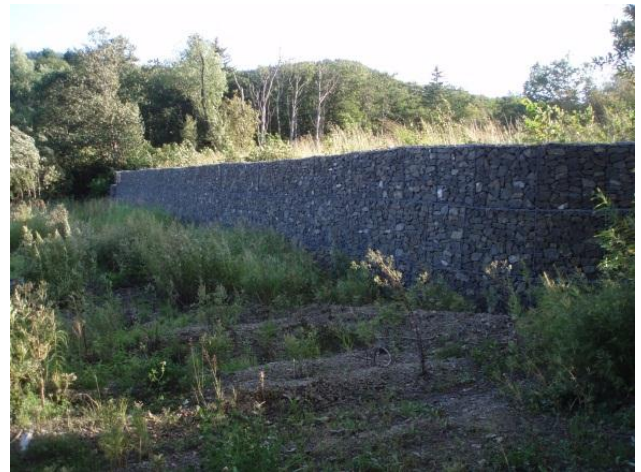
**Photo 2** – View south from the river showing the south bank gabion wall and silt fencing

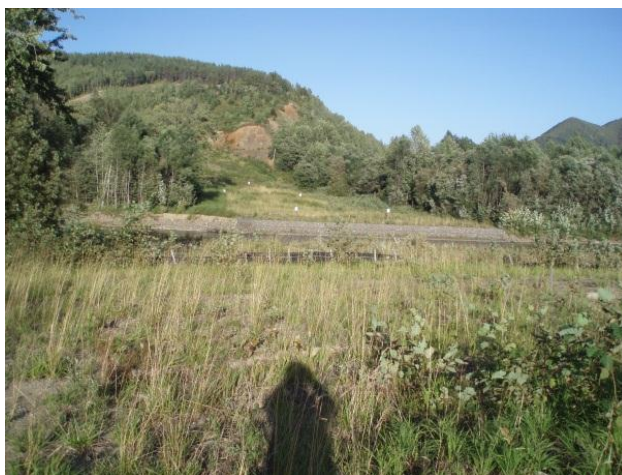
The adjacent RoW on both the northern and southern sides of the river is showing good re-vegetation (Photo 3).

**Photo 3** (left) – View showing RoW to north (far side) and south (nearside) of river. Silt fencing visible on south side.

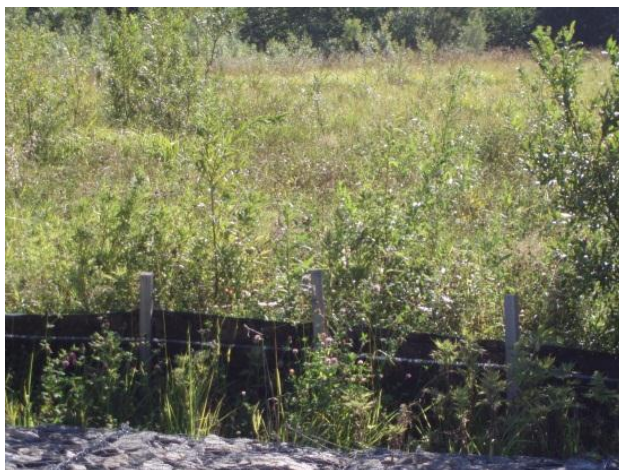
The Pegas River crossing banks are protected by Reno matting and gabion walls, and silt fencing is intact (Photos 1 and 2). The RoW on each side of the crossing is densely re-vegetated (Photo 3), although tree saplings are appearing that need to be removed. The slope above the river and MOB 10 block valve is also very well vegetated, although further re-vegetation of the side cut at the top of the slope is still required (Photo 4).

**Photo 3** – View of RoW to the south of the crossing showing dense re-vegetation.

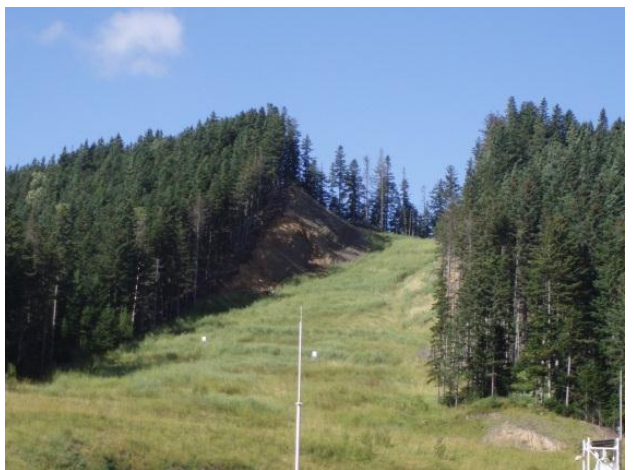
**Photo 4** – View north at the slope above the Pegas showing good re-vegetation.
