APPENDIX 4: RIGHT OF WAY REPORT

Title: Photographic Log – Right of Way	Client: Sakhalin-2 Phase 2 Lenders
Site: Sakhalin Energy Investment Company	Date: October 2015

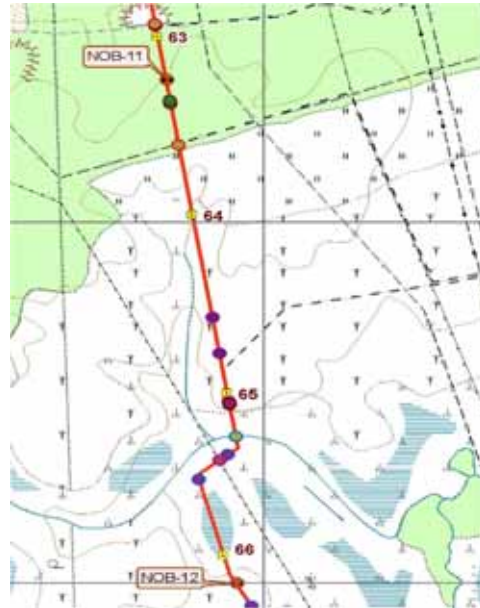
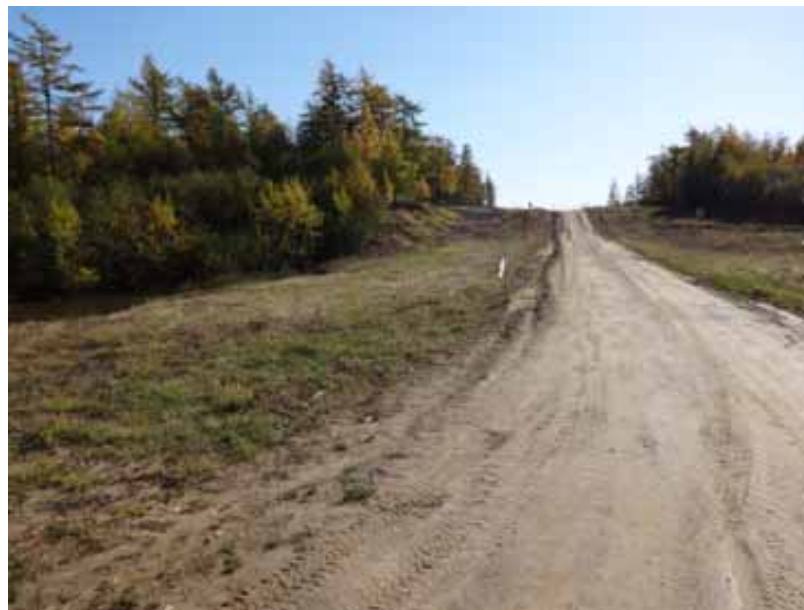
The RoW between KP 63 and 66 (ending at NOB-12) is well vegetated and with good sediment and erosion control. Previously, tree removal was undertaken by mechanised means which removed the grass cover as well. During this year’s monitoring visit it appears that the grass on the RoW has recovered and forming good ground cover (Photos 1 and 2).

Photo 1. View of RoW north of NOB-11

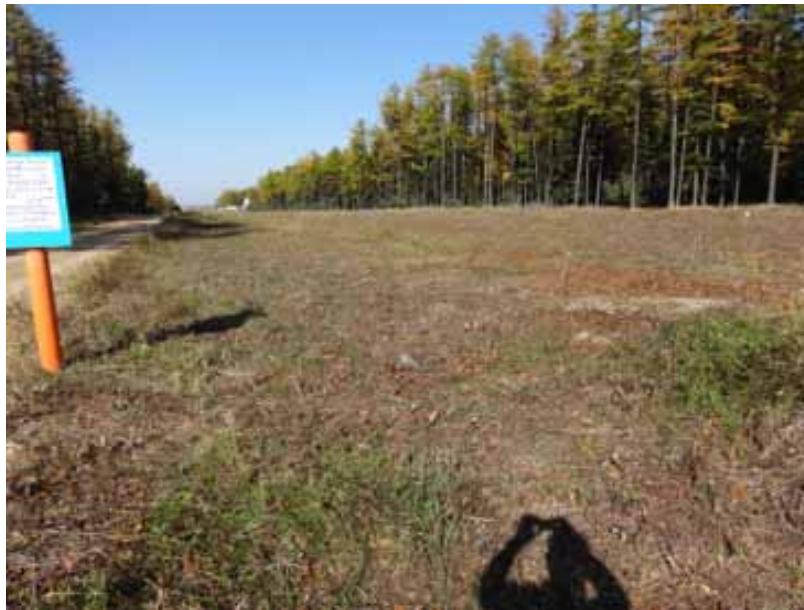
Photo 2. View of RoW south of NOB-11

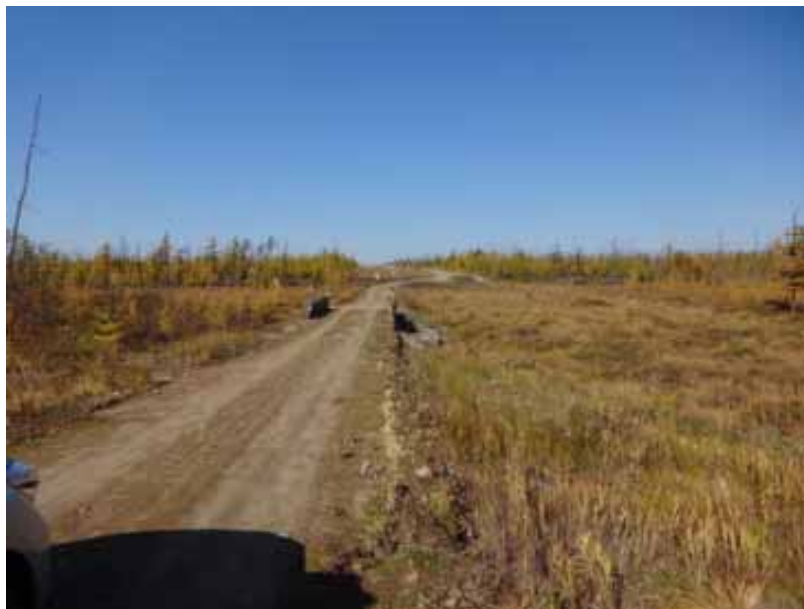
The wetland north of the Tomi River is continuing to recover. An access road bridge on a tributary of the Tomi River has sediment control installed.

Photo 3. View to the north of a RoW on wetland and a bridge on a tributary of the Tomi River

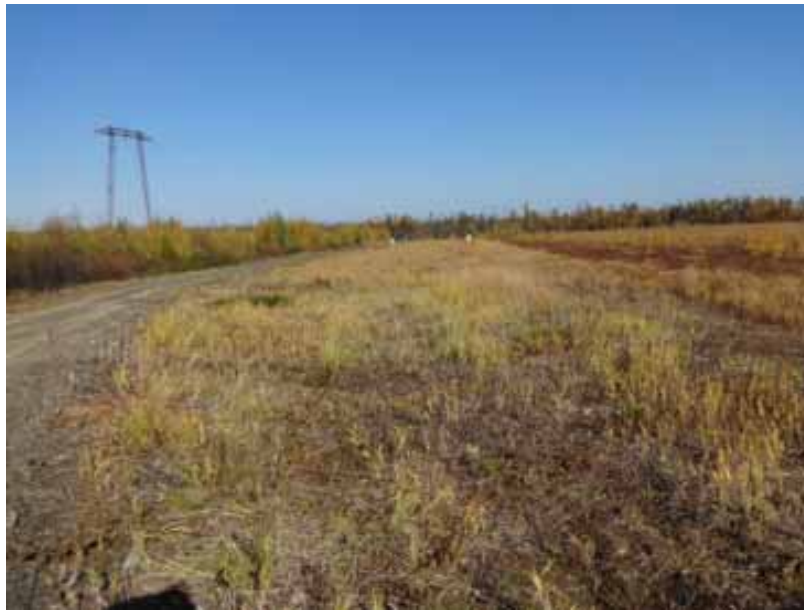
Photo 4. View of the wet land north of the Tomi River

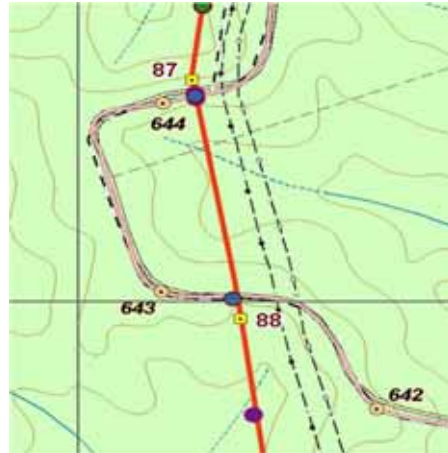
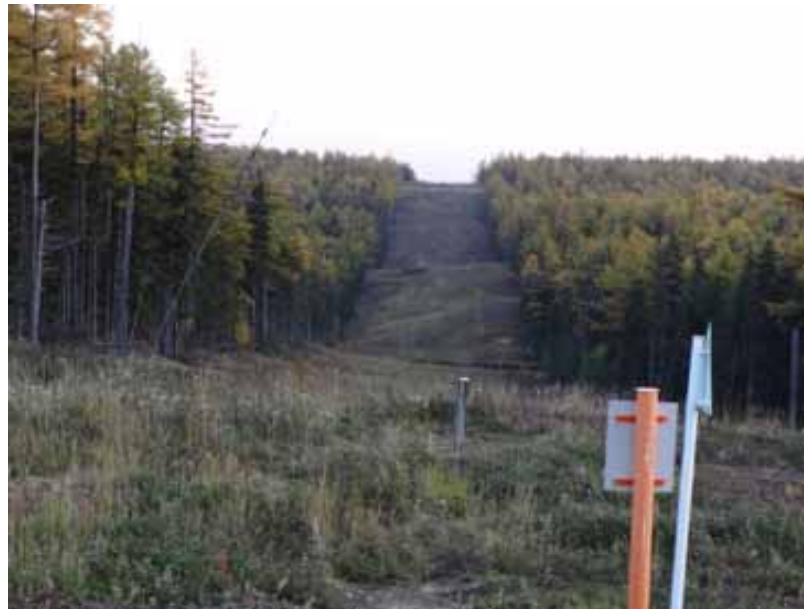
The RoW between KP 87 and 88 has steep slopes and side slopes. The RoW has good vegetation coverage and good erosion control (Photos 1 and 2).

Photo 1. View of RoW showing good vegetation cover on the slopes

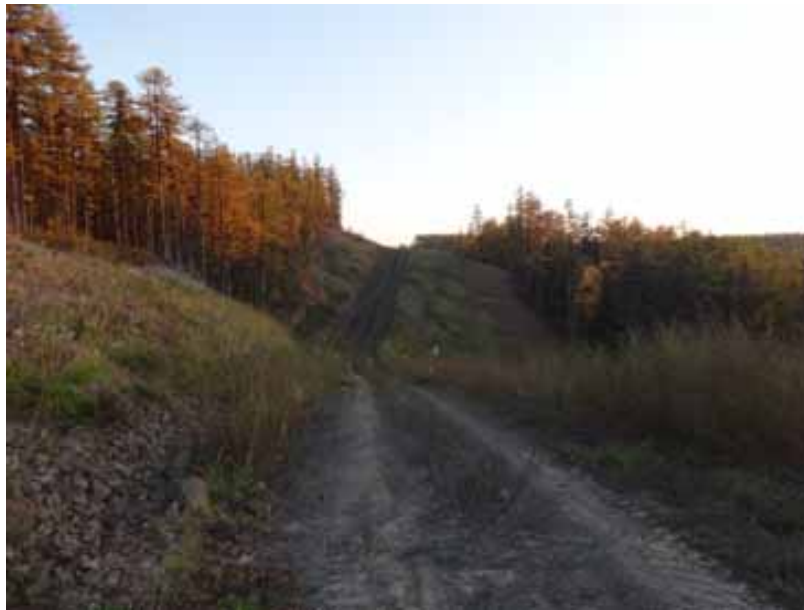
Photo 2. View of RoW showing slope protection and good vegetation

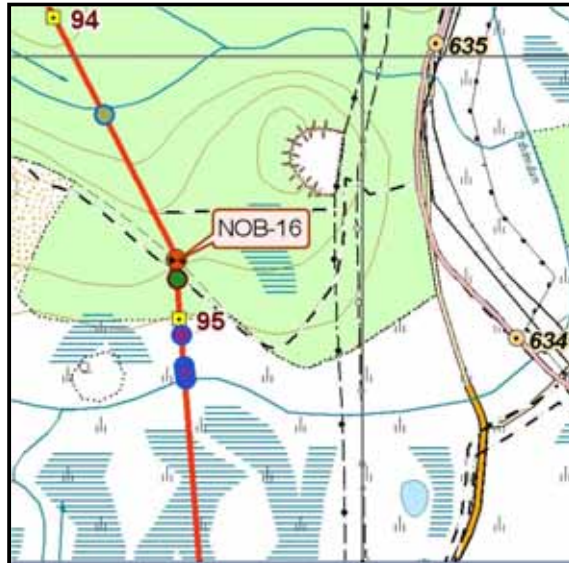
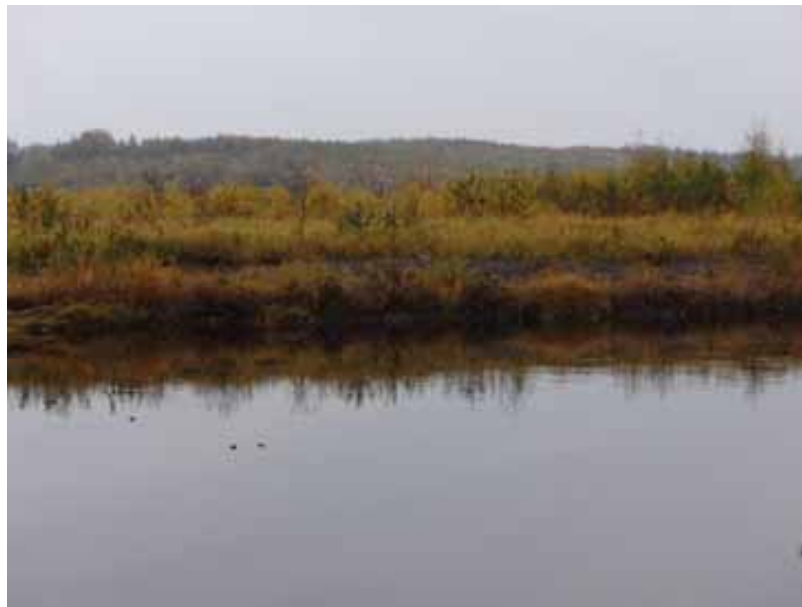
The riverbanks are well vegetated and with Reno matting on both banks. On the northern bank there are signs of reno mat deterioration that will require monitoring.

Photo 1. View across the river to the south showing riverbanks with reno mats.

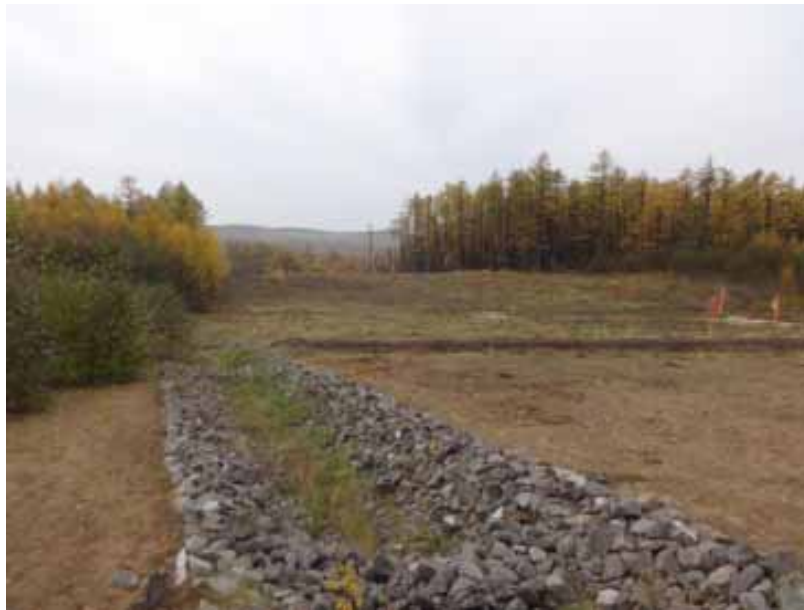
During last year’s monitoring visit the RoW south of NOB-16 Block Valve Station and north of the Djimdan River crossing on the slope leading to the river was covered by dense growth of Alder trees that reached two or more meters in height. Since then, the trees on the RoW between NOB-16 and the river have been removed – See comparison in Photos 2 and 3.

Photo 2. Oct 2015 – Same view as photo 3 (below) one year on, showing results of tree removal.

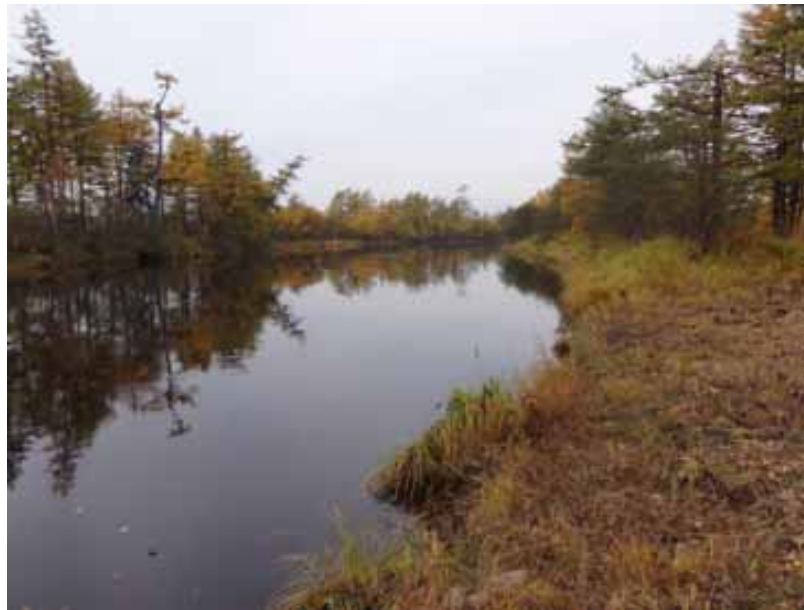
Photo 4. View to the upstream showing riverbanks with reno mats.

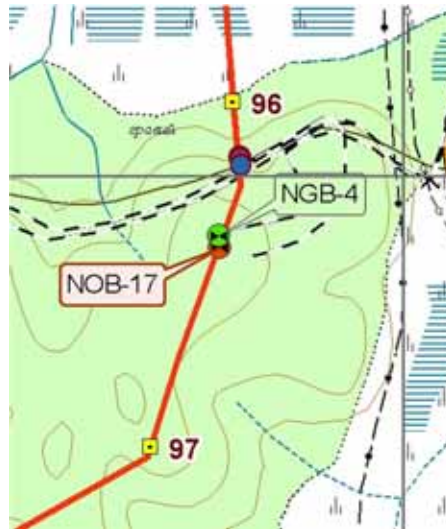
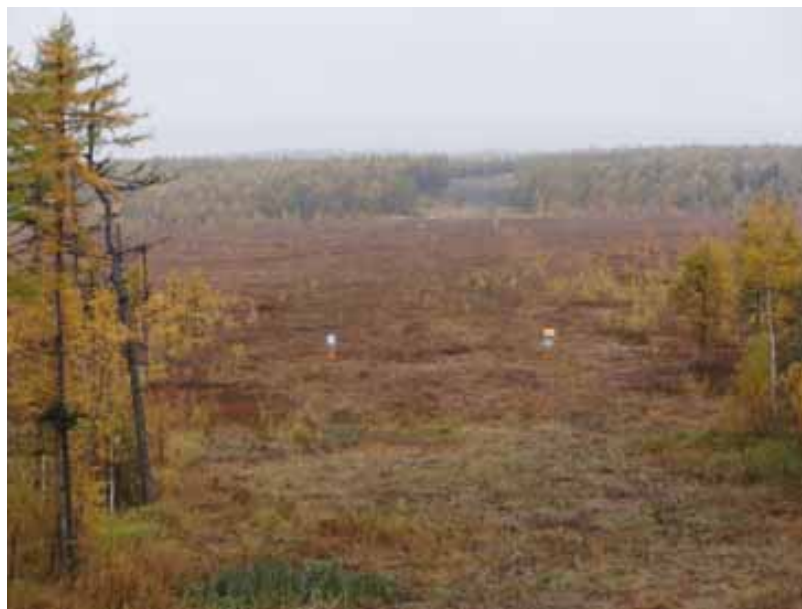
The wetland south of the Djimdan river is well vegetated as viewed from a vantage point south of the river. The slope from the south has slope breakers in place and good vegetation cover. Tree saplings have been effectively cleared while leaving the grass intact.

Photo 1. View across the Djimdan valley from the south showing vegetated wetland leading to the river. Trees and saplings on the slope in the foreground have been removed – see also photo 3.

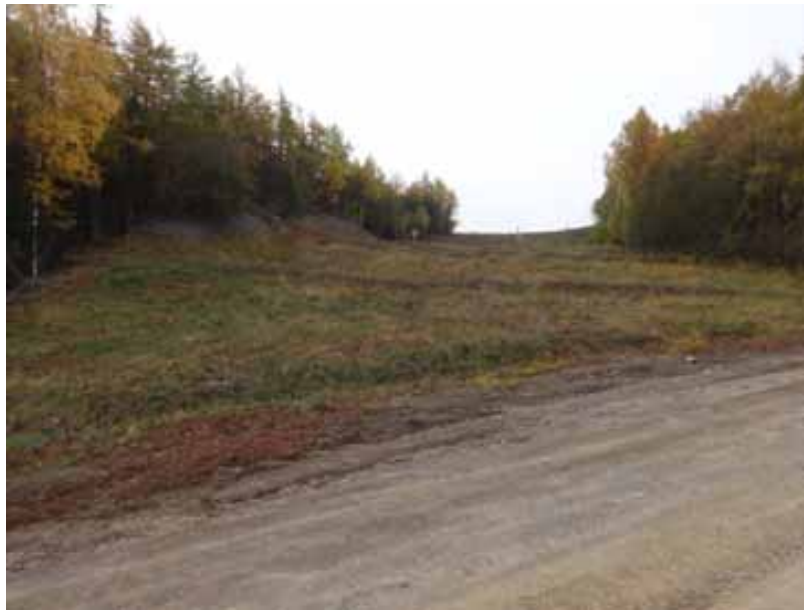
Photo 2. View to the south showing vegetated slope with slope breakers and removed tree saplings.

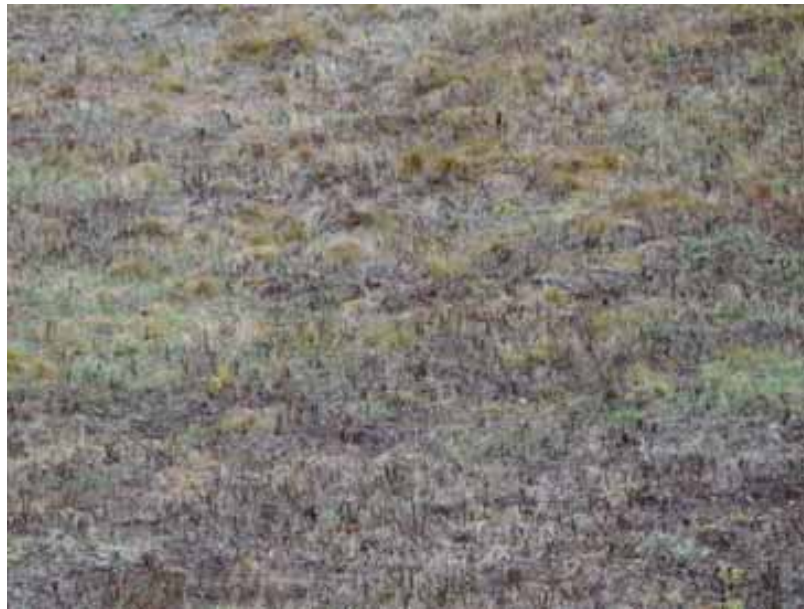
Photo 3. Close-up view of effective tree sapling removal with grass left intact.

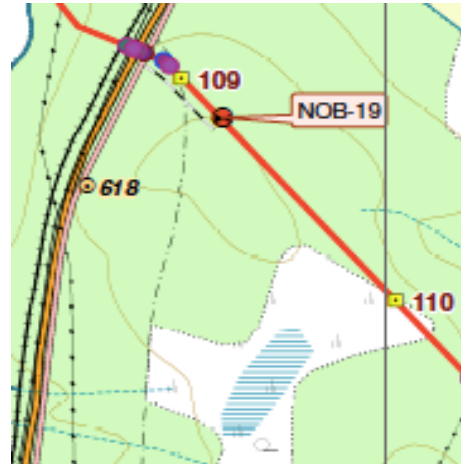
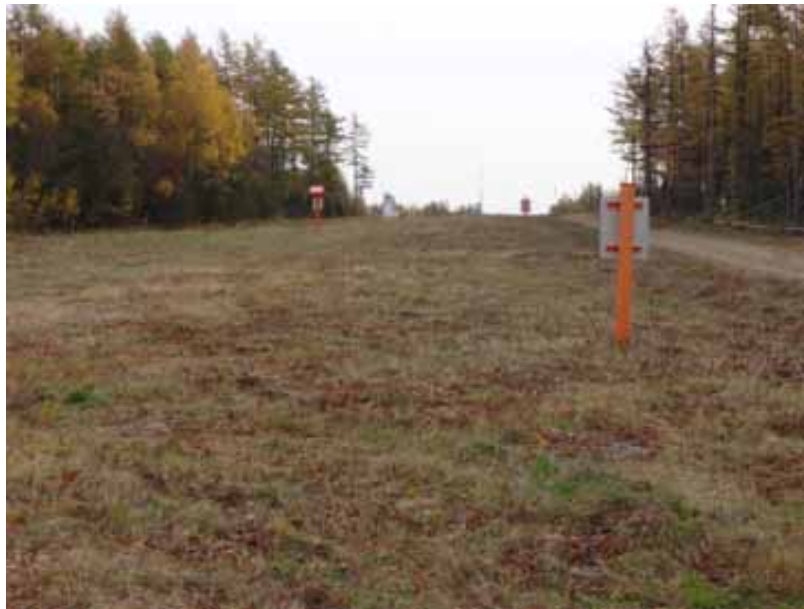
The RoW from KP 109 to 110 has good vegetation cover and with tree saplings effectively cut while maintaining grass cover in place. The cuttings are shredded and used as mulch on the RoW.

Photo 1. View to the south showing vegetated RoW and cut tree saplings.

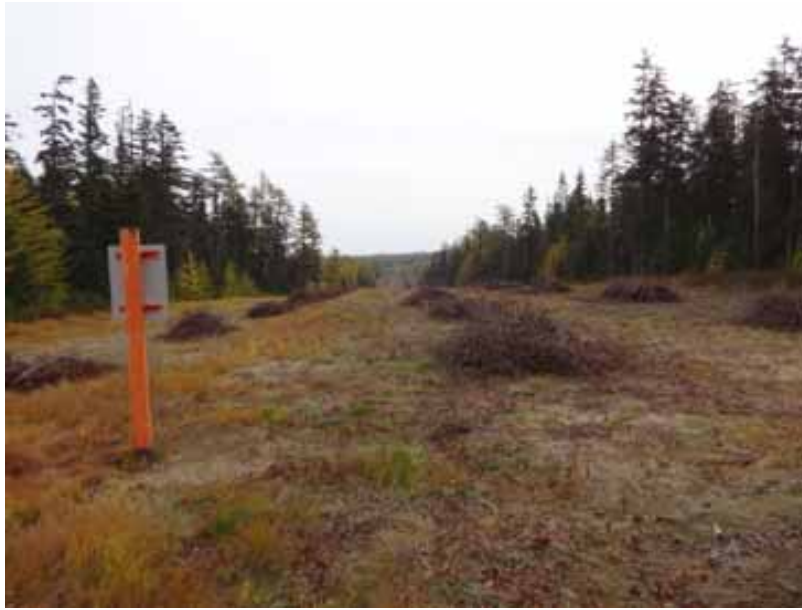
Photo 2. Close-up of effective tree sapling removal with grass left intact. Note the piles of cuttings awaiting mulching.

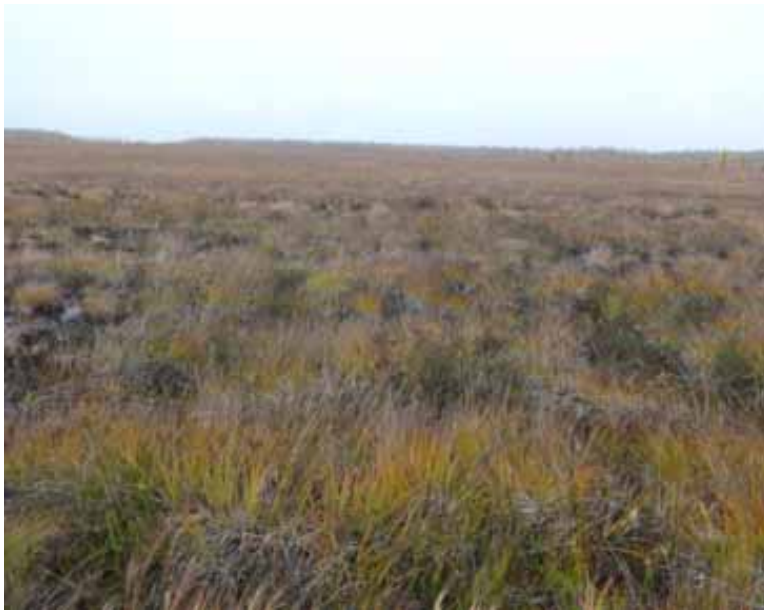
The wetland section between KP 149 at NOB-24 and KP 151 is continuing to recover.

Photo 2. View south across the RoW in along the wetland showing recovered area in comparison to unaffected area.

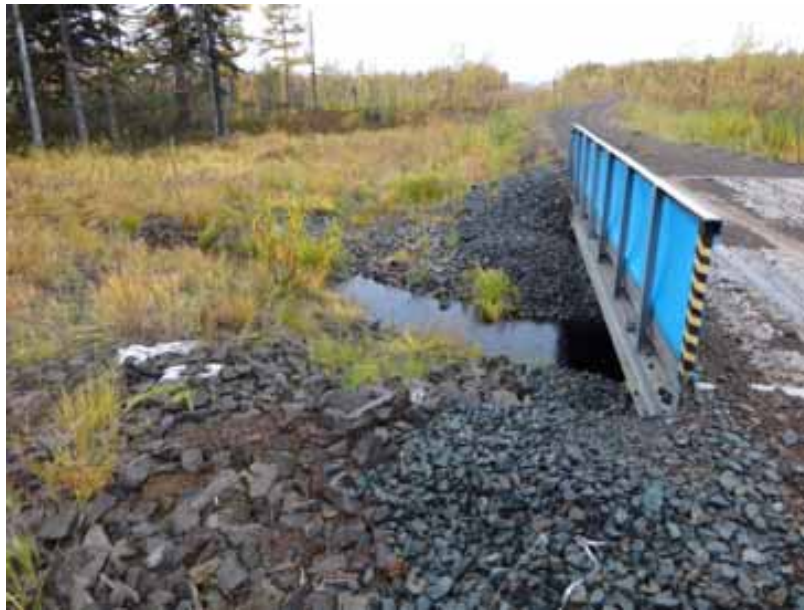
Few of the existing bridges along the access road were repaired/improved including the silt fences along the bridge and riprap covering the banks by the bridge footings (Photos 3 and 4).

Photo 4. View of protected drainage with riprap and good vegetation cover.

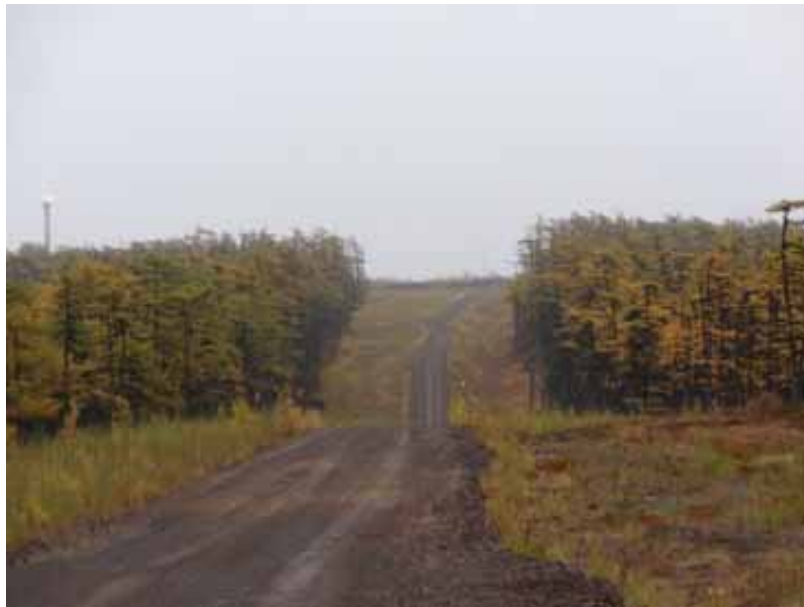
Photo 5. View of RoW with good vegetation cover.

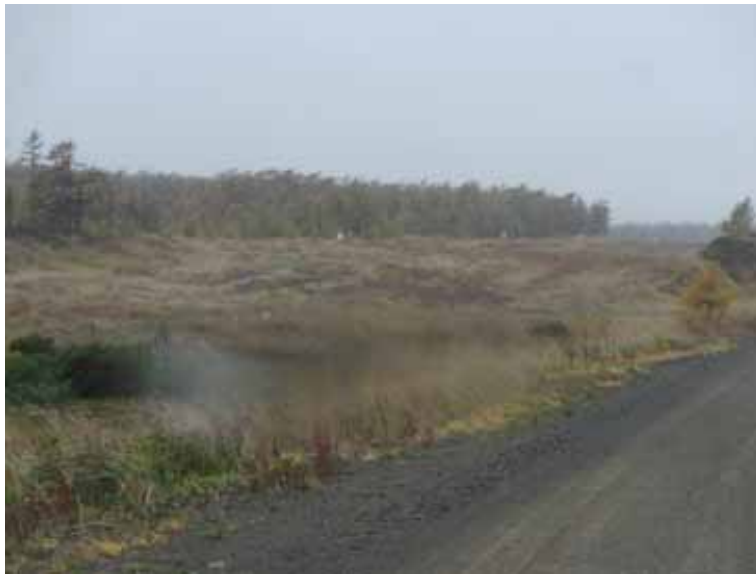
The LUN-A Landfall is the start of a seven km RoW terminating at the OPF. The RoW has mostly good vegetation cover. The slopes have slope breakers for sediment and erosion control.

Photo 1. View west along the RoW showing good vegetation cover.

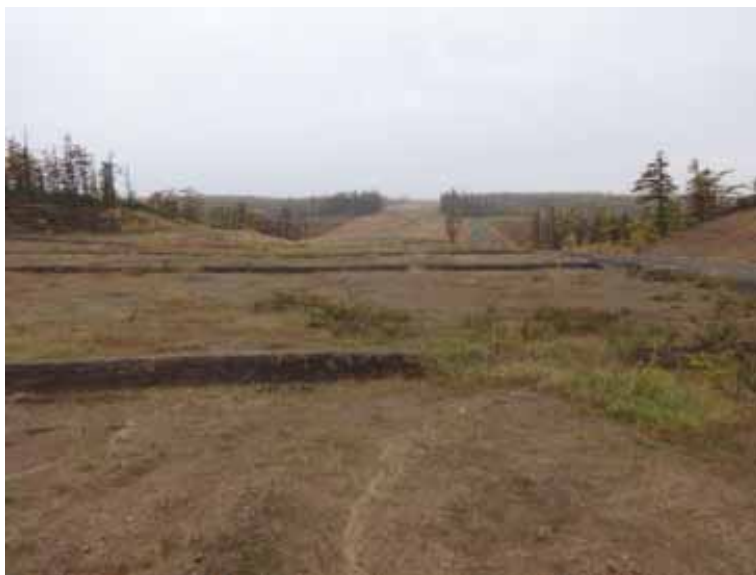
Photo 2. View west along the RoW showing vegetation and slope breakers.

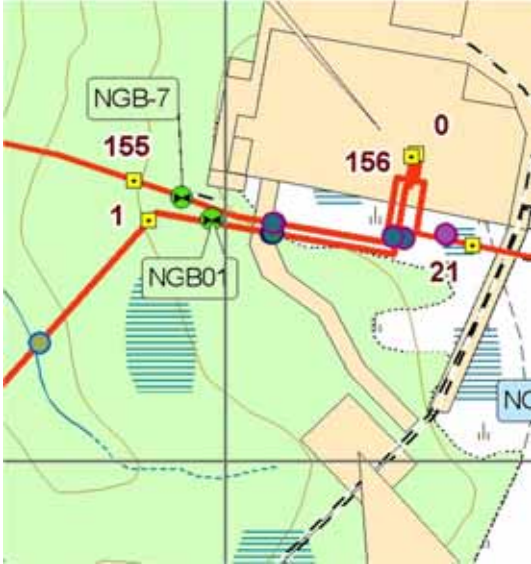
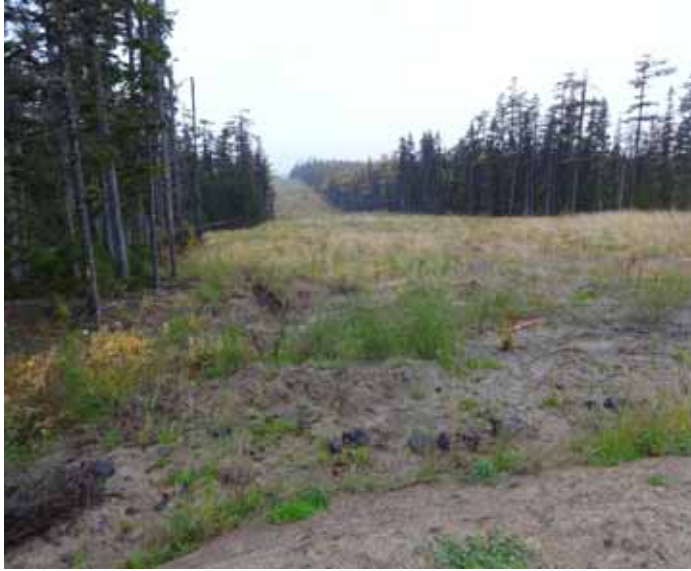
Photo 1.

The tie-in of Sakhalin-3 at KP 0 near the OPF was observed as part of the visit. The installation of the tie-in was finished two years ago. The disturbed area south of the tie-in is starting to recover (Photos 1 and 2).

View to the south from the tie-in location showing recovery of vegetation on disturbed area.

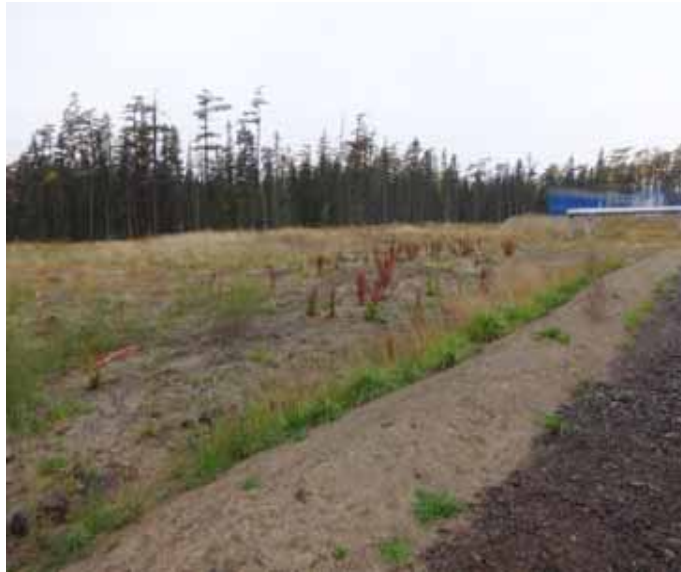
Photo 2. View to the south from the tie-in location showing recovery of vegetation on disturbed area.

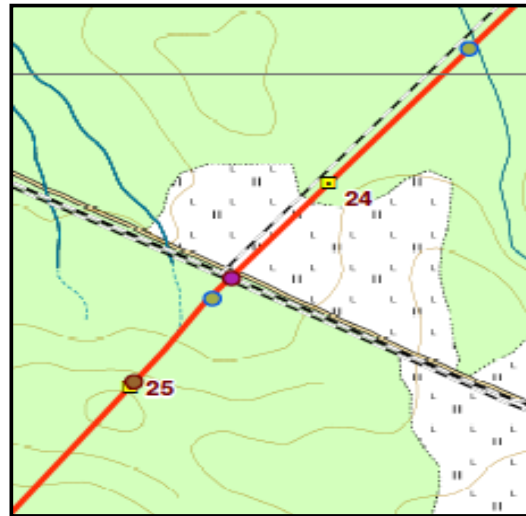
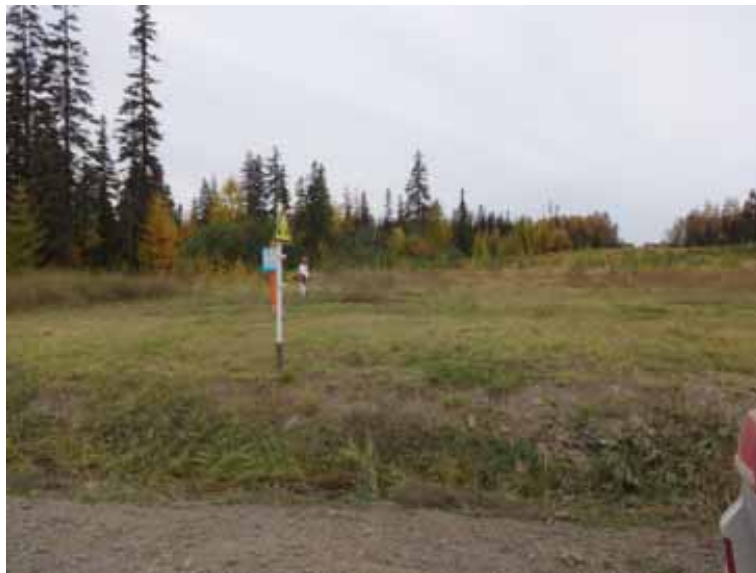
During the visit, a Gazprom field crew of was present and trimming the vegetation on the RoW along the road crossing, reportedly a standard Gazprom procedure at such locations (Photo 1).

Photo 1. View to the south showing the vegetation trimming process.

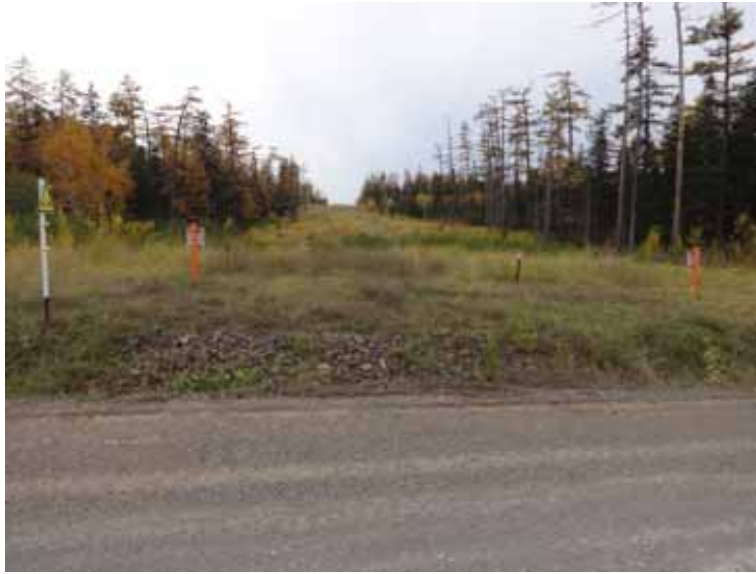
The RoW at this crossing has gently sloping topography and was showing good vegetation cover (Photo 1 and 2).

Photo 2. View to the south showing the RoW with a gentle slope and good grass cover.

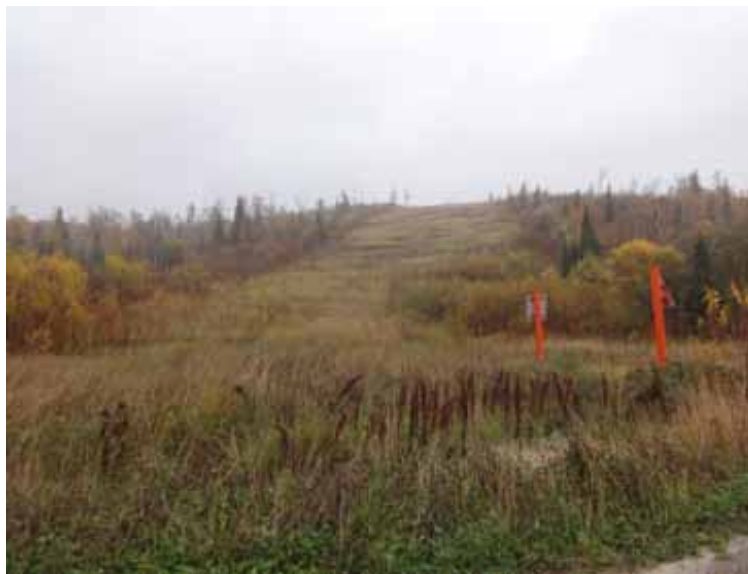
The RoW at this crossing has gently sloping topography. The RoW has good vegetation cover which consists mostly of grasses (Photo1).

Photo 1. View to the south showing the RoW with a gentle slope and good grass cover.

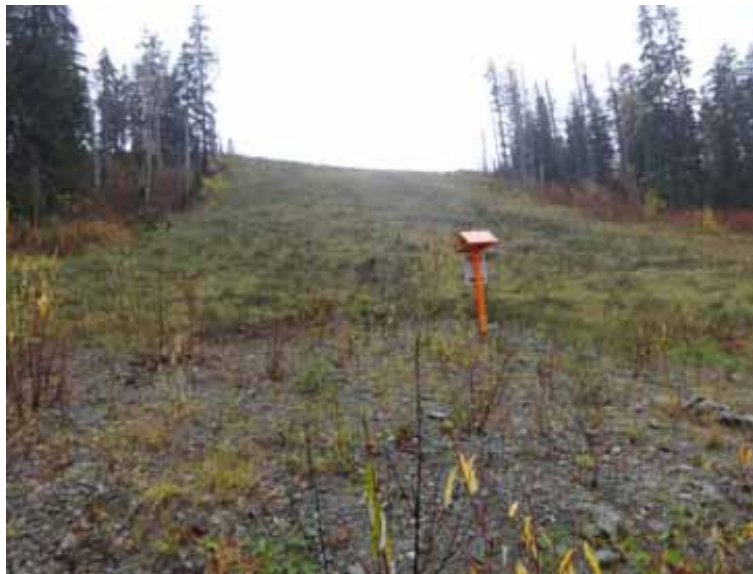
The slope appears stable and with some grass that was naturally established. The southern slope has a soil cover and good vegetation and slope protection.

Photo 1. View to the south showing a steep slope of the RoW with good vegetation cover and slope protection.

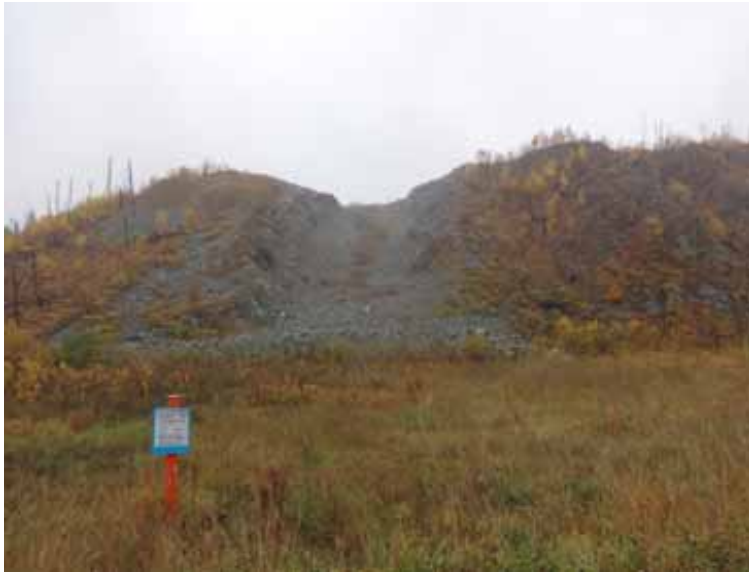
The Nabil River crossing has very steep slopes. The northern slope was blasted into solid rock and forms an indent in the topography of the hillside.

Photo 2. View to north showing the rocky slope of the RoW with some vegetation.

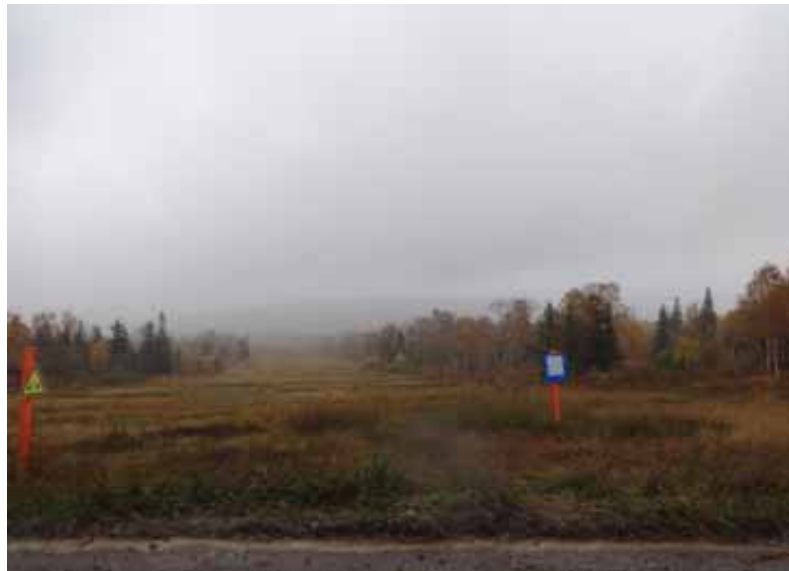
The RoW at this crossing has undulating topography. The RoW has good vegetation cover which consists mostly of grasses. (Photos1 and 2).

Photo 1. View to the south showing the RoW with a gentle slope and good grass cover.

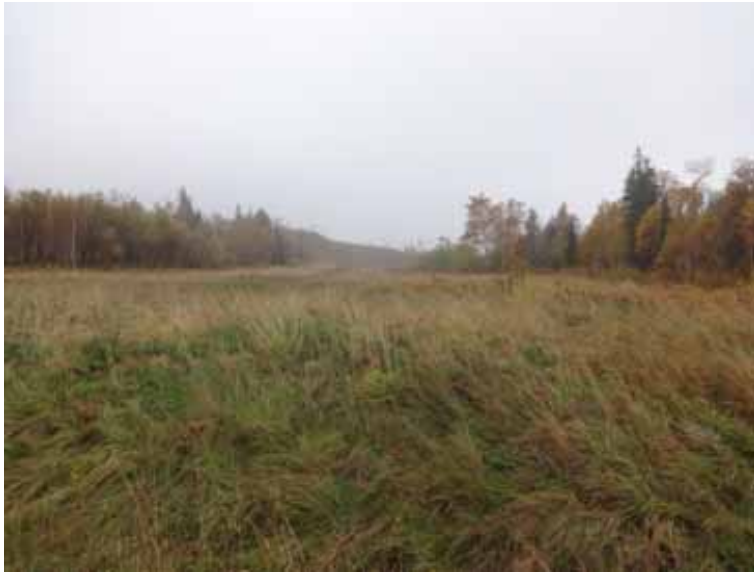
Photo 2. View to the north showing the RoW with a gentle slope and good grass cover.

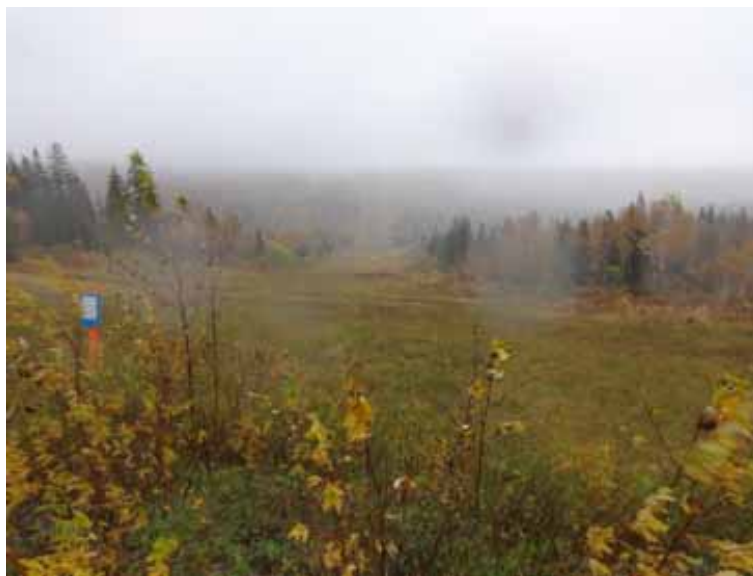
The RoW in this area is in undulating terrain with some steep slopes. The slopes are protected with slope breakers and with good vegetation cover.

Photo 1. View north along the RoW showing good vegetation cover and slope protection.

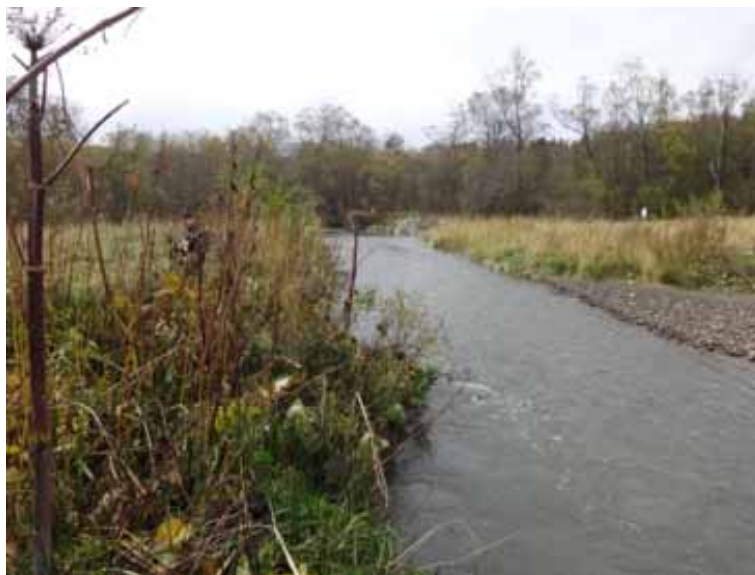
The RoW on each side of the crossing and the banks of the river at the crossing are well vegetated (Photo 3). A steep slope on the south side of the river valley is well vegetated and protected with slope breakers (Photo 4).

Photo 3. View of the crossing to the upstream.

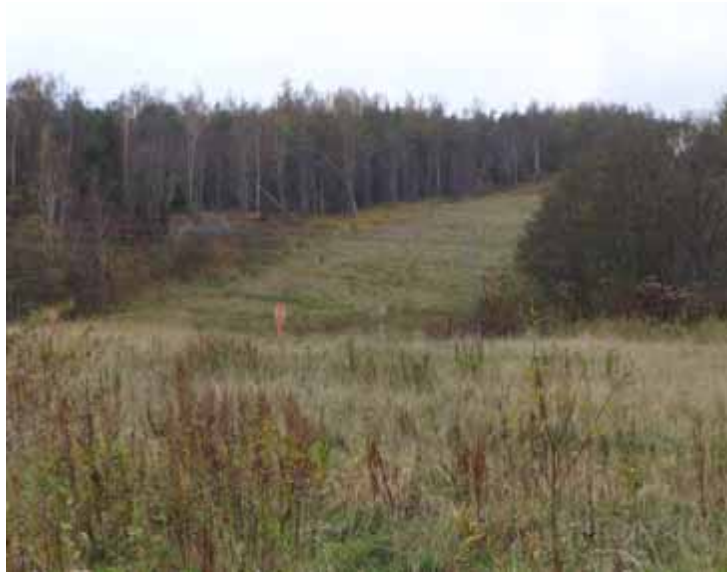
Photo 4. View to the south showing RoW and slope with good vegetation cover and slope protection.

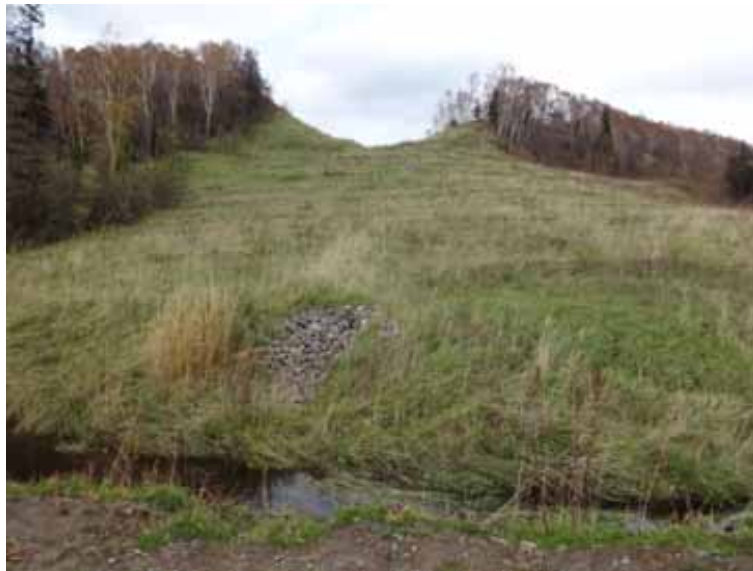
The Sovietkoy Ridge has required subsurface drainage to stabilise it during the construction and reinstatement stages.

Currently, the slope appears to be stable and has very good vegetation cover.

Photo 1. View of the slope to the north showing good vegetation cover. Note the outlet of a subsurface drain at the bottom of the slope.

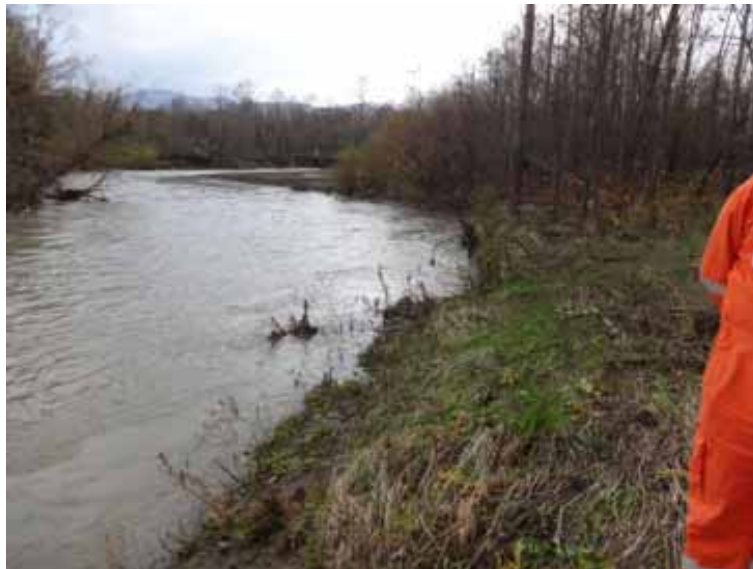
The river crossing appears in good condition and with very well vegetated banks (photos 1 and 2). The slope south of the river appears stable and well vegetated (Photo 3).

Photo 1. View to the upstream of the east bank.

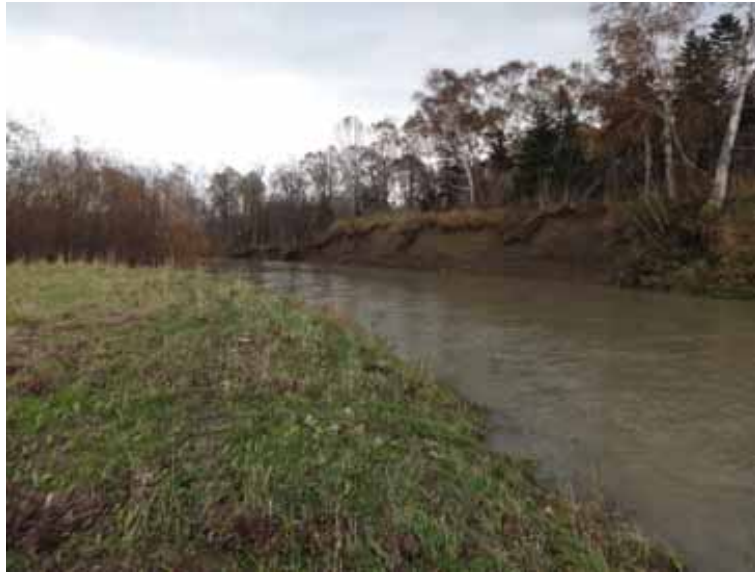
Photo 2. View to the downstream of the east bank.

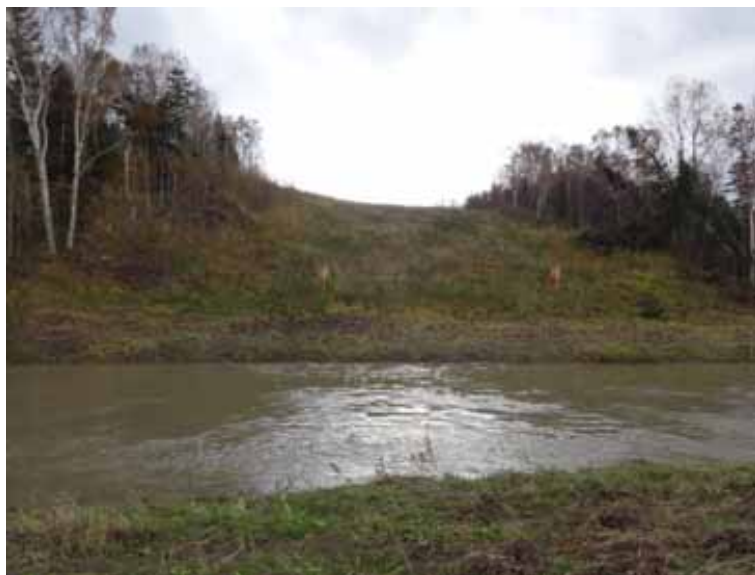
Photo 3. View to the south across the river at the west bank and the RoW slope.

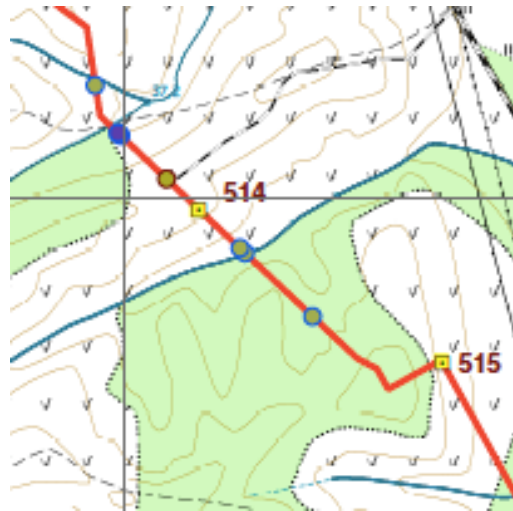
The RoW at KP 514 experienced a landslide from the edge of the RoW toward the east. The slide was stabilised and new drainage control and slope protection was constructed (Photo 1).

Photo 1. View from the RoW to the east of a repaired landslide area.
