Appendix 2: Individual RoW Descriptions

List of RoW Locations Visited		
KP	River / Location	Date Visited
33	East of Val River Near NOB 04	3 October 14
36-37	Wetland near NOB 06	3 October 14
63	Dagi River	3 October 14
95	Djimdan River Crossing	3 October 14
15 - 21	Plelarnya River and RoW	6 October 14

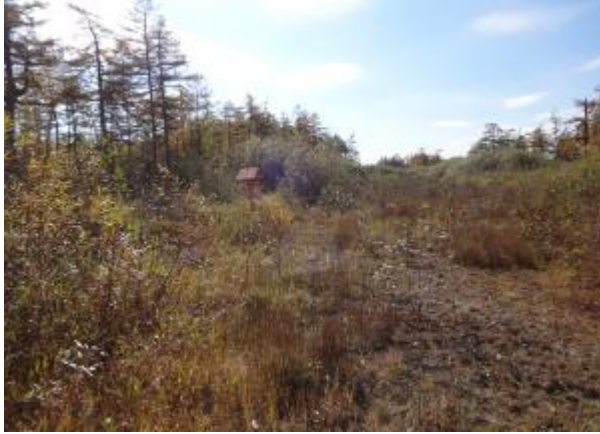
The RoW in the immediate vicinity of the access road is poorly vegetated (Photo 1). However, further to the west the RoW has good vegetation cover, which includes grasses on the running track section (Photo 2), and Alder and Willow trees above the pipes and on the periphery (Photos 3 and 4). Some of the trees reach four meters in height. The area was visited as part of the review of wetland. However, at the time of the visit the wetland area was mostly dry. There is evidence of rush *Juncus* sp. Growth, but no other wetland species and we suggest that this area should no longer be considered as a wetland.

Photo 3 – Showing trees next to KP 33

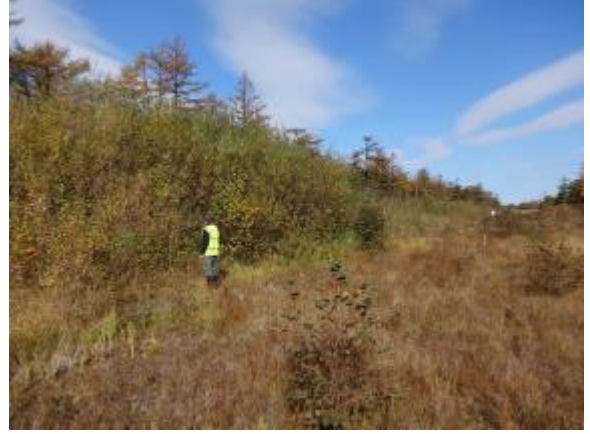
Photo 4 – Tall trees on the RoW in the vicinity of KP 33

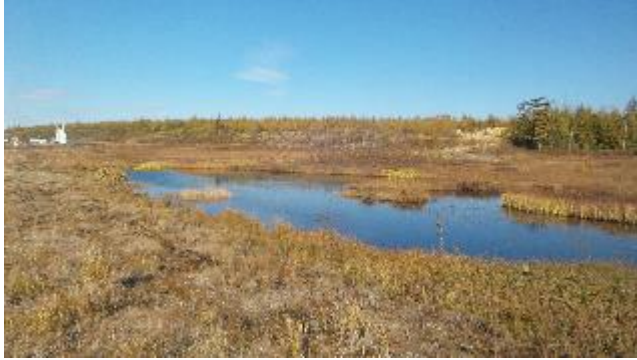
The area around the RoW supports a bog wetland with abundant bog mosses *Sphagnum* sp., and harestail cotton-grass *Eriophorum vaginatum*. The area above the RoW is grassier than the surrounding habitat, but the mosses and shrubs are showing evidence of recolonisation. Two areas of sedge fringed open water have formed over the pipelines. These are a different form of wetland to that present

prior to installation of the pipeline, but support native species and no negative effects on surrounding wetland was evident.

Photo 3 –Sedge fringed pool formed over pipeline

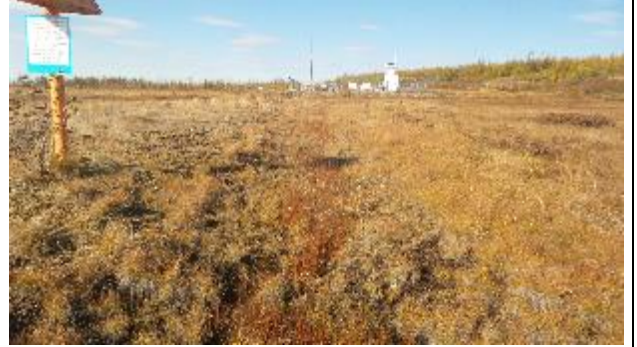
Photo 4 – Closer view of well revegetated RoW

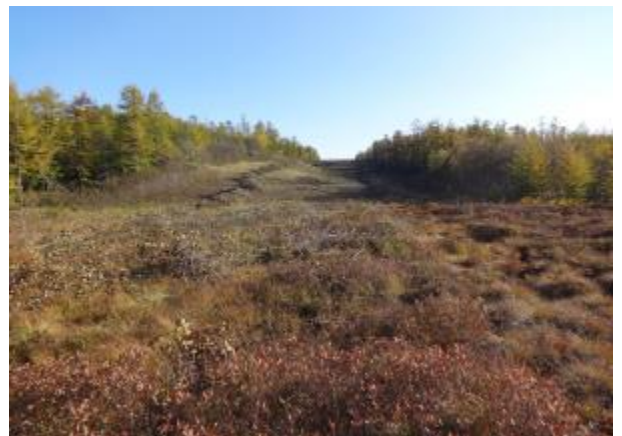
An additional area of tree removal was observed on the slopes leading out from the valley on the south side (Photo 4) where the cut trees were collected in piles on the RoW. This method of waste handling should be reconsidered.

Photo 4 – View south showing wetland vegetation and slopes on valley edge with cut trees piles.

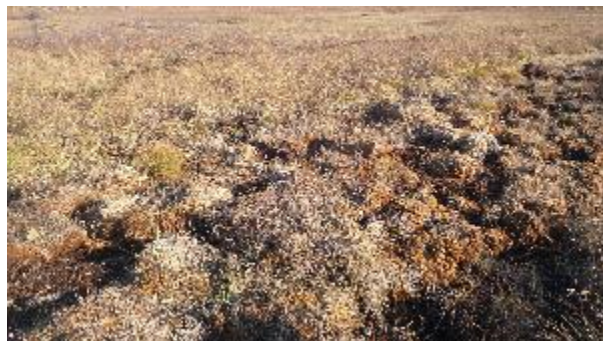
Some patches of peat that have been reinstated contain partially dried out sphagnum and do not look to have been placed correctly, which is the likely cause of the slow recovery. However, ENVIRON is now confident that the RoW will fully re-vegetate with wetland species.

Photo 7 Some dried out peat with new regrowth in between.

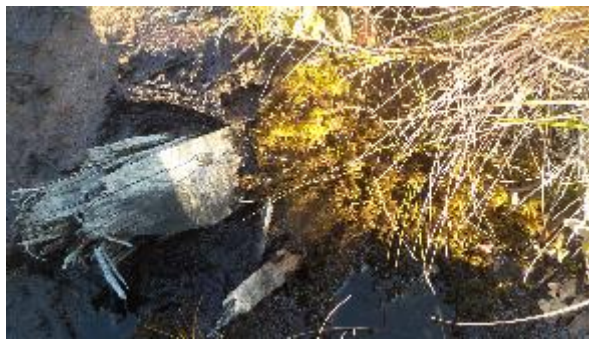
Previous visits to the Dagi wetland showed two clear dark lines above the pipelines where peat had not re-vegetated. This effect was not as noticeable on this visit, largely as a result of both moss and shrub species having started to grow on the previously bare areas. A number of sphagnum species are showing new growth in small hollows on the peat and young bog bilberry *Vaccinium uliginosum* and Labrador tea *Ledum palustre* have also colonised with some small plants found to be present.

Photo 8 Close up showing sphagnum regrowth

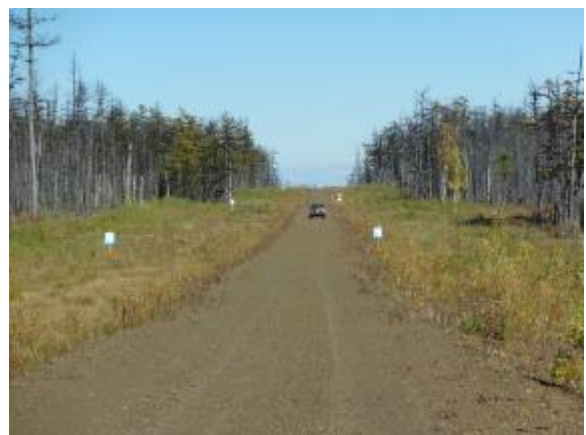
The RoW between KP 21 and 15 has good vegetation cover on each side of the access road (Photos 4 and 5). A sloping section of the RoW just north of NOB 01 had deep erosion along the slope last year that has since been repaired.

Photo 4 - View to the north showing good vegetation cover on each side of RoW

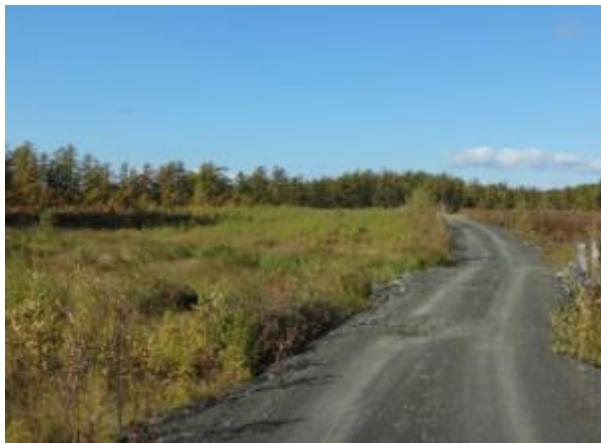
Photo 1 – Good re-vegetation of RoW

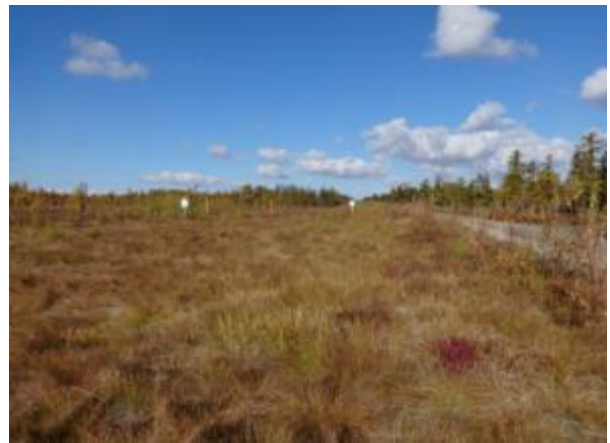
Photo 2 – Good re-vegetation of RoW

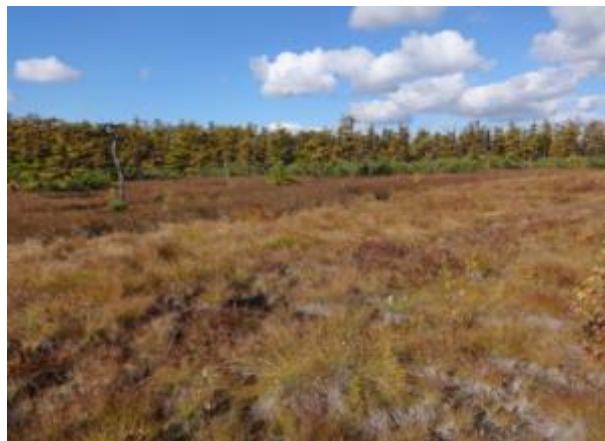
Over the RoW itself, the shrub species and mosses have been slower to colonise than the cotton grass and other graminoids, leaving a distinct boundary between the undisturbed and disturbed areas. However, here, as at the Dagi wetland, evidence was found that species from these groups are starting to establish themselves, and ENVIRON is confident that in time the shrub species will recover to a comparable height to the surrounding wetland.

Photo 3 –Typical revegetation-more
graminoids, hence lighter colour

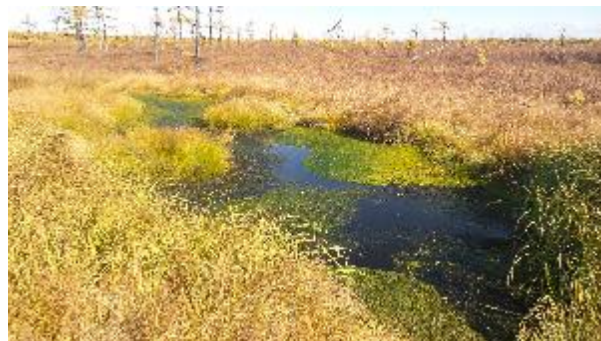
Additionally, no negative effects on the surrounding wetlands were noted.

Photo 4 –Existing wetland near KP143
showing no negative effects from nearby RoW

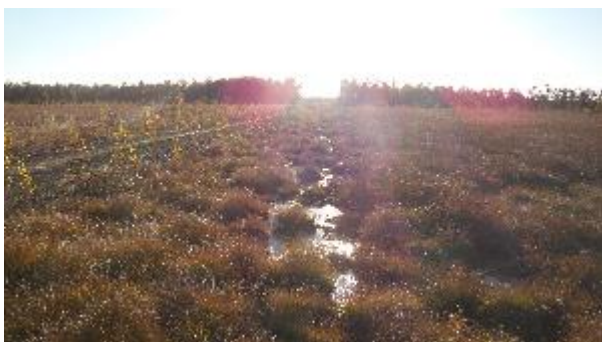
The RoW in this area is similar to that seen between KP141-144. Small wetland shrubs and bog mosses are slowly colonising the RoW, but at a slower pace than the harestail cotton grass and other grasses so a distinction between the reinstated and undisturbed bog is visible (as is the case in the area between Kp141-144 as described above). Some areas of bare or poorly vegetated peat were seen, but these were small and infrequent.

Photo 7 – Well revegetated RoW with small areas of bare peat

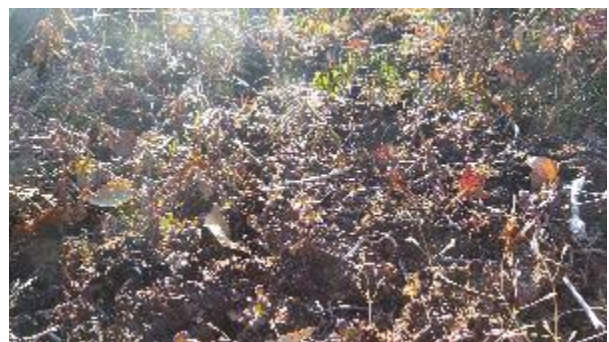
Photo 8 Close up of revegetation of ROW of small shrub species

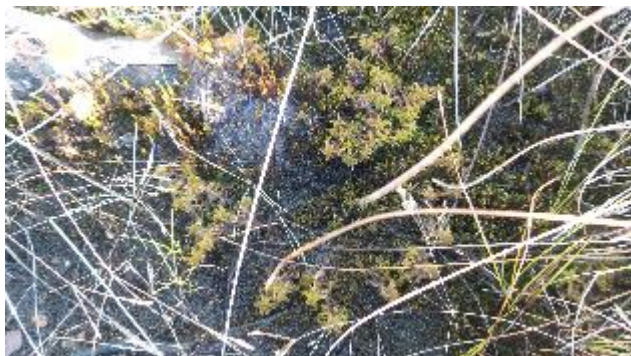
Photo 9 close up showing recolonisation by bog moss Sphagnum species.

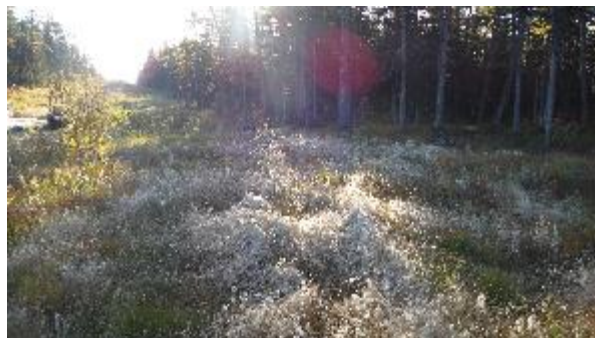
Closer to KP 152, a small wetland hollow between the coniferous trees has been re-vegetated by a carpet of harestail cotton grass, which provides good coverage.

Photo 10 Colonisation of wetter area at KP152 by cotton grass.

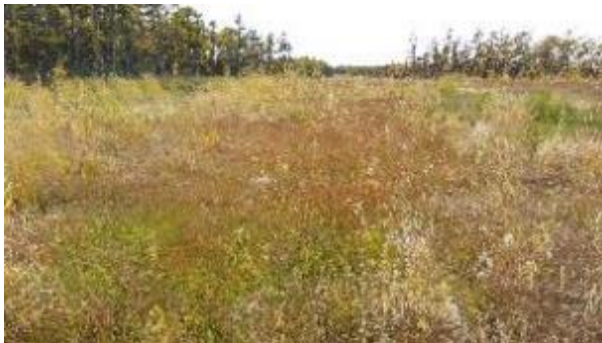
The RoW has re-vegetated well with a grass dominated mix of plant species. Wetter areas have been colonised by sedges and small pockets of sphagnum species with patches of taller emergent vegetation such as cat-tail *Typha latifolia* and reed *Phragmites australis* and sedge *Carex* sp. Hair mosses *Polytrichum* sp. are the most abundant bryophytes in this area.

Photo 1 – Well revegetated RoW

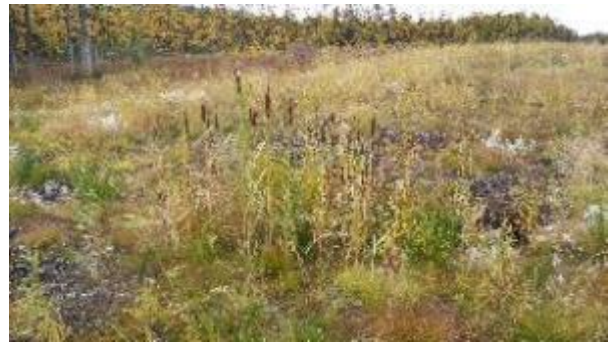
**Photo 2** Emergent vegetation colonising wetter depressions of RoW

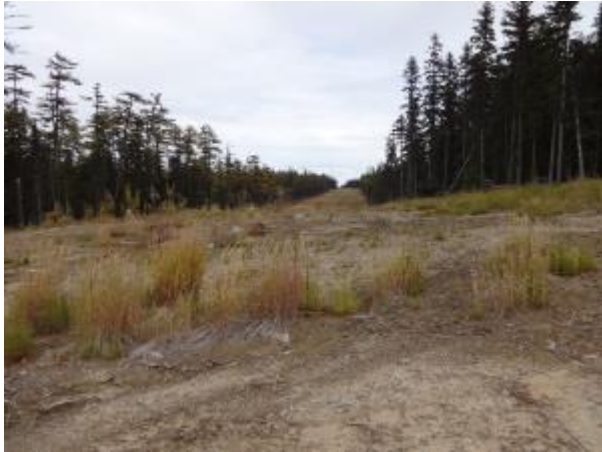
Photo 3 – View south from KP 3 showing RoW partially vegetated

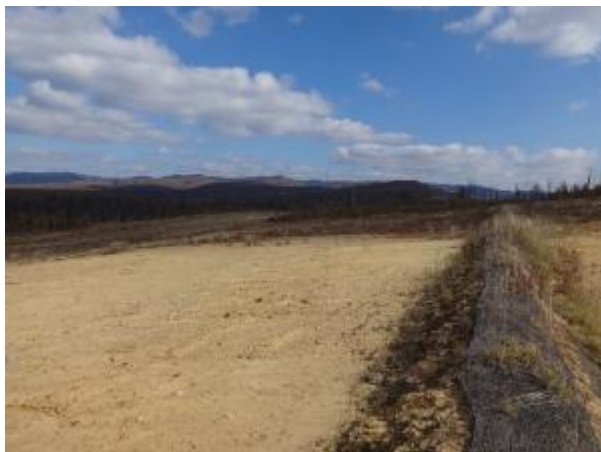
Photo 3 – Area between access road and RoW is devoid of vegetation.

The area immediately adjacent to and southeast of the RoW was most likely used as a staging area during construction. Currently the area is bare of any vegetation (Photo 3). It is recommended that the area be put on a seeding/reinstatement schedule.

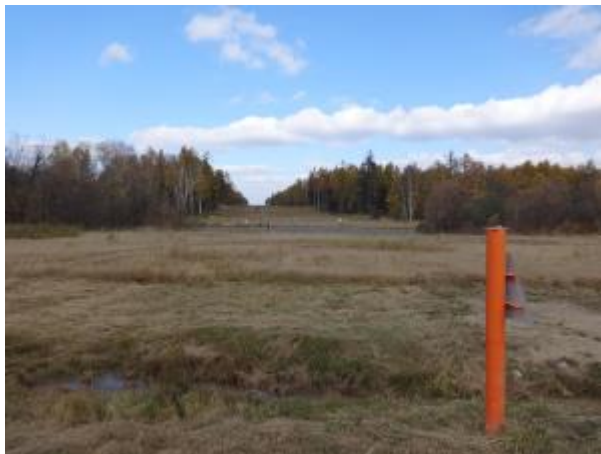
The RoW north and south of the river has good vegetation cover (Photos 1 and 2). The riverbanks are well protected by reno matting and have grass cover on the lower portions by water level (Photos 3 and 4).

Photo 1 – View north along the RoW and across the river showing good vegetation cover

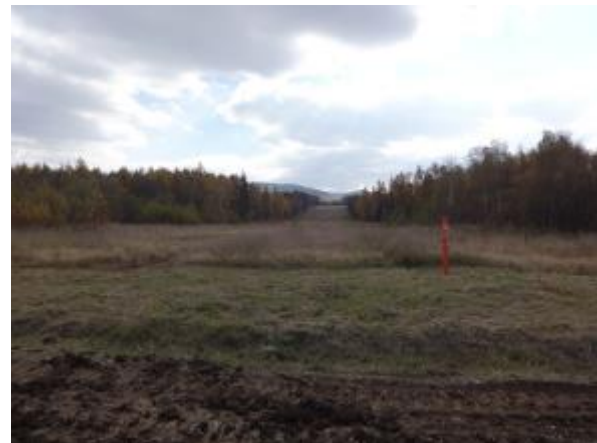
Photo 2 – View south along the RoW showing good vegetation cover.

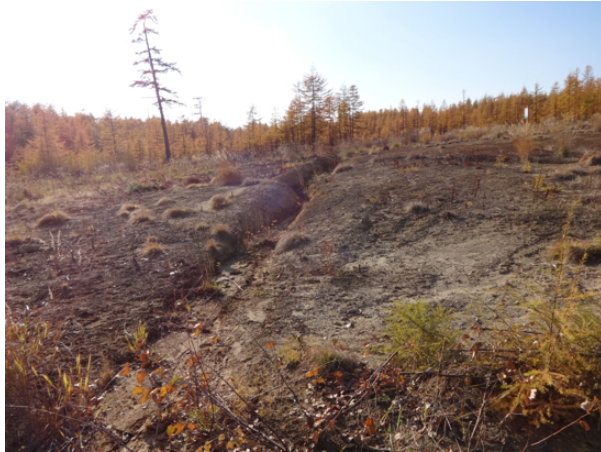
The RoW north of TOB 12 has generally good ground cover, although the east side of the RoW is recovering at a slower pace. The area immediately adjacent to the block valve station has poor ground cover and erosion (Photos 3 and 4), and more seeding and remedial works are needed in the area. The RoW in this area passes through another area where bog wetland occurs under relatively scattered coniferous forest and where a Labrador tea dominated shrub layer is the typical understorey.

Photo 4 – Area adjacent to the block valve shows poor ground cover and erosion

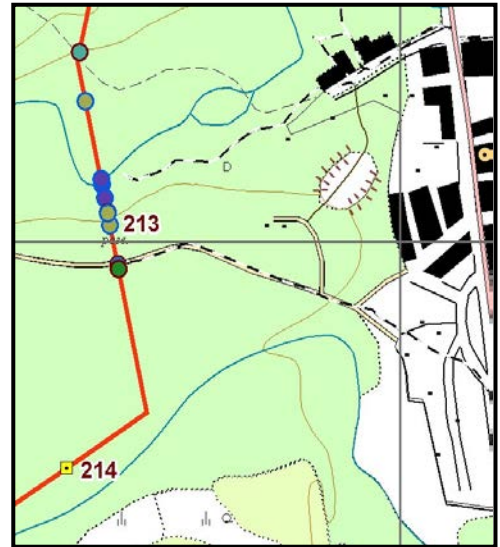
The Podbiedenka River is a high energy river and requires robust bank protection on the southern bank. The multi-level gabion wall on the southern bank is mostly in good condition (Photos 1 and 2), although a small portion shows minor sagging. Large riprap protection cover on the upstream portion of the south bank is intact. Both the wall and the riprap should be monitored regularly.

Photo 1 – View to the downstream showing gabion wall and opposite bank

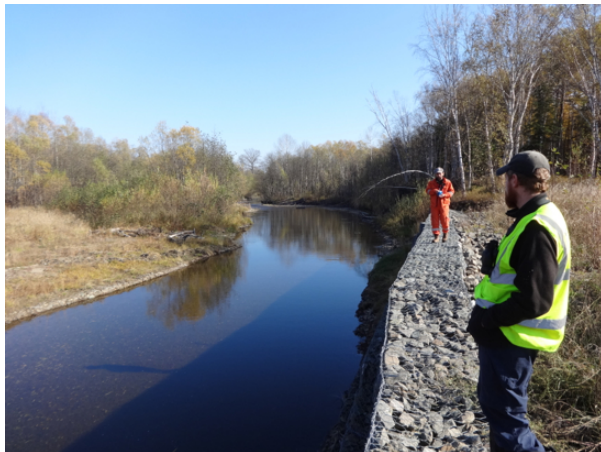
Photo 2 – View to the upstream showing gabion wall and riprap protection

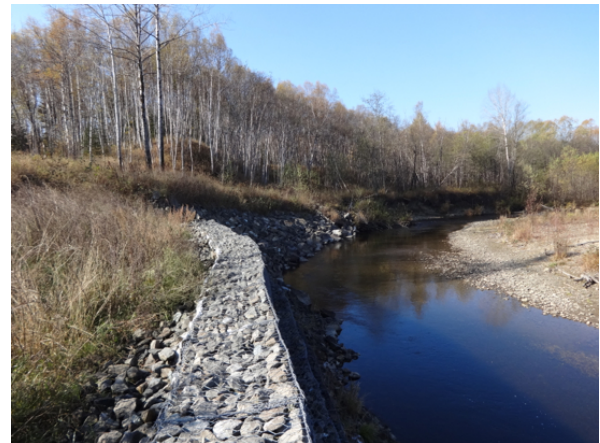
The RoW on both sides of the river has good vegetation cover and the slope on the south side is protected with slope breakers (Photos 3 and 4).

Photo 3 – View north across the river at the RoW

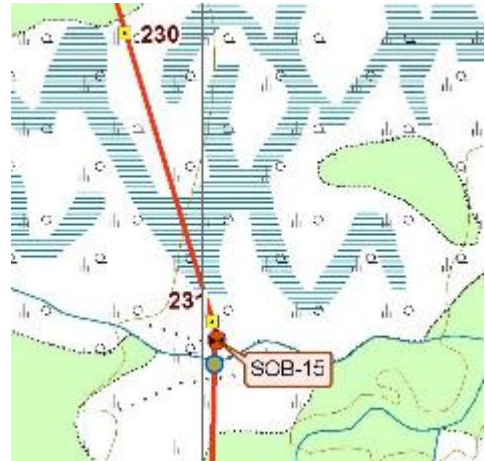
Secondly, a ditch and berm has been created in the south of the area on the western side of the RoW close to the block valve. This ditch is acting to drain water from the western area of wetland and carrying it to the south. As such, water is not reaching the RoW or the wetland to the east of the RoW, which is showing signs of negative effects with dried out understorey vegetation present and a noticeable reduction in bog mosses.

Photo 1 – Ditch and berm on west of RoW

As a result of the factors described above, the RoW is barely vegetated with only occasional ephemeral grasses. No wetland plants are present. In order to address the issues identified, the ditch and berm should be filled in and fully removed. Additionally, approximately five small culverts should be installed under the access track approximately every 200m between KP 230 and KP 231.

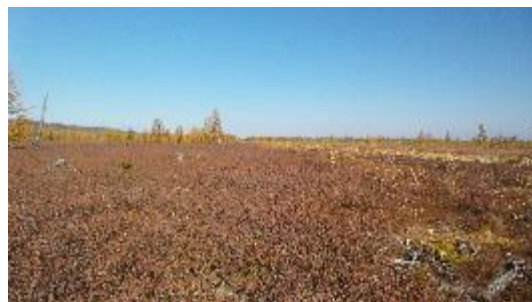
Photo 3 Bare RoW with no wetland vegetation

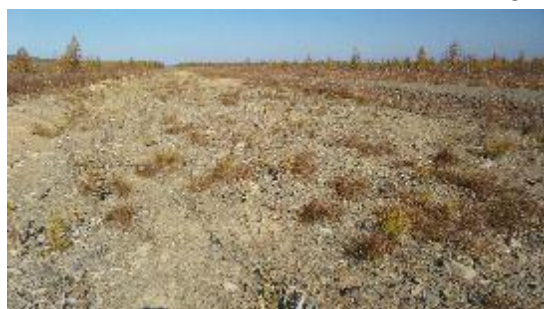
Photo 4 Wetland east of RoW that is drying

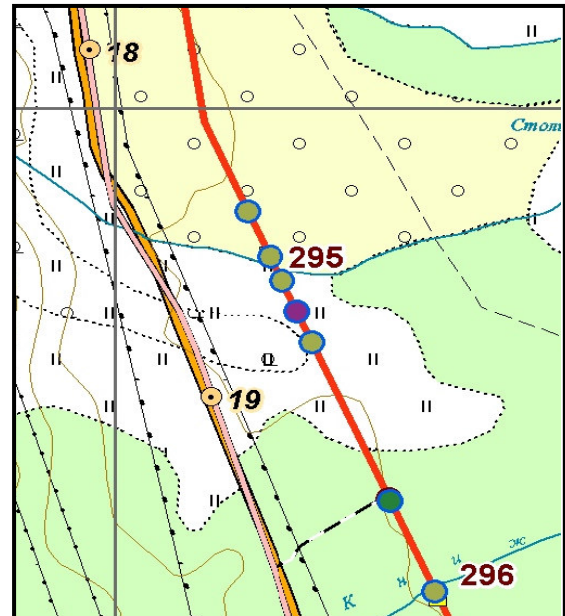
The dig-up at this location was visited last year and there is a visible improvement. The actual area of the dig-up has good vegetation cover. The access road (on the RoW) that was constructed for the purpose of repair works is recovering slowly and may need additional seeding. The banks of a drain ditch that crosses the RoW north of the dig-up are well protected with very good vegetation cover.

Photo 1 – View north across the dig-up showing good vegetation cover and a bare spot where the access road reached the site

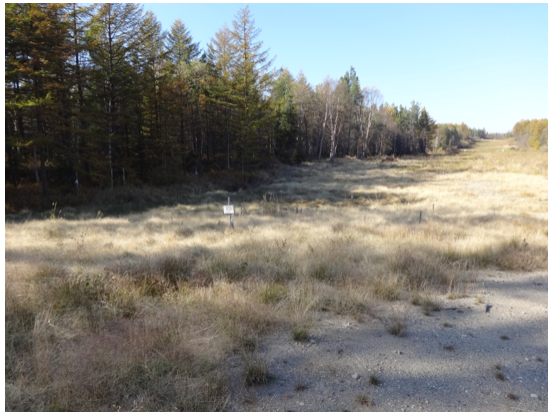
Photo 2 – View to the north showing RoW with good vegetation cover

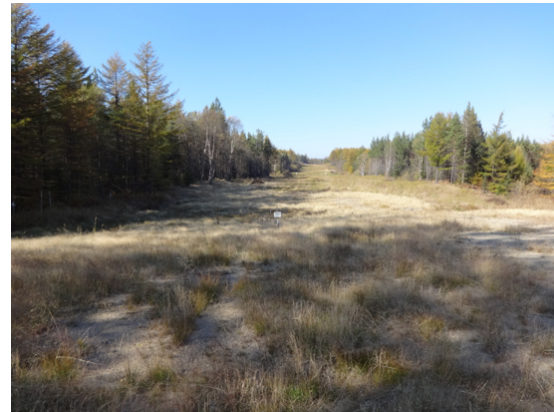
Photo 3 – View of a crossing drainage with vegetation cover on the banks.

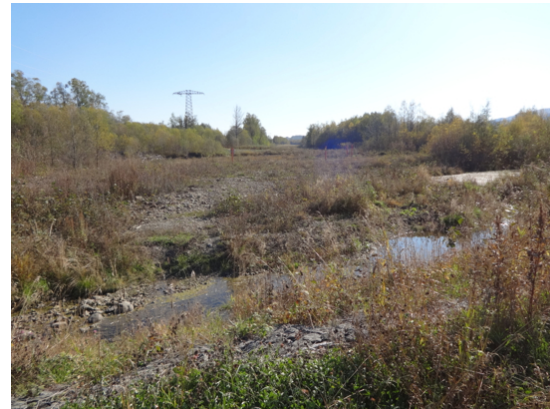
The Gastlovka River is a high energy braided river with multiple channels. The main channel shows gravel banks with no scouring. The bank of the northern channel (currently the minor channel) is well fortified with Reno mattings that are in good condition and with vegetation growing through the mats.

Photo 3 – View east at the banks of the main channel.

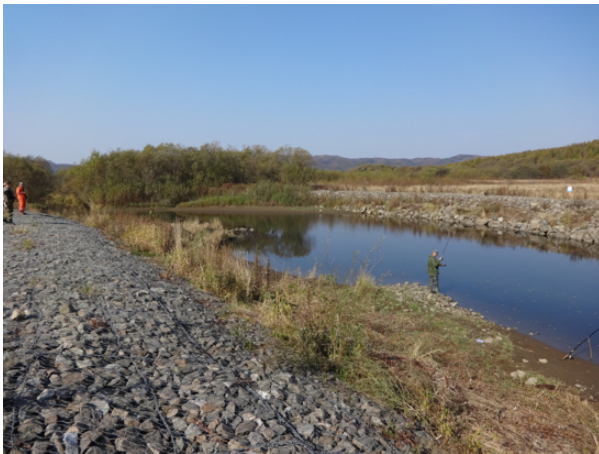
The Pugachevo River crossing appears stable. The south bank is protected with reno matting, with some grass growing through the matting. The north bank is protected with large riprap and also has vegetation coming through the rocks (Photos 1 and 2). The RoW on both sides of the river has good vegetation cover (Photo 3). The slope on the southern edge of the river valley is protected well by slope breakers (Photo 4).

Photo 2 – View downstream showing reno matting and riprap

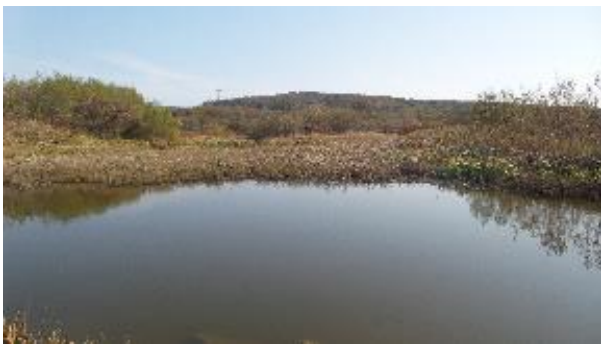
The Pugachevo area comprises a series of ox bow lakes and supports wet grassland/tall wetland species. The RoW passes right through one ox bow lake and the access track partially remains. However, the track is being reclaimed by native emergent/marginal vegetation that fringes the lake. The track is partially submerged. No negative effects on the lake were seen.

Photo 6 Retained track, ox bow lake

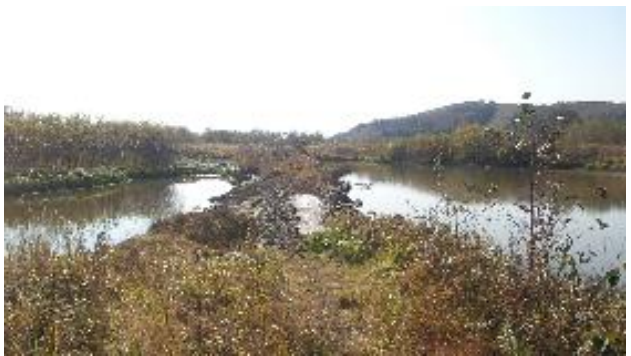
Photo 7 View north from ox bow lake showing river crossing and grassy wetland beyond

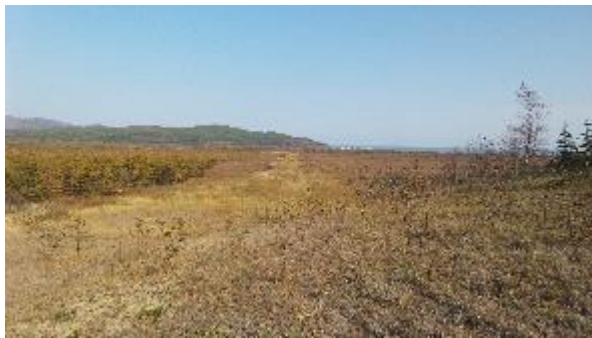
Bare patches are now only visible on the western side of the RoW (the gas pipeline), with the eastern side of the RoW now completely re-vegetated.

Photo 2 Close up of RoW

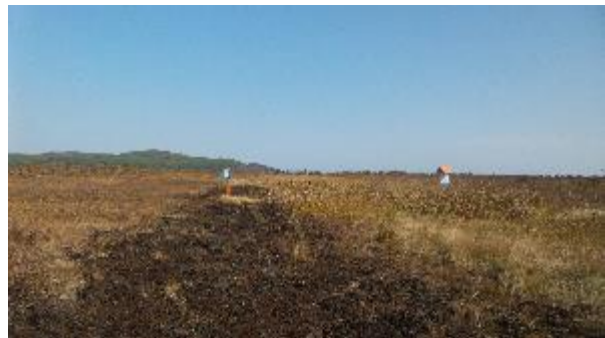
Upon closer inspection, the apparently bare areas are also re-vegetating with the small shrub and moss species from the surrounding wetland, including small areas of sphagnum in hollows on the peat surface and numerous round leafed sundews *Drosera rotundifolia*. The entire RoW area is very wet, indicating that the pipeline installation has not resulted in the RoW drying out. It appears that the central area of the RoW between the two pipelines has settled slightly, creating a depression where standing water occurs. This has been successfully colonised by cat-tails and other emergent.

Photo 3 Evidence of wetland plant regrowth

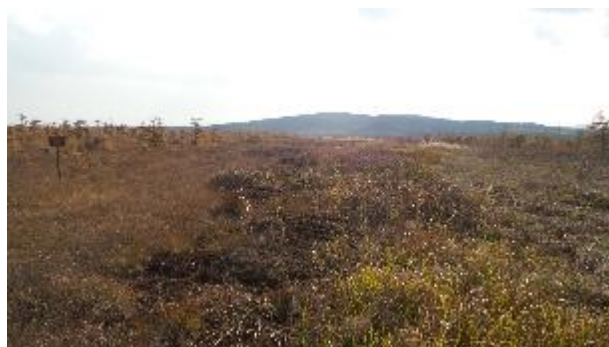
A very similar pattern of re-vegetation has occurred at Dolinsk as found at Manui. The RoW has generally re-vegetated well and, although slower to return that grass species, the shrubs and mosses from the surrounding wetland are now recolonizing the RoW. The difference here is that instead of cat-tails, there are stands of common reeds that have colonised the central parts of the RoW where settlement has allowed water to stand and pool.

Photo 2 Regrowth of wetland plants

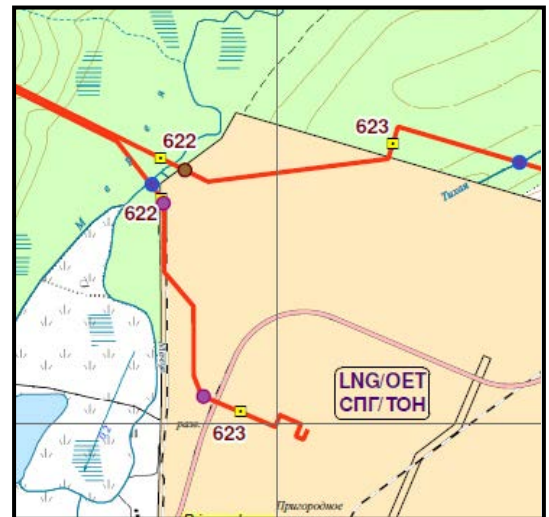
The Mereya River is crossed with two separated RoWs, one for the oil pipe and one for the gas pipe (Photo 1). Both crossings are protected with Reno matting. Significant vegetation growth has come up through the matting and the banks appear to be stable.

Photo 1 – Riverbank re-vegetation on the gas line crossing
