Lenders' Independent Environmental Consultant: Monitoring Report June 2010 Sakhalin-2 Phase 2 Project

Report to Sakhalin-2 (Phase 2) Project Finance Parties

Restricted – Commercial
AEAT/ENV/R/3052 Issue 1
July 2010

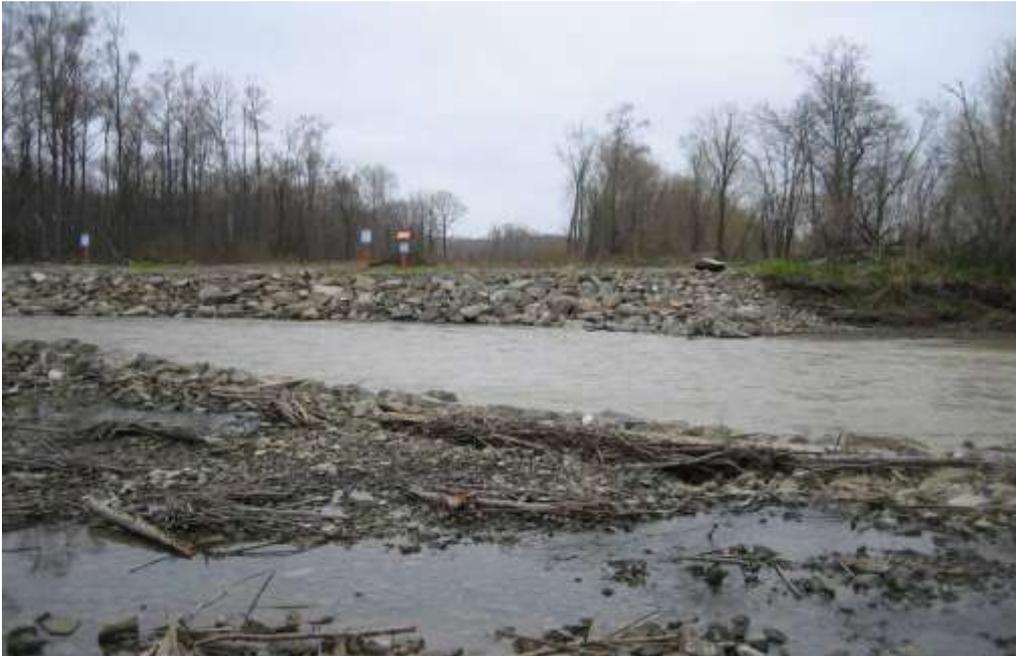
Photo 1 Nitui River - KP 326.6 – View of large riprap on opposite bank

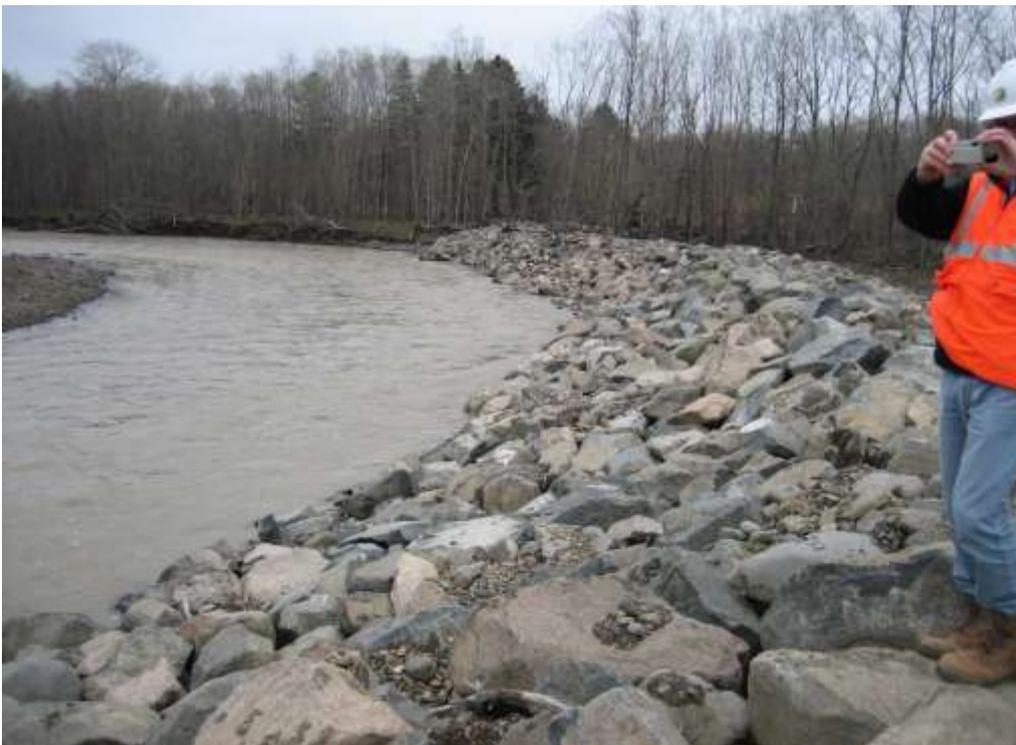
Photo 2 Upstream meander band of the Gornaya River – KP 344

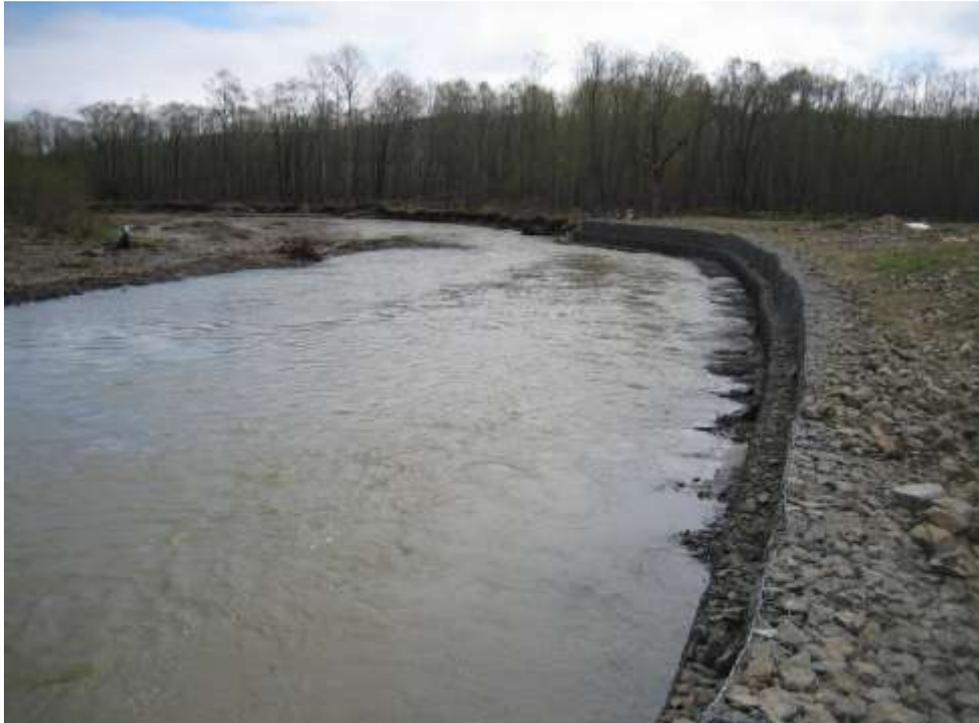
Photo 3 View of gabion wall on the Madera River - KP 373

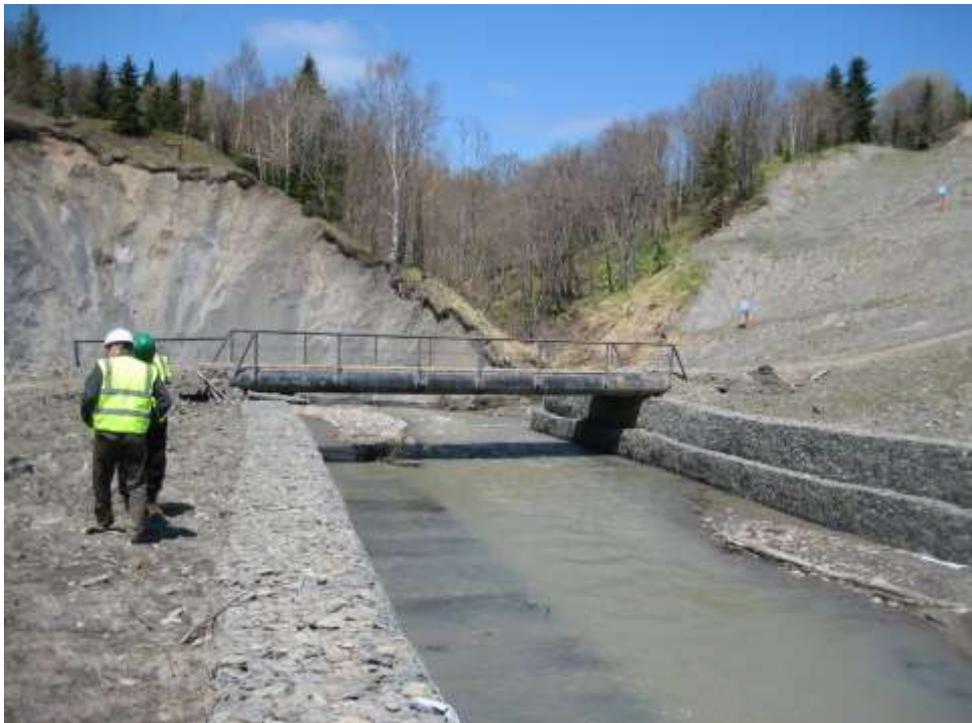
Photo 4 View of gabion walls on the banks of the Lazovaya 2 River crossing – KP 384.5

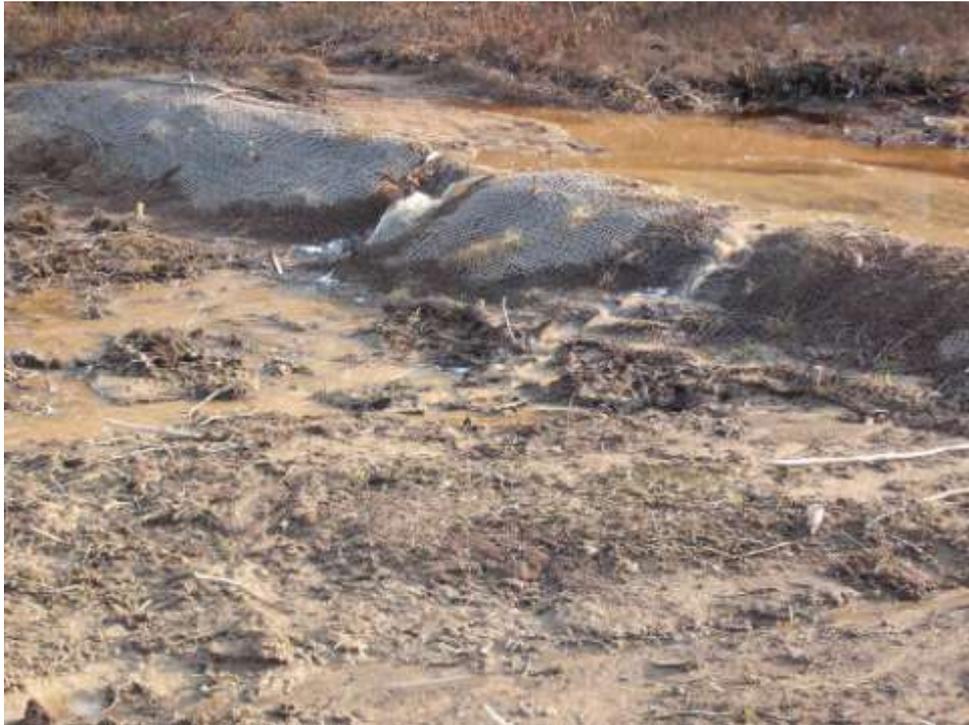
Slope breakers are an important component in managing slope drainage and erosion control. Most of the slopes observed during the visit were protected with slope breakers. For the most part, the slope breakers that were observed were performing well (Photo 7). However, there were instances in which slope breakers were constructed with too steep an angle causing rill development, or with an inconsistent gradient causing overtopping and sometimes failure of the slope breaker (Photo 8). The frequency of slope breakers on a slope is another critical aspect in their performance. More are needed as the slope gradient increases and/or the soil is less cohesive.

Photo 8 Over-topping of slope breaker near Orkunie River

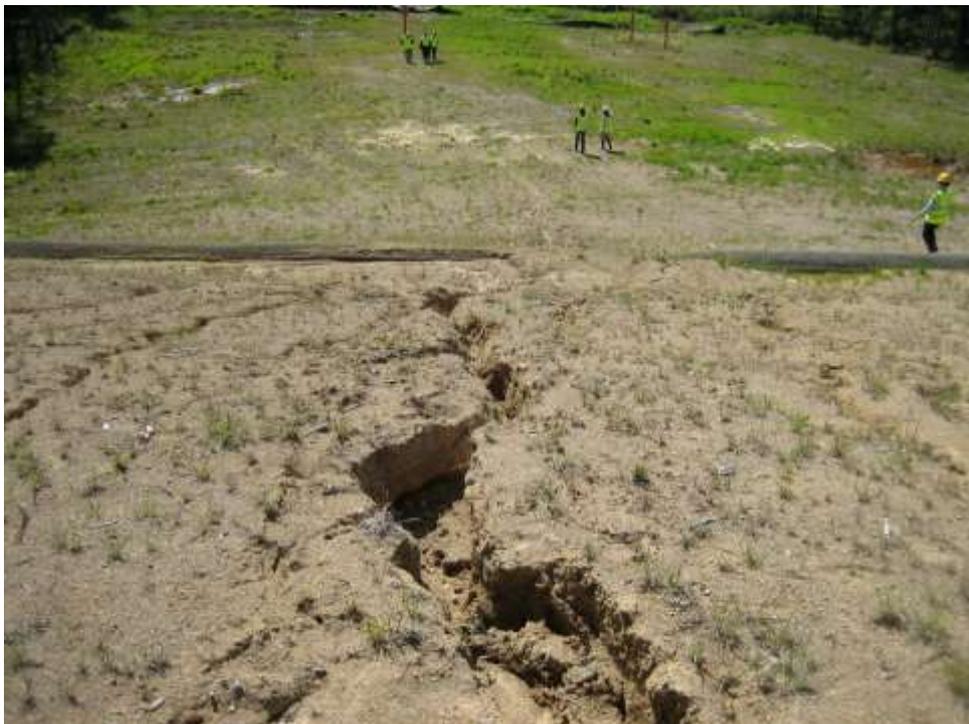
It was observed during the visit that there were some cases where too few slope breakers were installed for the conditions, resulting in soil erosion (Photo 9). It is recommended that during future repairs and other maintenance activities on slopes, more emphasis is placed on proper slope breaker construction.

Photo 9 Slope on Korsakov River showing soil erosion between slope breakers

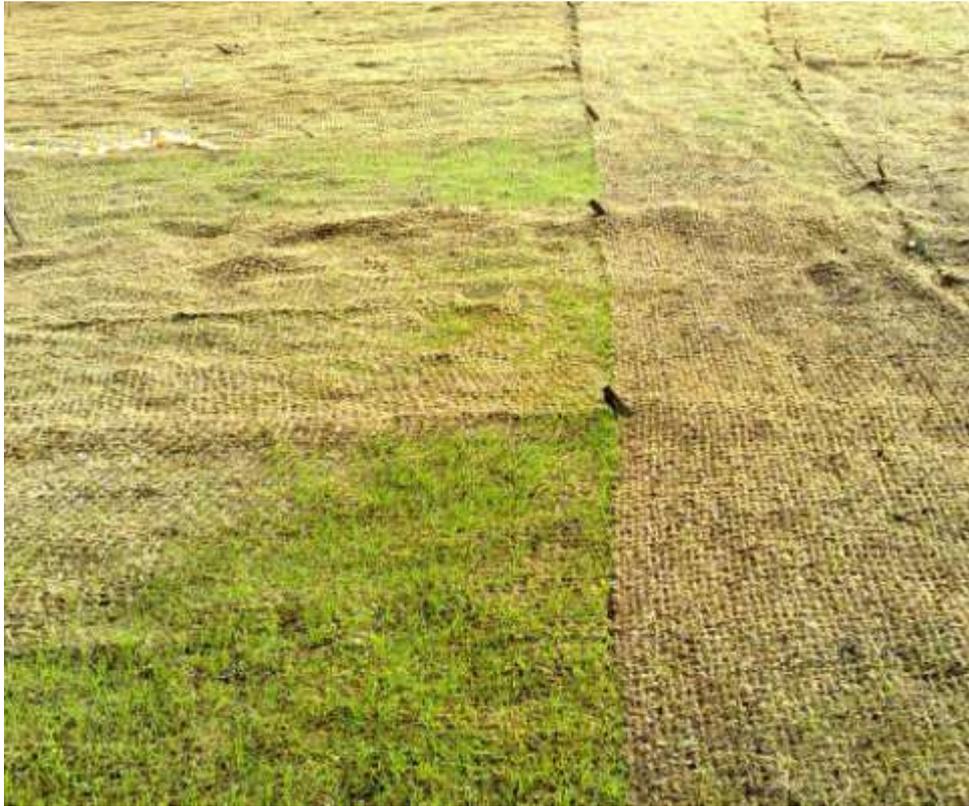
Photo 10 **Geo-jute and seeding (2008) – sandy slopes KP125**

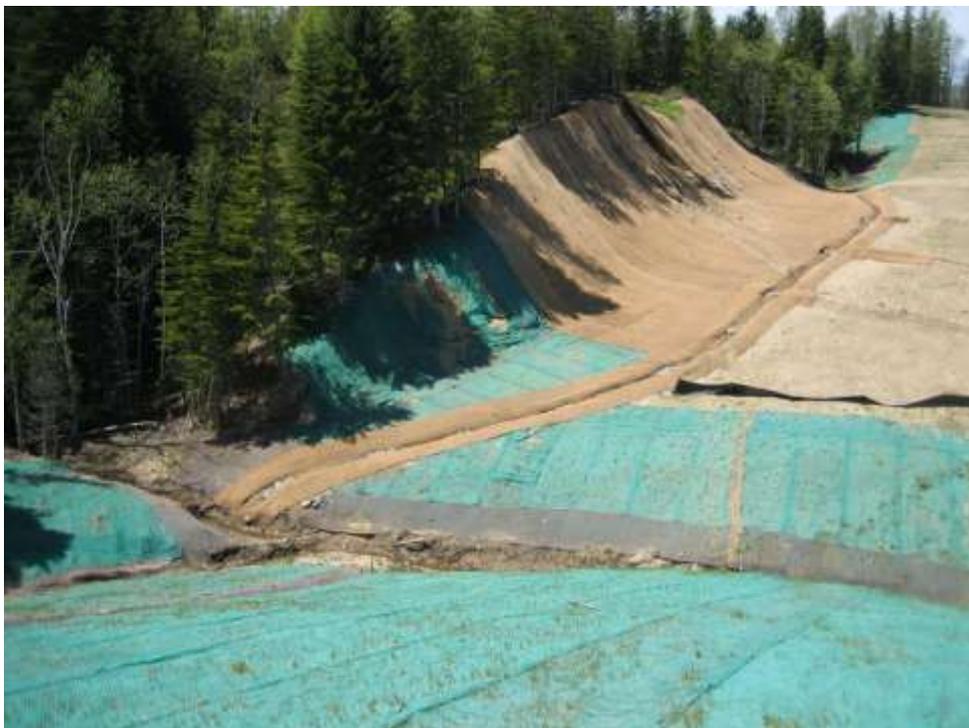
Photo 11 **Geojute and Geotextile (Enkemat) on the sandy slopes KP 512**

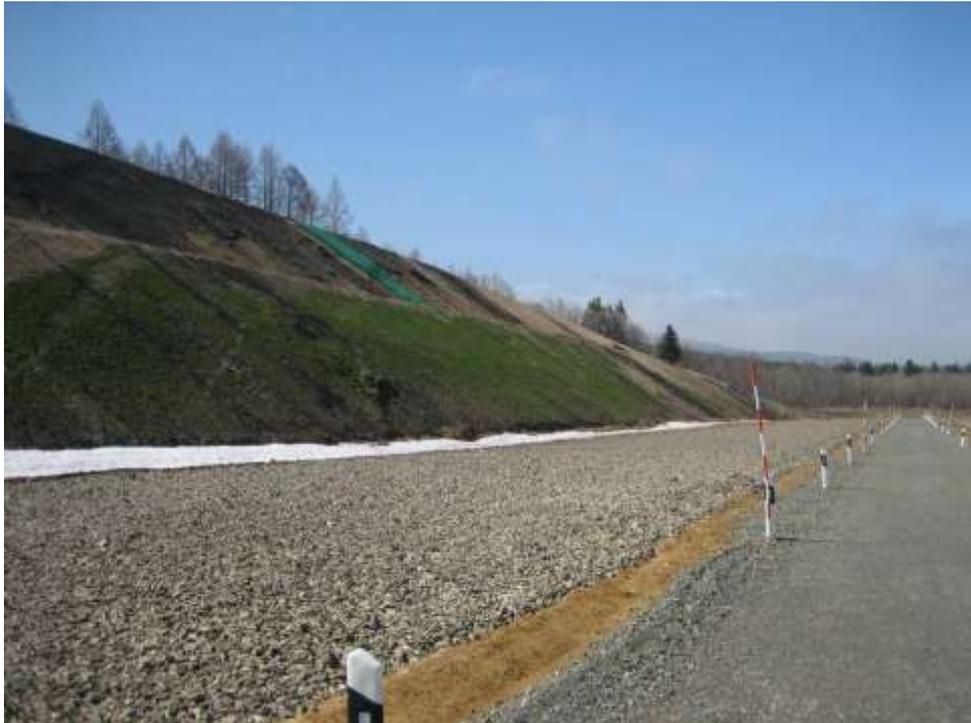
Photo 12 Partially successful use of Geotextile (Enkemat) side cuts at Fault Crossing KP 304

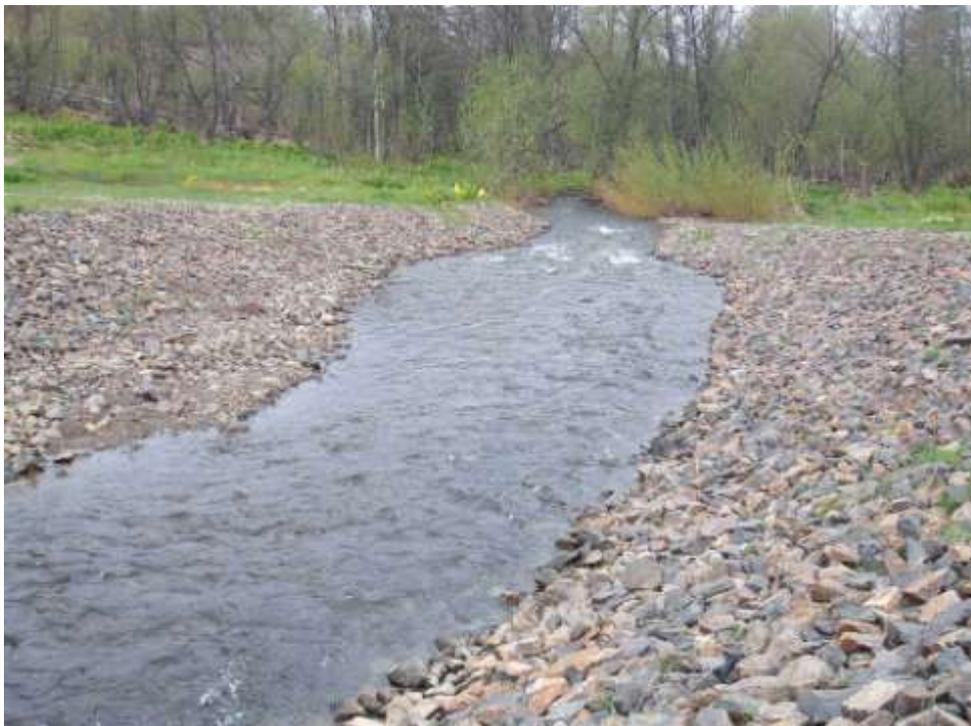
Photo 13 KP56 Svetye Stream Riprap

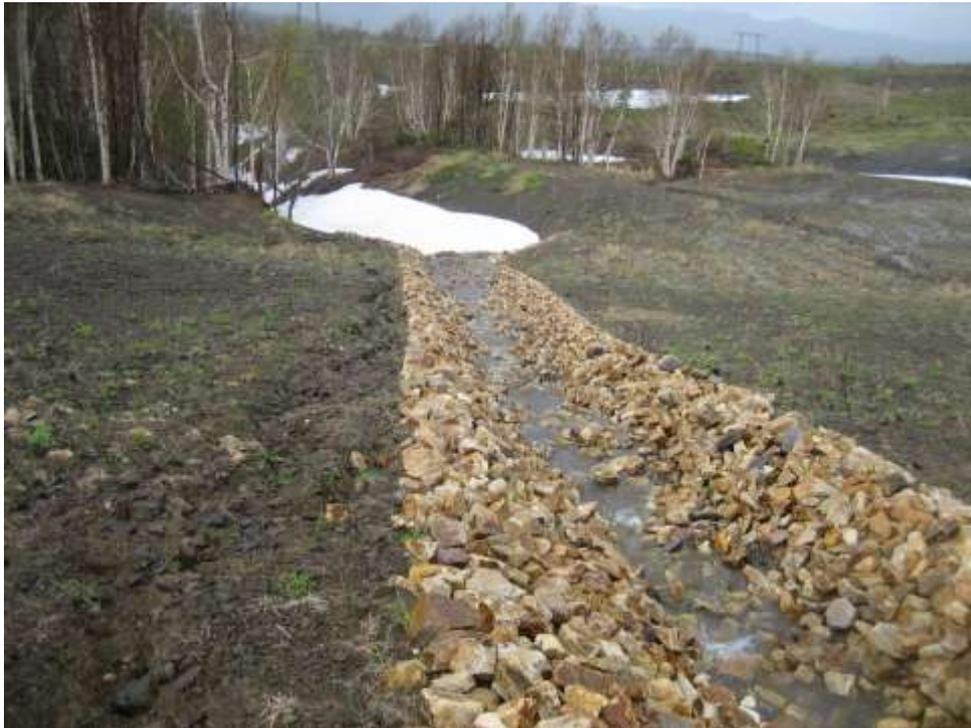
Photo 14 KP 434.9 slope on tributary to the Travyanaya River – use of riprap to line a drainage channel

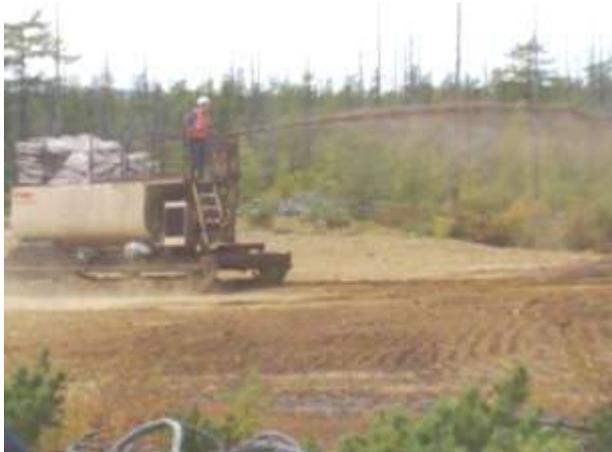
In September 2008, an IEC audit of the bio-remediation progress was carried out and found that the work was proceeding well through a mixture of hydro-seeding (Photo 17) and hand seeding of the more remote areas of the RoW. At the time, the grass growth was observed to be vigorous (Photo 18 and Photo 19) due in the main to the inclusion of a fertiliser in the hydro-seed mix. Discussions between AEA and the construction re-instatement team during the September 2008 visit highlighted the need for on-going work, further seeding and fertilisation over the next few growing seasons in order to generate a new organic-rich, self-sustaining growing medium and to aid topsoil development.

Photo 17 Hydro-seeding operation, 2008

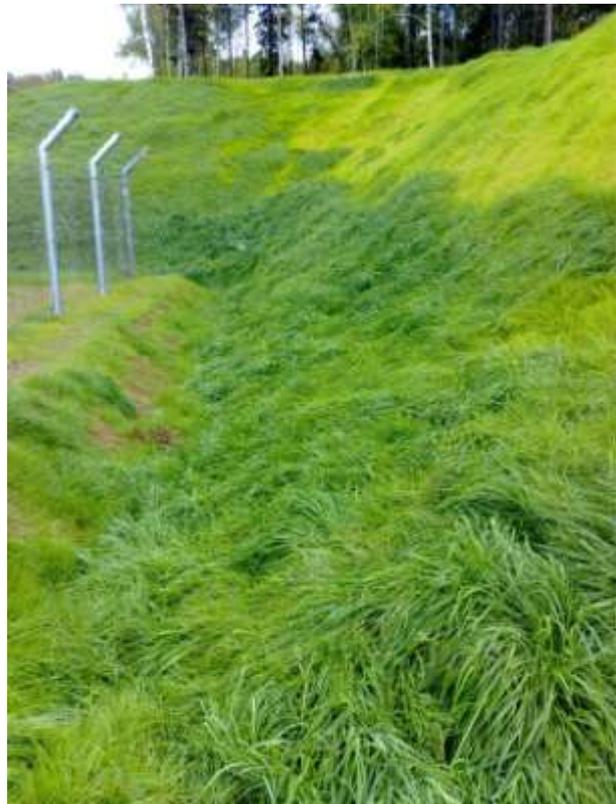
Photo 18 Lush grass growth at block valve station (BVS), 2008

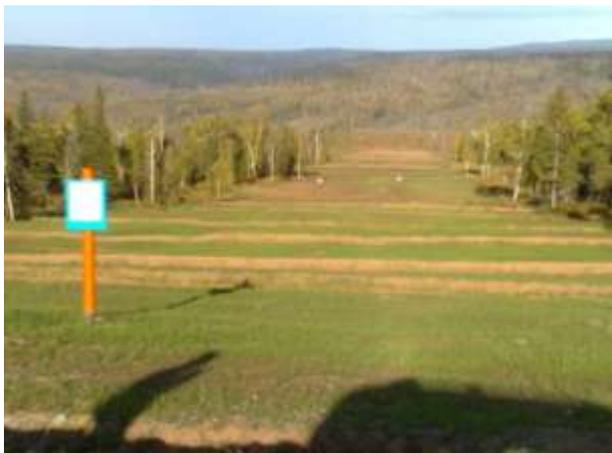
Photo 19 Grass growth on RoW, 2008

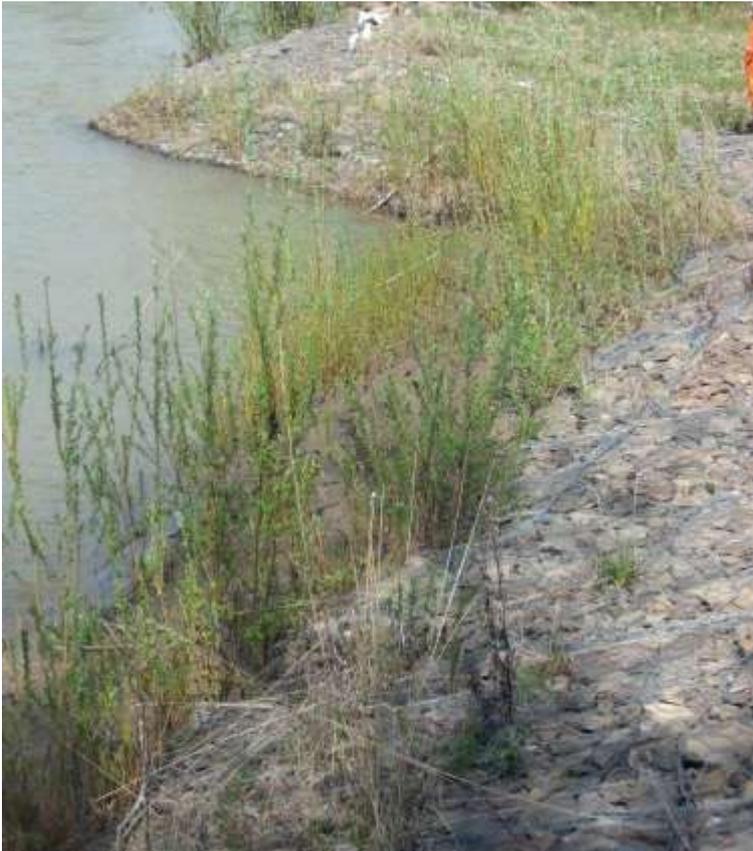
Many of the river crossings have engineering works associated with the completion – riprap, Reno mats or gabions. River flood events following the snow-melt have resulted in silt and sand sediments being deposited in varying amounts along the protected river banks. This provides a good growing medium and is resulting in natural re-vegetation in many places, which will in turn provide greater bank stability (Photo 20 and Photo 21). Generally the river banks are showing good signs of recovery.

Photo 20 Silting and Re-vegetation of Onor River, 2010

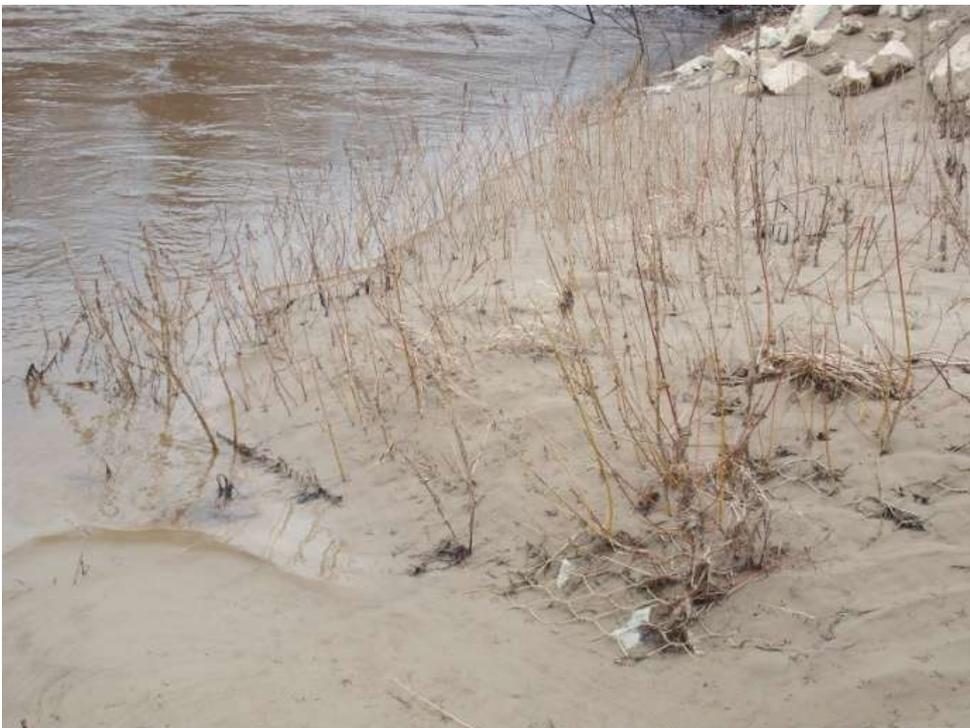
Photo 21 Silting and Re-vegetation of the Dagi River

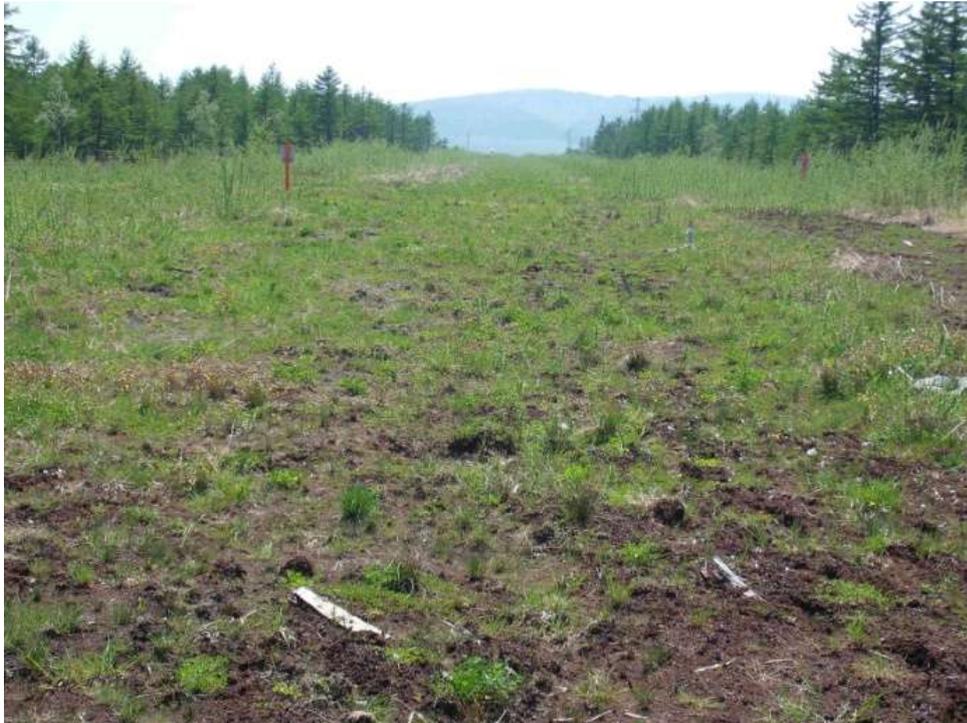
The wetland areas and river flood plains are naturally kept moist through local hydrological processes and have relatively high natural organic content. The result of this is to encourage growth both of any grasses sown as part of the reinstatement and natural re-vegetation of indigenous species (Photo 22 and Photo 23). The wetland areas in particular are showing good recovery of vegetation and the re-establishment of many native species. Sakhalin Energy is aware of the running track materials left in-situ in the Dolinsk wetlands and is currently in the process of having these removed. Due to the sensitive nature of the area, all work is being undertaken manually in order to minimise damage to the RoW.

Photo 22 Natural re-vegetation at Dolinsk

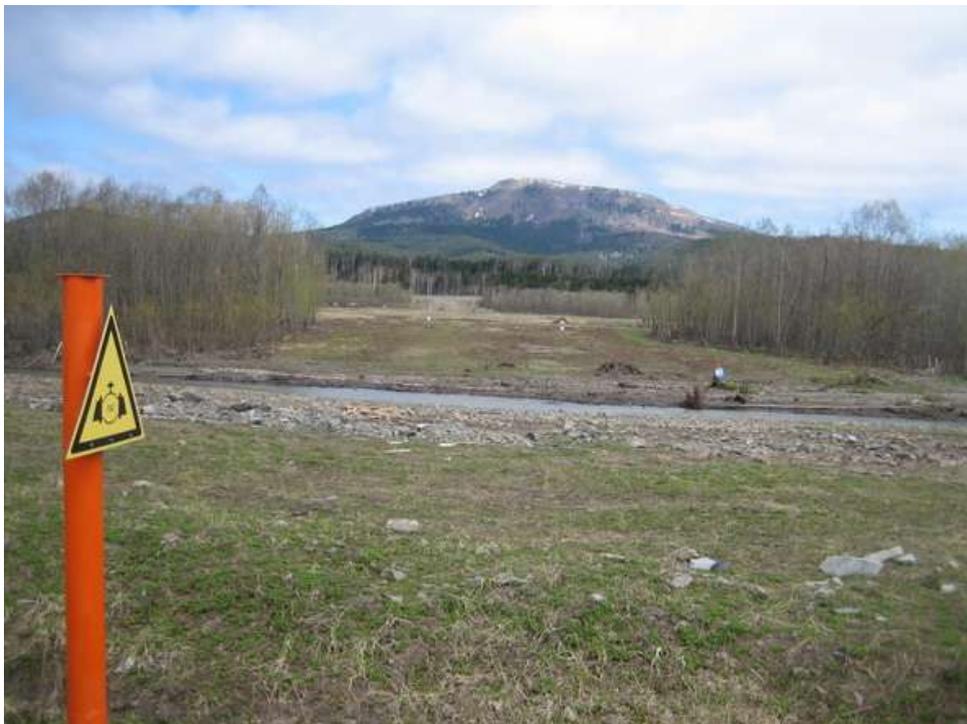
Photo 23 Vegetation at Madera River

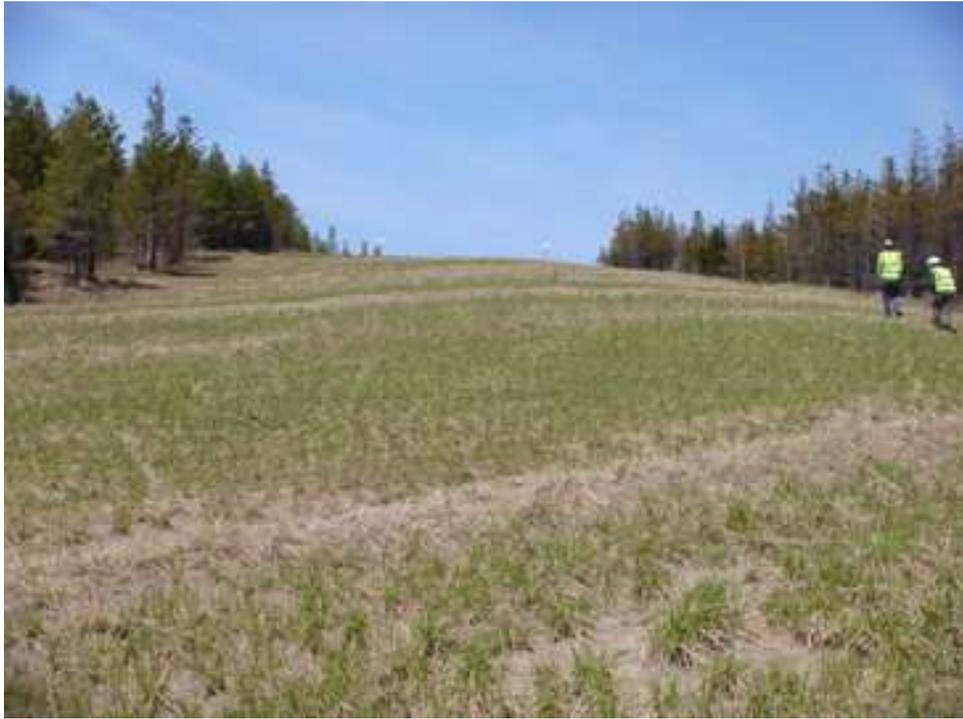
There are many areas of the RoW away from the rivers that are still low-lying – these tend to be drier and more variable in the nature of the soil than the wetland areas. The result of this is a more patchy vegetation take with some areas having good coverage (Photo 24) and others being virtually barren (Photo 25). Some work is required over the next few growing seasons to improve vegetation cover; where the coverage is already reasonable this will take the form of the addition of a suitable fertiliser in order to promote future growth and encourage the development of the root mass. Where the seeding has not taken so well, there will be a need to re-seed and fertilise and put in place a long-term maintenance ground-works programme. Hydro-seeding may need to be considered in areas where the soil cover is minimal and initial root propagation requires some encouragement. Further consideration is also required with regard to the choices of seed stock as it is evident that grass seed is not necessarily the most appropriate species for certain areas of the RoW, particularly in the north of the island. The availability of indigenous plant seeds or clovers should be explored.

Photo 24 Good vegetation on RoW to Vulkanka River

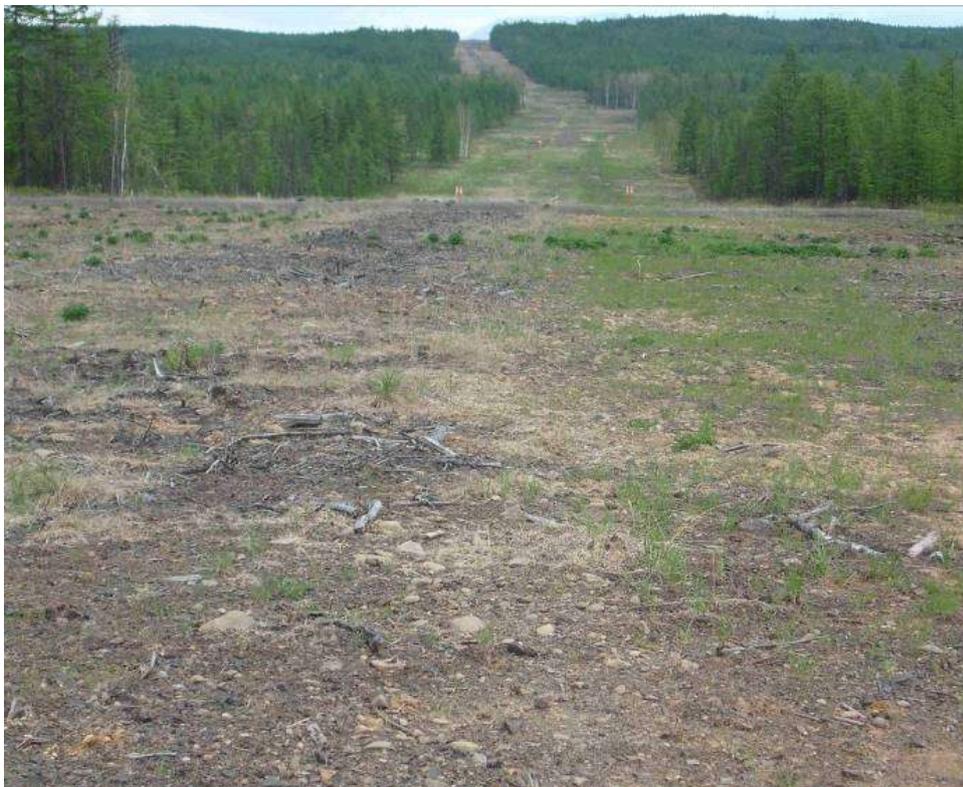
Photo 25 Sparse vegetation on approach to Taulyanka River

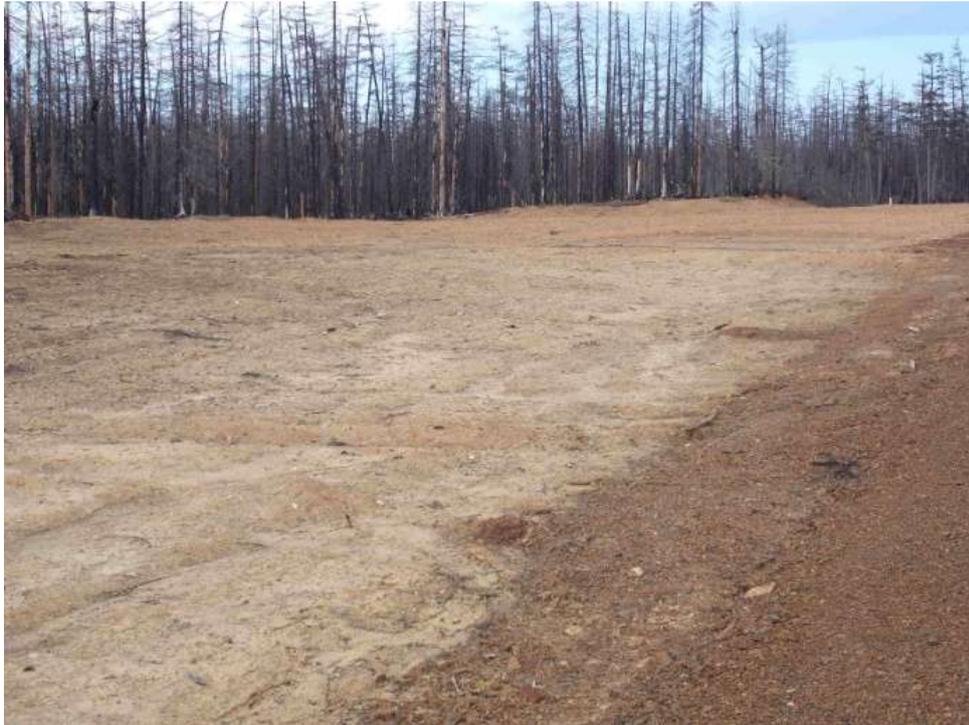
Photo 26 Lack of soil cover on sandy RoW

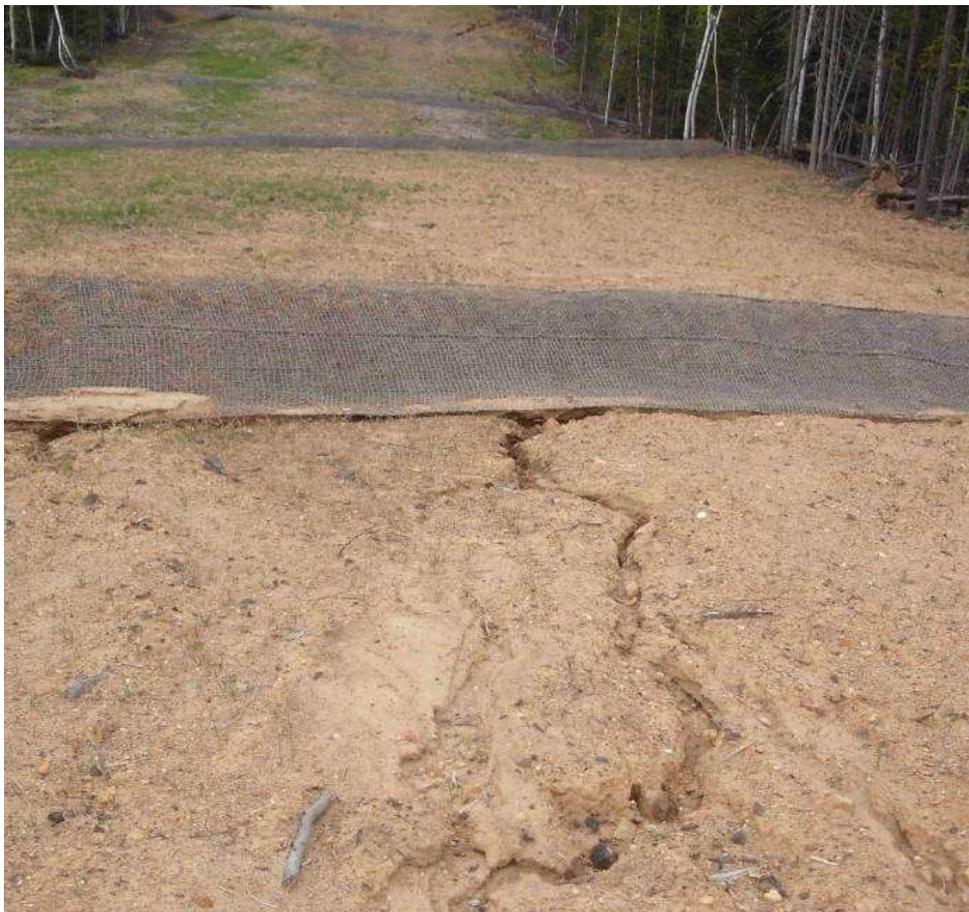
Photo 27 Sandy slopes showing barren and sparse vegetation areas

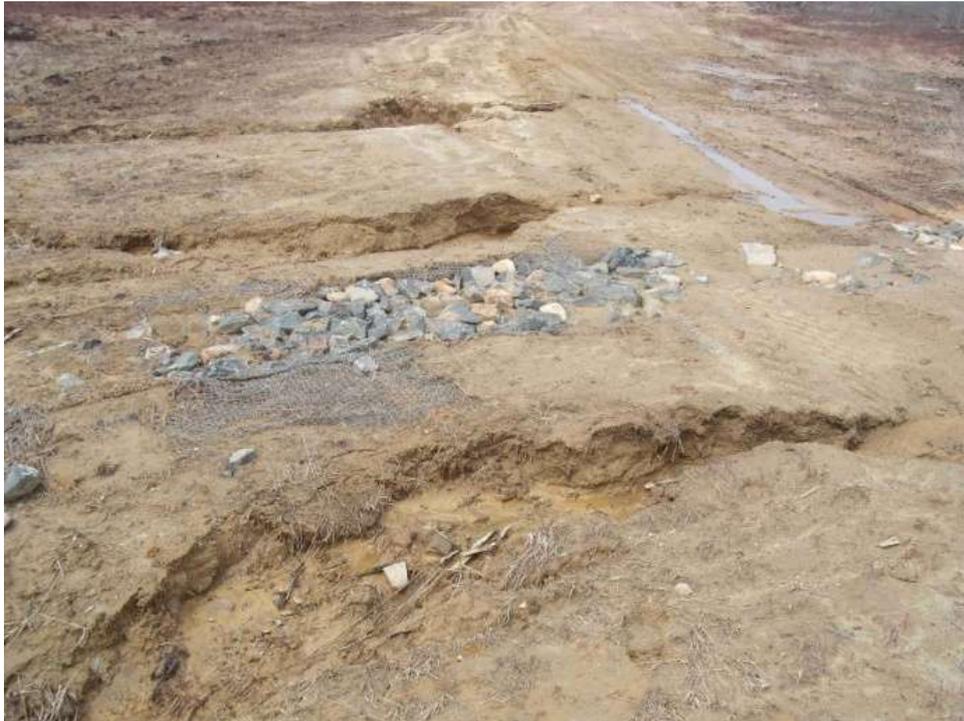
There are many kilometres of RoW that are predominantly composed of sand with little or no topsoil cover – this is particularly apparent north of Nogliki and an area in the former construction Spread 2 around KP 125. There are several other parts of the RoW where the underlying geology has resulted in a mainly sandy soil at surface. The majority of these stretches have no vegetation or poor vegetation cover as the result of there being no suitable soil growing medium present (Photo 26 and Photo 27). This is resulting in silt and sand run-off from the RoW and the development of erosion features (Photo 28) affecting the long-term viability of these areas.

Photo 28 Erosion features in sandy RoW

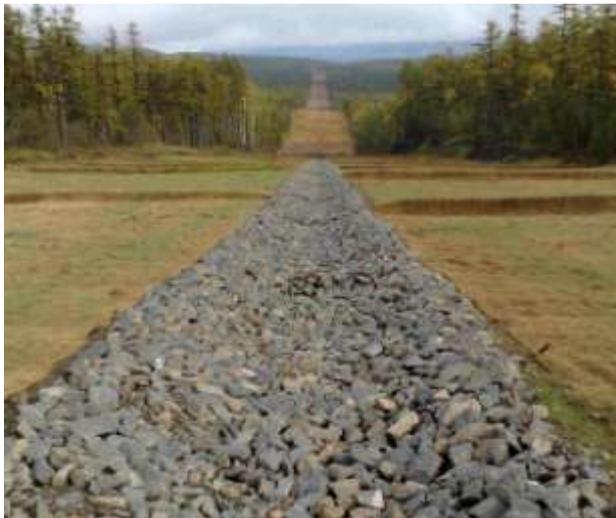
(Photo 29). However, it would appear that certain elements of the long-term maintenance such as on-going fertilisation and silt trap cleaning, have not been rigorously enforced. This has the result that vegetation growth is poor or non-existent in some areas and the benefit of the root system fixing the soils in place is not being achieved (Photo 30). These areas now require complete renovation with new drainage systems being put in place, the installation of silt fencing and silt traps for short-term run-off prevention, renewal of the coco matting in sensitive areas, re-seeding (potentially hydro-seeding to enhance early growth) and long-term fertilisation over a few growing seasons to encourage the development of root mat. As stated before, consideration needs to be given to the type of seed stock used to enhance the chances of success in these areas.

Photo 29 Sandy slopes 2008 with drainage, coco matting and grass growth

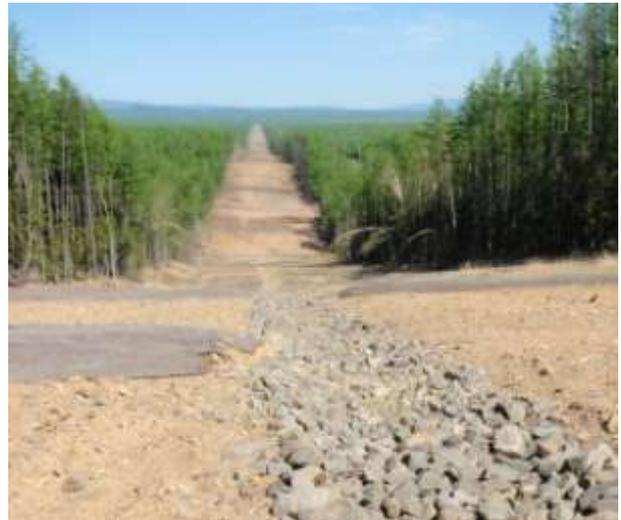
Photo 30 Sandy slopes 2010 – coco matting on slopes gone and seed stock not in evidence, no shoots showing

In the sandy areas, where there is a majority of barren stretches of RoW, alternatives need to be explored to re-introduce active plant growth since hydro-seeding in isolation has not resulted in a long-term solution. It is likely that several years of work, revisiting the areas every growing season, will be required before the slopes become self-sustaining.

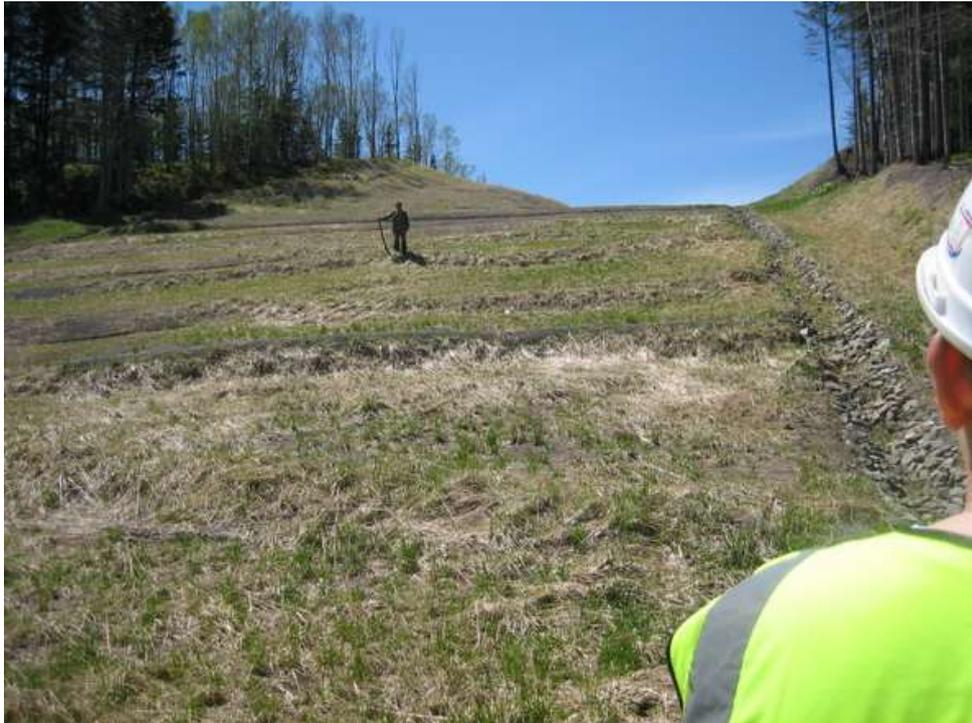
The lower slopes of the hills along the RoW, in particular those with a southern aspect, are generally showing good re-vegetation, possibly due to moisture run-off down the slopes and the associated increased nutrition load (Photo 31). In places these slopes still require some further nutrition addition to encourage further growth (Photo 32) and in some areas there will be limited re-seeding to be carried out. However in general, these are in good condition and should require minimal, but continued, maintenance.

Photo 31 Well vegetated lower slope, Podgornaya River

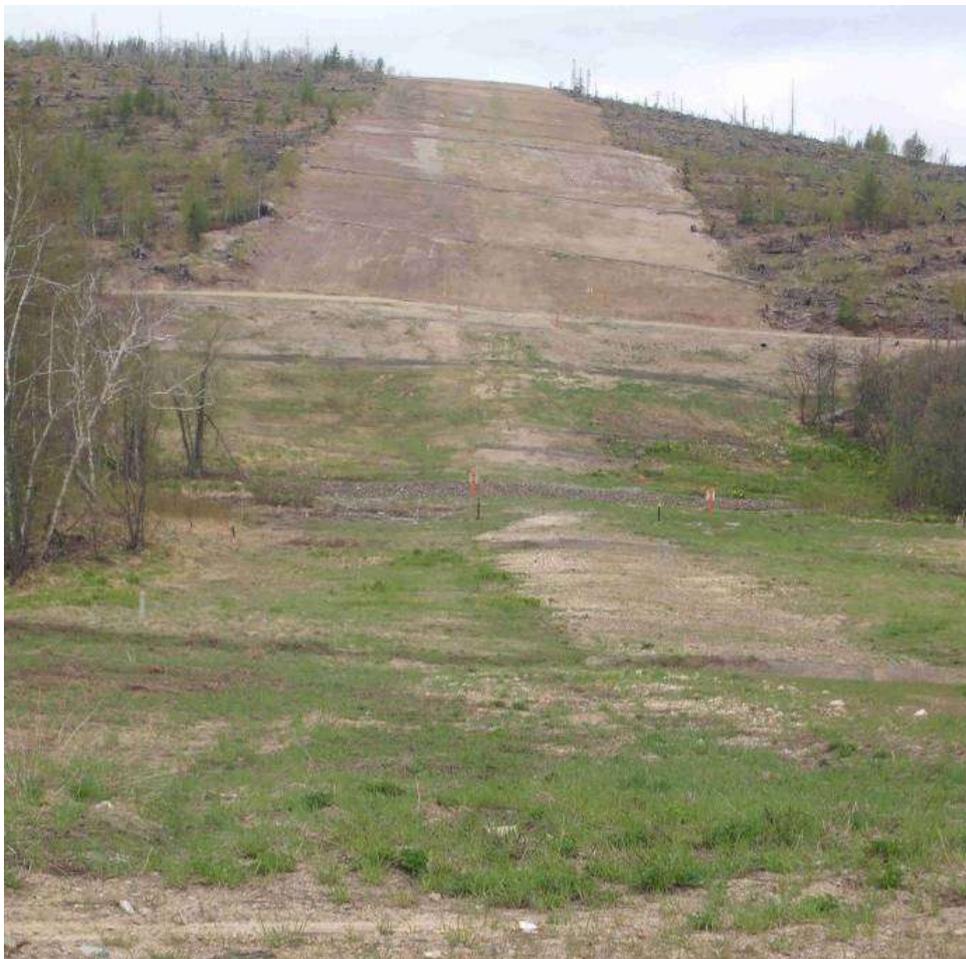
Over many parts of the RoW it was apparent that the re-vegetation of the hill-tops had not been as successful as that lower down the slopes. This graduation can be seen in Photo 32. As a result, Sakhalin Energy is having to carry out work in maintaining the slope engineering, slope breakers drainage etc. which is holding the main slope stability well (Photo 33 and Photo 34) but is still resulting in shallow failures and run-off. Further work is required to encourage vegetation growth on these slopes with extensive re-seeding and fertilisation needed. Some slopes would benefit from hydro-seeding initially, with follow up fertilisation at the start of the growing season for a few years until the root mat is established.

Photo 32 Graduation in slope vegetation KP56.6 Svetly Stream

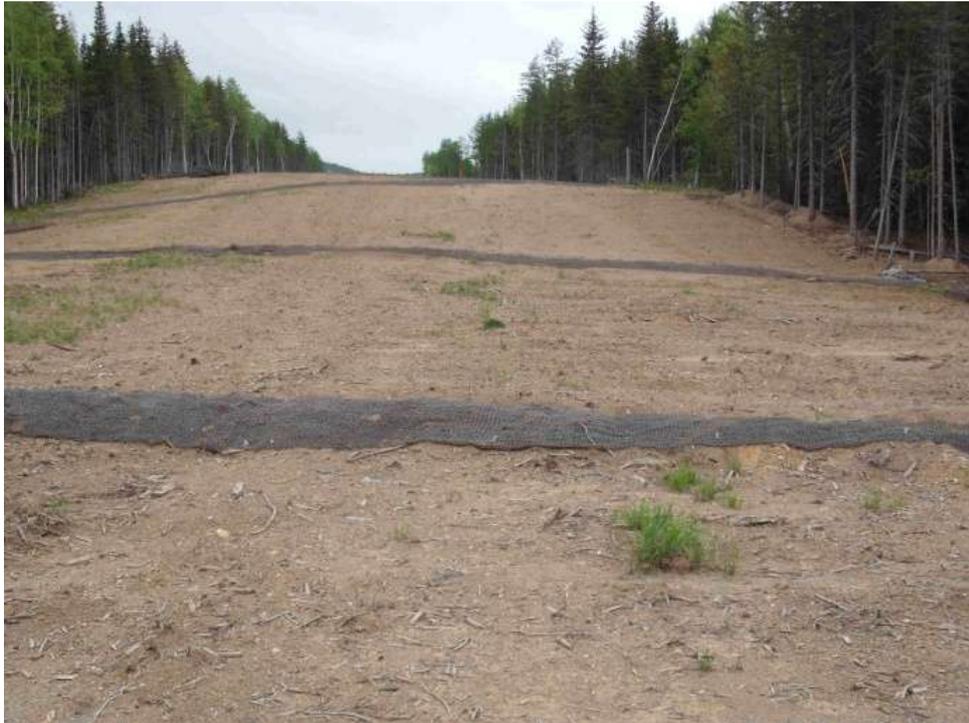
Photo 33 Sparse vegetation on upper slopes, Voskresenka River

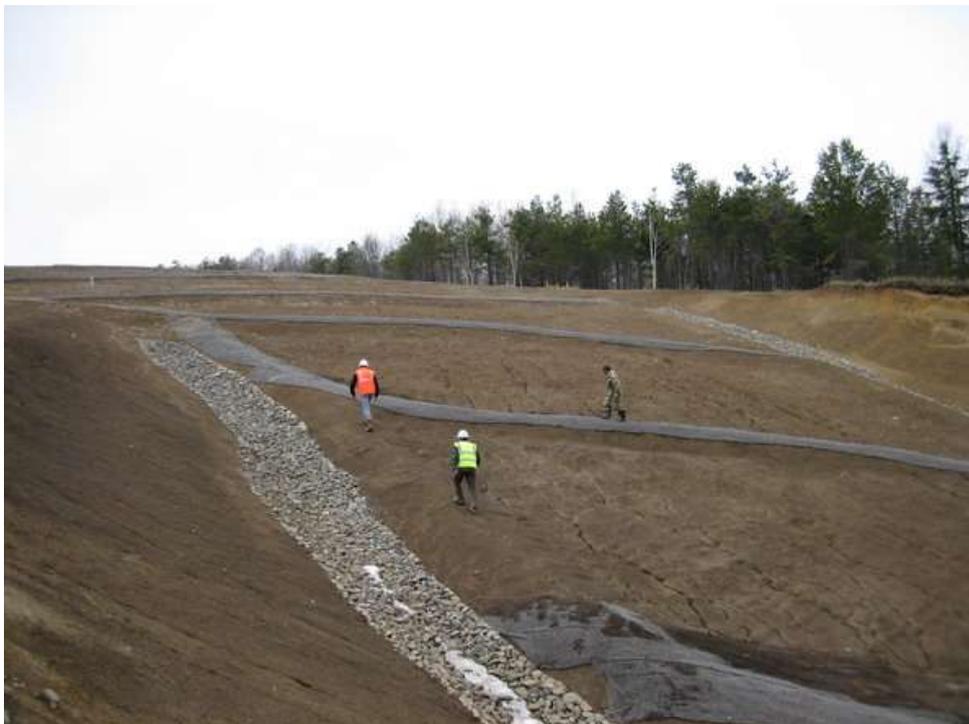
Photo 34 Heavy duty engineering works but lack of vegetation, Khormovaya River

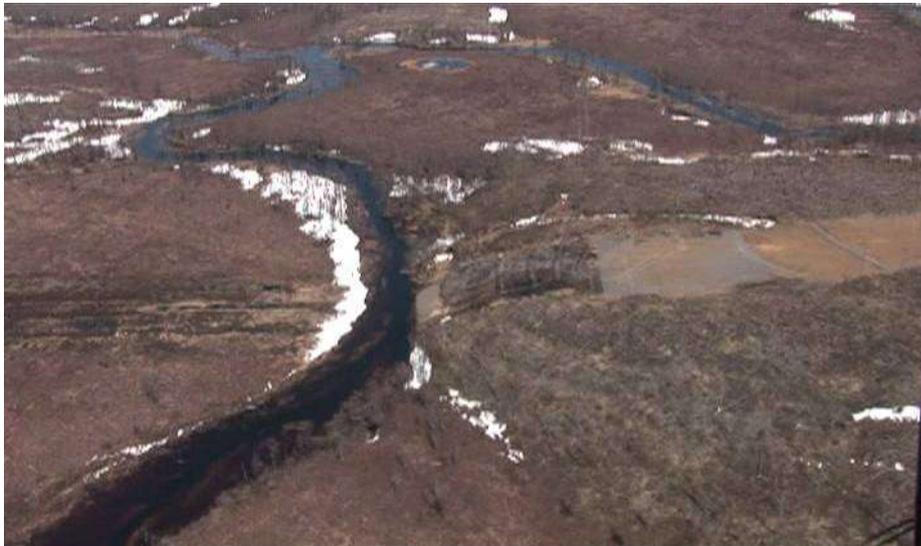
2. As an overview of areas of biological reinstatement, the video was useful as it was clear which parts of the RoW were showing good growth and which were barren (Photo 40).

Photo 40 Bauri River showing good vegetation to the left and no vegetation to the right

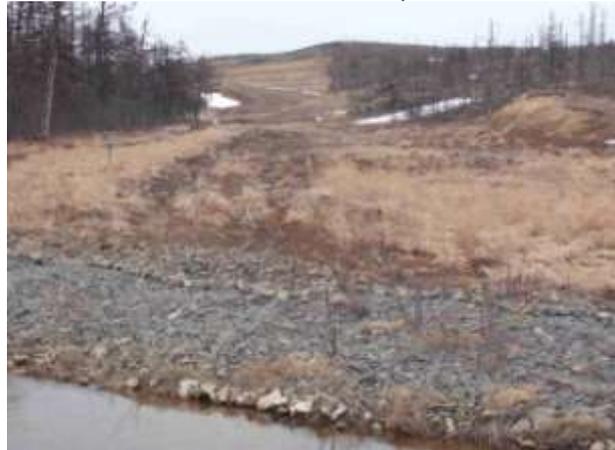
The river banks are protected by Reno matting which appears in good condition with a limited amount of growth through the matting starting to appear (Photo 1). The RoW slopes to the north show evidence of good vegetation, particularly on the lower slopes towards the river where the peat concentrations are higher, and the slope breakers appear to be functioning well (Photo 1). The southern bank appears to be more sandy and, while there is evidence of reasonable vegetation over the last year, there is still evidence of the start of erosion rills forming (Photo 2) the time of year so close to the snow-melt made it difficult to ascertain as to whether there will be a recovery of vegetation this year. In places the erosion is becoming more severe with washouts behind slope breakers (Photo 3) and sand and silt run-off away from the RoW (Photo 4).

Photo 1 – Northern Bank and Slopes

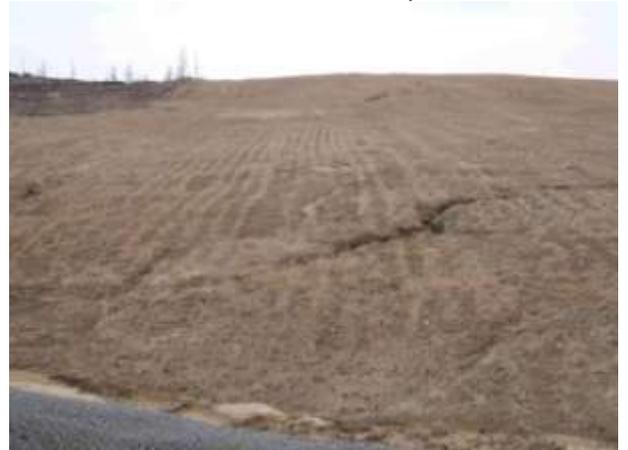
Photo 2 – Southern Bank and Slopes
