Lenders' Independent Environmental Consultant: Monitoring Report June 2010 Sakhalin-2 Phase 2 Project

Report to Sakhalin-2 (Phase 2) Project Finance Parties

Restricted – Commercial
AEAT/ENV/R/3052 Issue 1
July 2010

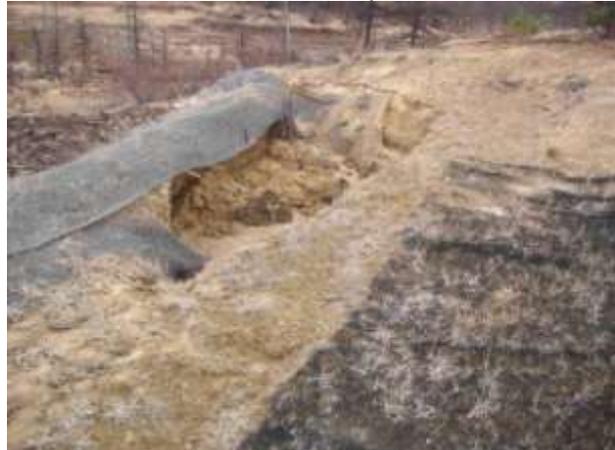
The river banks are protected by Reno matting which appears in good condition with a limited amount of growth through the matting starting to appear (Photo 1). The RoW slopes to the north show evidence of good vegetation, particularly on the lower slopes towards the river where the peat concentrations are higher, and the slope breakers appear to be functioning well (Photo 1). The southern bank appears to be more sandy and, while there is evidence of reasonable vegetation over the last year, there is still evidence of the start of erosion rills forming (Photo 2) the time of year so close to the snow-melt made it difficult to ascertain as to whether there will be a recovery of vegetation this year. In places the erosion is becoming more severe with washouts behind slope breakers (Photo 3) and sand and silt run-off away from the RoW (Photo 4).

Photo 3 – Washout behind Slope Breaker

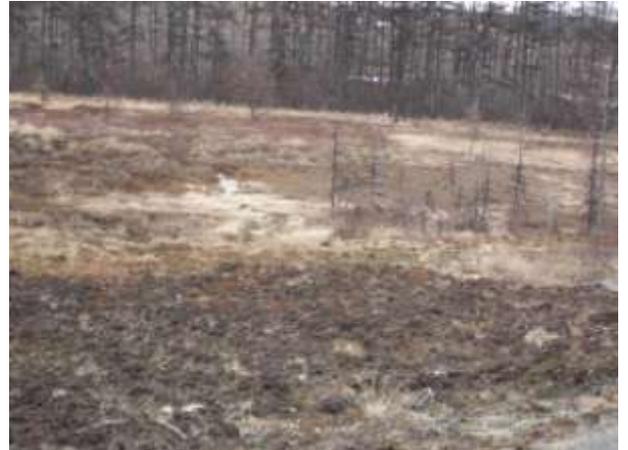
Photo 4 – Silt run-off from the RoW

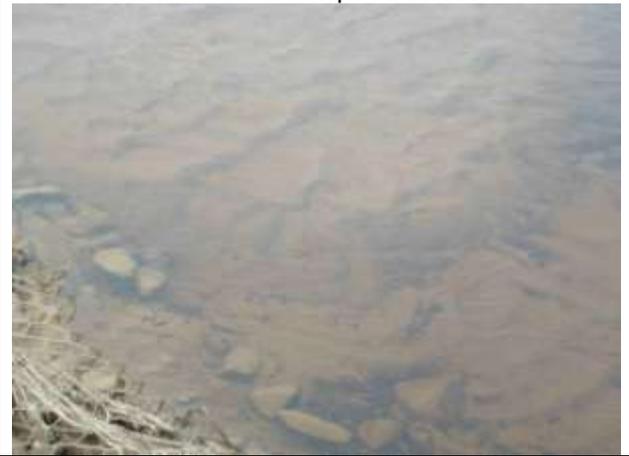
It was noted that across the width of the RoW in the river bed there was a significant deposit of fine sand and silt over the river bed. This was only apparent in the RoW indicating that materials are being washed into the river, possibly through the Reno mats.

Photo 5 – Sediment Build up in RoW River Bed

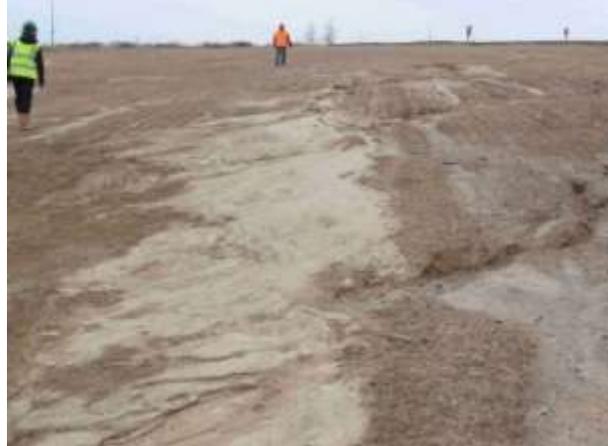
The pipeline RoW is gently sloped from east to west along this stretch with pronounced run-off evidence across the slope and the lack of vegetation growth is resulting in several areas of silt run-off (Photo 1) and erosion rills forming (Photos 2 and 3). This in turn is leading a large volume of material spreading off the RoW into the surrounding countryside (Photo 4).

Photo 1 – Vegetation lack and start of silting

There is an urgent need in this area for further drainage works to control the run-off across the slope and re-seeding / soil protection to prevent further silting.

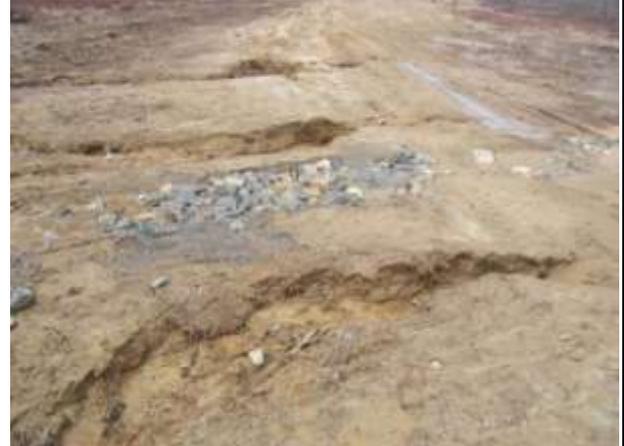
Photo 2 – Erosion rills forming

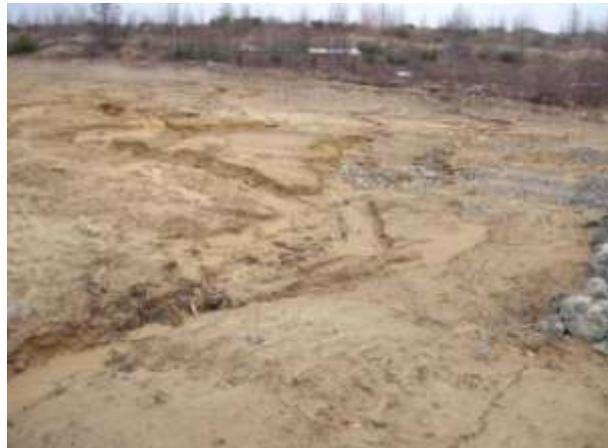
Photo 3 – Erosion runs from east to west across RoW

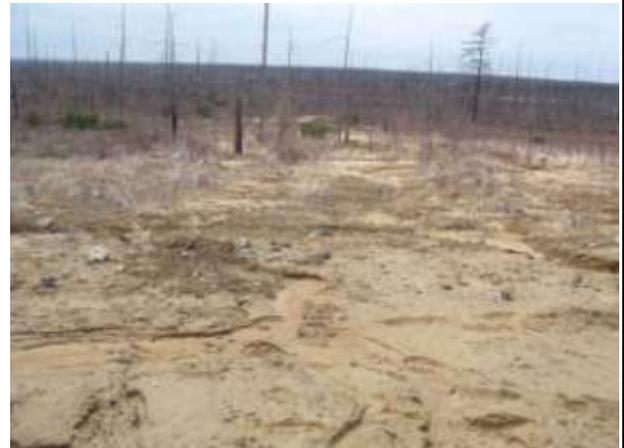
Photo 4 – Silt and sand run-off away from the RoW

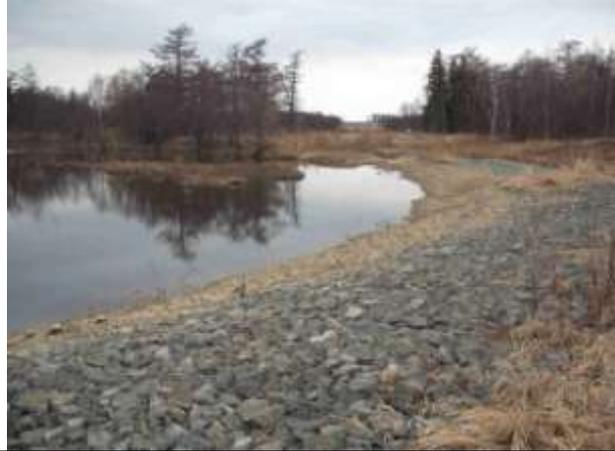
The northern approach to the crossing was very wet but showing good signs of re-vegetation, the protection works installed along the shore of the ox-bow lake to the west of the RoW were in good condition with the Reno mats undamaged (Photo 1). The main river crossing was in good condition with the Reno mats in position as far as could be ascertained due to a thick covering of silt from the river. The silt layer is proving to be a good growing medium for the re-vegetation of the river bank (Photos 2 and 3) which will have the beneficial long-term effect of further bank stabilisation. The southern bank and approach to the river seemed to be in good condition and showing good vegetative growth (Photo 4).

Photo 1 – Ox-bow lake bank protection

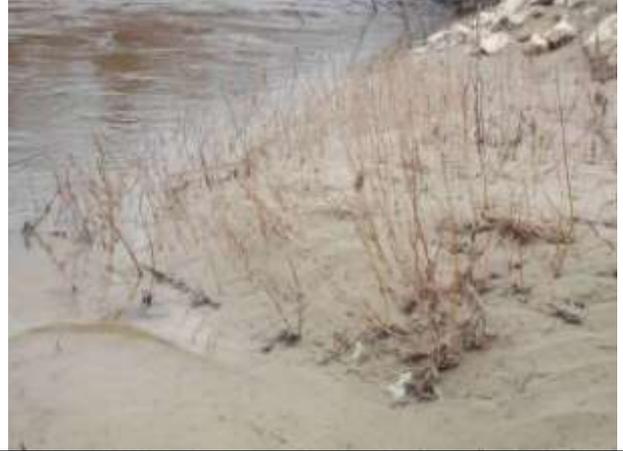
Photo 2 - Silting and re-vegetation of north bank

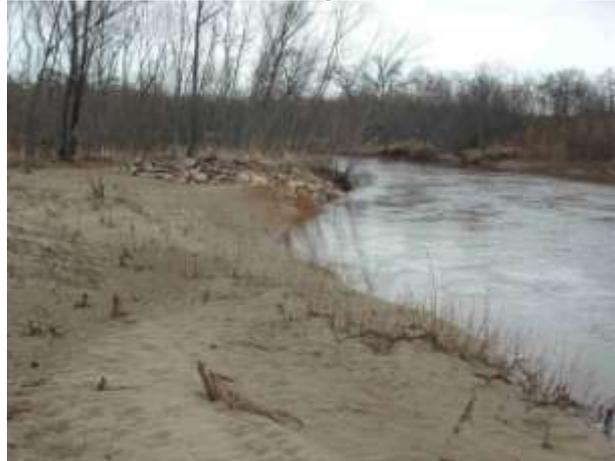
Photo 3 – North bank silting of Reno mats

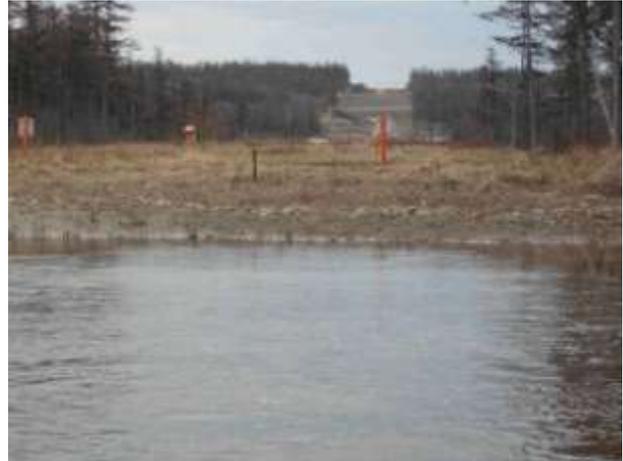
Photo 4 – View to south bank

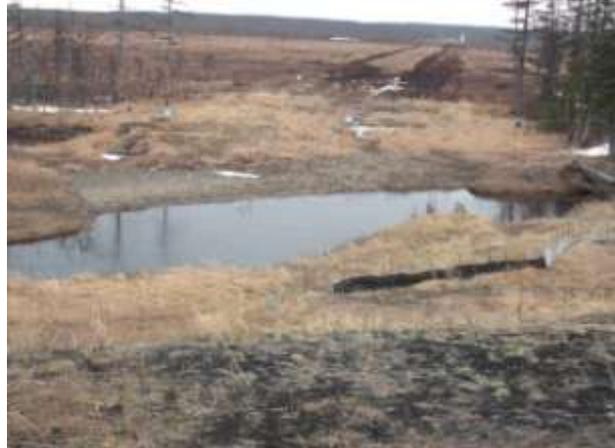
The crossing area itself has the Reno mats in reasonable condition with some silting up from river deposition; the vegetation around the river has recovered well (Photo 1). There is some evidence that the meander to the east of the crossing has cut into the bank further and there is a risk that this could cut in behind the RoW bank protection (Photo 2). This should be monitored for further development and, where necessary, bank protection work undertaken.

Photo 1 – Bank protection and vegetation

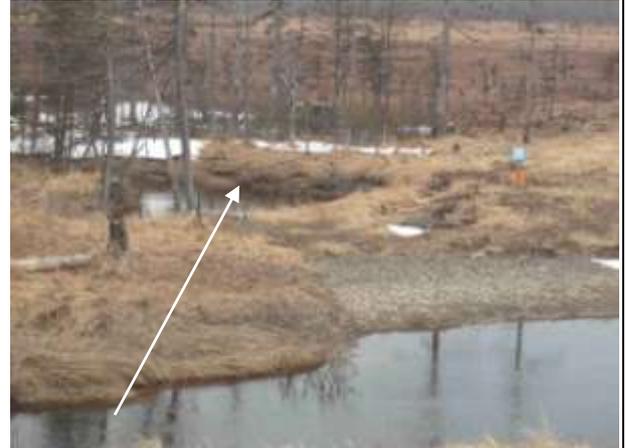
Photo 2 – Meander to rear of RoW

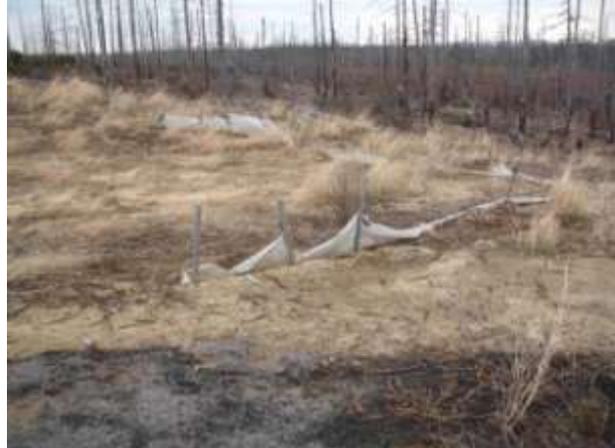
Vegetation further away from the river on the north side has not established so well, this has led to erosion and silt run-off in places that has overwhelmed the silt fencing (Photo 3). Work is required to re-vegetate the RoW in the long-term and to remove silt and replace silt fencing in the short-term.

Photo 3 – Silt fencing overwhelmed

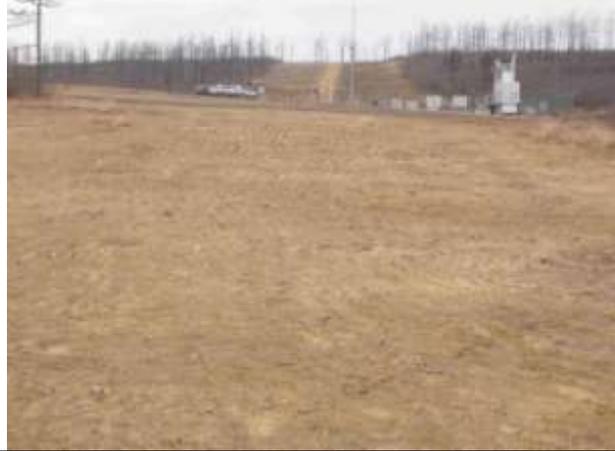
Vegetation at the top of the hill is sparse (Photo 1), although at this site there is no evidence of erosional features forming and the slope breakers are holding well, this is an improvement as the area had a major silt flow occur in 2006/07. The vegetation growth improves further down the hill (Photo 2) and is good in the river valley area where there is more peat and organic matter in the soil (Photo 3).

Photo 1 – Sparse vegetation on hill tops

Work is required at the site to improve the vegetation on the hill tops and upper slopes.

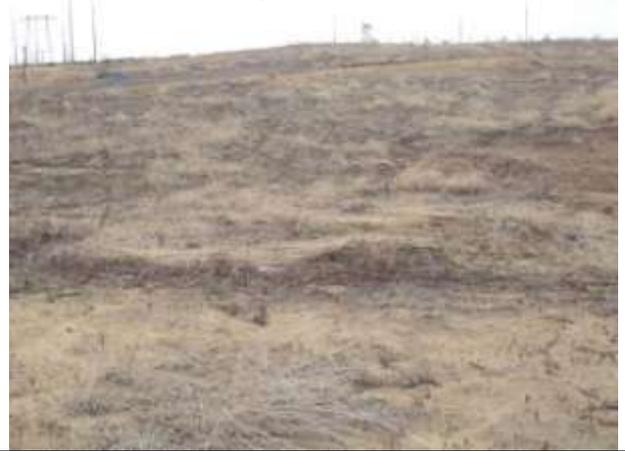
Photo 2 – Thicker vegetation on lower slopes

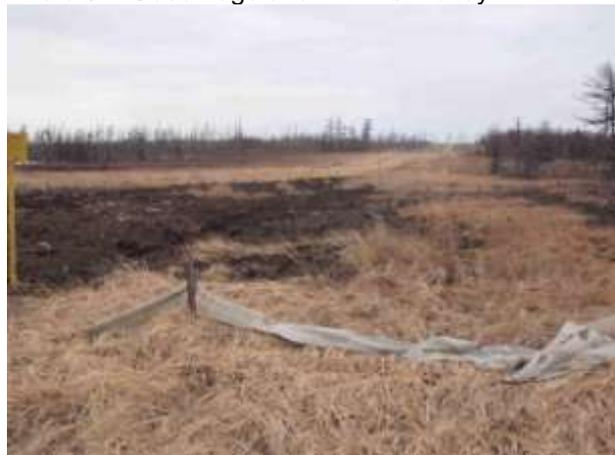
Photo 3 – Good vegetation in river valley

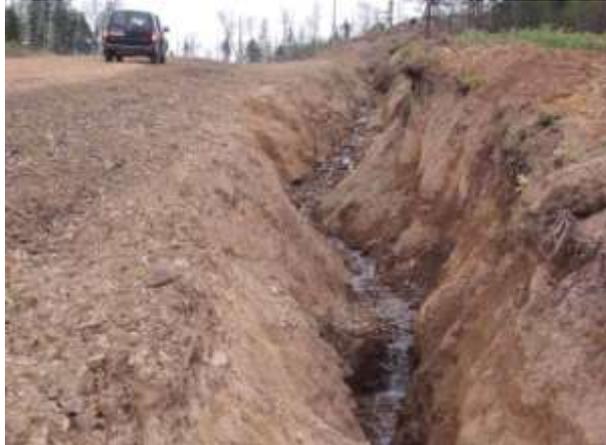
The approach road is generally well made and holding its integrity, however on the slope down to the main valley there is evidence of the start of a wash-out forming (Photo 1) which is leading to silting of the river valley (Photo 2) and subsidence of the road and safety barrier (Photos 3 and 4). Some road maintenance is required to improve the road surface and barrier at this point to prevent on-going failure.

Photo 1 – Erosion rill at side of access road

The drainage of the slope run-off needs improvement to prevent further erosion and silt controls, silt fencing or trench breakers, to be installed to stop further silting of the valley floor.

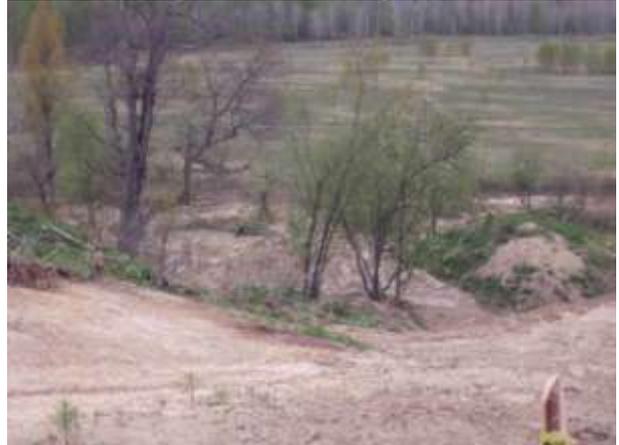
Photo 2 – Silt run-off on to valley floor

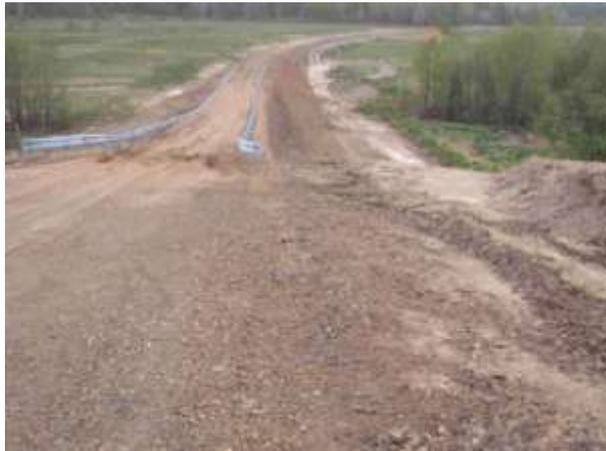
Photo 3 – Access road subsidence

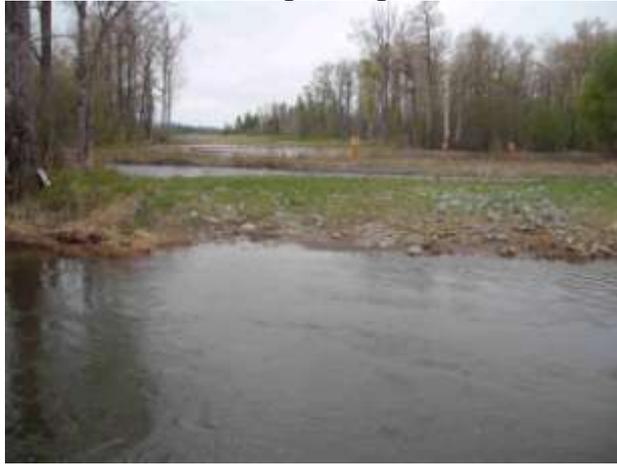
The river banks are in good condition with silting of the bank encouraging growth and bank stabilisation (Photos 1 and 2), the river bed appears clean and gravelled.

Photo 1 – River crossing looking south-west

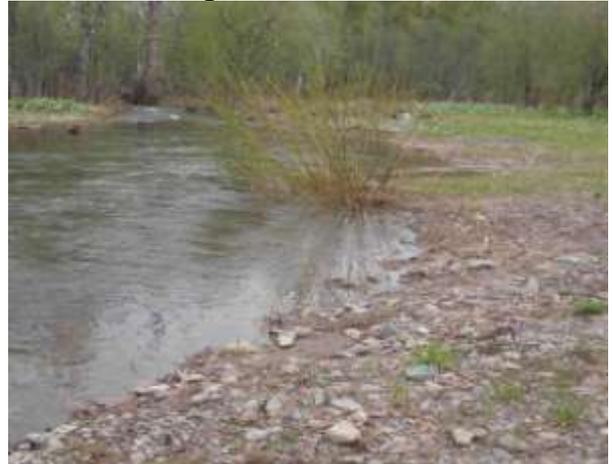
Photo 2 – Re-vegetation of river bank

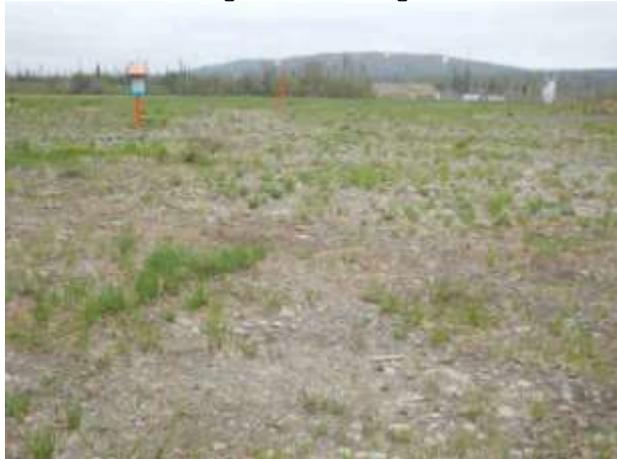
The approach to the river is partially re-vegetated with a reasonably healthy looking cover coming through although this is still quite patchy and may require further fertilising in the future to encourage further growth (Photos 3 and 4).

Photo 3 – RoW vegetation looking to TOB-01

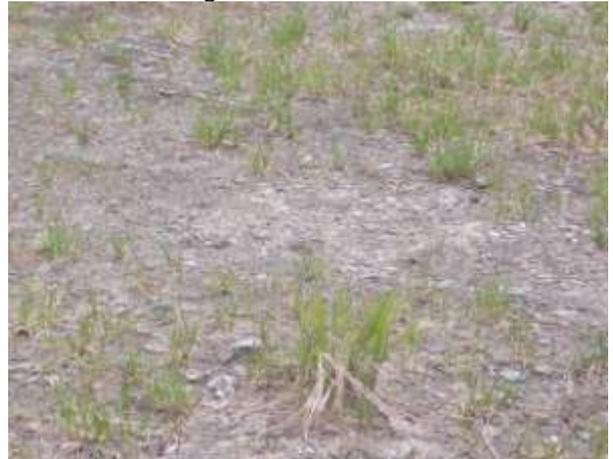
Photo 4 – Re-vegetation detail

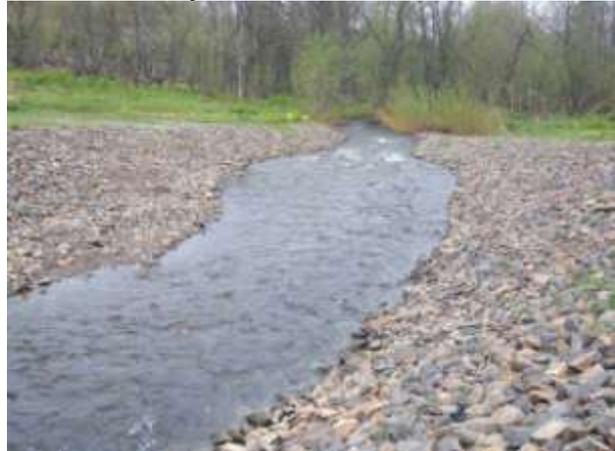
The river crossing is protected by rip-rap and was in very good condition with the river running clean with no evidence of silting (Photo 1).

Photo 1 – Svetly Stream banks

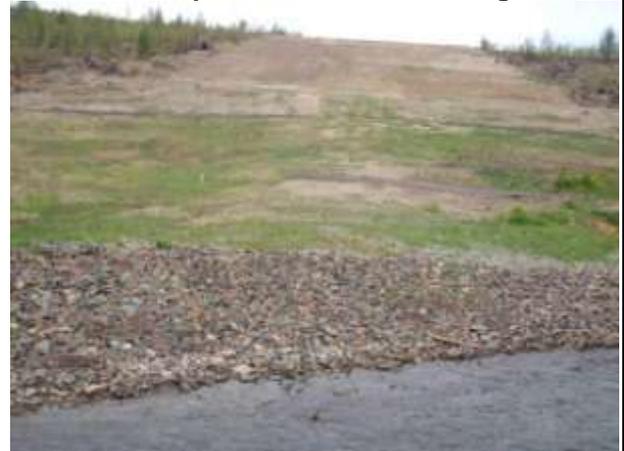
The re-vegetation is good close to the river on the lower slopes (Photo 2) but the old running track is still visible due to poor vegetation recovery (Photo 3) and the hill tops also show poor re-vegetation (Photo 4), although it was noted that the slopes were structurally sound with the slope breakers working well. Fertiliser application will be required in these areas and some limited re-seeding in the more barren areas.

Photo 2 – Svetly Stream west bank re-vegetation

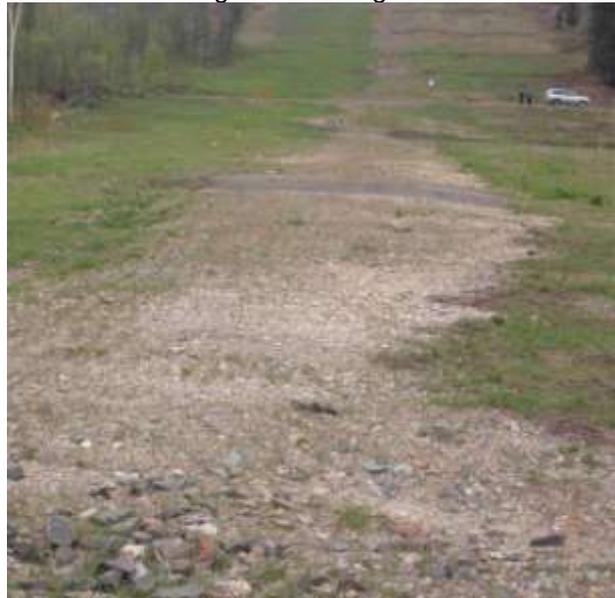
Photo 3 – Running track looking east

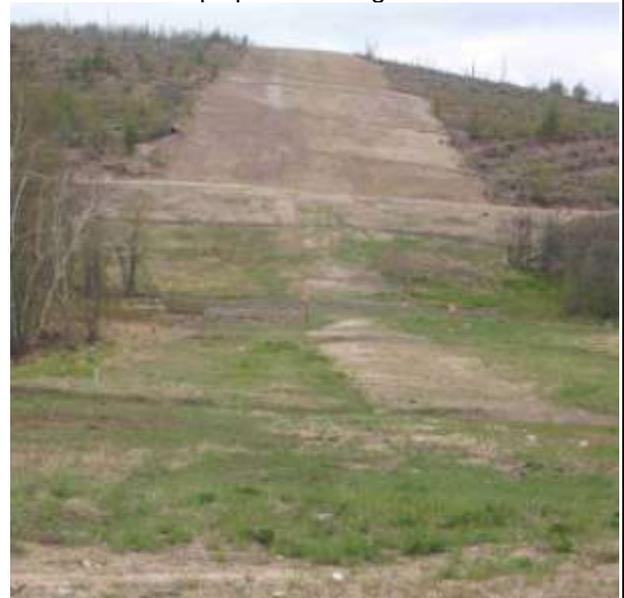
Photo 4 – Hill top sparse re-vegetation

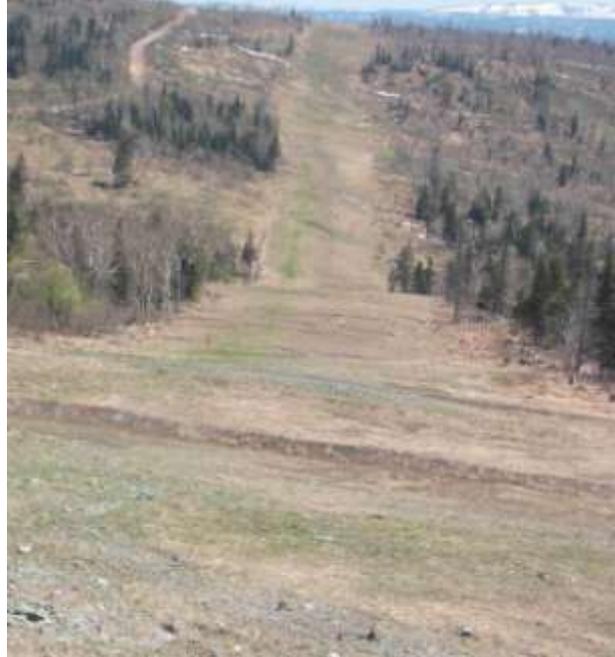
Photo 1 – KP45.5 looking south west

The RoW over this stretch is in very good condition with all slopes holding well and in general good re-vegetation (Photos 1, 2, 3 and 4). There are a few areas on the upper slopes where the vegetation hasn't taken so well (Photo 5) and these will require some attention with added nutrients or re-seeding. The small river crossing of the Krivon at KP46.8 is protected by rip-rap and is in good condition with the river bed being clean with no sign of silting (Photo 6).

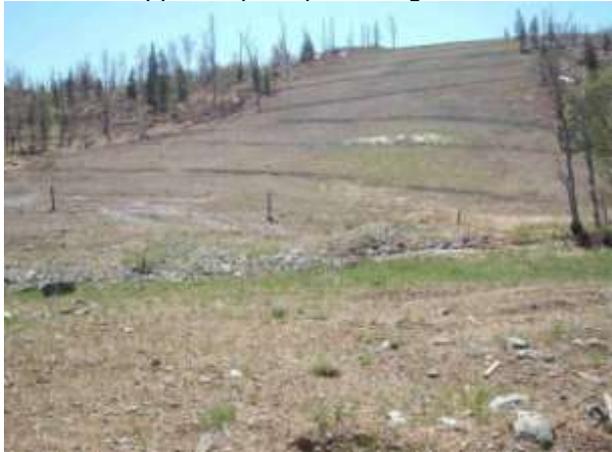
Photo 5 – Upper slopes sparse vegetation

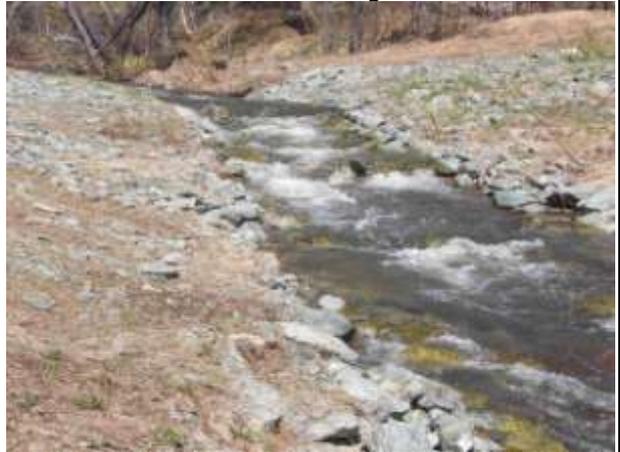
Photo 6 – River Krivon crossing

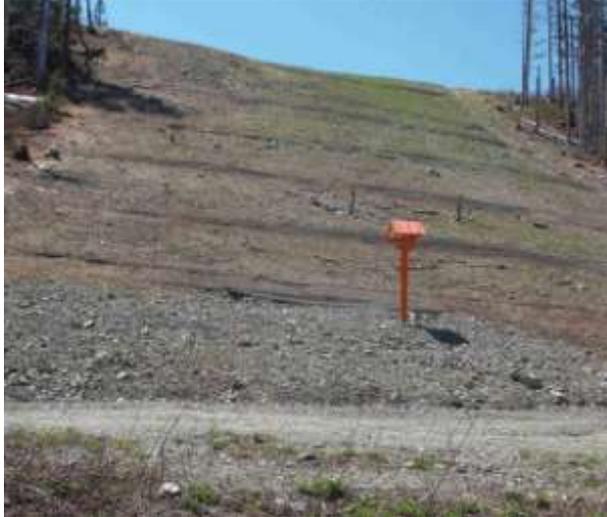
Both of the slopes down to the river are in good condition with the south facing slope below NOB-02 re-vegetating well and the slope breakers being in good condition (Photo 1). The north facing slope is currently a scree slope and is unlikely to show any change for many years (Photo 2). However, the slope appears stable and is showing no signs of any failure or movement. The river banks have been widened slightly to ensure that there is no preferential scour and the banks have been strengthened using the larger material from the blasting operation, the banks and the river look to be in good condition (Photo 3). Away from the main exposed rock areas the vegetation is recovering well (Photo 4).

Photo 1 – South facing slope below NOB-14

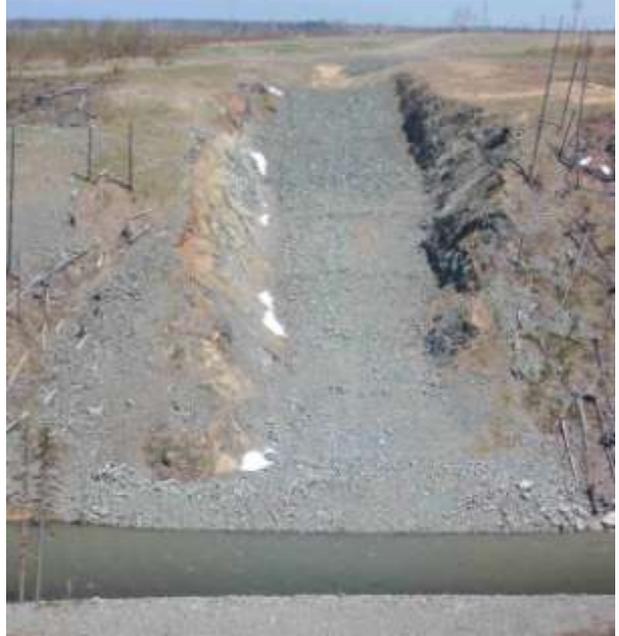
Photo 2 – North facing Scree Slope

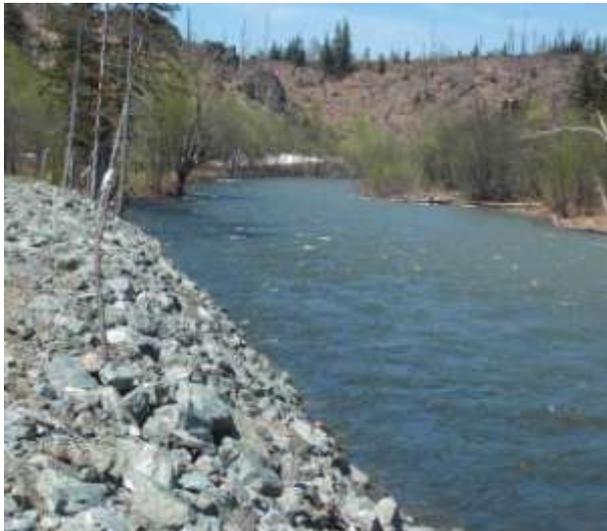
Photo 4 – Vegetation mat in Nabil Valley

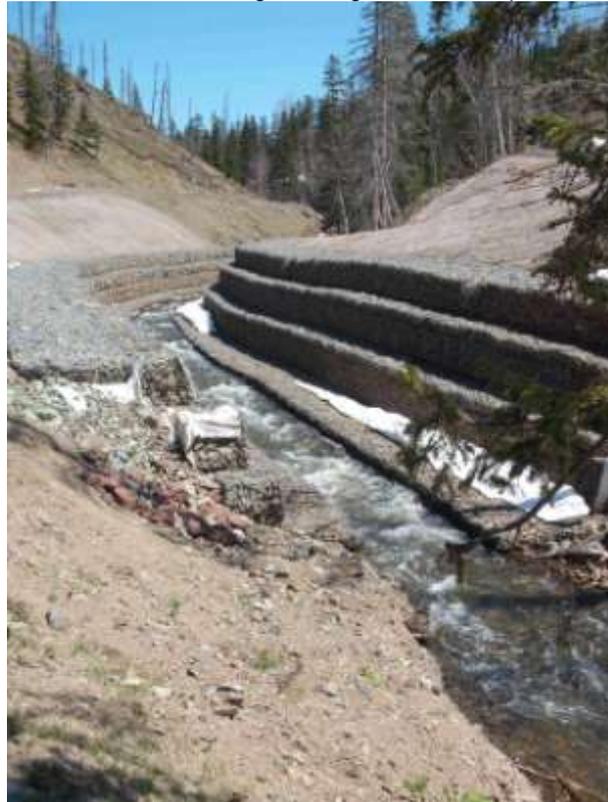
The slopes on either side of the river are not re-vegetating well, although the coco matting placed immediately behind the gabions is still in place (Photos 2 and 3) and a small amount of growth is showing through these. However, further work is required to encourage growth further up the slopes.

Photo 3 – Southern slope

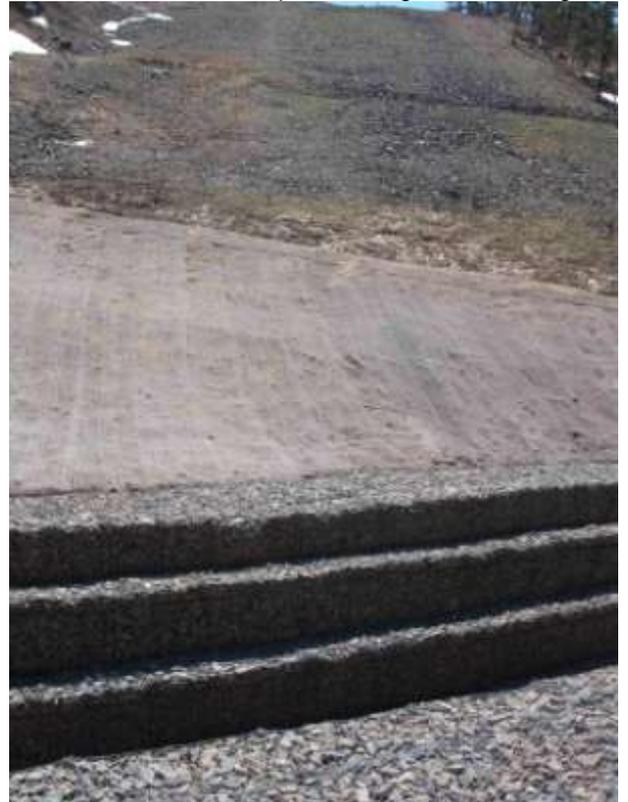
During the visit it was noted that a tension crack had opened up at the top of the slope behind the gabions on the south bank (Photo 4). While this is not a major problem at present it will require monitoring in order to ensure that does not become a structural concern and may require drainage control and further engineering works.

Photo 4 – Tension crack on southern bank

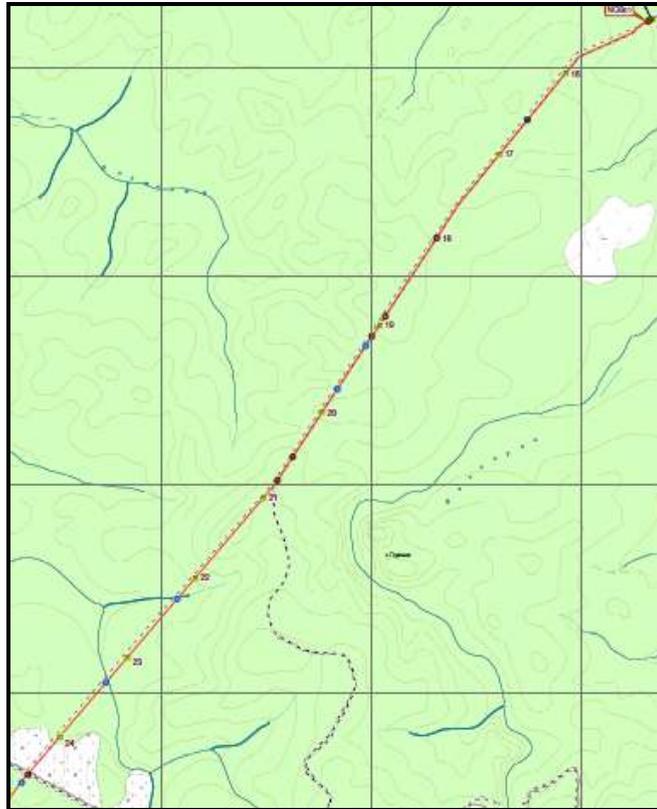
While the access road itself is in good condition, the RoW is very sandy, showing very poor growth recovery, and in many places having extensive erosion rills and high silt and sand run-off (Photos 1, 2 and 3).

Photo 1 – Lack of vegetation on RoW

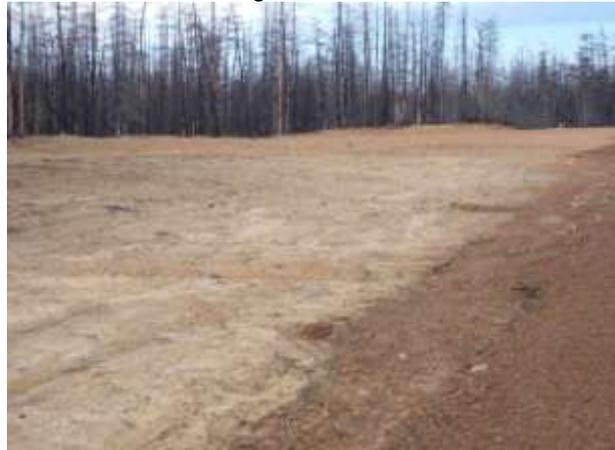
Photo 2 – Formation of erosion rills

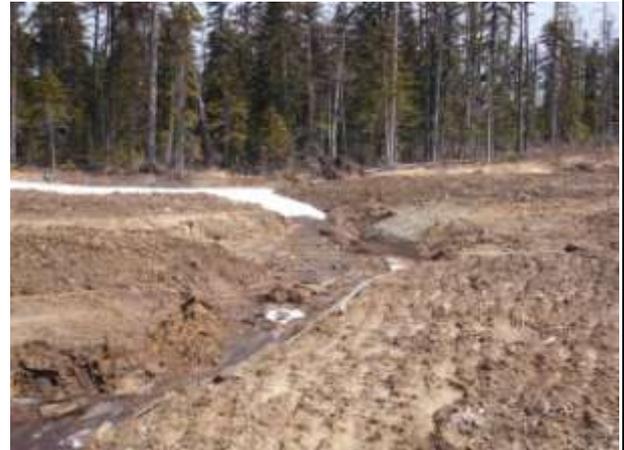
Photo 3 – Scour on RoW

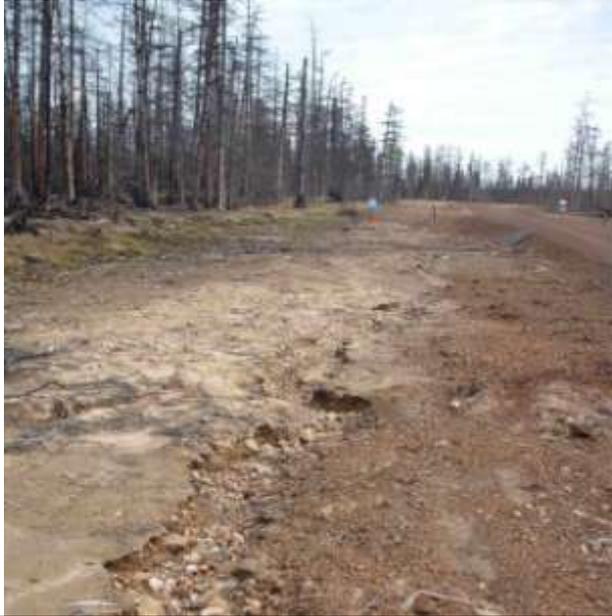
Some slope breakers have been overwhelmed due to the build up of sand behind them with the result that they overtop during precipitation or snow-melt run-off (Photo 4). Some of the drainage installed as part of the access road works has become choked with silt and will require cleaning out (Photo 5) and some silt fencing is no longer effective allowing silt and sand to flow into the streams along the RoW (Photo 6). There are a few areas, generally in low lying terrain where there are peat deposits, where the grass has taken, but this is the exception. Further work is required on the biological re-instatement along this access route.

Photo 4 – Sand build-up behind slope breaker

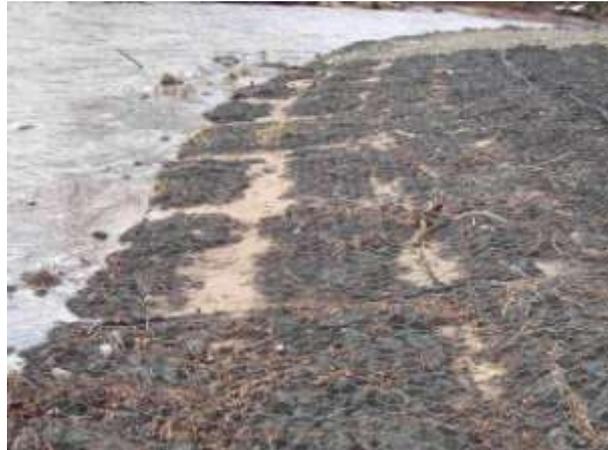
Some river bank erosion just upstream from the RoW was noted which, while not a problem at the time of the visit, has the potential to develop and scour behind the Reno mats on the eastern bank. This needs to be monitored carefully and corrective engineering undertaken as needed in the future. The re-vegetation of the eastern bank seems to be taking well (Photo 3), while the western bank vegetation is more sparse and may require further attention (Photo 4).

Photo 2 – Scour upstream on east bank

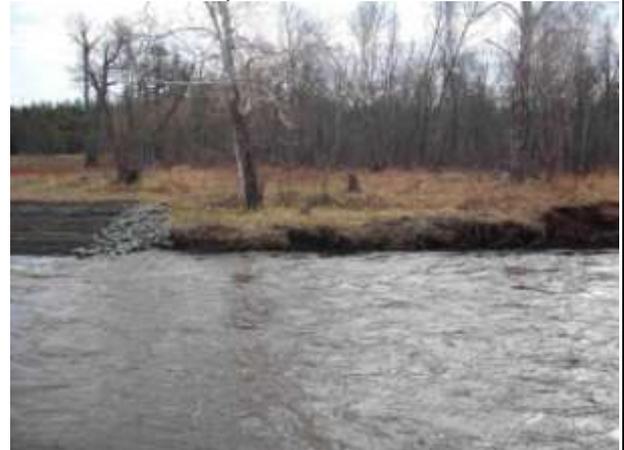
Photo 3 – East bank vegetation

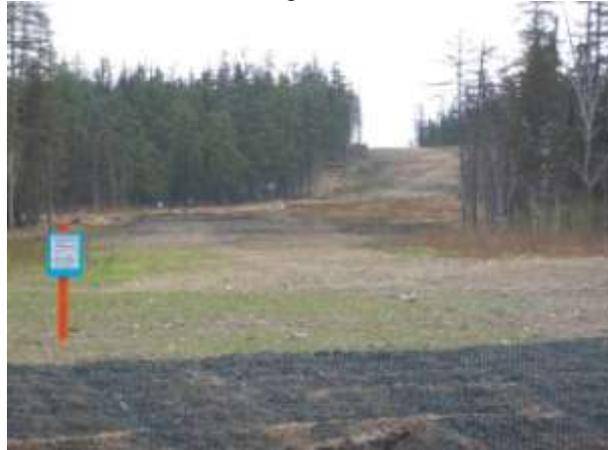
Photo 4 – West bank vegetation

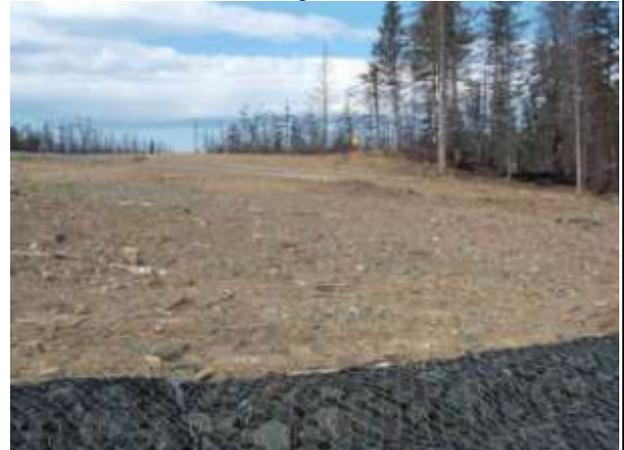
Some break-back of slopes under tree roots was noted despite the presence of geotextile (Photo 5) – this will require monitoring and possible reinforcement work before the next spring thaw. Redundant silt fencing was noted discarded to the side of the RoW, as at other places on the route (Photo 6). As a matter of good housekeeping this should be collected and disposed of at an appropriate facility.

Photo 5 – Undercut tree roots, West bank

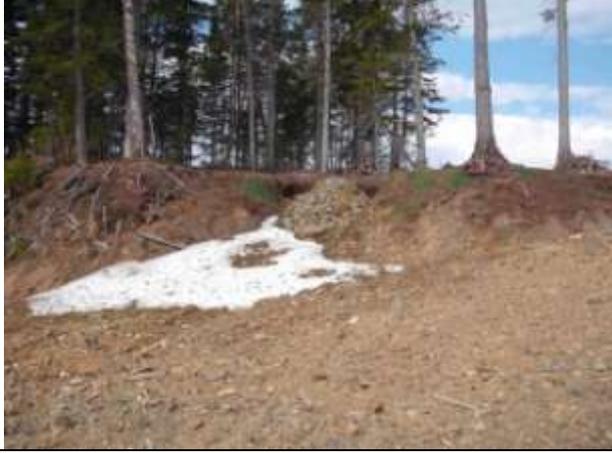
Photo 6 – Discarded silt fence

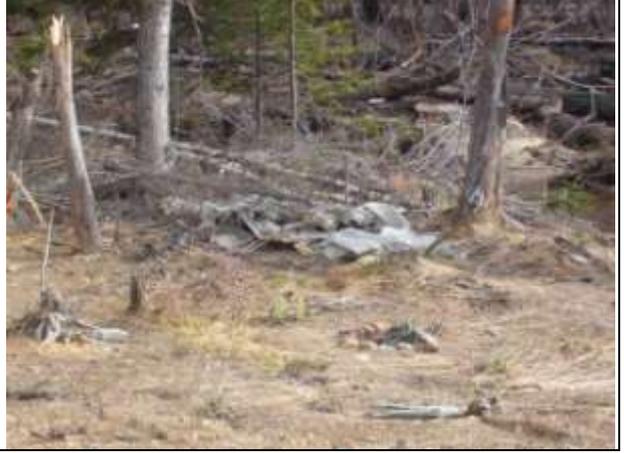
During construction, this river was extensively damaged by the installation of the pipe crossing. Extensive work and repairs have been undertaken at the crossing and the river now flows clean between two banks of Reno mats (Photo 1) that appear to be in good condition and holding well. The RoW has been re-graded back to the original profiles and extensive drainage installed on the eastern bank and slope (Photo 2). Re-vegetation will be slow in this area due to the acidic and saturated nature of the ground close to the river, but there are signs of some recovery (Photo 3).

Photo 1 – Reno mats and river bank condition

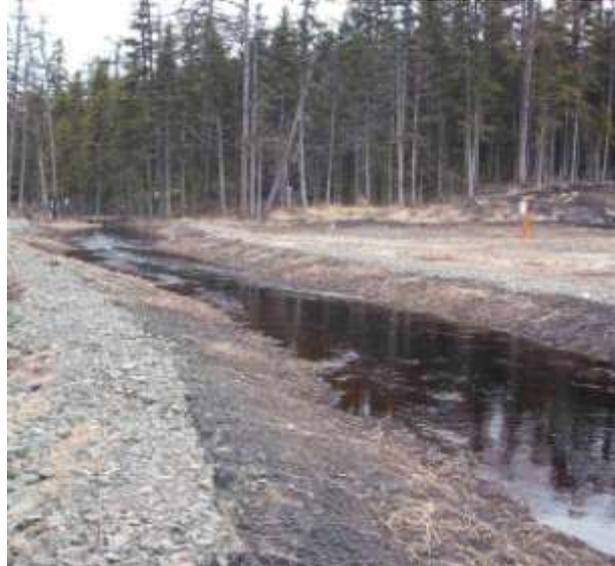
Photo 3 – West bank RoW adjacent to river

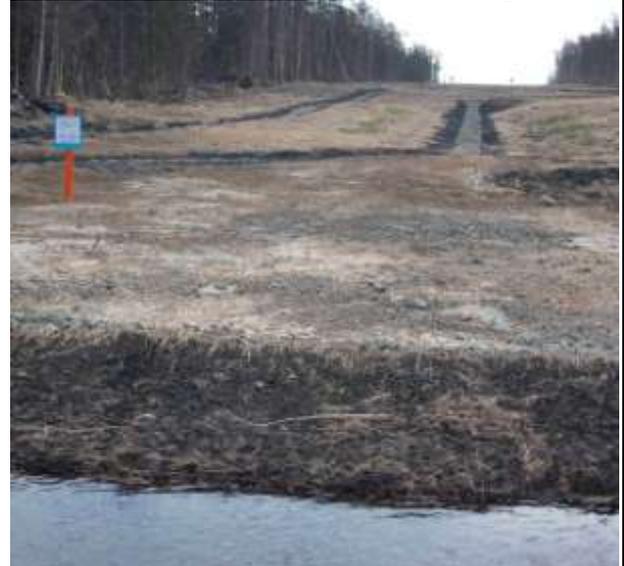
The RoW going west towards the OPF is structurally sound with the slope breakers being in good condition and some signs of vegetation recovery (Photo 4).

Photo 4 – West bank RoW away from river

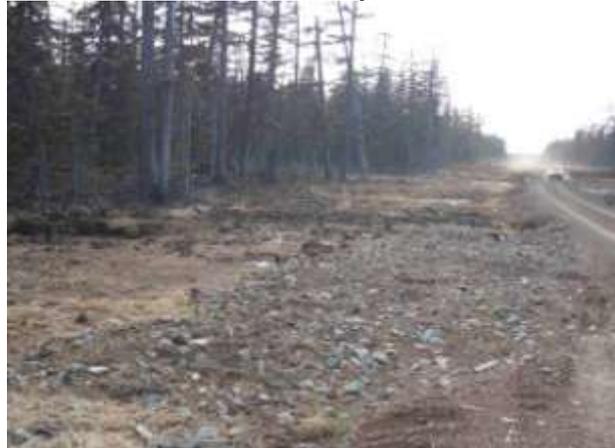
The access road is in good condition and well maintained but there are areas of the RoW that will require attention. In the peat bog areas it is apparent that one side of the access road is drier than the other (Photos 1 and 2). This implies an interference of the groundwater and surface water flows across the access road. Should monitoring of the vegetation recovery show large anomalies between the two sides over the next year, it would be recommended that more cross road drainage be installed to enhance the flows and equalise the water levels. Some subsidence over the pipelines was noted within the peat areas with one notable hole having opened up at KP 151.8 (Photo 3).

Photo 2 – North road RoW wet

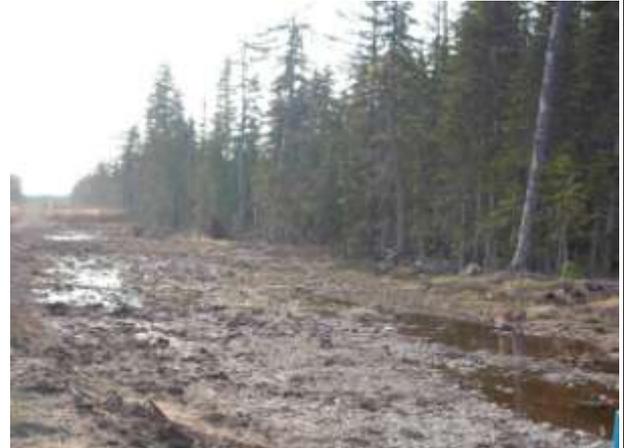
Photo 3 – 1m hole over pipeline KP 151.8

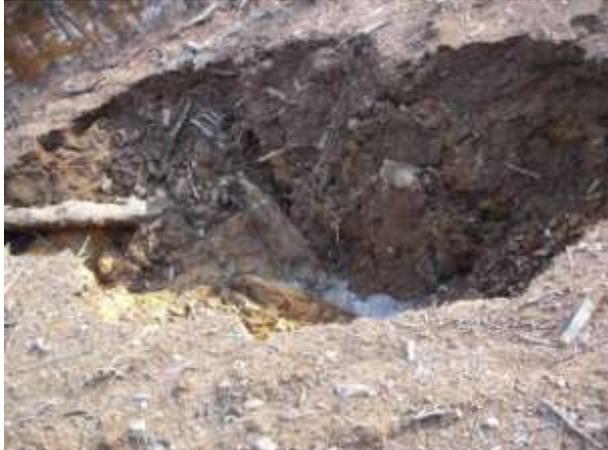
The sandy areas along the road again show the poor recovery of the vegetation noted elsewhere on the RoW. This is leading to silt and sand washing out, and in places build up and over-topping of the slope breakers (Photo 4) preventing them from functioning properly and leading to silt build up in some of the streams (Photo 5). In the short-term there is a need for the slope breakers to be cleaned out and new silt fencing to be installed, while in the long-term the re-vegetation of the RoW to prevent silt scour needs to be addressed.

Photo 4 – Over-topped slope breaker

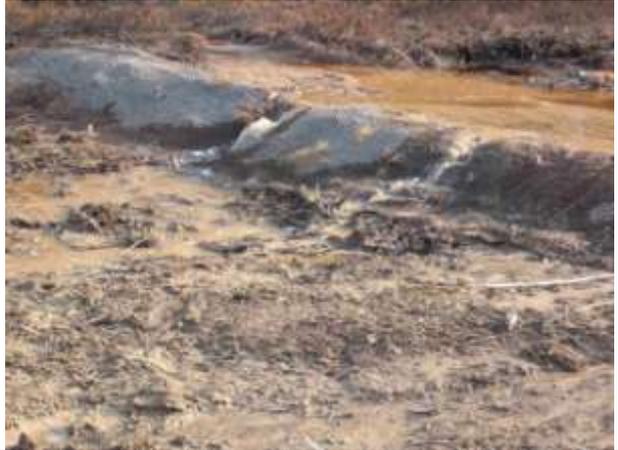
Photo 5 – Silt running into river

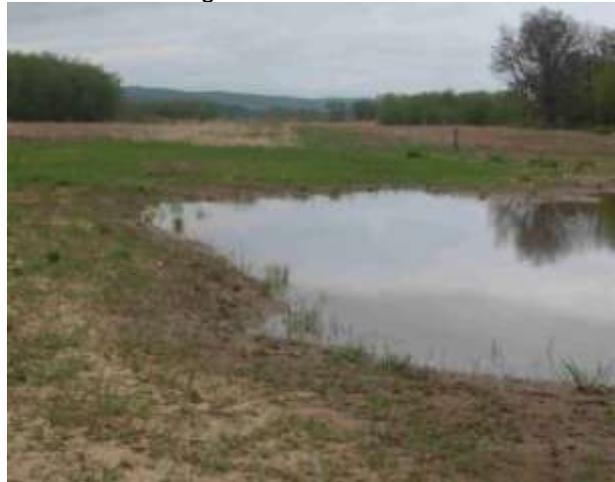
Re-vegetation along the RoW is good where the river flood has deposited silt (Photo 3) although this does become patchier further away from the banks. A bund had been constructed as part of the original RoW protection work – this is no longer effective and has been over-topped during recent flood events (Photo 4). It is recommended that the remains of the coco matting are removed from this structure and the river allowed to redistribute the gravel and other bund material naturally during future floods.

Photo 4 – Damaged bund on north bank

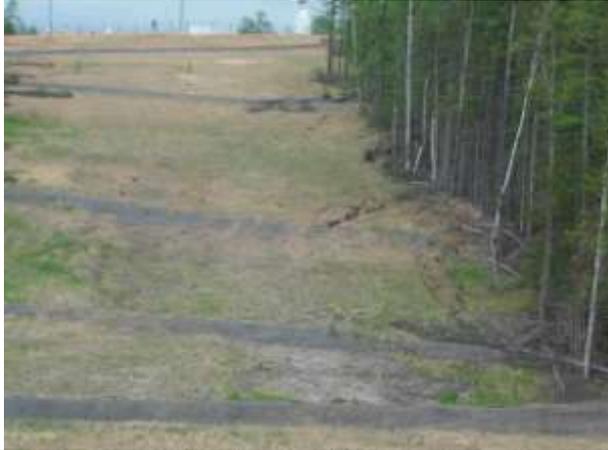
This area had been a problem during the construction period with wash-outs and erosion difficult to control. It was noted during this visit that the slopes had held up reasonably well with the slope breakers still in place and some signs of grass growth, particularly on the lower slopes (Photos 1 and 2). However, in common with the other sandy areas visited, there was evidence of erosional features with erosion rills formed in areas of barren growth (Photo 3), and silt and sand build up behind slope breakers (Photo 4) that could lead to over-topping and scour where the run-off has built up (Photo 5).

Photo 1 – Slopes looking north to TOB-11

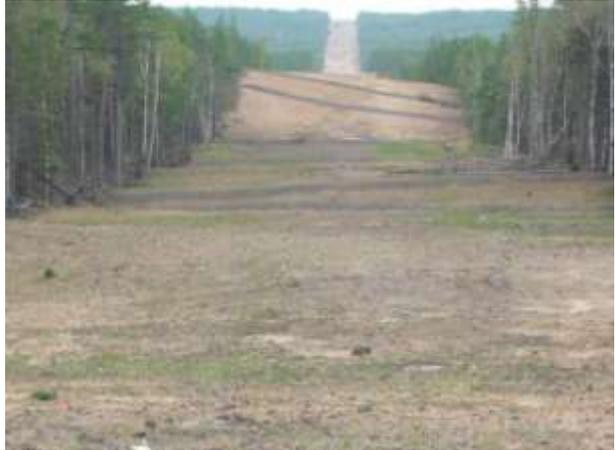
Photo 2 – Photo looking south

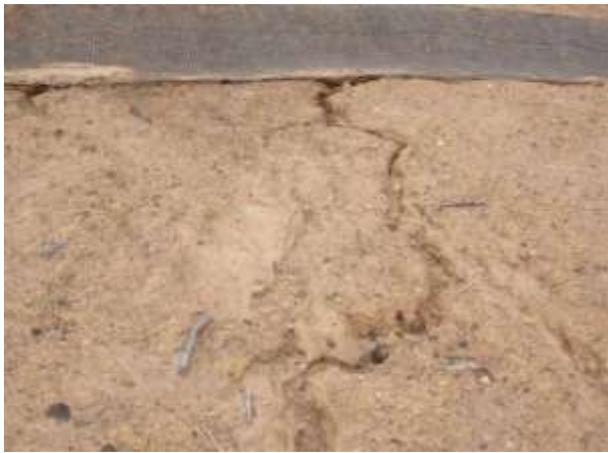
Photo 3 – Erosion rills in barren soil

The sparsely vegetated areas of the slopes will need further re-seeding and fertilisation to try and create a long-term solution to the erosion, while in the short-term repairs and maintenance will be required for the engineered areas of the slope. It was noted that grass had grown in areas where previous erosion had occurred (Photo 6) and this seemed to have stabilised the movement of materials.

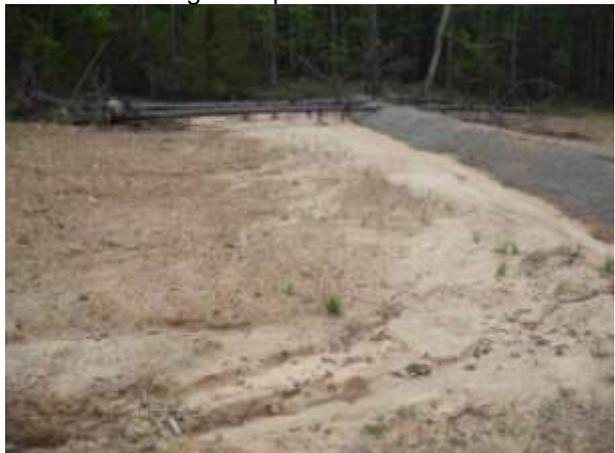
Photo 4 – Silting of slope breaker

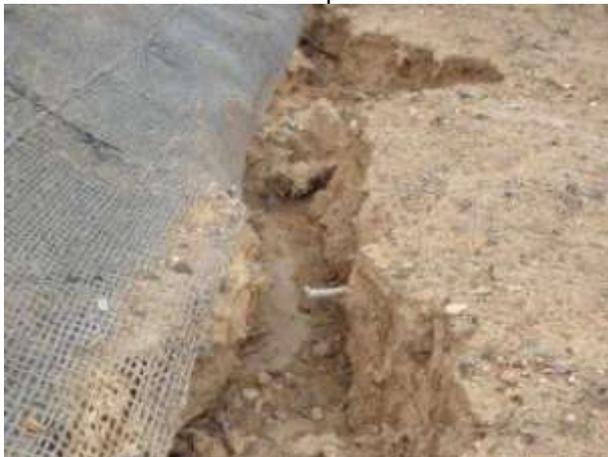
Photo 5 – Scour behind slope breaker

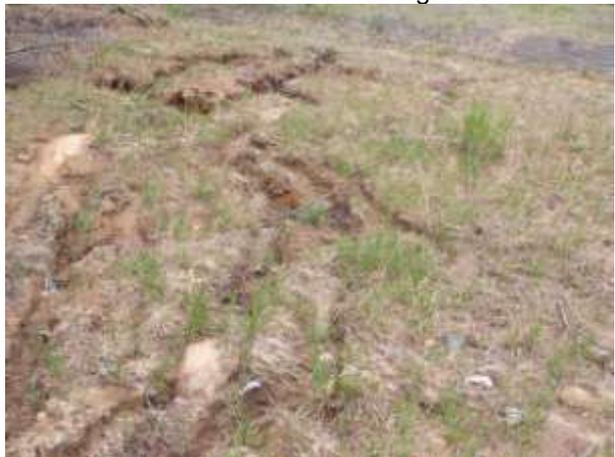
Photo 6 – Old erosion feature overgrown

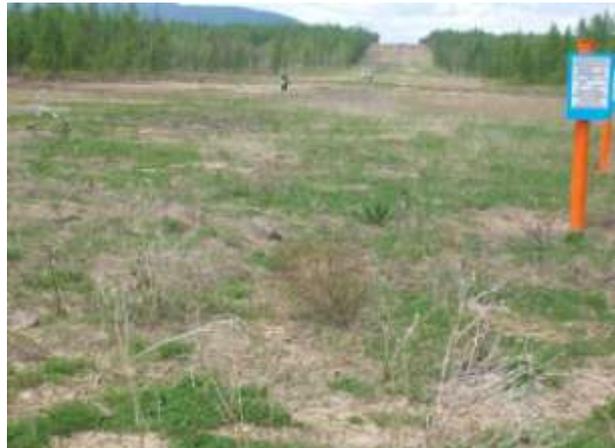
The RoW into the river is generally wet with much peat in the soil and, as such, has had a good vegetation recovery with much local re-vegetation taking place (Photo 1). The higher ground areas to the north of the river are also showing good growth recovery, although these areas may still require some aftercare to ensure sufficient nutrition is available for continued development (Photo 2).

Photo 1 – RoW General view south to river

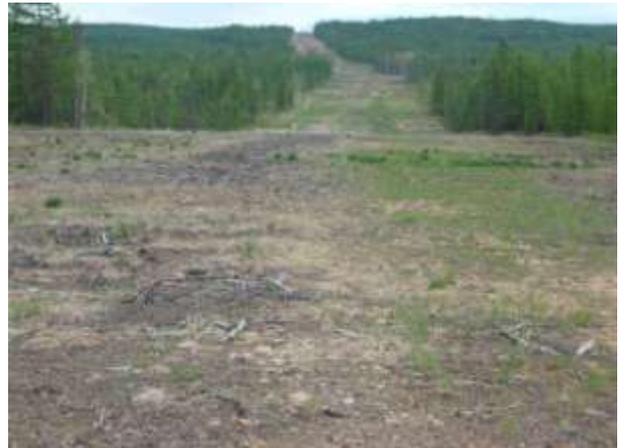
Photo 2 – RoW General view north
