Lenders' Independent Environmental Consultant: Monitoring Report June 2010 Sakhalin-2 Phase 2 Project

Report to Sakhalin-2 (Phase 2) Project Finance Parties

Restricted – Commercial
AEAT/ENV/R/3052 Issue 1
July 2010

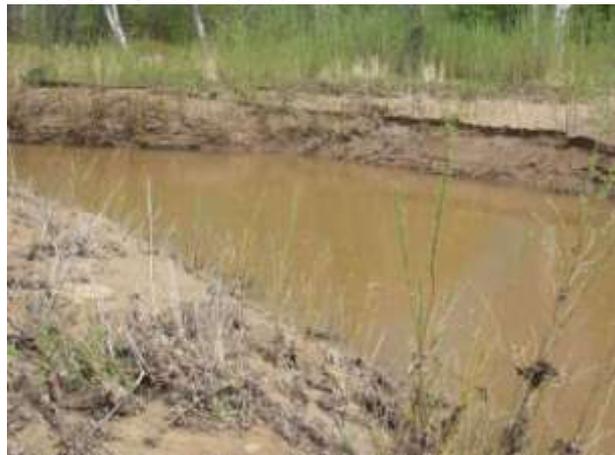
The river crossing was in good condition with both banks showing a good build up of silt cover following flooding, to a depth of 30cm over the Reno mats placed during construction (Photo 3). There was a good vegetation covering, particularly of clover, just back from the river banks (Photo 4). The crossing was in good condition.

Photo 3 – Silted river banks

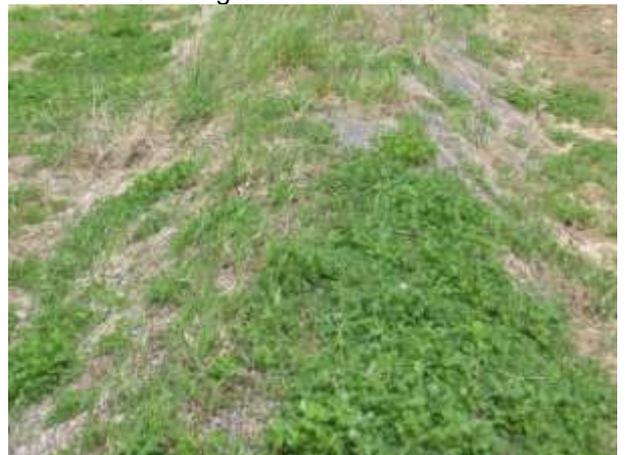
Photo 4 – Clover growth near river bank

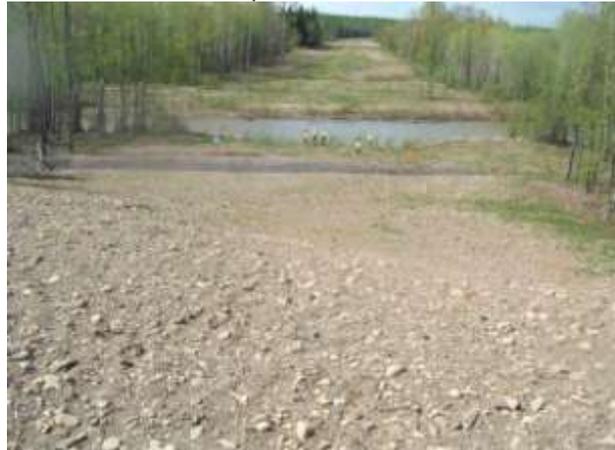
The slope down to the river was sparsely vegetated (Photo 1) but was holding well with the slope breakers in good condition (Photo 2). Further work is going to be required to encourage and maintain growth on the slopes, it was noted that clover, rather than grass seemed to be establishing better.

Photo 1 – Barren slope down to the river

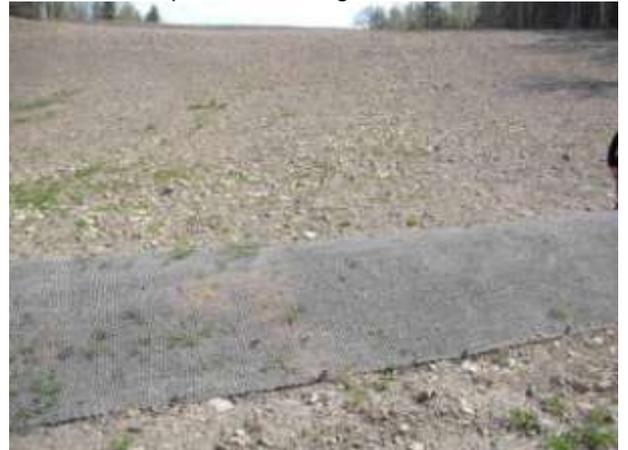
Photo 2 – Slope breaker in good condition

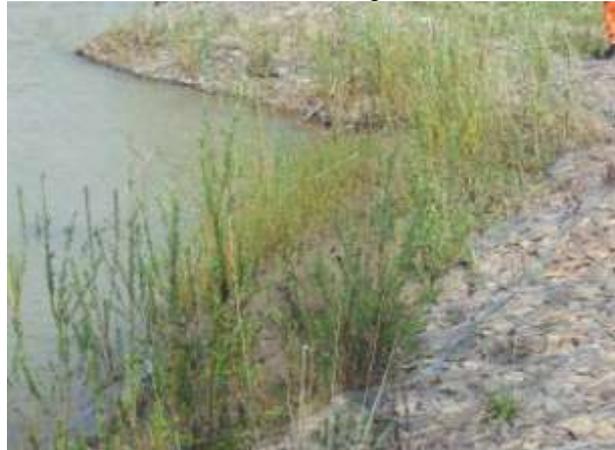
The river banks were both in good condition with the Reno matting holding well and starting to show signs of natural re-vegetation showing through (Photos 3 and 4). The river was running clean and the river bed looked to be in good condition.

Photo 3 – Northern bank re-vegetation

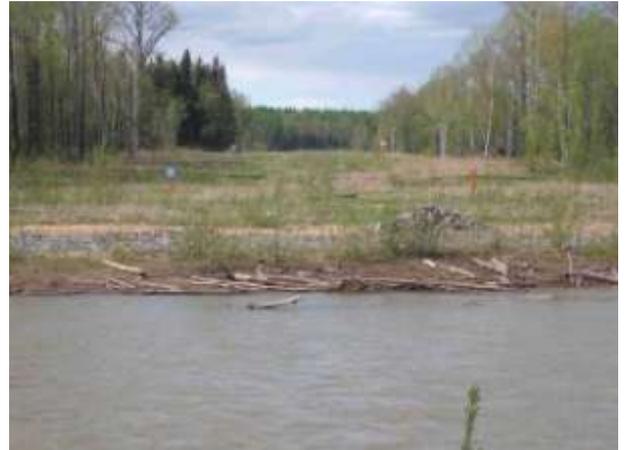
Photo 4 – View to southern bank

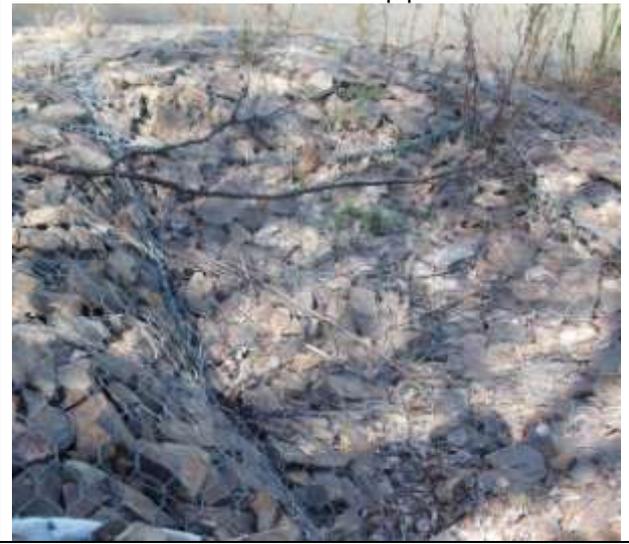
One area of slight subsidence was noted over the pipeline to the east where the Reno mats had settled by some 30 to 50cm (Photo 5), this will require some repair and maintenance.

Photo 5 – Subsidence over the pipeline

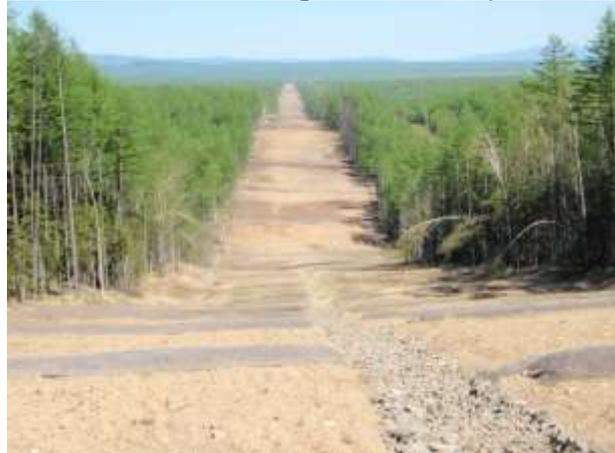
The southern slope running down towards the river is engineered with slope breakers and central and side drainage gullies to manage and channel water off the RoW (Photo 1). Drains channel water down the slope and then across to a holding pool at the edge of the RoW for filtration and low velocity release into the forest (Photo 2). This appeared to be working well.

Photo 1 – Central drainage, southern slope

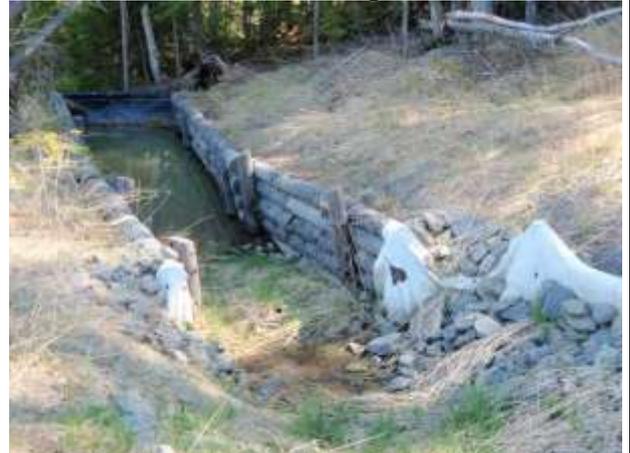
Photo 2 – Slow, filtered drainage to forest

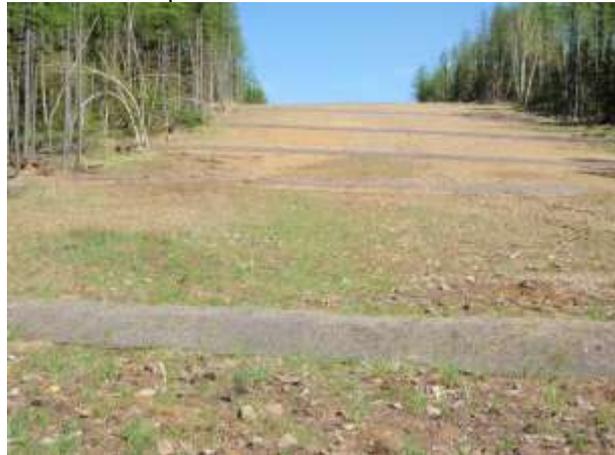
Vegetation on both the upward slope from the access road and the downward slope to the river is generally poor. Both established and new grass growth is evident on the wetter parts of the slope (edge of the RoW, lower-lying areas and drains, Photos 2 and 4), although higher ground is notably dry, rocky and barren (Photo 1). The overall revegetation situation is significantly worse than that noted in 2008 and additional reseeding is recommended in these areas.

Photo 3 – Slope south of access road

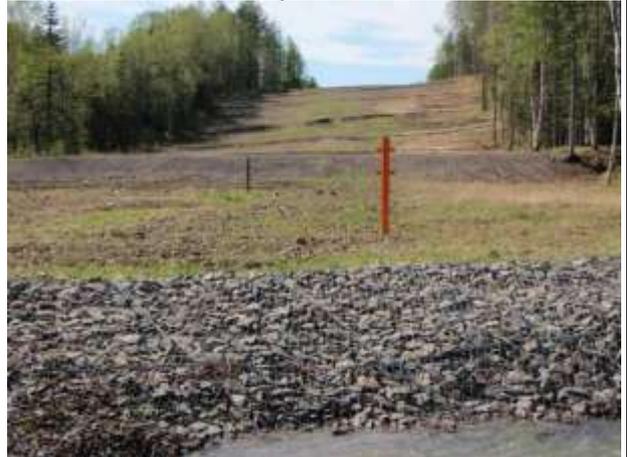
In addition, locals appear to be using the RoW, as indicated by a cut tree spanning the river to the right of Photo 4 and the missing signage noted in Photos 2 and 3 (and many other locations). Sakhalin Energy should continue to note any unauthorised use of the RoW and take appropriate action if this becomes a problem.

Photo 2 – Southern slope

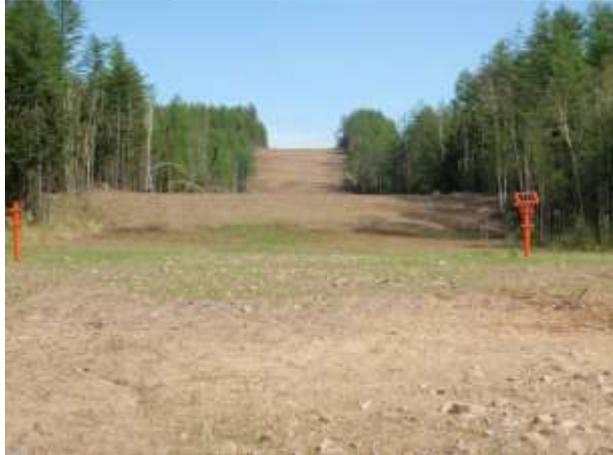
The RoW crosses the river just upstream of a small meander, shown in Photo 1. Both banks are protected with Reno mats – these are in good condition although remain unvegetated at present. Vegetation on the southern slopes is patchy although new growth is encouraging (Photo 2). Vegetation on the slopes north of the access road was not quite as established with bare areas north of KP 176, shown in (Photo 3).

Photo 3 – Slopes north of access road

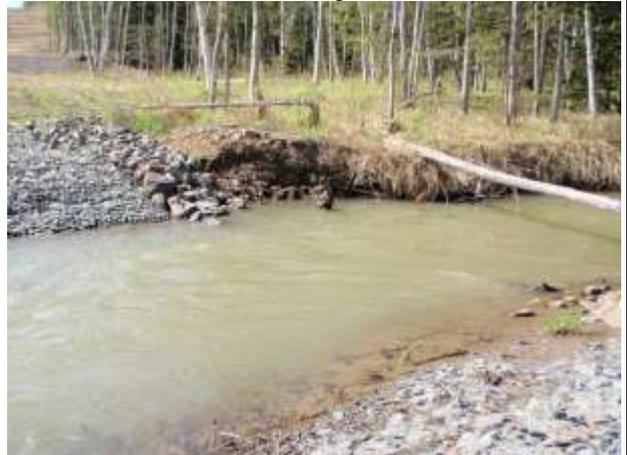
Some undercutting of the southern river bank was noted upstream of the river crossing, just off the RoW (Photo 4). Riprap is currently protecting the Reno mats, and while this is not currently an issue the bank should be monitored to ensure that this does not get any worse with the river potentially cutting behind the Reno mats.

Photo 4 – River undercutting southern bank

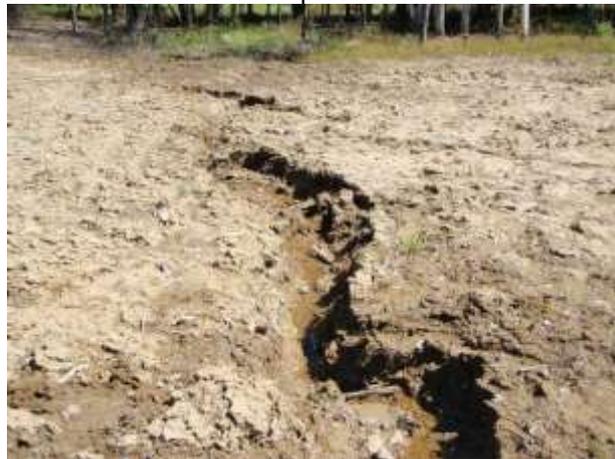
The area adjacent to the BVS was particularly muddy, with erosion rills and preferential channels forming across the RoW (Photo 1).

Photo 1 – Erosion rills & preferential channels

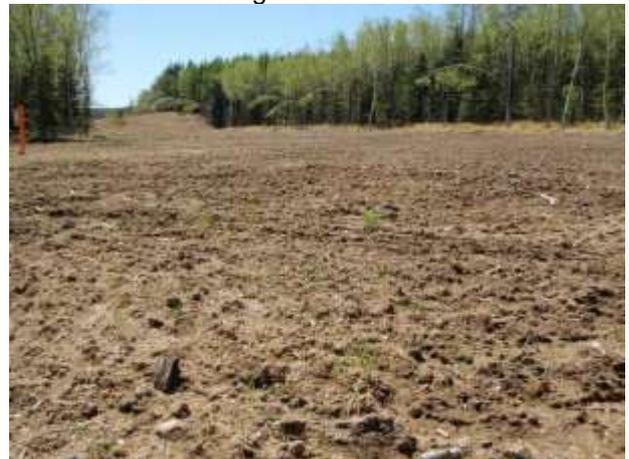
Vegetation was patchy and variable, with some areas showing promising new growth (albeit sparse) and others very little. Little new growth was noted near the BVS (Photo 2) however a healthy patch of seemingly native new vegetation was noted near the edge of the RoW. It is possible that this species is tolerant to these limited growing conditions, and Sakhalin Energy should explore whether this species can be encouraged across more of the RoW. More vegetation was noted towards the river and along the tops of the Reno mats (Photos 3 and 4).

Photo 2 – Little new growth near BVS

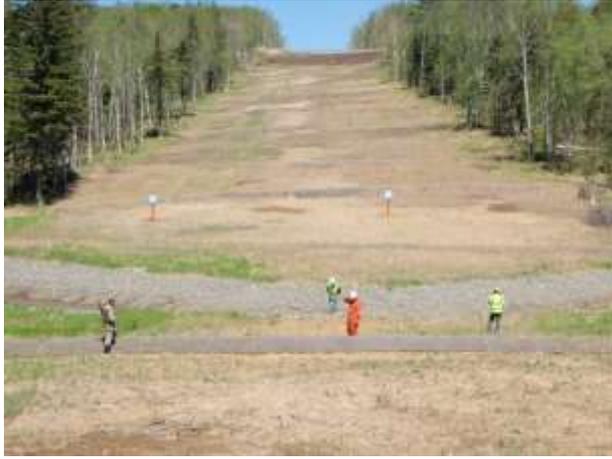
Photo 3 – Looking towards northern slope

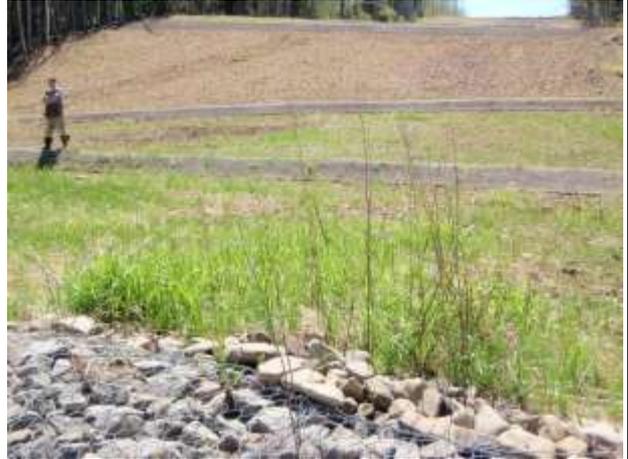
Photo 4 – Revegetation along southern bank

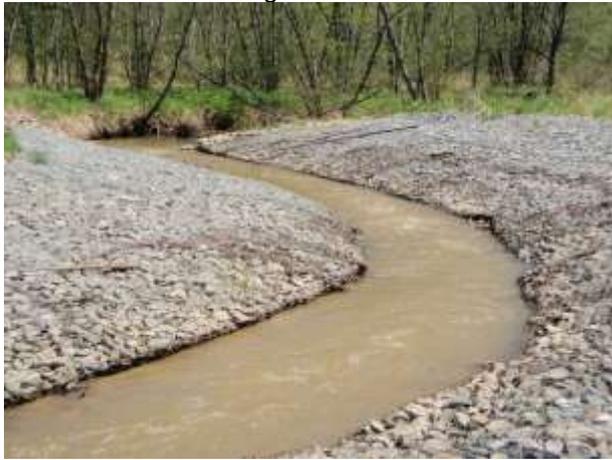
The main engineering aspects of the slopes and river were good – slope breakers were well placed and well maintained, and coco matting armour remained in place. Reno mats guiding the small meander in the river were in good condition (Photo 5). Silt deposition and debris showing the high water line was evident along the Reno mats; early signs of revegetation were starting to show however this will take some time.

Photo 5 – Reno mats guide the meander

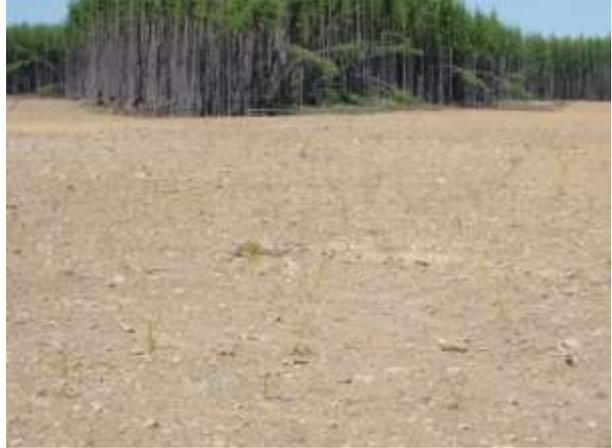
The original RoW (to the right of Photo 2) was very sparsely vegetated, with very poor topsoil and only a few shoots. AEA understands that the original RoW – land cleared prior to re-designing the Fault Crossing route – will be reforested back to its former state, although there was no evidence at Fault 7 to suggest that this had started yet.

Photo 2 – Original RoW – sparsely vegetated

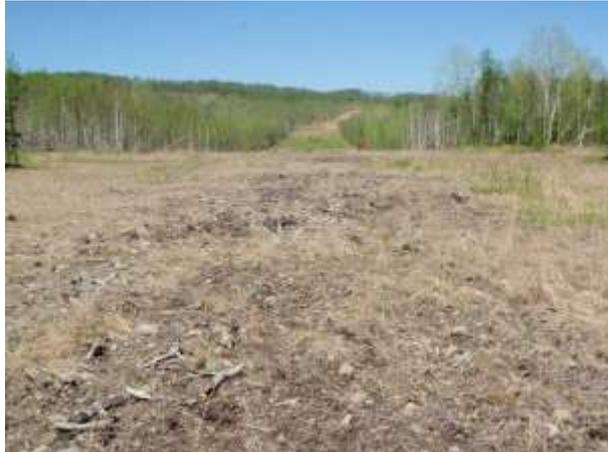
Revegetation at the Pobedinka River was notably more established than at previously visited locations in the north. The ground adjacent to the access road was wetland, with better quality, more nutrient-rich topsoil. As a result, re-vegetation was advanced with a variety of grasses and plants. Vegetation along the outside of the RoW had been established for three years, while the central strip (a temporary access road) had recently been reinstated and reseeded. (Photos 1 and 2)

Photo 1 – RoW

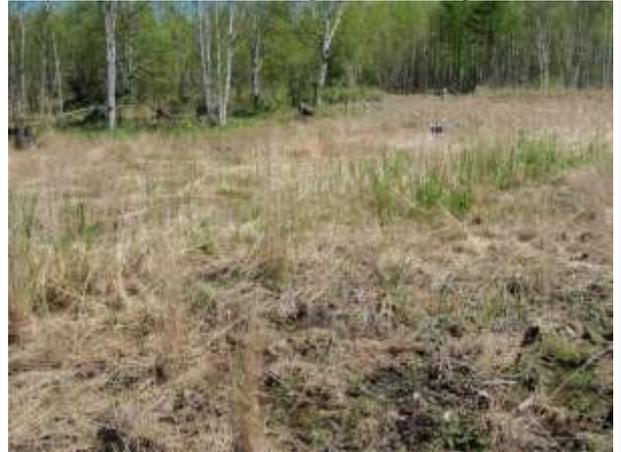
Photo 2 – Established vegetation along RoW

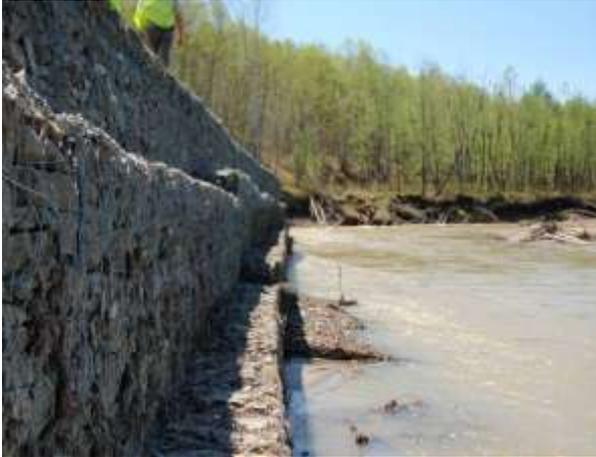
The southern bank of the Pobedinka River has been re-engineered on many occasions over the past three years. The current stabilisation measure is a three-tier gabion wall that runs the width of the RoW (Photo 3). During this visit, the gabion wall was noted to have been pushed forwards toward the river due to pressure from the slope behind. A distinct bulge could be seen in the shape of the wall, and the rip-rap backfill has fallen into the gap, exposing the textile behind (Photo 4). Sakhalin Energy will need to empty, straighten, re-pack and re-tie the baskets into position again. A few minor repairs are required to other baskets. However of greater concern is the fact that the river bank stabilisation is requiring attention every year; should this continue, Sakhalin Energy may need to reconsider the riverbank engineering strategy at this location.

Photo 3 – Gabion wall

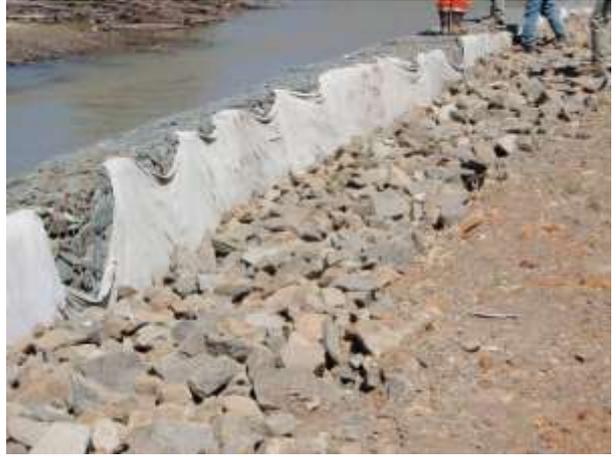
Photo 4 – Gabion pushed forwards

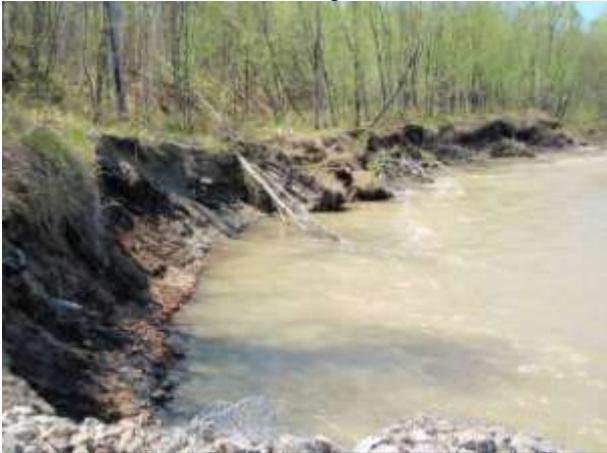
Undercutting of the upstream, outer bank of the river should also be monitored at this location. Evidence of this is shown in Photo 5 – trees have collapsed into the river as ground underneath has been washed away. Undercutting presents a threat to pipeline integrity should the river erode behind the gabion wall. It is recommended that Sakhalin Energy considers requesting permission to work upstream of the RoW to reinforce the outer curve of the river bank.

Photo 5 – River undercutting outer bank

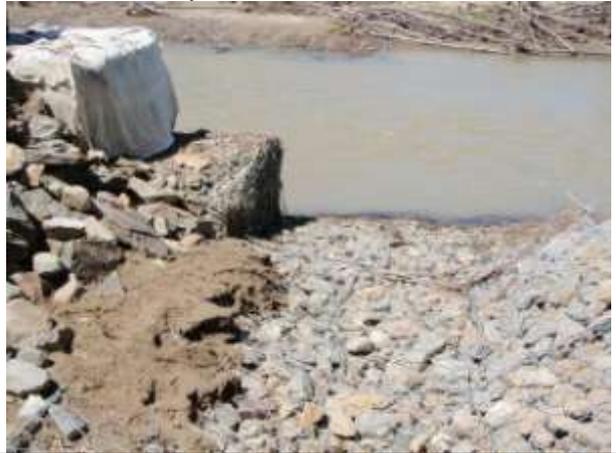
Photo 6 – Newly laid drain

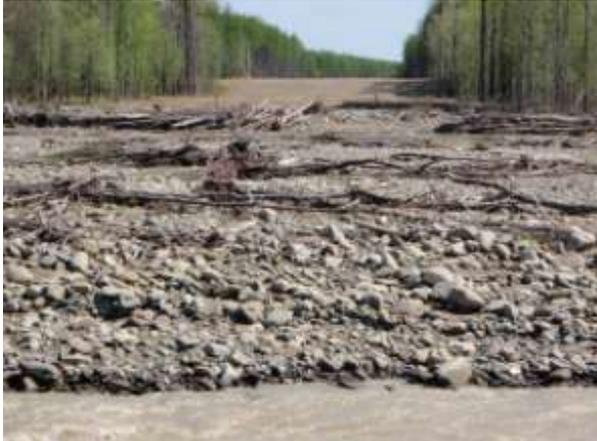
Spring thaw debris was visible on the central island (Photo 1). The southern bank Reno mats require a little maintenance following the spring thaw – some had broken open and some slumped into the river (Photo 2). Repair work is reportedly on Sakhalin Energy's list of 2010 activities, and will probably be undertaken during October.

Photo 1 – High water debris on river bank

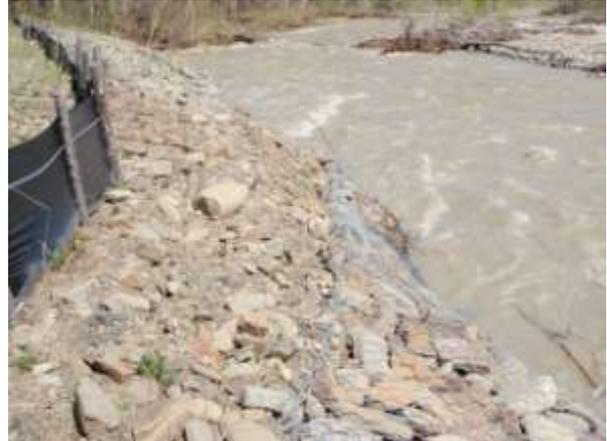
Although the topsoil is poor, vegetation was reasonable by the access road (Photo 3) – cows noted on the RoW will be helping to transfer seed and provide additional nutrients to the soil. Vegetation was not so good towards the river banks, and the river remains protected on the southern bank by silt fences (Photo 2) – these should remain until vegetation on the river banks becomes more established.

Photo 2 – Reno mats require maintenance

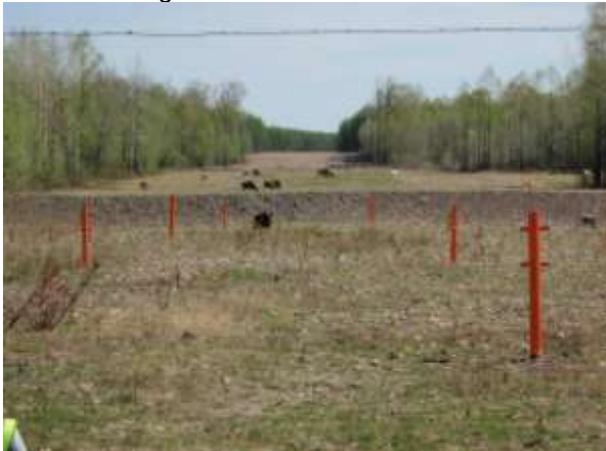
Photo 3 – Vegetation and animals on RoW

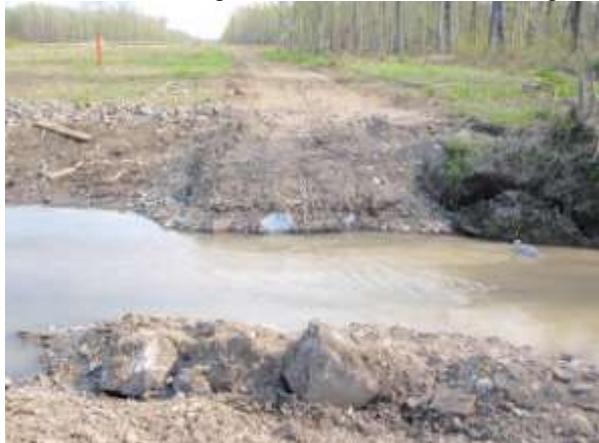
The Leonidovka underwent major engineering works during early 2010, which were completed mid-April. This unnamed stream had been crossed by heavy vehicles en-route to the Leonidovka, and still showed the damage caused by such works. The running track was still in place and stream's river banks need to be reinstated at the crossing (Photo 1). According to Sakhalin Energy, the soil in the river will be dragged out quickly using an excavator. AEA considers this to be 'in-stream works' – as the river is likely to be a tributary to the Leonidovka (which has significant salmon spawning habitat downstream of the crossing) Sakhalin Energy will need to give appropriate consideration to the timing of this exercise, either waiting until the salmon spawning season has finished, or creating a diversion path for the river while excavation works are going on in the main stream channel.

Photo 1 – Running track and river bank damage

In addition, left-over large riprap and mats left on the edge of the RoW need to be removed from a housekeeping point of view.

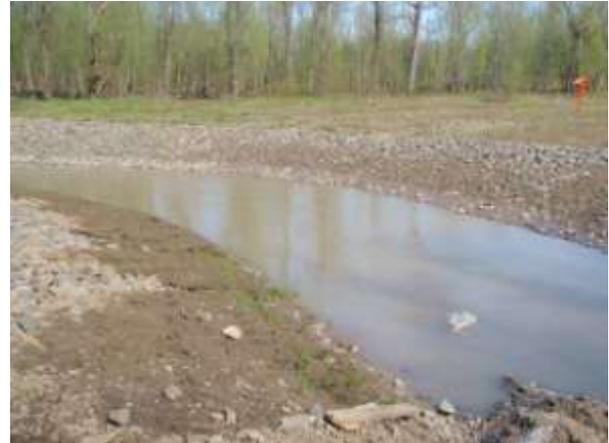
The river banks were silted with evidence of new growth starting to come, although this will take some time. Revegetation was good on the stretch between the BVS and the stream (Photo 3).

Photo 2 – Silted riverbanks

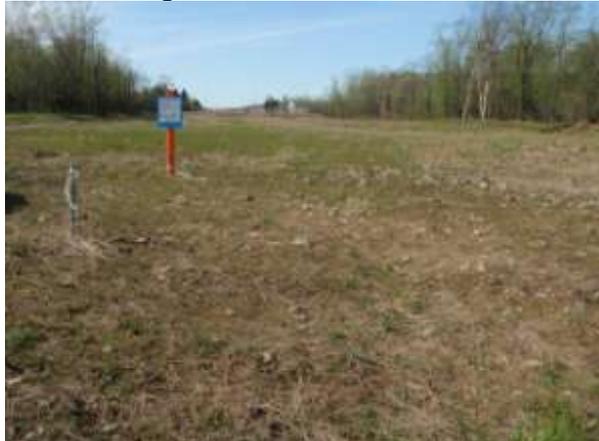
Photo 3 – Vegetation on RoW

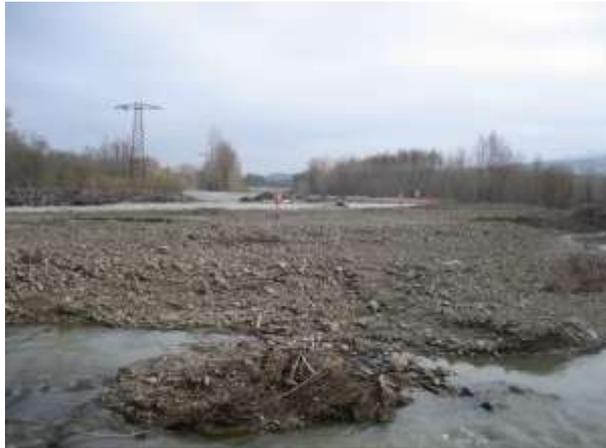
The Gastellova River experienced high flow rates following the typhoon of autumn 2009. This resulted in damage to bank protection of southern bank of the northern channels. Sakhalin Energy performed emergency repair during the later parts of 2009 to reinstall bank protection on the south bank. During the current visit it was impossible to cross the river and view the south bank. According to Sakhalin Energy, more work is scheduled to be performed following the spawning season this year. The repaired south bank is partially visible from a distance (Photo 1). The north bank of the north channel was not impacted and the Reno matting is intact.

Photo 1 – View to the south bank

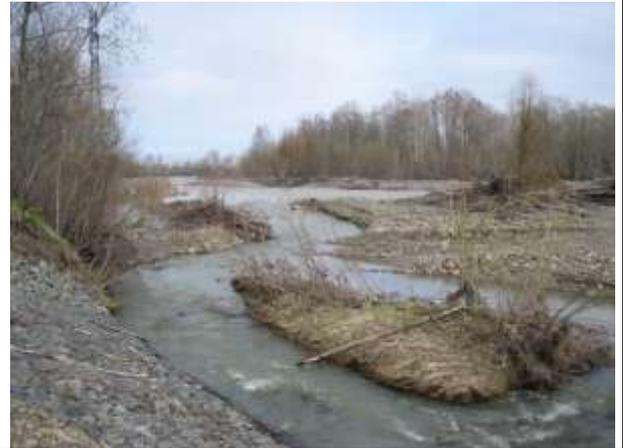
Photo 2 – View of the north bank

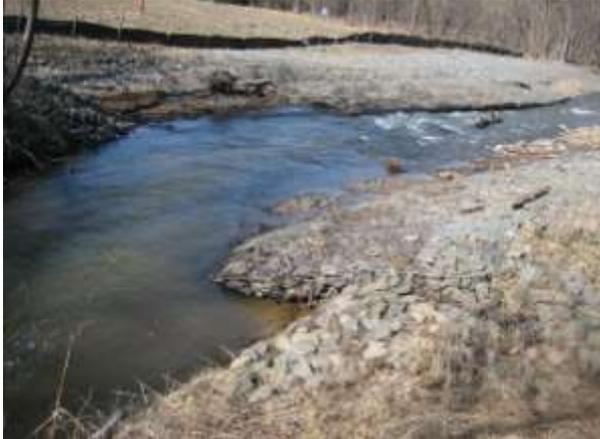
The Kissa River is protected with Reno matting on both banks and with silt fencing at the top of the banks (Photos 1 and 2). The Reno matting at the upstream corner is being undermined by the flow and will need to be monitored (Photo 1). Vegetation at the site is spotty and in need of further seeding.

Photo 1 – Matting with damage – bottom right

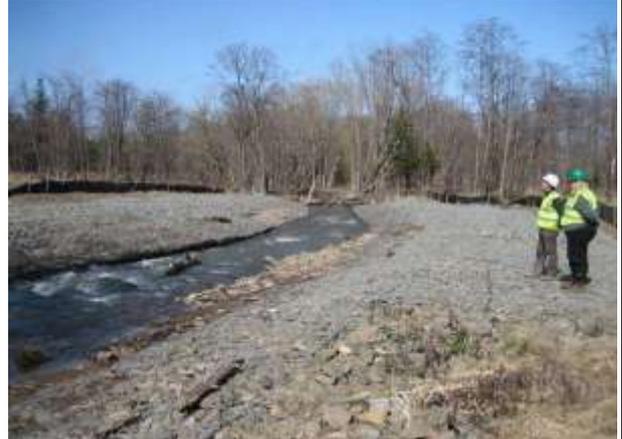
Photo 2 – View of Reno matting on banks

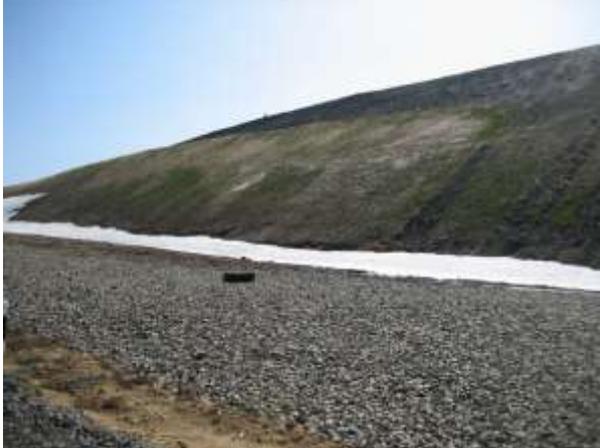
Fault crossing 9 was walked through on the way to the Kissa. The side cuts were hydro-seeded but currently do not have full coverage and could use additional bio-restoration (Photo 3). At other side cut there was a failure behind the geotextile which will require repair (Photo 4).

Photo 3 – Fault crossing side cuts

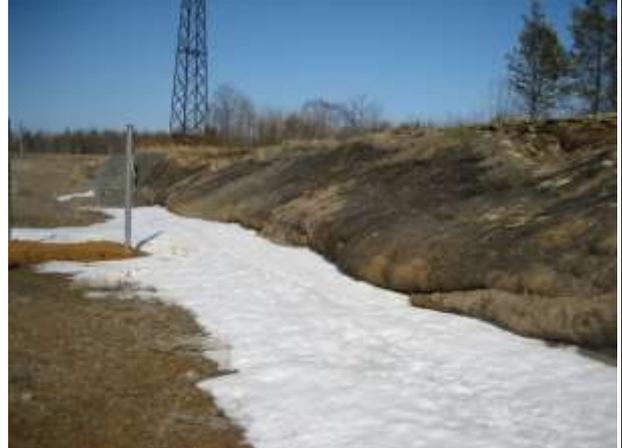
Photo 4 – Failed site cut

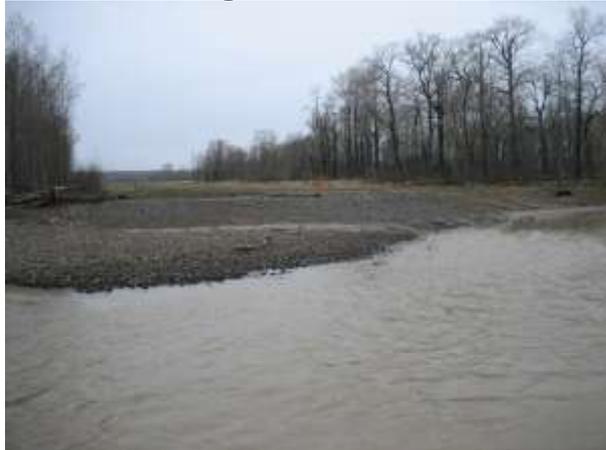
The northern bank is developing a natural gravel bank deposit on top of the matting (Photo 1). The southern bank is intact however some bank erosion is developing upstream of the crossing adjacent to the matting and will require future maintenance (Photo 2). Very sparse vegetation is present on both banks. The RoW in the flood plain has good vegetation cover, however south of the crossing on the slopes away from the river the vegetation cover is poor (Photo 3).

Photo 1 – Natural gravel bar on Reno mats

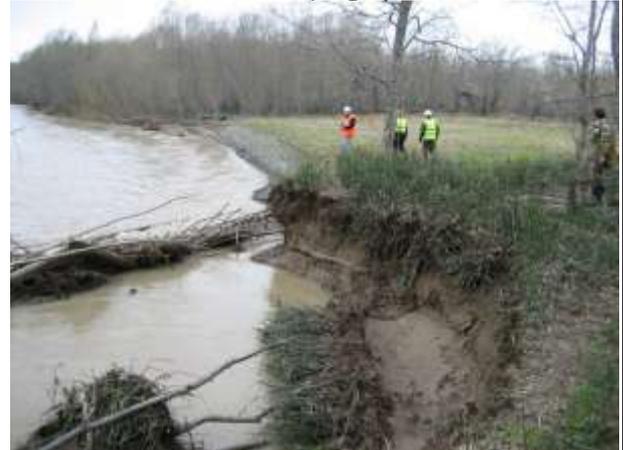
Photo 2 – Erosion developing upstream

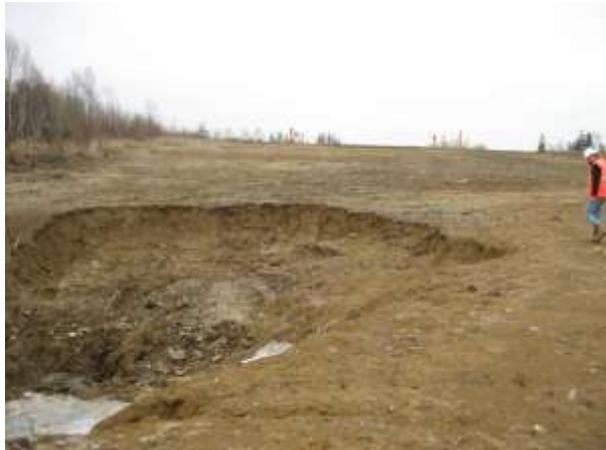
A washout was observed on the RoW side between the river and the BVS to the south (Photo 3). This was noted by the Company and explained to be at the access point to the pipe trench drain cleanout. Photo 4 demonstrates a recurring problem of theft of pipeline signage along the RoW.

Photo 3 – Wash out at a clean out drain

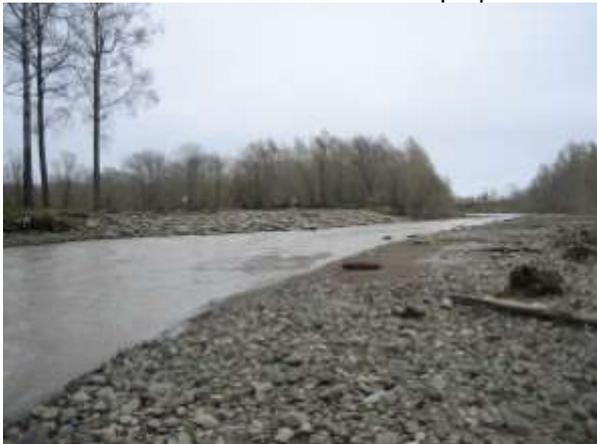
At the time of the visit there was heavy riprap on the northern bank of the south channel and some on the inside band (Photos 1 and 2), and the washout on the pipe was repaired. Photo 3 was taken just east of the crossing of the north channel (no access was possible at the time of the visit) and illustrates the multi channel braided nature of the river.

Photo 1 – View to the far bank with riprap

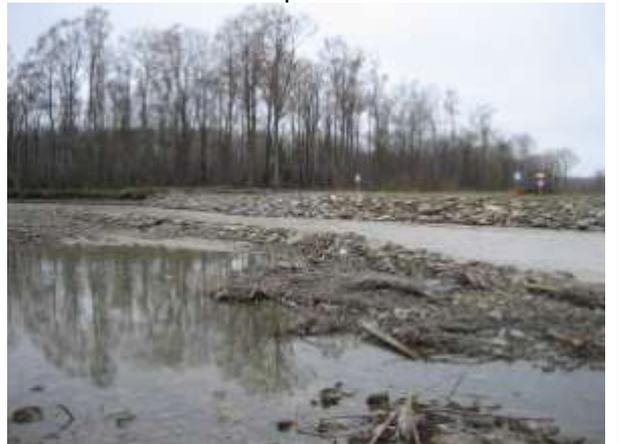
Photo 2 – View to the upstream

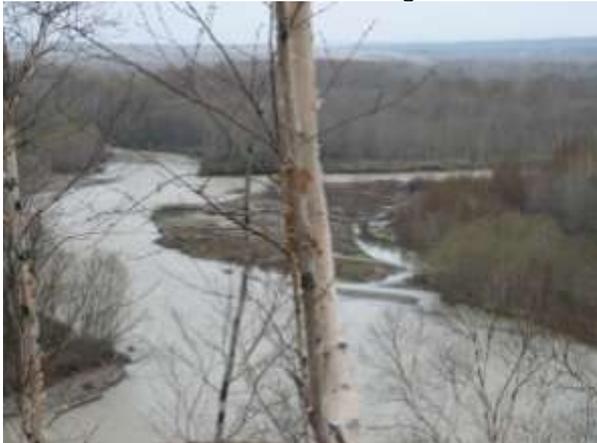
Photo 3 – View toward the crossing from the east

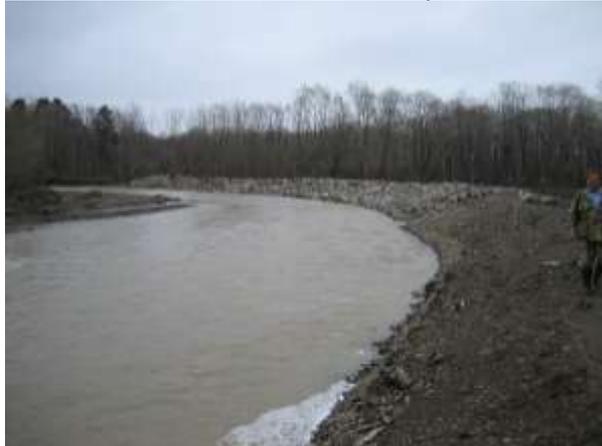
The Gornaya is a large meandering river with a very tight meander just upstream of the crossing. During the typhoons of June/July 2009, the river jumped the bank following a blockage of the main channel. Its path short-cut the bend, and began flowing across the RoW outside of the channel. Both the gas pipeline and FOC became exposed and critical spawning habitat was compromised, so was treated as an emergency. Sakhalin Energy conducted extensive emergency repairs at the site which included fortifying the channel bank upstream of the crossing (Photo 1) and constructing a fortified overflow channel across the RoW north of the present channel (Photo 2). Reportedly, this will allow flood water to cross the RoW in a controlled manner.

Photo 1 – Fortified meander bank upstream

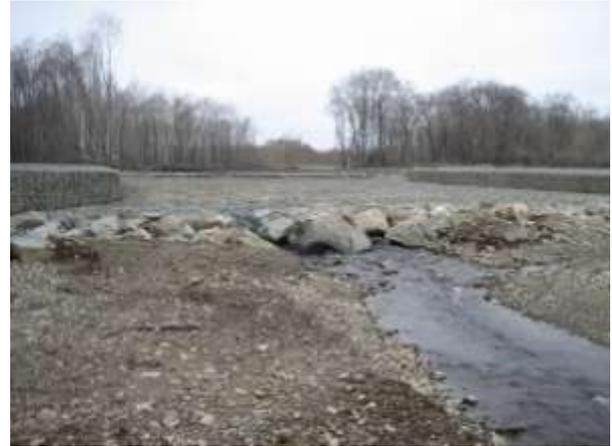
Photo 2 – Overflow channel

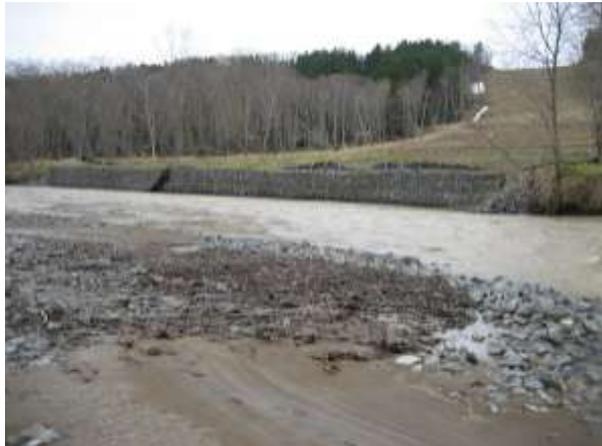
The outside bank on the original channel has gabions and was not impacted by the flooding (Photo 3) the slope south of the river appears intact but with sparse vegetation. The RoW north of the crossing has very little vegetation and much un-germinated seed was observed on the ground (Photo 4).

Photo 3 – Gabion wall on the south bank

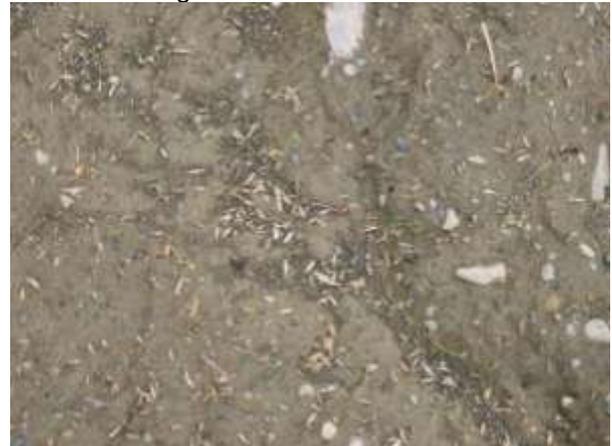
Photo 4 – Un-germinated seed

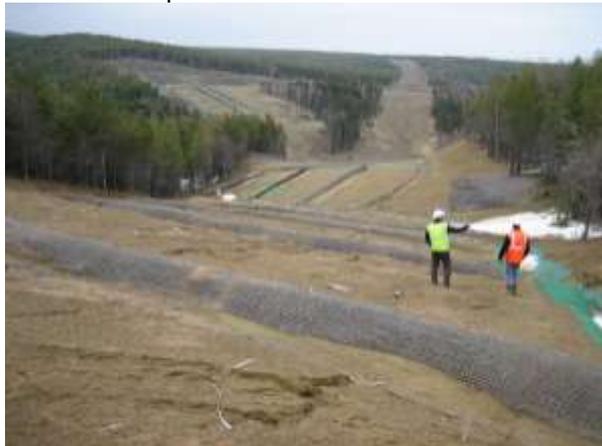
During the visit it was observed that although the slope held during the spring thaw there was significant erosion starting at different parts of the slope with a resulting sediment flow to the river below. Deep rills and washouts were observed where the drainage control was not adequate. In addition, the slope was almost devoid of vegetation.

The river banks are protected by Reno matting and were intact. The silt fencing was effective in capturing some of the sediment flow from the slope. The main issues at this location are erosion and drainage control and bio-restoration on the steep slope (Photos 1 to 4).

Photo 1 – Slope south of the river

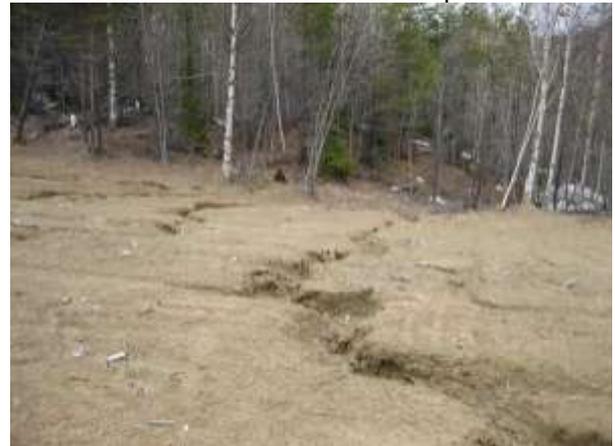
Photo 2 – Erosional rills on south slope

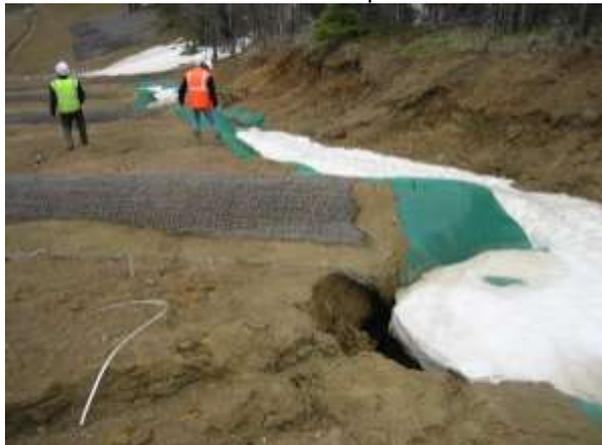
Photo 3 – washout under a slope breaker

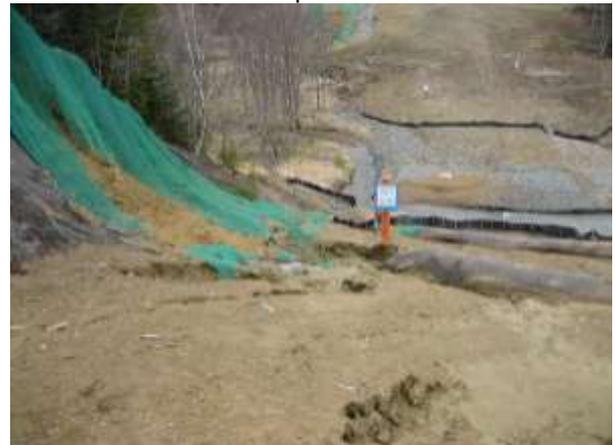
Photo 4 – Erosion of slope above the river

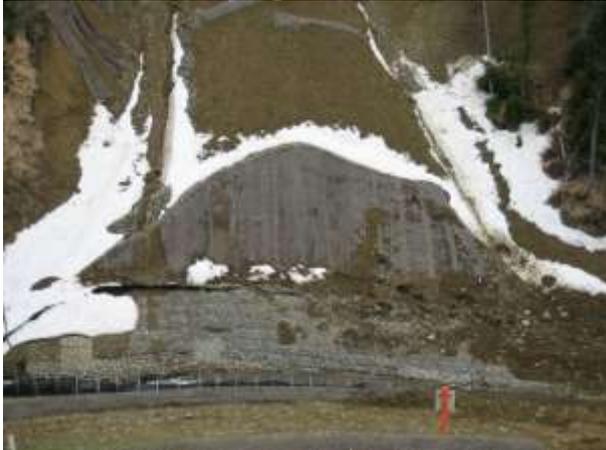
The Gar River crossing was damaged during last year's typhoon and required emergency repairs following the rains. The Reno matting on both banks and river bed were repaired (Photo 1). However, the work was not completed and more is scheduled to be done this year following the spawning season.

Photo 1 – Reno matting on river banks

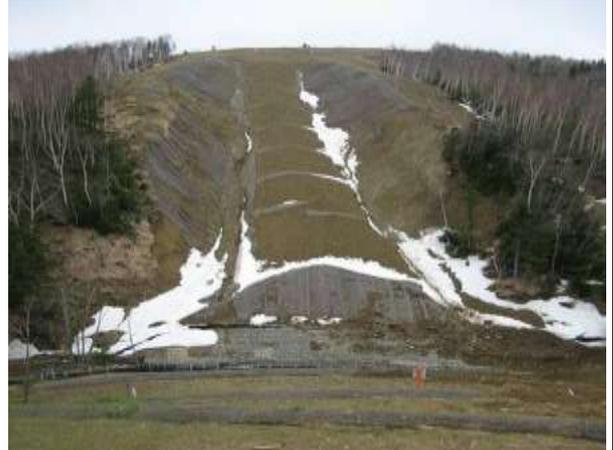
The south slope held during the typhoons and this year's thaw but some repairs are required for the drainage system – particularly the vertical drains (Photo 2). The northern slope held but was disturbed by heavy equipment movement during the emergency repairs. Slope breakers were restored at the time of the equipment pullout but they need a more permanent repair (Photo 3).

Photo 2 – View of southern slope

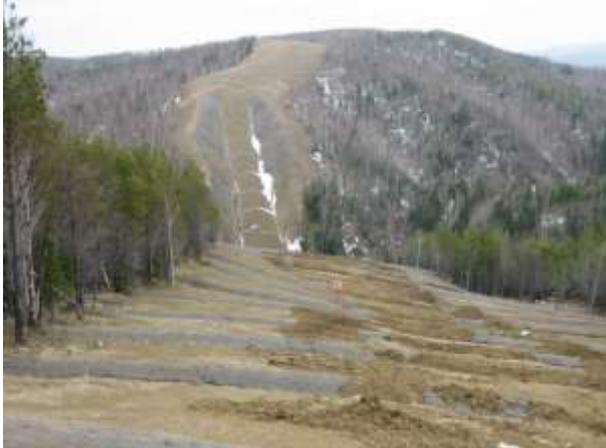
Photo 3 – View of northern slope - slope breakers

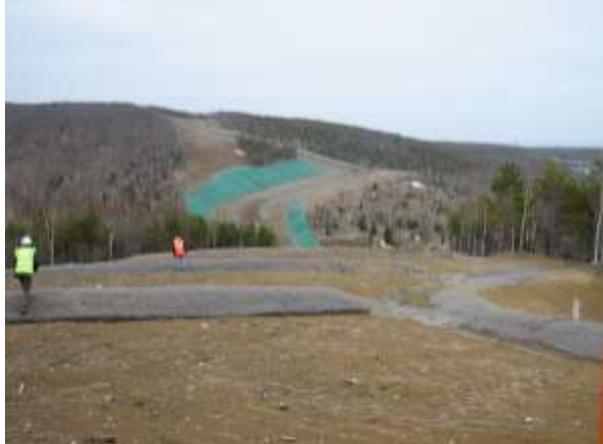
During the visit it was observed that the south slope has generally good surface run-off control but is almost entirely devoid of vegetation (Photos 1 to 3). Also, a significant sized failure was observed at mid slope (Photo 2). The north slope showed evidence of sediment flow to the river along the side cuts. The surface of slope as well the side cuts (which are covered with geotextile) show no vegetation.

Photo 1 – View of the upper southern slope

The river banks are well protected by gabion walls which held well during the typhoons and the spring thaw (Photo 4). The failure on the south slope indicates a need for better surface and subsurface drainage control. Further bio-reinstatement is also necessary to further stabilise the slopes and reduce sediment transport to the river.

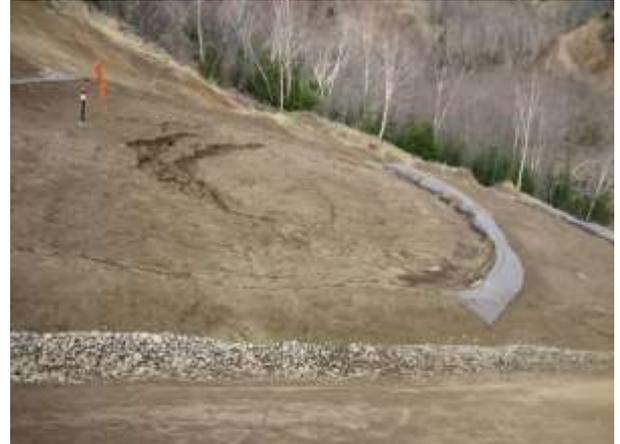
Photo 2 – View of a slope failure at mid slope

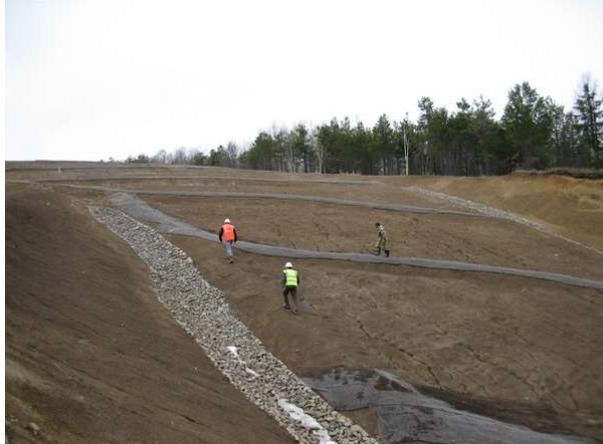
Photo 3 – View of the southern slope lack of vegetation

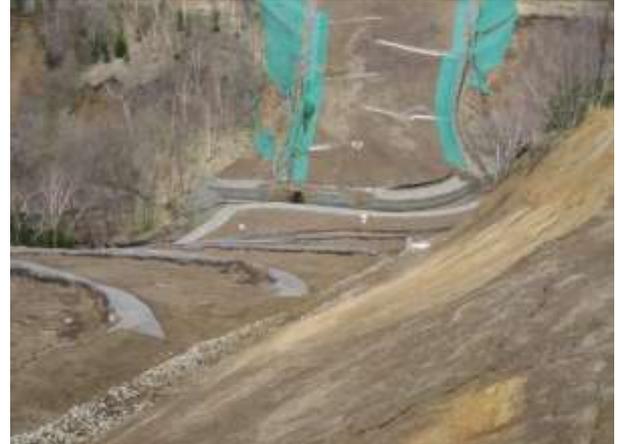
Photo 4 – View of the slopes and gabions on river banks

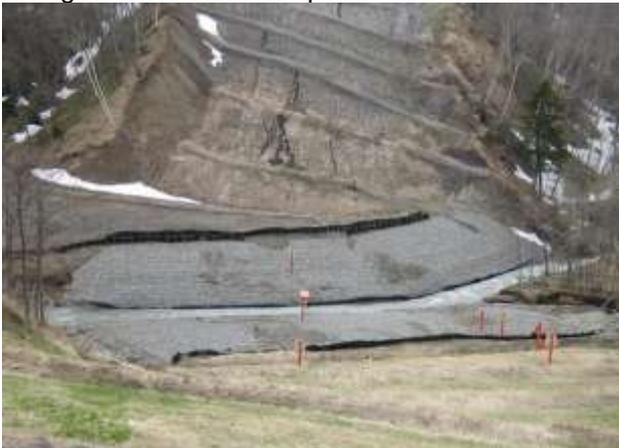
The Krinka river banks are protected with extensive Reno mats and silt fencing. The mats and the fences appear to be in good shape. The northern slope is heavily vegetated and with good drainage control and slope breakers. The southern slope held during the typhoons and the thaw but shows significant rills and a lack of vegetation on the slope surface and on the side cut (Photos 1 to 3).

Photo 1 – Reno mats on river, and erosion and lack of vegetation on south slope

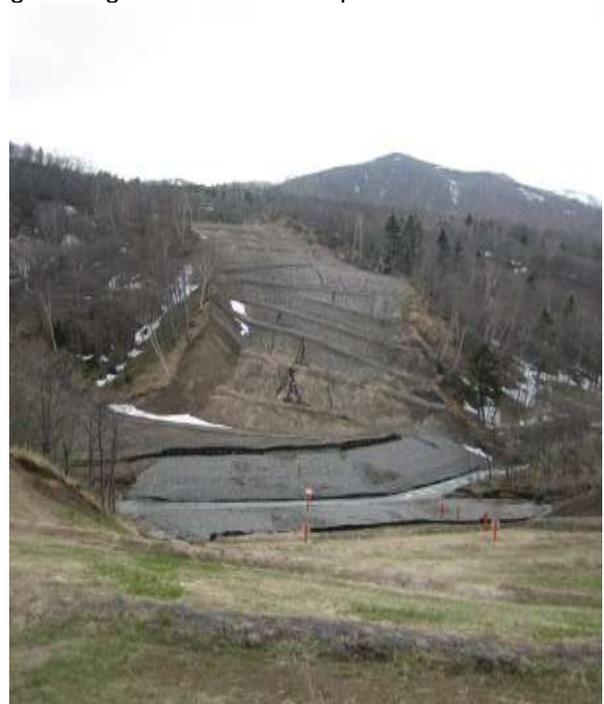
Photo 2 – View of both slopes and river showing good vegetation on near slope

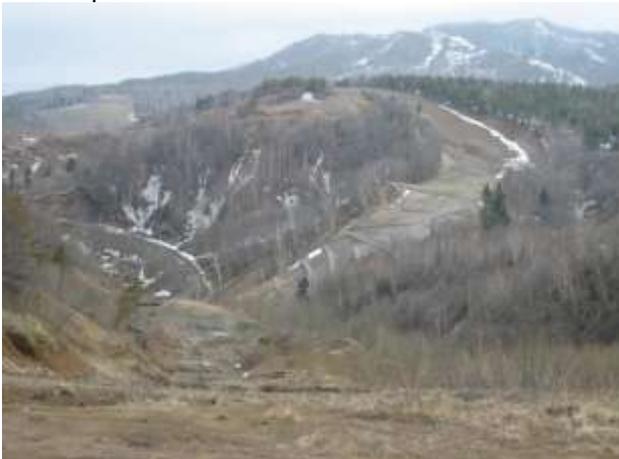
Photo 3 – View to the south at the long south slope with slope breakers

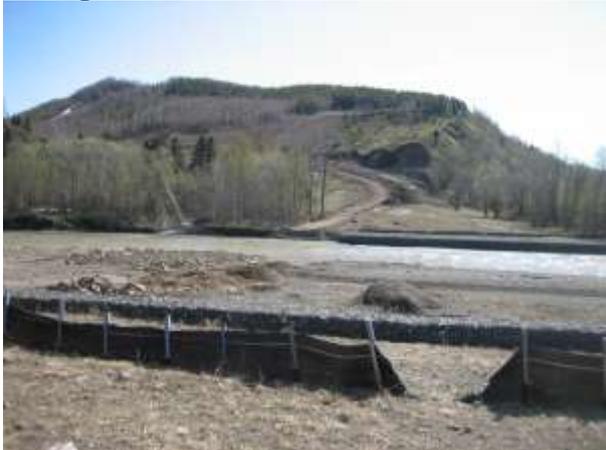
The river bank protection consists of gabion walls on both banks. The north bank gabion wall is damaged at the upstream point and will need repair (Photo 2). The RoW on the north side has a running track leading to the BVS (Photos 1 and 2). Reportedly, the running track will be removed and the slope will be reinstated. The gabion wall on the south bank is intact; however the bank and the RoW to the south have construction debris and a temporary road (Photos 3 and 4). All this is reportedly scheduled to be removed following the spawning period. Vegetation on the RoW to the south is good, and the north RoW will need to be seeded when the slope is reinstated.

Photo 1 – View north across the river showing running track

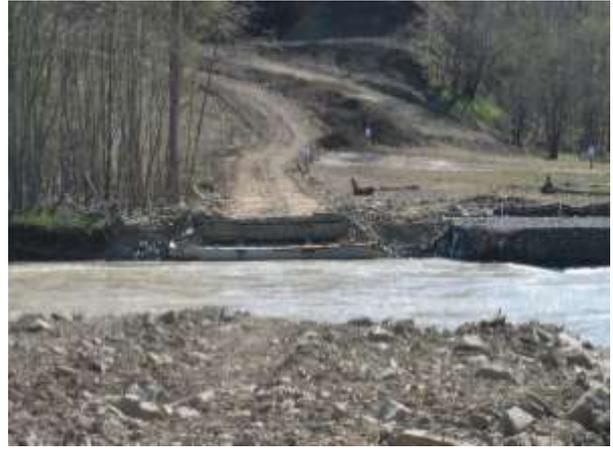
Photo 2 – Damaged gabion wall and bridge foundation

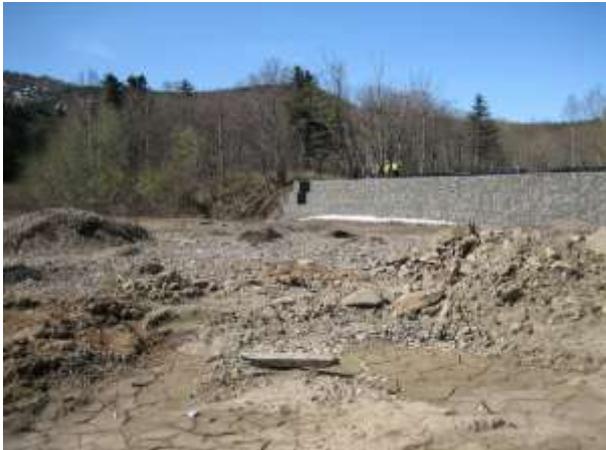
Photo 3 – South bank gabion wall and construction debris
