Lenders' Independent Environmental Consultant: Monitoring Report June 2010 Sakhalin-2 Phase 2 Project

Report to Sakhalin-2 (Phase 2) Project Finance Parties

Restricted – Commercial
AEAT/ENV/R/3052 Issue 1
July 2010

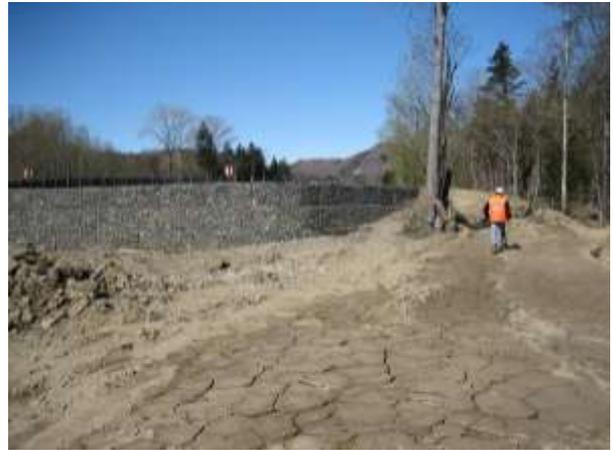
Photo 4 – South bank and unfinished ground works

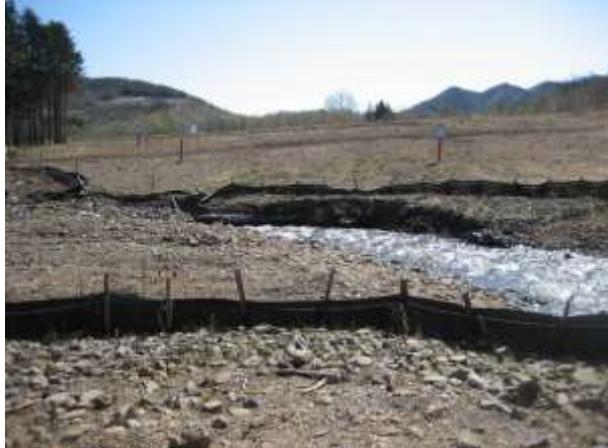
The Solyanka River banks are still covered with small riprap that was installed during construction. Since then, some of the riprap has been lost during high flows. Also, the bridge foundation is still visible in the north bank (Photos 1 and 2). Reportedly, the river is scheduled for installation of new bank protection and removal of the bridge foundation.

Photo 1 – River with bridge foundation and riprap

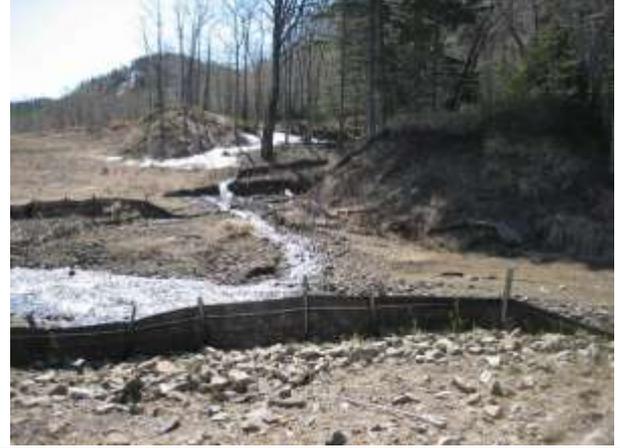
Photo 2 – View of river and tributary

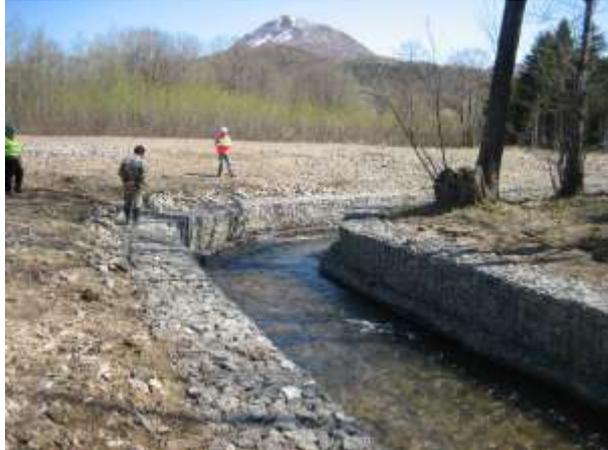
The gabion protected channel upstream of the crossing and parallel to the RoW was damaged during the typhoons of last year and repaired on an emergency basis last year (Photo 3). More work is scheduled to be performed upstream of the repaired area (Photo 4).

Photo 3 – Repaired channel

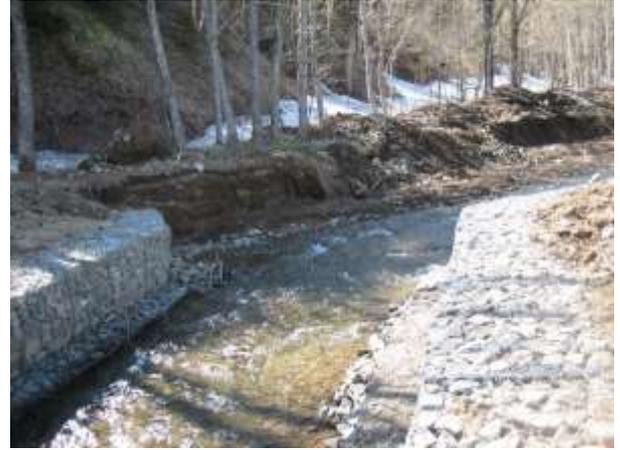
Photo 4 – Upstream of repaired channel at future planned works

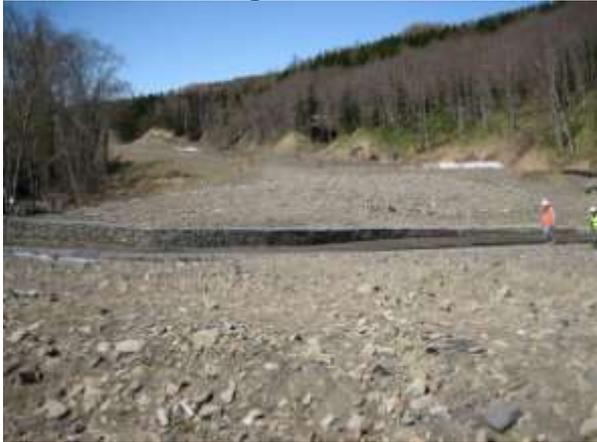
The RoW in the vicinity of the crossing is in need of additional seeding (Photo 3). The area where the RoW is crossing a forestry road is disturbed and in need of additional grading and seeding (Photo 4).

Photo 3 – Lack of vegetation on RoW

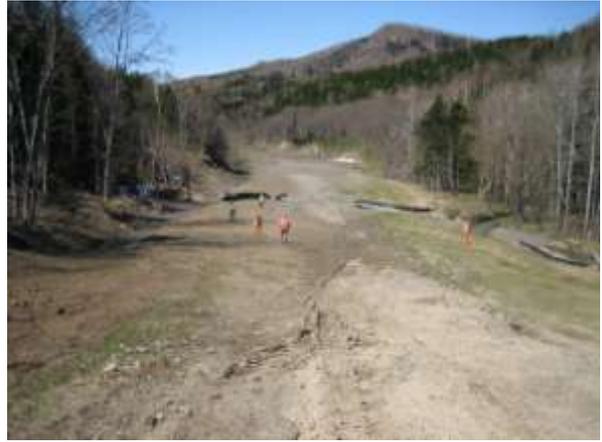
Photo 4 – View of disturbed RoW

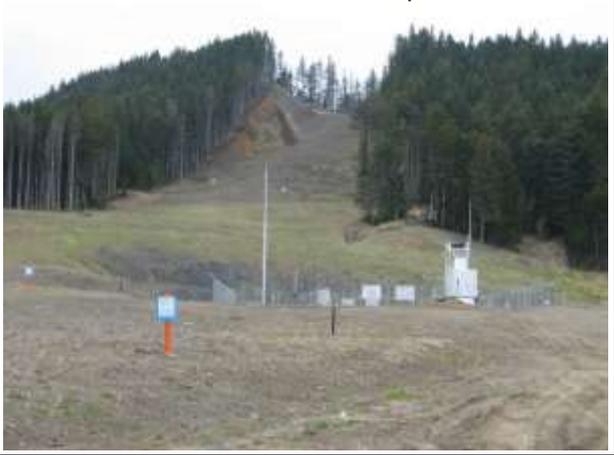
The Pegas River crossing is protected with gabion wall on each bank and the RoW is well vegetated. The slope above the BVS is protected with slope breakers but in need of additional seeding.

Photo 2 – View of the northern slope

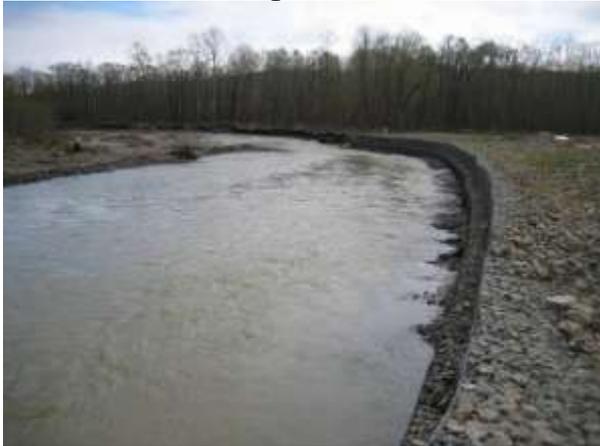
The Madera River crossing was damaged in last year's typhoons and repaired on an emergency basis. Currently, the river is protected by a gabion wall on the south bank and Reno mats on the north bank (Photos 1 and 2). The upstream corner of the gabion wall and the adjacent natural bank will need to be monitored.

Photo 1 – South bank gabion wall

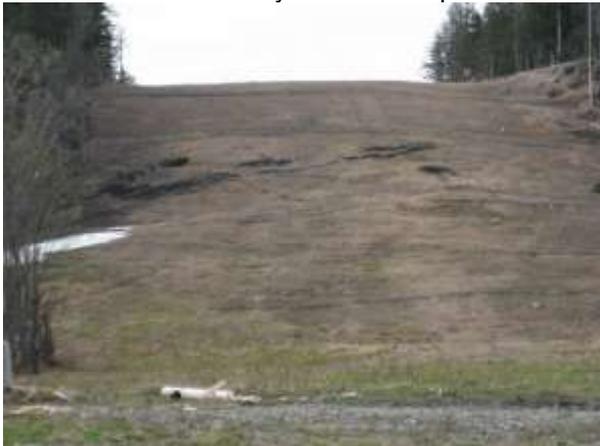
The RoW on both sides of the river have good vegetation cover, however the slope further south has spotty cover and some soil instability (Photo 3). More seeding is needed on the slope and a continuous monitoring of the slope condition.

Photo 3 – Soil instability on south slope

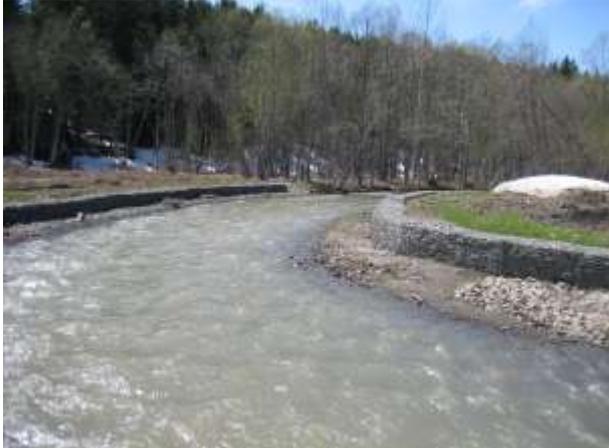
The Zhelezhnyak River crossing was damaged during last year's typhoons and was repaired last year as an emergency operation. Currently the river banks are protected with gabion walls on both sides of the river (Photos 1 and 2). The slope south of the river is well vegetated (by hydro-seeding) and held well (Photo 3).

Photo 2 – Downstream of repaired gabion walls

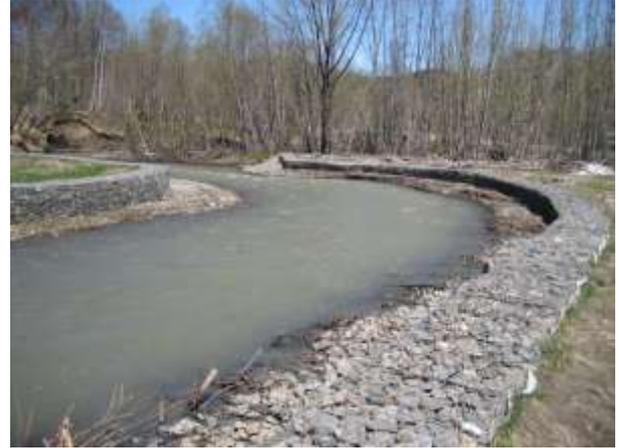
Photo 3 – South slope with good vegetation

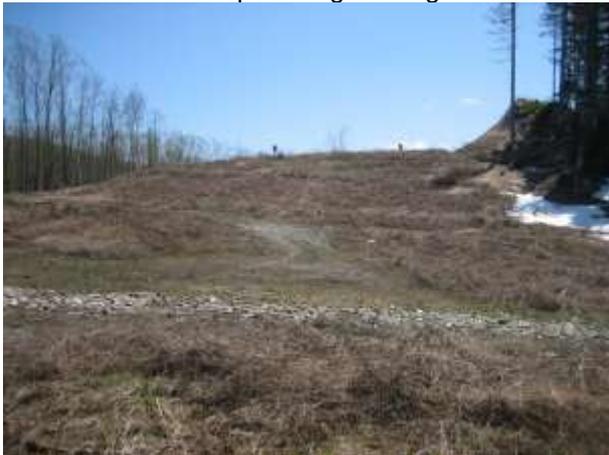
The RoW on the north side is partially disturbed, probably due to the emergency, works and is need of reinstatement (Photo 4).

Photo 4 – View north at RoW across the river

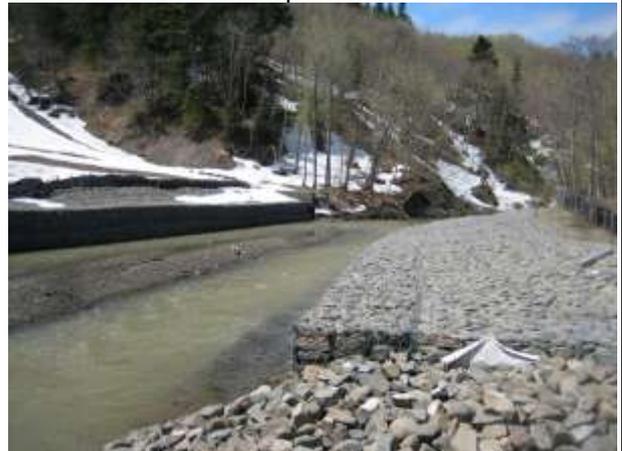
The slope on the south side is very steep and at the time of the visit was partially covered with snow. Soil movement was observed at about mid slope on the gas pipe side (Photos 3 and 4). Reportedly, Company personnel have noted the condition of the slope and added it to the maintenance schedule.

Photo 3 – View south at the slope across the river

The slope also has very limited grass cover and is in need of further bio-restoration.

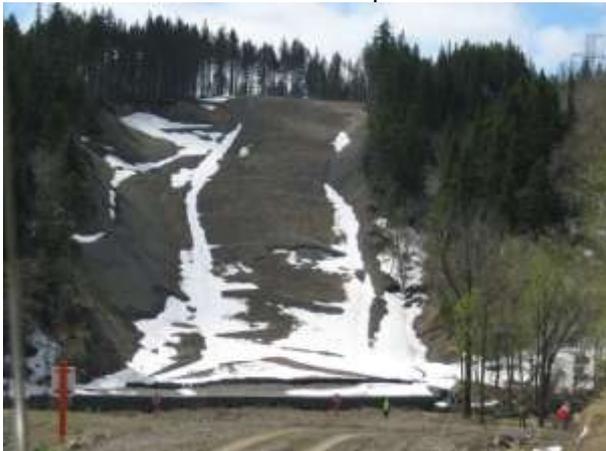
Photo 4 – Soil movement at mid slope

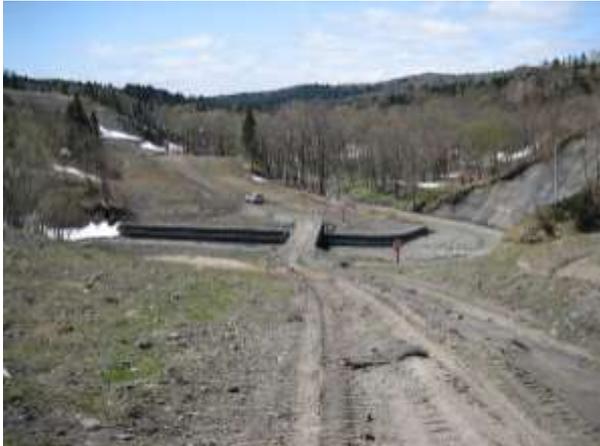
As seen in the photos below, the bridge and the running track are still in place. Reportedly, the bridge is scheduled to be removed and the running track reinstated.

Photo 2 – Downstream – bridge and gabion walls

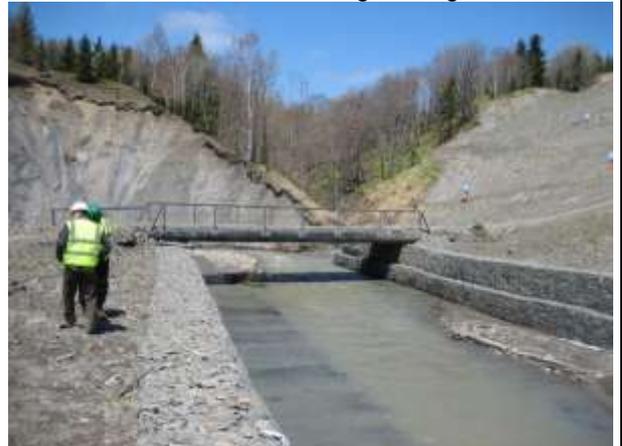
The slope above the river on the north side held during the thaw and is protected with slope breakers. However, it has very minimal vegetation cover and is need of a further seeding (Photo 3).

Photo 3 – Downstream – bridge and gabion walls

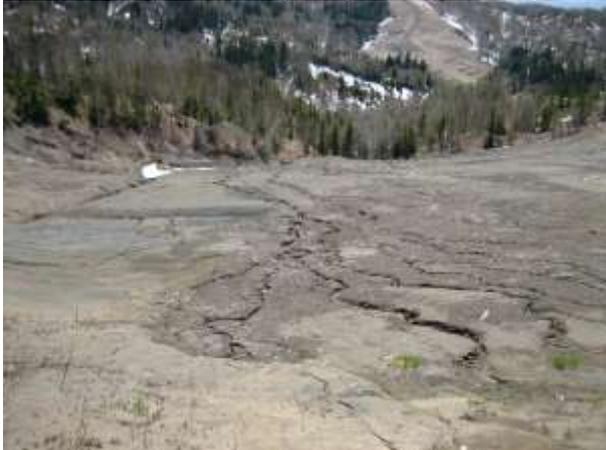
On the RoW itself, at the top of the northern slope there was a slope failure to western side of the RoW (Photo 2). This too was noted by Company representatives. The opposite slope appears intact and is protected with slope breakers (Photo 3). Both slopes are in need of further seeding.

Photo 3 – View at failed ROW slope

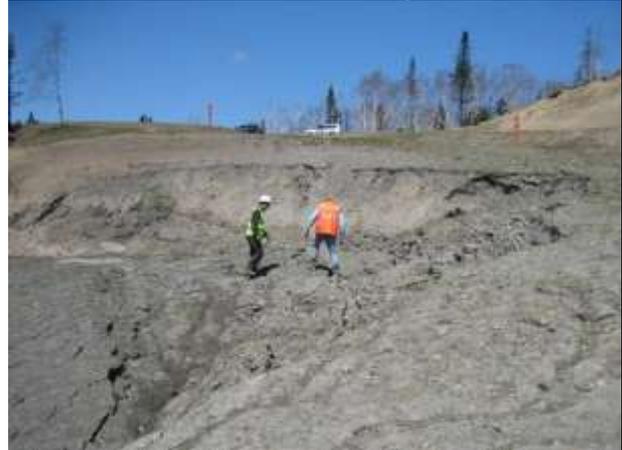
Photo 4 – View to the south at slopes across the river

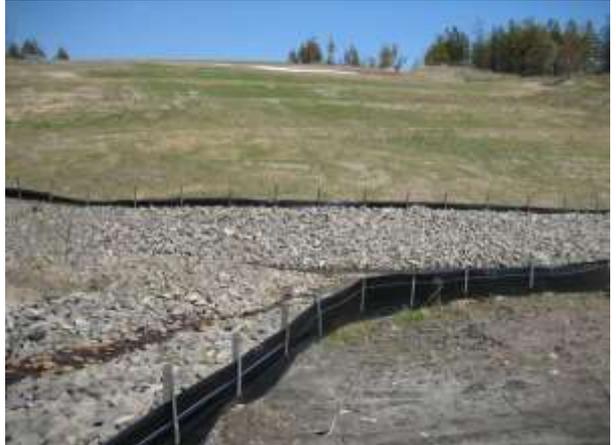
The RoW leading to the stream is mostly in good shape but in need of further seeding. As seen in Photos 1 and 2, the grass cover on the RoW is very inconsistent – in this case it is good on the opposite slope and poor on the near slope. The un-named stream is well protected with riprap and silt fencing (Photos 1 and 2). At approximately KP 415 the RoW is less vegetated and with some soil movement on the side cuts (Photo 3).

Photo 3 – View south at the RoW with poor bio-restoration and soil movement on the far slope.

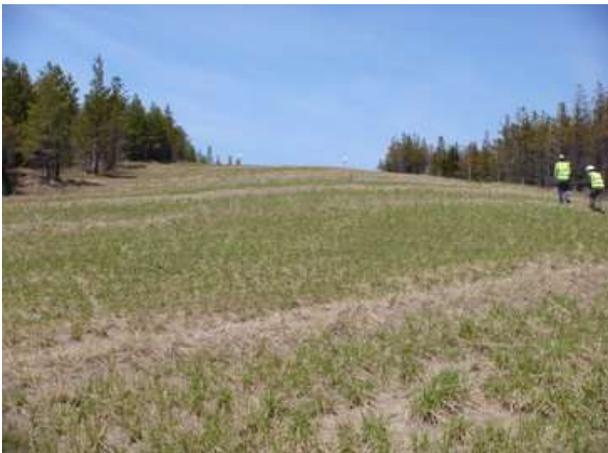
The Vulkanka River has steep slopes on both sides of the river. The slopes are well protected with slope breakers and covered with grass (Photo 1). The river banks are protected with Reno matting and silt fencing (Photo 2). The RoW leading to the river from the south has inconsistent grass cover. Some is good as in Photo 3, and some is minimal as in Photo 4. More and more effective seeding is needed on parts of the RoW.

Photo 4 – RoW leading to the river with poor grass cover.

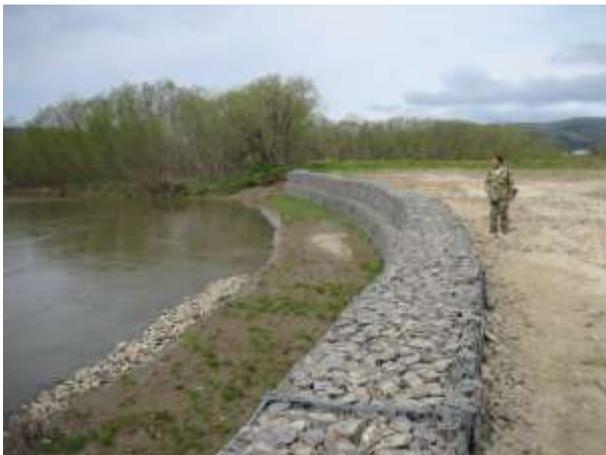
Photo 2 – South bank with mostly buried gabion wall

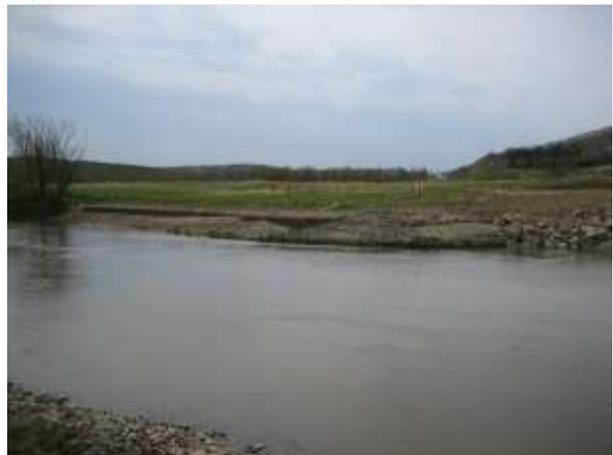
Photo 3 – View of the south bank upstream of the crossing with temporary fortified bank

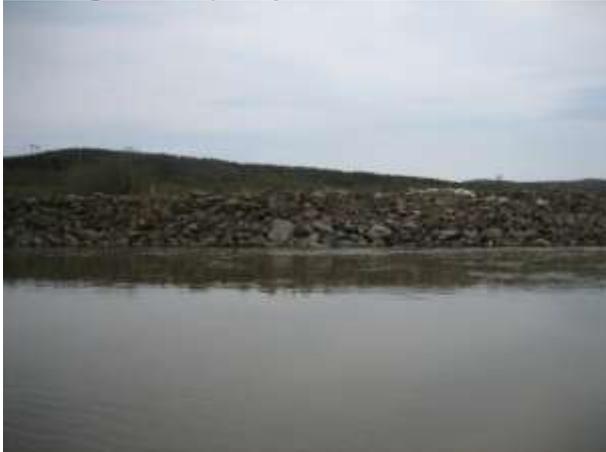
Photo 4 – same as photo 3, the new fortification starts where the gabion wall ends

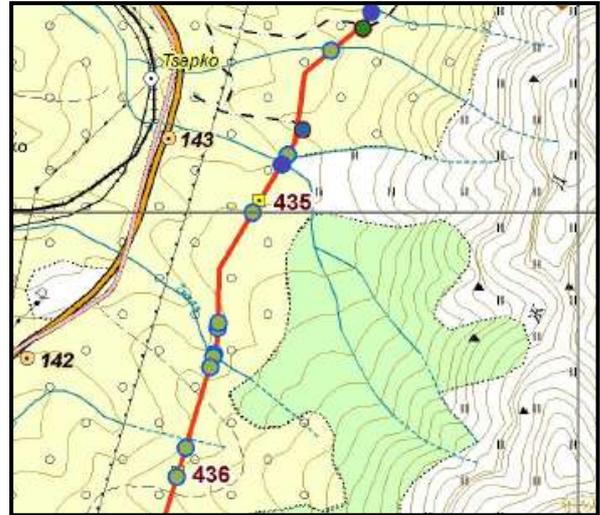
The unnamed tributary which crosses the RoW was heavily eroded during last's year typhoons and required emergency repair. The stream's bed and banks are now completely protected by Reno mats and gabion walls Photo 1 and 2). Further work was performed upslope from the tributary on a minor crossing drainage in order to prevent erosion across the RoW (Photo 3).

Photo 1 – View to the north across the tributary showing gabion walls

The slope leading to the tributary is in need of bio-restoration (Photos 1 to 3).

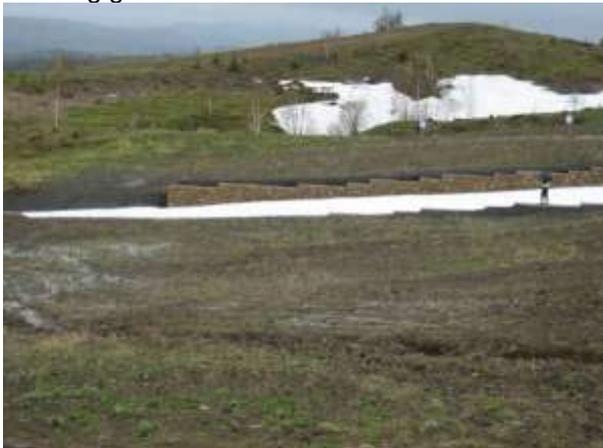
Photo 2 – View of cascading Reno mats and gabion wall construction

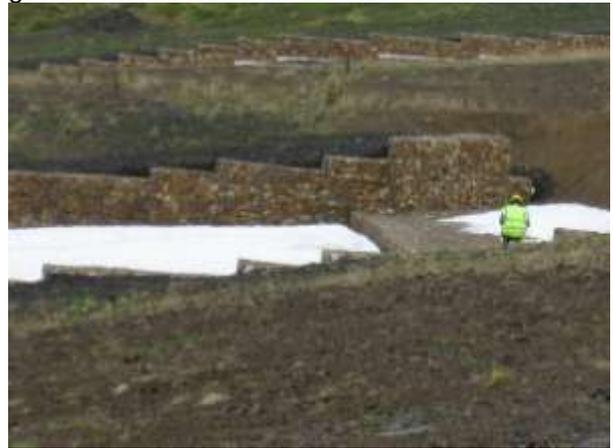
Photo 3 – Armouring of a crossing drainage

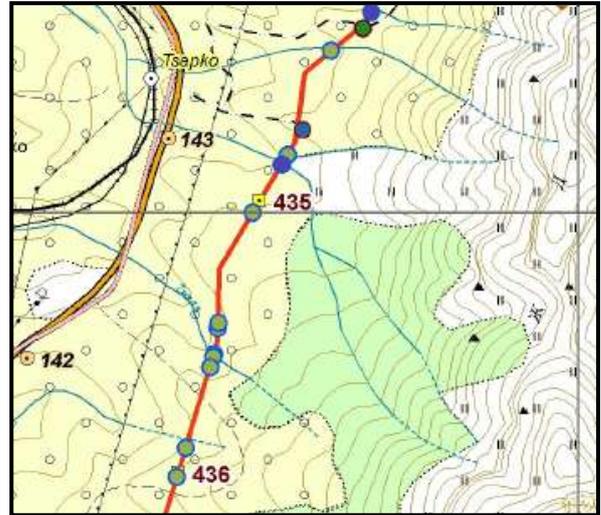
The Travyanaya 2 river crossing has steep slopes above the banks. The south slope has a crossing drainage that was previously difficult to control. Subsequently, the drainage was rerouted to flow along the RoW and to enter the river on the upstream side. This results in difficulties with erosion and sediment control. The Company is aware of the situation and more work is scheduled to be performed on this slope (Photos 1 and 2). The river banks are protected with Reno matting and riprap.

Photo 1 – River valley with south slope drainage

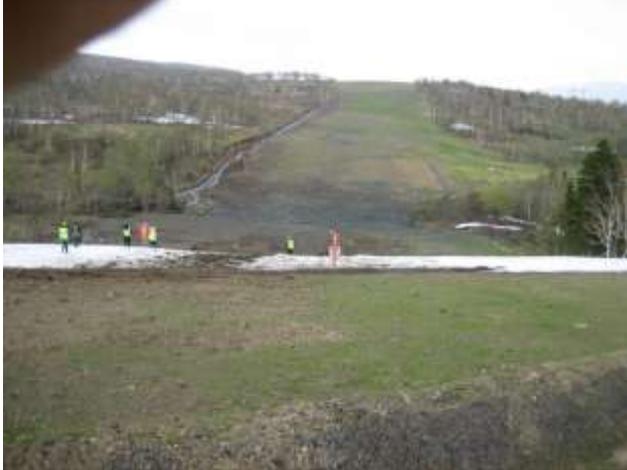
Photo 2 – Close up of the drainage channel

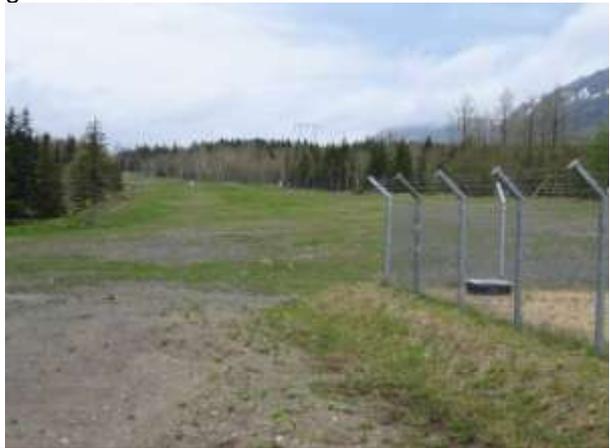
A permanent road was build to provide access to the BVS north of the Tikhaya River. The RoW in the vicinity of the station has inconsistent ground cover and can use additional seeding on certain parts (Photos 1 and 2).

Photo 1 – View north showing RoW with good grass cover.

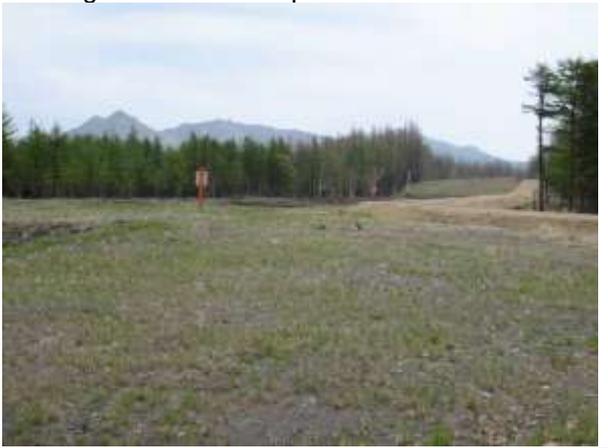
Photo 2 – View south showing RoW with lesser coverage. Also note the permanent access road.

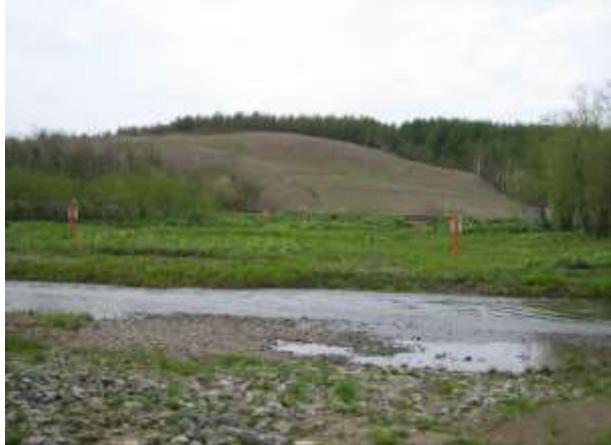
The Tikhaya River flows adjacent to the railroad and both were crossed using a horizontal thrust boring method. This resulted in undisturbed river banks which can be seen in their natural state in Photos 1 and 2. The river valley was disturbed by the excavation for the thrust boring and pipe trenches but it is graded and mostly well vegetated. As Photo 1 shows, the vegetation in the valley is in better condition than on the slope the south.

Photo 1 – View south across the river and railroad

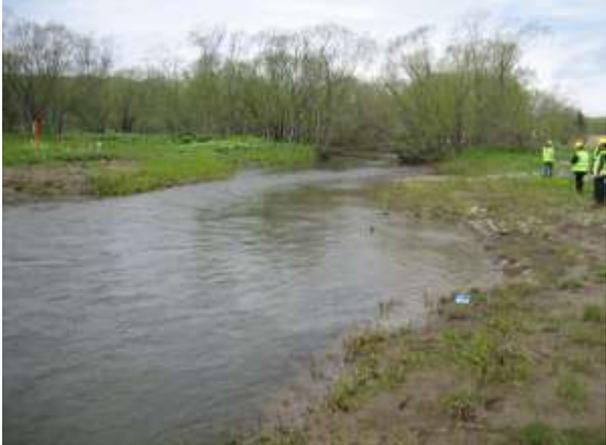
Photo 2 – view of river banks

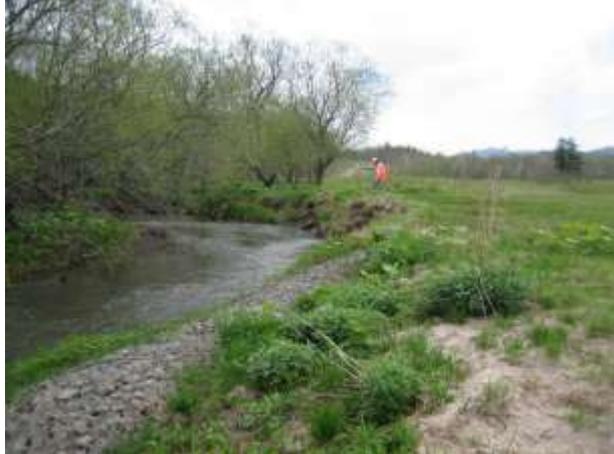
The river banks are protected by Reno matting that held during last year's storms and the spring thaw (Photos 1 and 2). The Company is reportedly monitoring the condition of the leading edge of the Reno matting upstream of the crossing for possible erosion along the bank. The slope is partially vegetated (Photo 2) although is in need of further seeding. The valley between the Duet 2 and Duet 3 crossing (Photos 3 and 4) is mostly vegetated but shows inconsistency in grass cover and will benefit from additional seeding.

Photo 1 – South bank with Reno mats

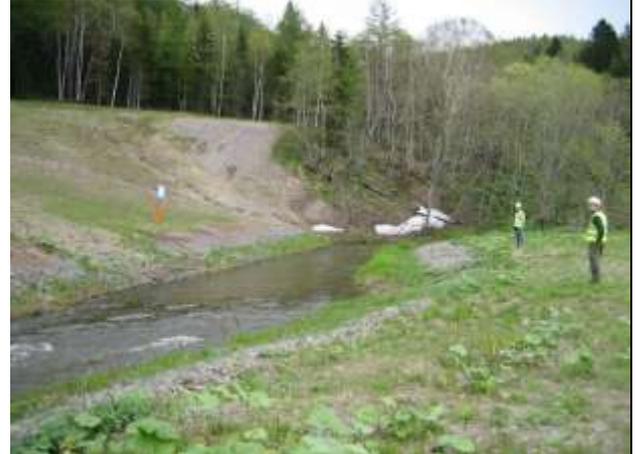
Photo 2 – View across the river to the north slope

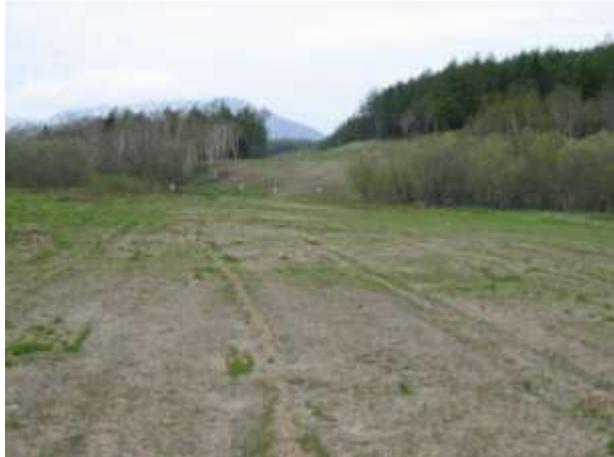
Photo 3 – View to the north of partially vegetated ROW between Duet 2 and 3

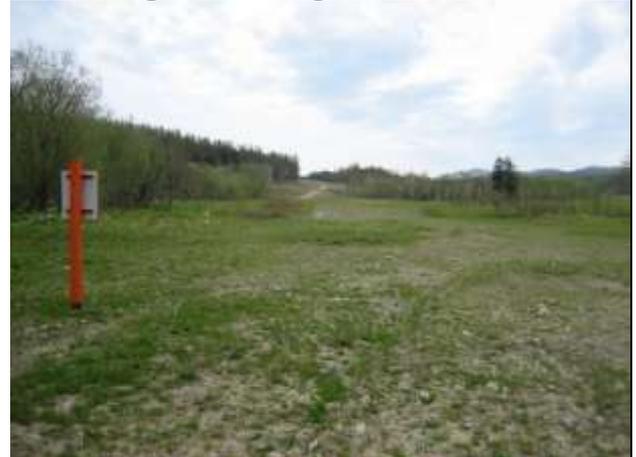
Photo 4 – View to the south of RoW between the two crossings with better ground cover.

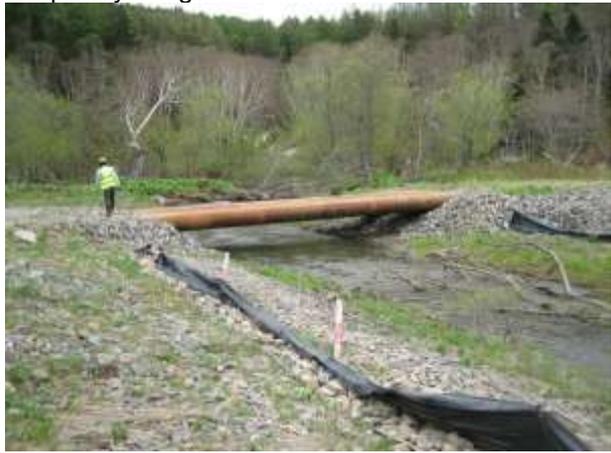
The Duet 3 River crossing is situated at the southern edge of valley, and the river flows along the RoW to the Duet 2 crossing (see above). The river banks are protected with Reno mats and are partially vegetated. A temporary bridge is still in place as well as the running track on the RoW, leading south to a BVS (Photos 1 and 2). Reportedly, a plan is being formulated to construct a permanent bridge and access road.

The silt fencing is damaged and will need to be repaired until construction activity is finished.

Photo 1 – View of river bank with Reno mats and temporary bridge

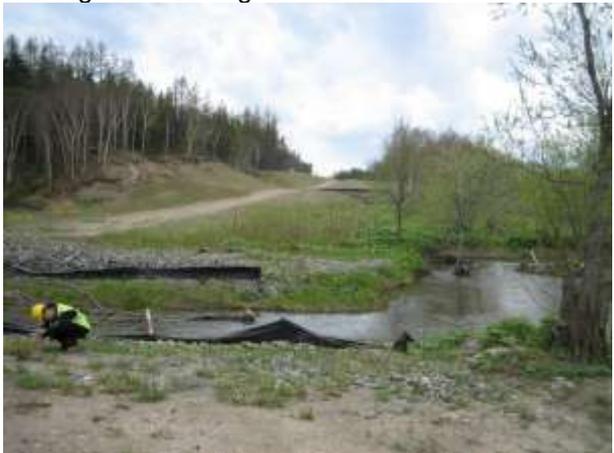
Photo 2 – View across the river at RoW with running track leading to BVS

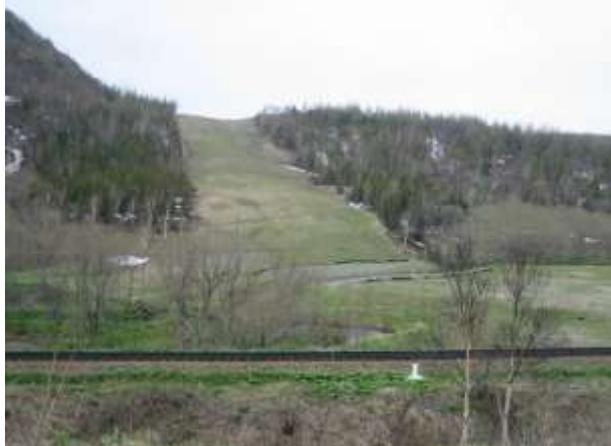
The Krasnaya River has a long steep slope on the south side and a flat river valley on the north. The River banks are protected with Reno mats and silt fencing (Photos 1 and 2). The slope is well vegetated and protected with slope breakers and drainage control. The river valley and the RoW across the Federal Highway are well vegetated (Photos 2 and 3).

Photo 1 – South showing slope and river crossing.

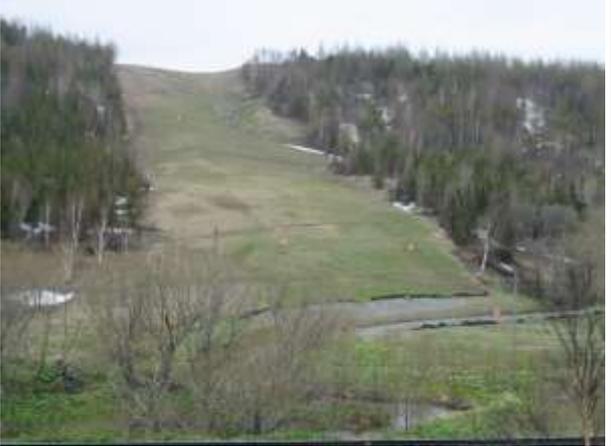
Photo 2 – View of crossing and slope

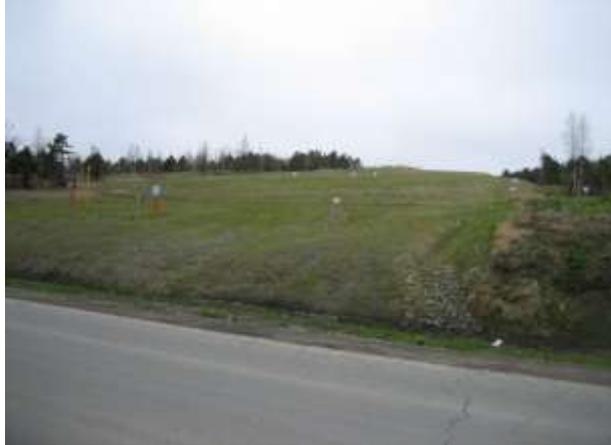
Photo 3 – View north across the Federal Highway

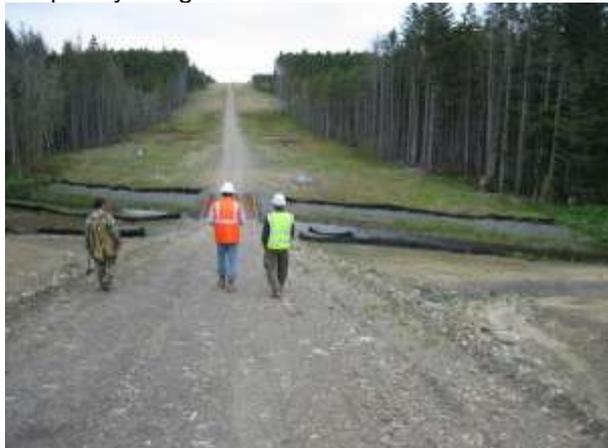
There is a temporary bridge on the crossing and a running track which continues north. Reportedly, the Company is reviewing the temporary bridge situation in this area and will make a decision in the near future regarding running track and temporary bridges in the area.

Photo 1 – View north showing river crossing and temporary bridge

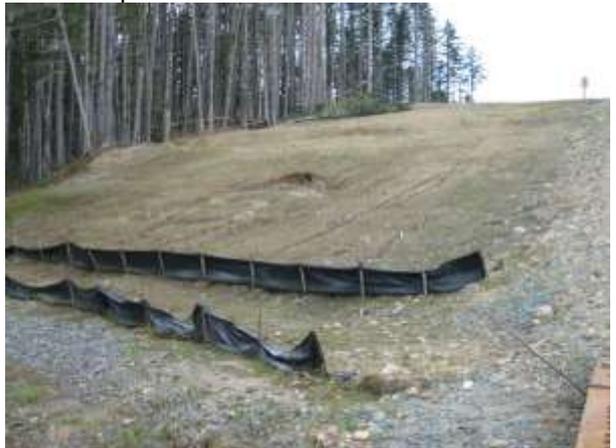
The Slavnaya River is protected with Reno mats and silt fencing. The slope on the south side of the crossing has soil movement at mid slope and erosional rill development. Sakhalin Energy personnel noted the situation and added the site to its maintenance list.

Photo 2 – View of south slope with soil movement at mid slope

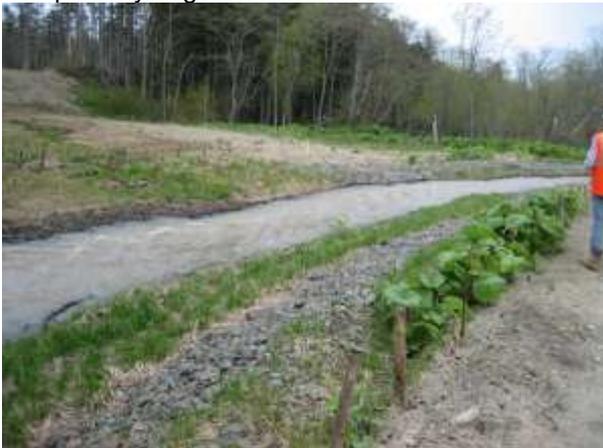
The Primorskaya River banks are protected with Reno mats and are partially vegetated (Photo 1). The RoW leading the river from the BVS to the south is not fully reinstated (Photos 2 to 5) and is on the Company's works schedule for this year. More work is needed on slopes protection such as slope breakers and drainage control, as well as repairing erosion that has already occurred (such as erosion rills – some which are quite deep), and soil movement on the lower part of the south slope above the river (Photo 4).

Photo 1 – River banks protected with Reno mats and partially vegetated.

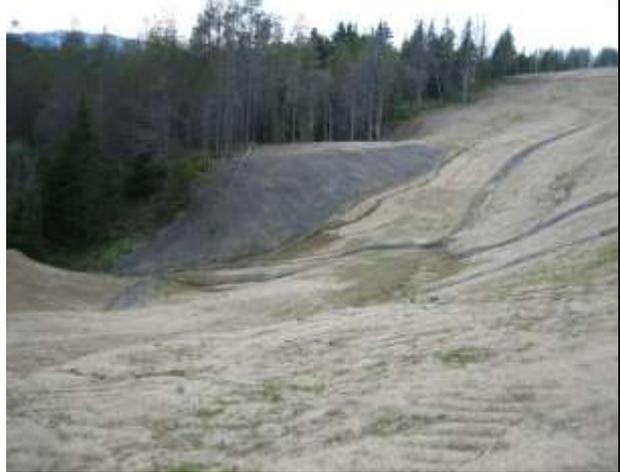
The entire segment of RoW between the BVS and the river is almost completely without vegetation. In addition, the slope north of the river is need of better erosion control and seeding.

Photo 2 – View of ROW with sparse ground cover

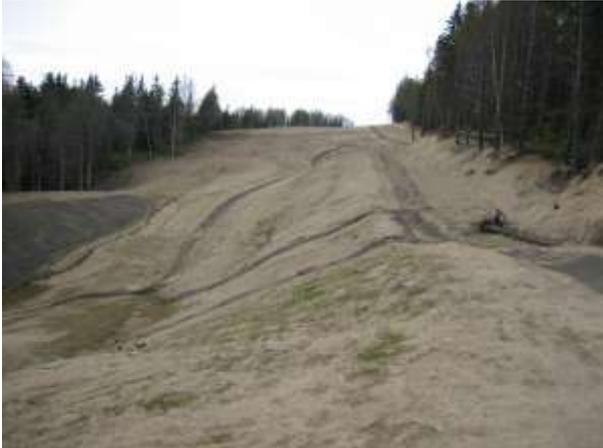
Photo 3 – RoW with sparse ground cover and erosional rills

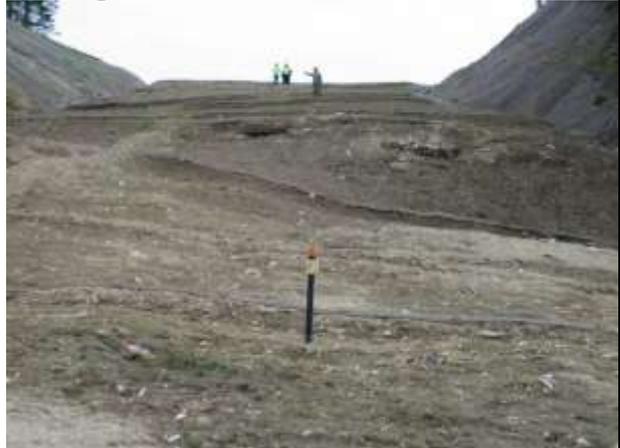
Photo 4 – South slope with soil movement and sparse ground cover

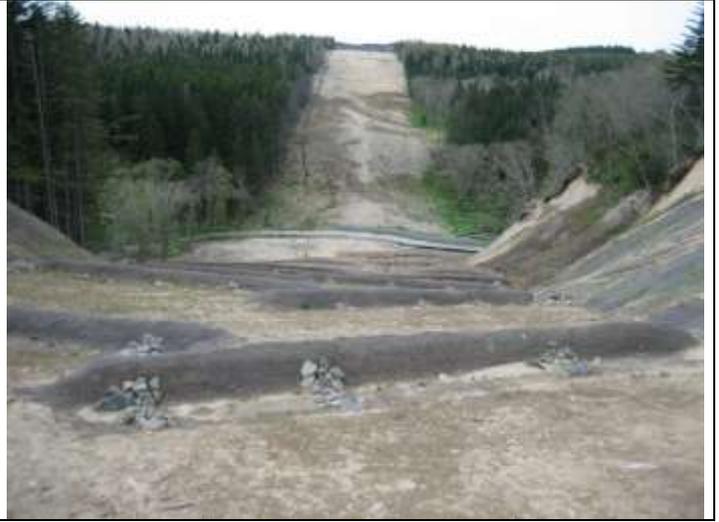
Photo 5 – View of south slope protected with slope breakers but with sparse grass cover. North slope with minimal slope protection and grass cover.

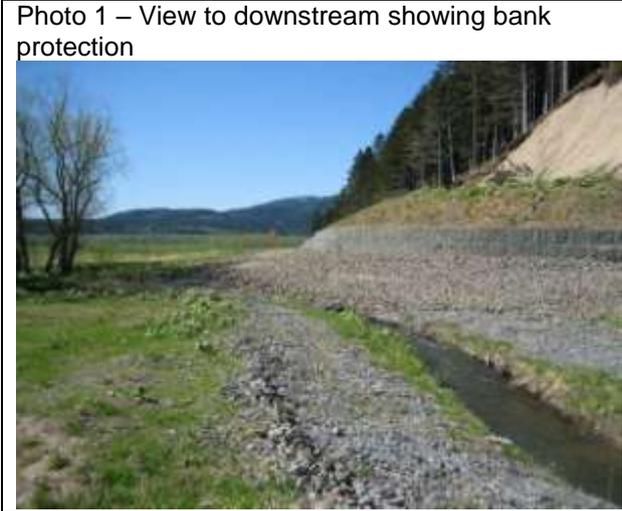
The banks are well protected with Reno mats (Photo 1). The mats are generally in good condition and are partially vegetated. There is a subsidence in the north bank on the upstream portion of the crossing (Photo 2) in the vicinity of the gas pipeline. Sakhalin Energy personnel have noted the subsidence and have added it to the maintenance schedule.

The RoW in the vicinity of the crossing is well vegetated. South of the crossing where there is a near vertical, tall side cut; Sakhalin Energy had installed a gabion wall and soil buttress against the cut. The soil on the buttress is well vegetated but the remaining exposed side cut is not (Photo 1).

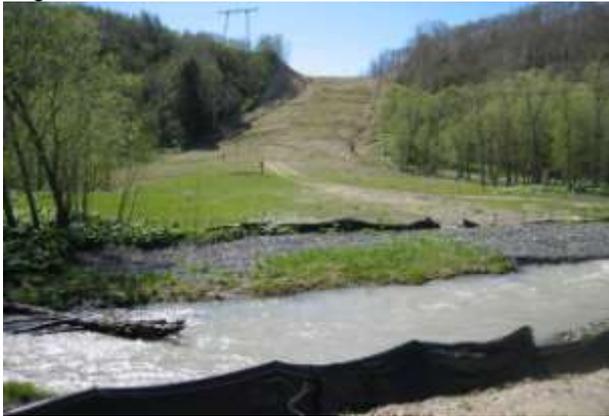
The river banks are protected with Reno mats and are partially vegetated. The RoW and slope to the south are mostly well vegetated and with erosion control on the slope (Photo 1). The slope to the north is the beginning of the fault crossing. The RoW section between the fault crossing and the river bank has no vegetation at all (Photo 2). However, silt fencing is in place between the river bank and the RoW.

Photo 1 – View of the crossing with Reno mats, and the RoW and south slope with good vegetation.

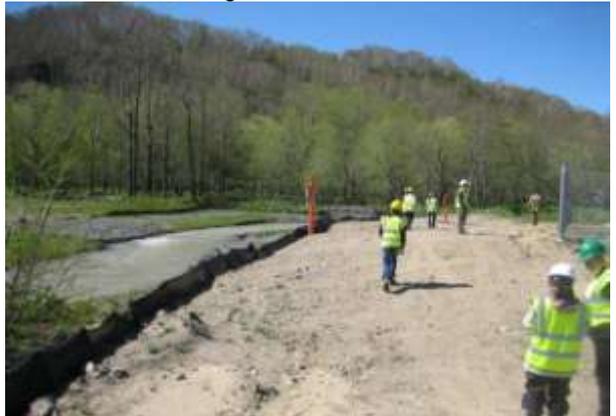
Photo 2 – View of the north bank and adjacent RoW between the river and the Fault Crossing – note the lack of vegetation.

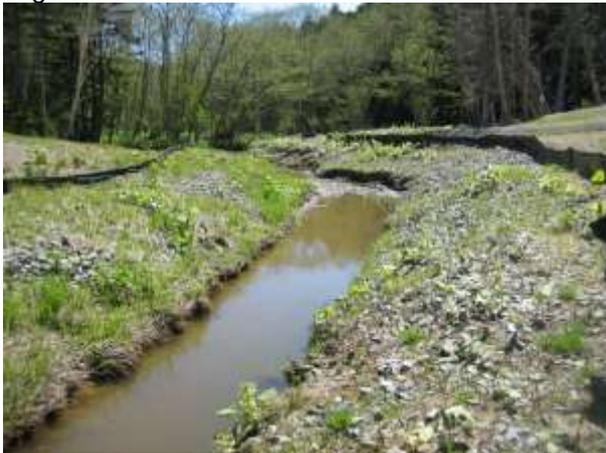
The river banks are protected with riprap and silt fencing and are partly vegetated (Photos 1 and 2).

Photo 1 – Downstream showing riprap and vegetation on banks

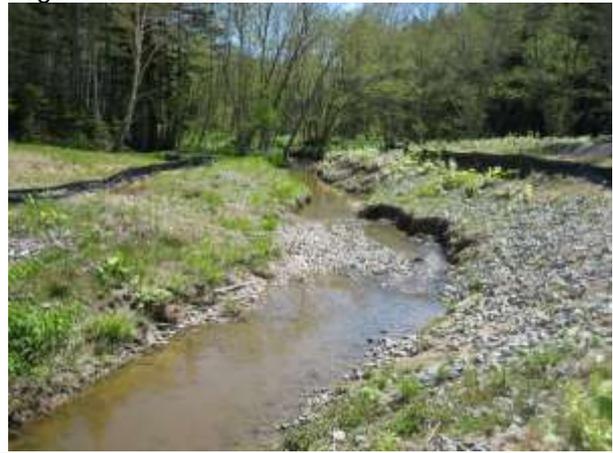
Photo 2 – Upstream showing riprap and vegetation on banks

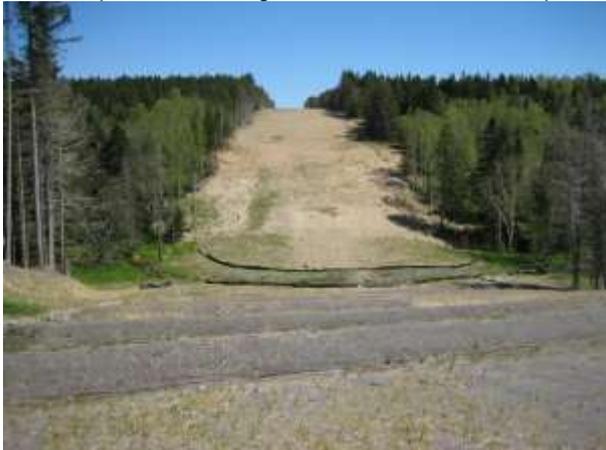
The slope to the north is in need of further bio-restoration as it has almost no ground cover (Photo 3). The south slope has very good grass cover and slope breakers (Photo 4). The work on this slope was part of the effort to stabilise the Sovetskoye Ridge (see next entry) and was performed by a specialist subcontractor and then hydro-seeded.

Photo 3 – Slope protection and vegetation on the near slope, lack of vegetation on the north slope

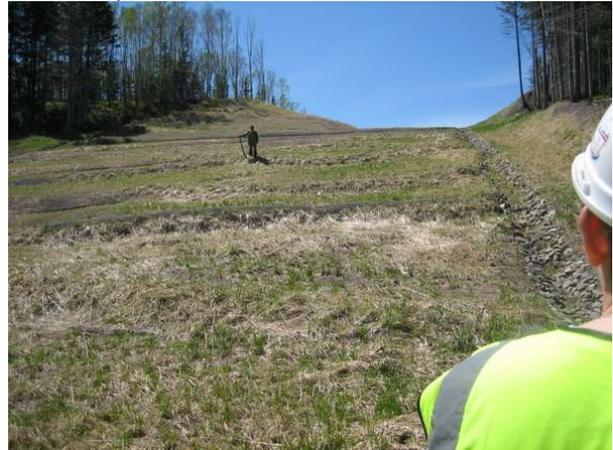
Photo 4 – Slope protection and vegetation on the south slope.

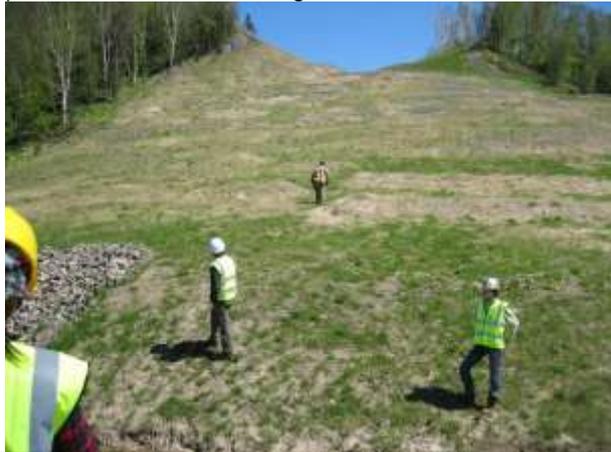
Photo 1 – View of Sovetskoye slope with good protection and dense vegetation.

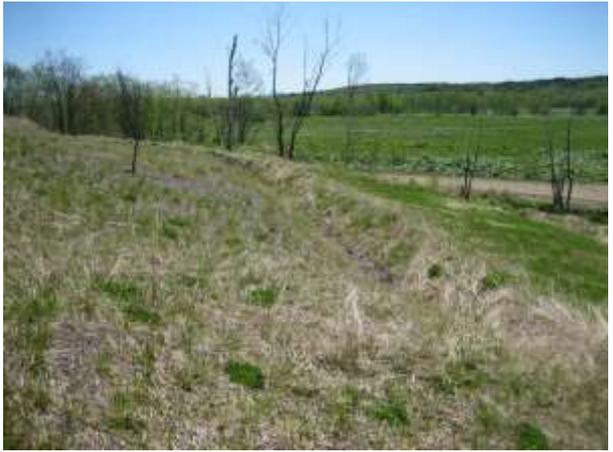
Photo 2 – close up of the dense vegetation cover.

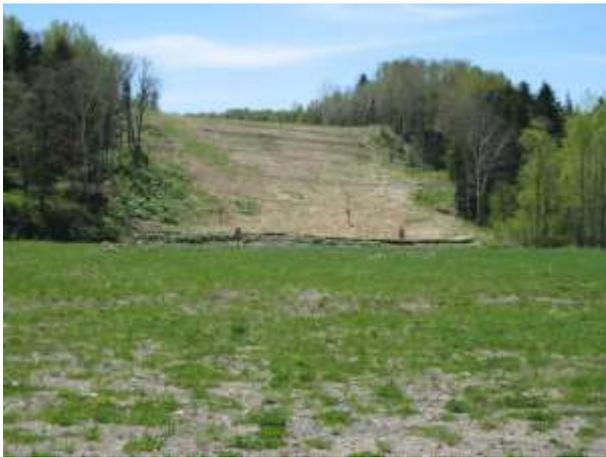
The Ai River has a short steep slope on the south side and a broad river valley on the north side. The Slope is protected by slope breakers and dense vegetation and held well. Reportedly, in 2009, trench breakers were installed in both pipe trenches resulting with improved slope stability (Photo1). The banks are protected with Reno matting and are partly vegetated. The RoW on the Ai valley is well vegetated (Photos 1 and 3).

Photo 1 – View to the south showing protection on slope and good vegetation.

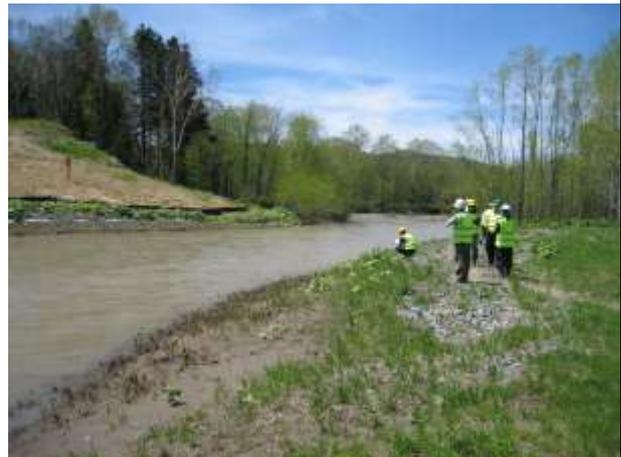
Photo 2 – Upstream showing north bank with partially covered Reno mats with good grass cover

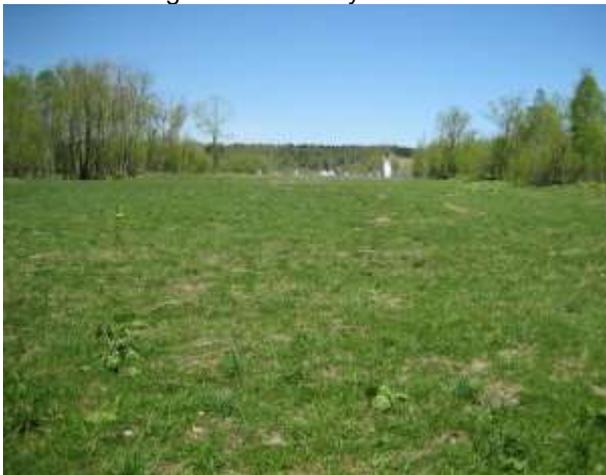
Photo 3 – View north showing good vegetation on the RoW along the river valley

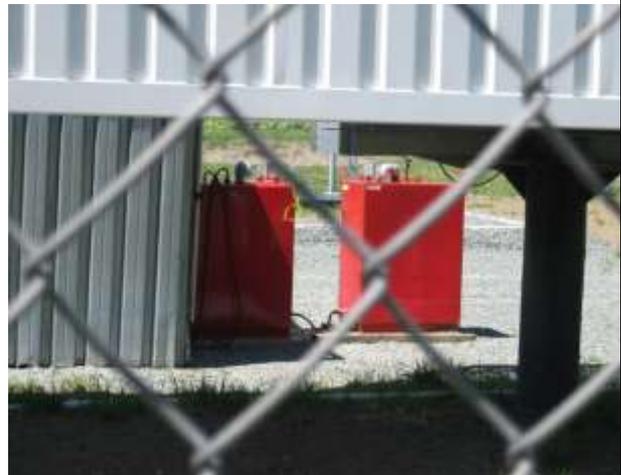
At the BVS, there are two diesel day tanks (Photo 4) which reportedly are necessary for the backup generator since the gas take-off generator is in repair.

Photo 4 – Diesel day tanks without secondary containment

These tanks require secondary containment.

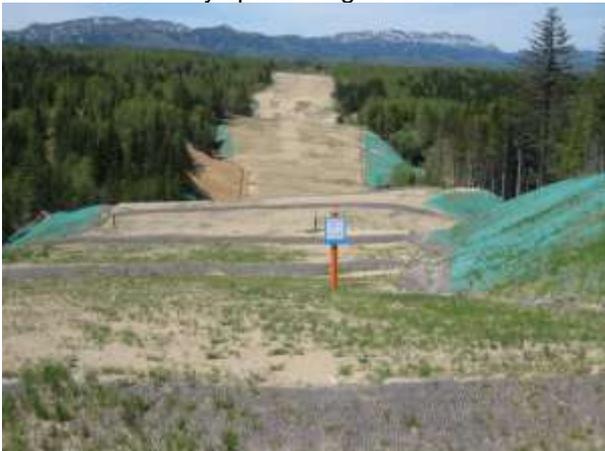
The sandy slopes along the RoW in this area have very inconsistent grass cover, but mostly they are without any vegetation at all (Photos 1 to 6). Much work was done to protect some of the steep slopes with slope breakers and generous use of geotextile. The slopes that were observed during the visit appear to mostly hold well following the typhoon and the thaw, but rills have already started to develop (Photo 3) and with future rains will act as preferential conduits and will grow larger. The area is in need of thorough bio-restoration to prevent future erosion.

Photo 1 – View north showing RoW with slope breakers and very sparse vegetation

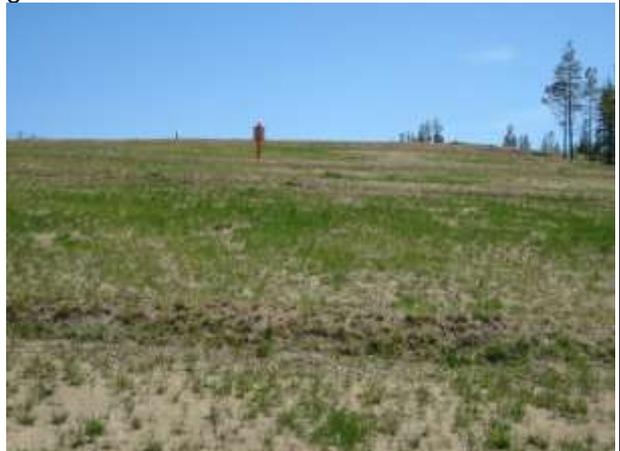
Photo 2 – View south showing RoW with good grass cover.

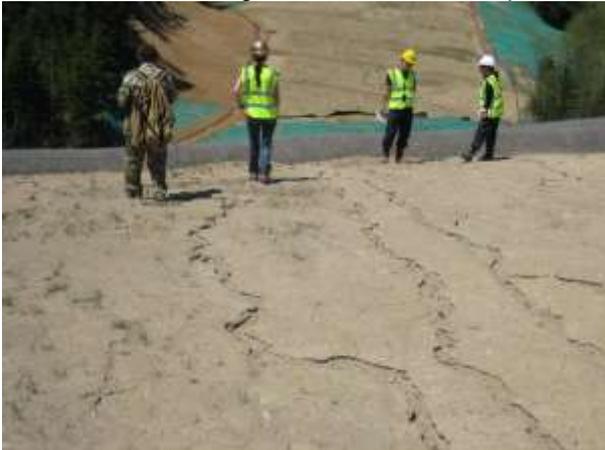
Photo 3 – Lack of vegetation and rill development

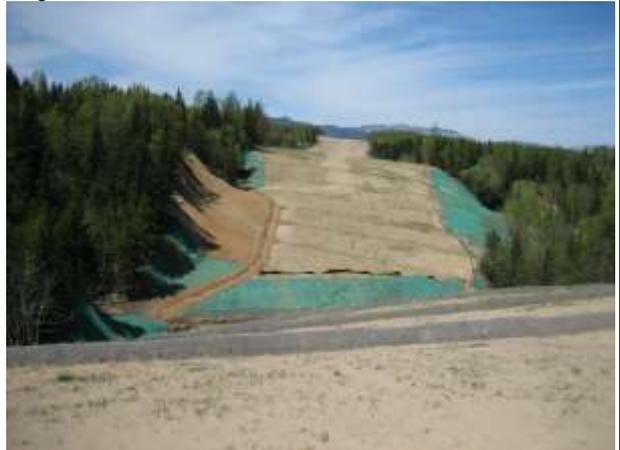
Photo 4 – RoW with erosion control but without vegetation

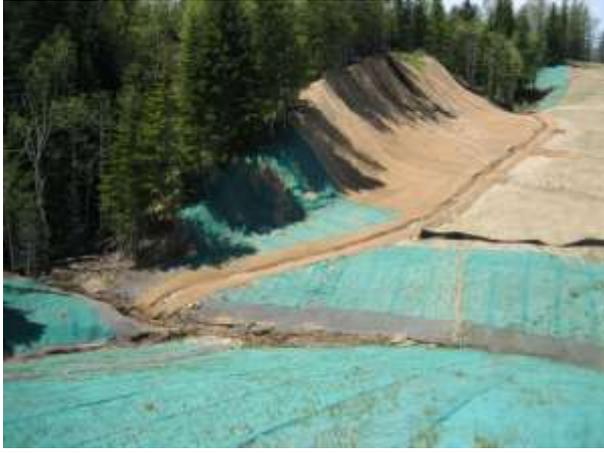
Photo 5 – Heavily protected crossing drainage, including slope breakers and geotextile
