Lenders' Independent Environmental Consultant: Monitoring Report June 2010 Sakhalin-2 Phase 2 Project

Report to Sakhalin-2 (Phase 2) Project Finance Parties

Restricted – Commercial
AEAT/ENV/R/3052 Issue 1
July 2010

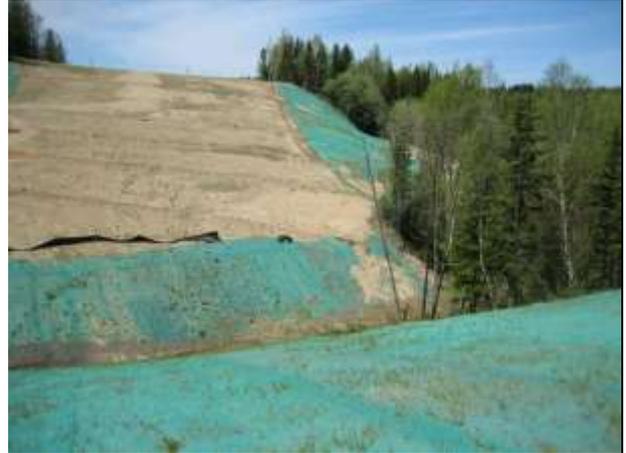
Photo 6 – As in Photo 5

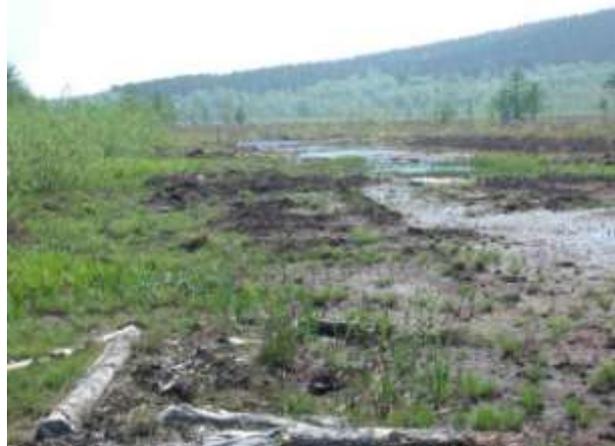
There are three main issues along this stretch of RoW: the running track tree trunk foundations that weren't removed upon completion of construction (Photo 1), the presence of concrete blocks and foundations that have been left in-situ (Photo 2) and the areas of peat that have not been levelled back to ground level over the tops of the pipes (Photo 3). Sakhalin Energy has accepted that there is a problem and are arranging to rectify the issues. The RoW generally has re-vegetated naturally back to a reasonable state of repair (Photo 4) but there are areas where the groundwater flows are interrupted causing ponding (Photo 5). All works are proposed to be carried out manually in order to minimise further damage with personnel and equipment all walking into the sites to be repaired. This is accepted as best practice in this instance.

Photo 1 – Foundations of log road in situ

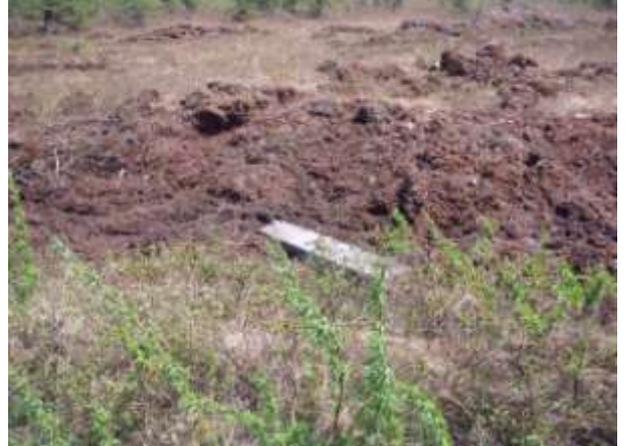
Photo 2 – Concrete blocks in situ

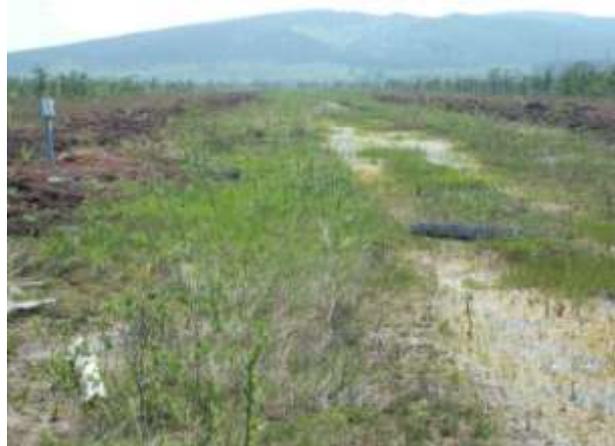
Photo 3 – Twin mounds over the pipelines

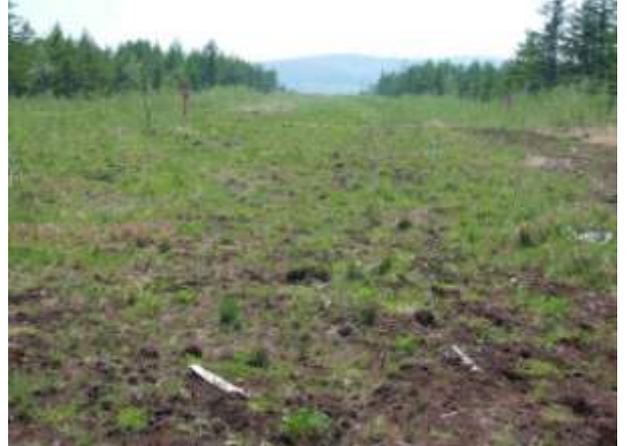
Photo 4 – Good re-vegetation on RoW

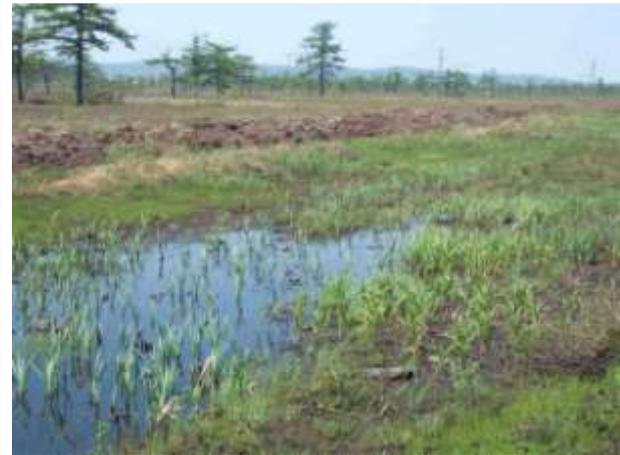
Photo 5 – Ponding due interrupted groundwater flow

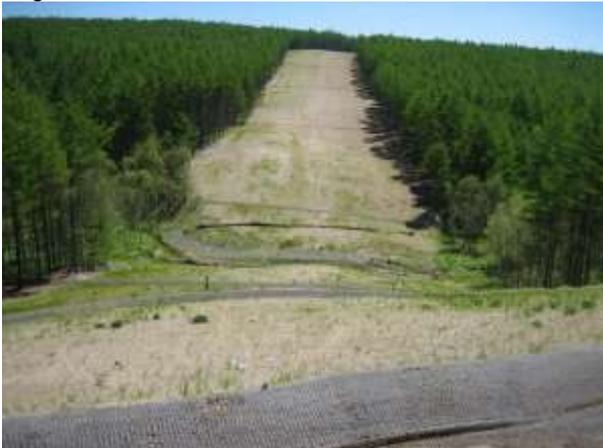
The river is protected with Reno matting and silt fences (Photo 1). The slopes have slope breakers, which held during last year's storms and the spring thaw. A location of subsidence was visible on the RoW between the pipes and was noted by the Company representatives.

Photo 1 – View south showing river crossing and slopes with slope breakers and very little vegetation

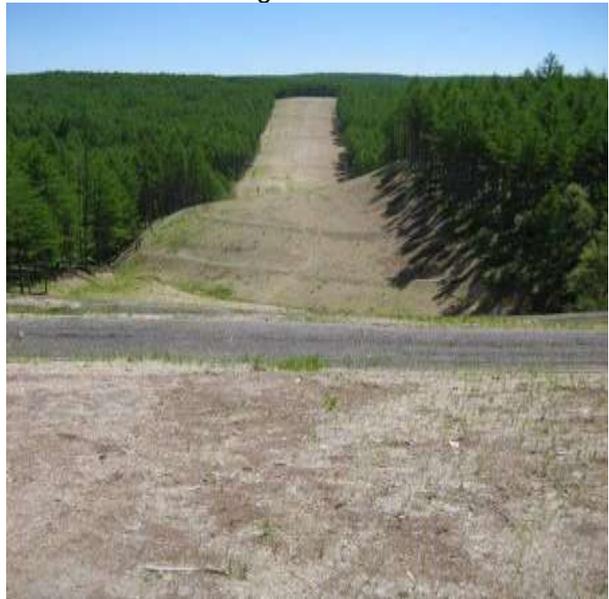
There is very little vegetation on the slopes and there is a need for additional bio-restoration to prevent future erosion (Photos 2 and 3). A flat portion of the RoW at the north side of the access road is well vegetated (Photo 4).

Photo 2 – Showing slopes with drainage control but with little to no vegetation.

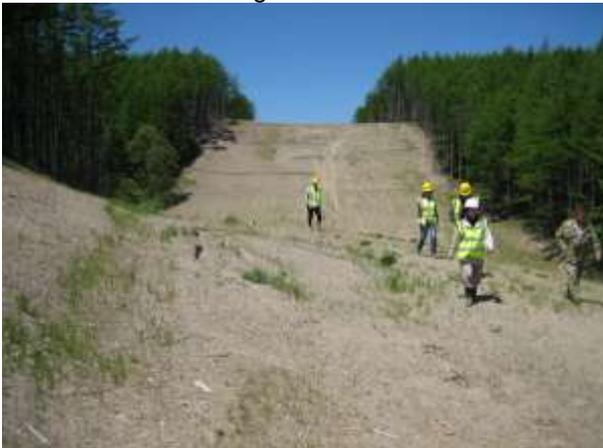
Photo 3 – Showing slopes with drainage control but with little to no vegetation

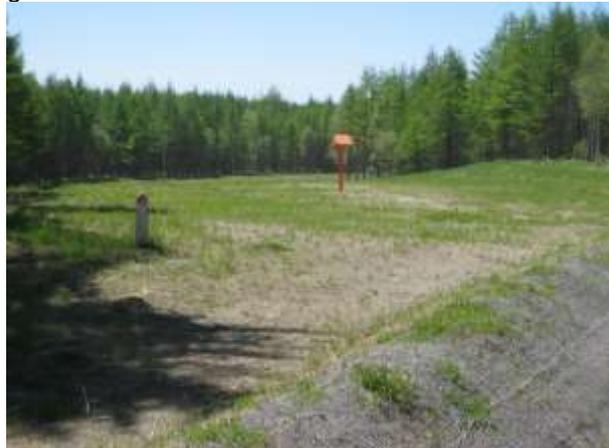
Photo 4 – Flat RoW near access road with good grass cover.

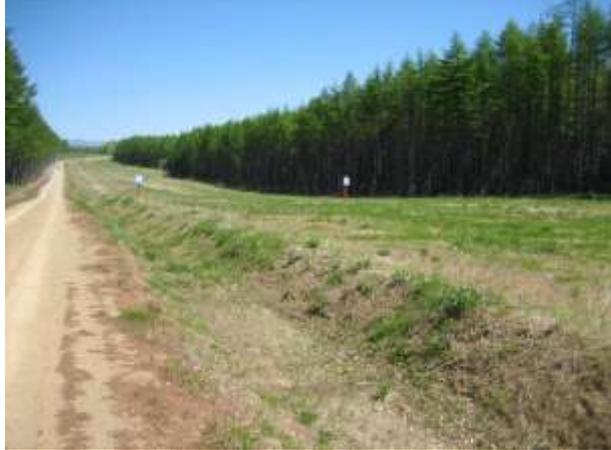
Photo 1 – RoW segment with good grass cover

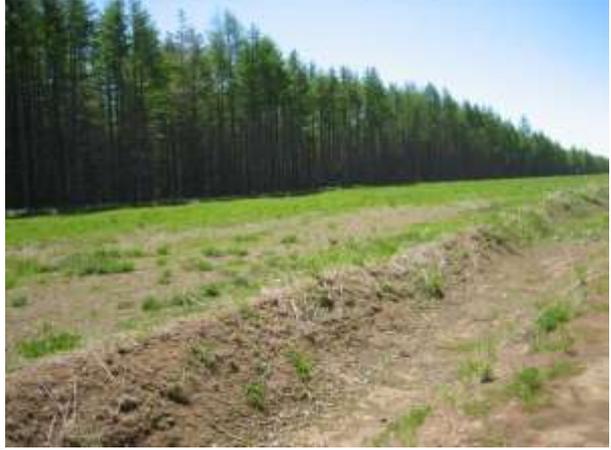
Photo 2 – RoW segment with good grass cover

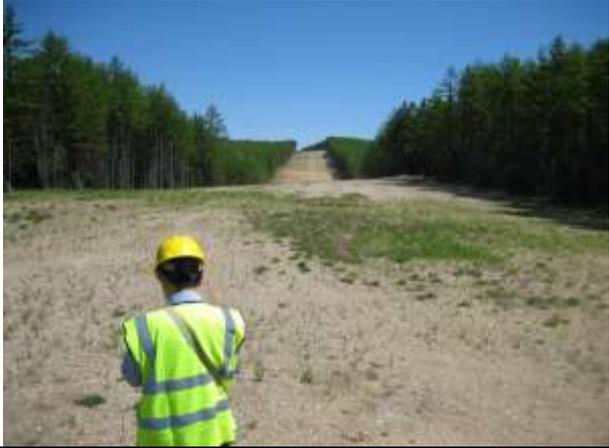
RoW segment at a forestry road crossing, showing poor grass cover. This location is in need of further seeding and application of fertilizer.

Photo 1 – RoW segment with poor grass cover

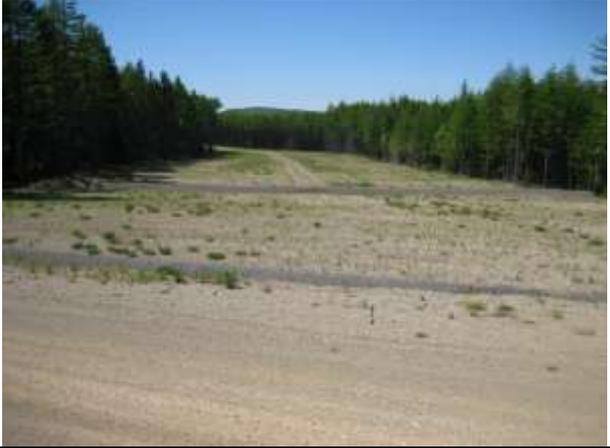
Photo 2 - RoW segment with poor grass cover

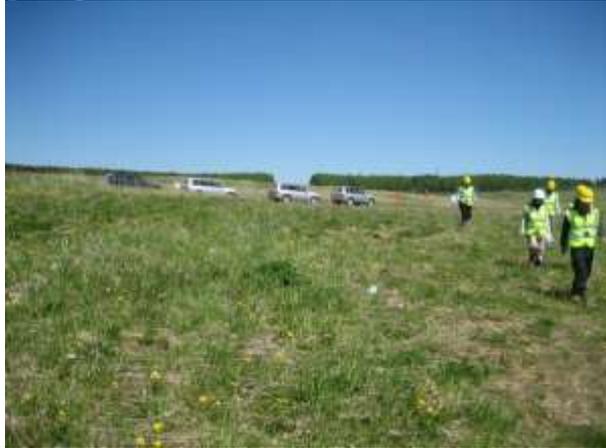
Photo 1 – View north at RoW segment with very good grass cover

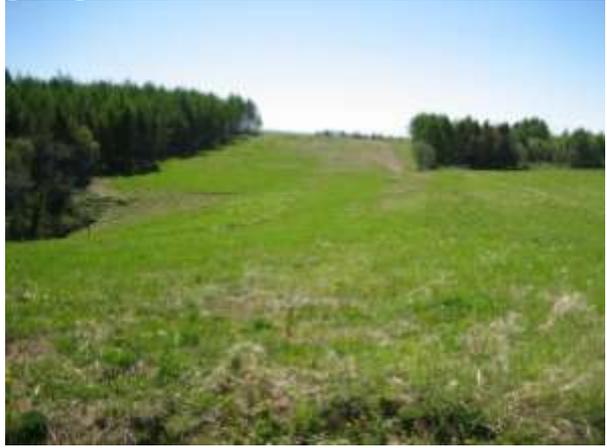
Photo 2 – View north at RoW segment with very good grass cover

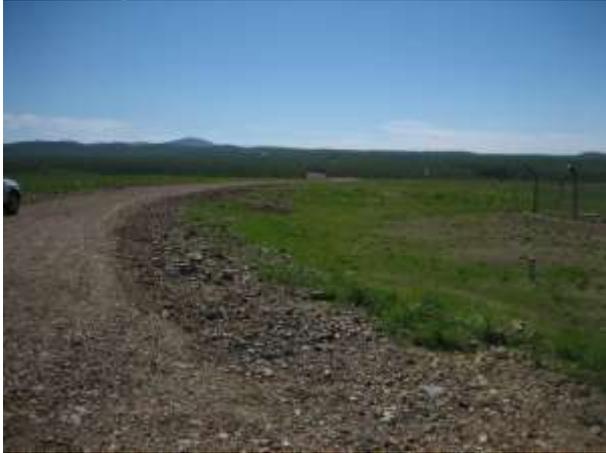
Photo 1 – View south showing permanent access road and good bio-restoration.

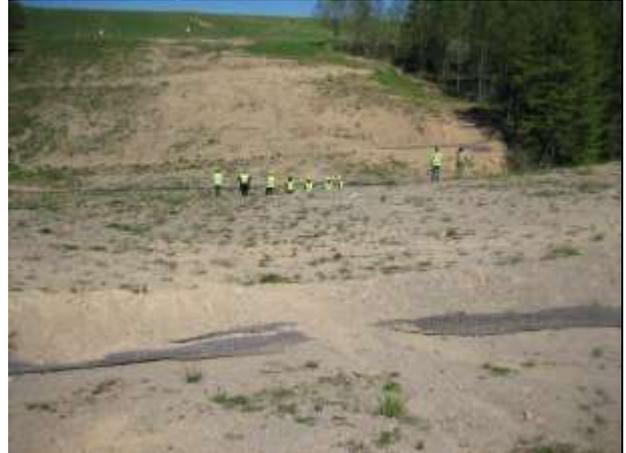
To the north of the BVS there is a crossing drainage protected by geo-jute and slope breakers. However the RoW in this segment has only spotty vegetation cover and is need of further bio-restoration (Photos 2 to 4).

Photo 2 – View of the ROW north of the block valve without grass cover.

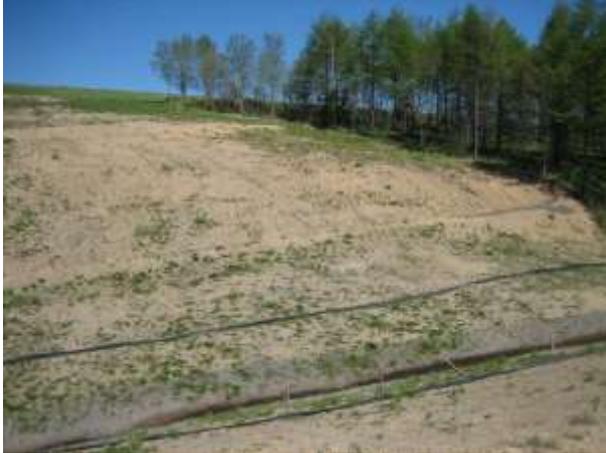
Photo 3 – View of a crossing drainage protected with geo-jute and slope breakers. However, poor grass cover.

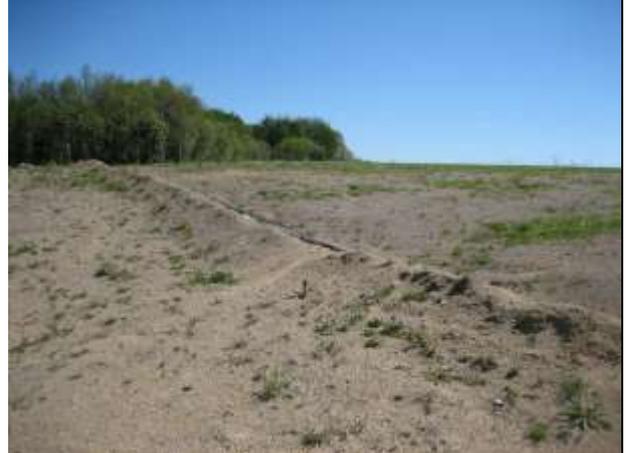
Photo 4 – Slope breaker on the south slope with minimal vegetation.

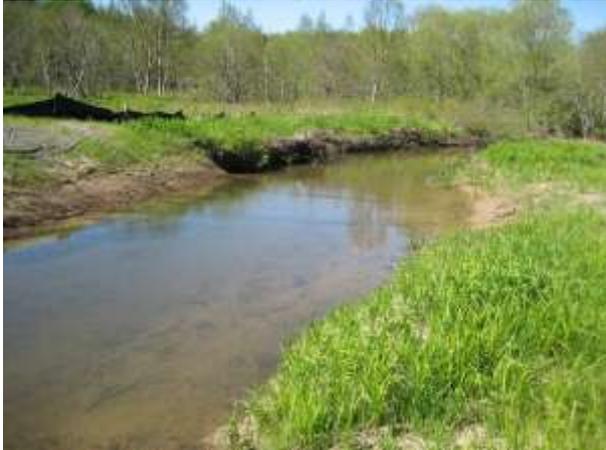
Photo 2 – View to the north showing river valley with good vegetation but slope without vegetation.

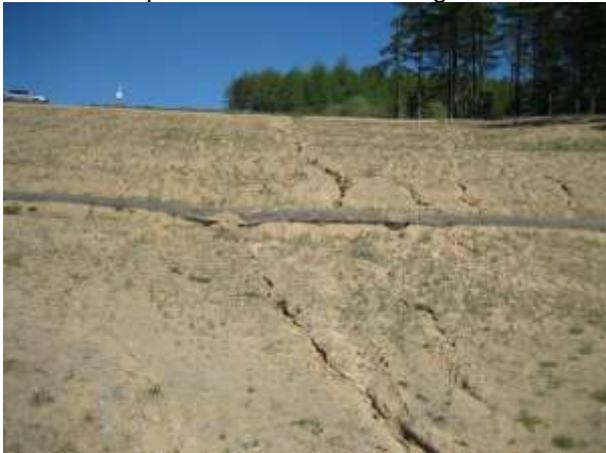
Photo 4 – View of deep erosional rill at mid slope

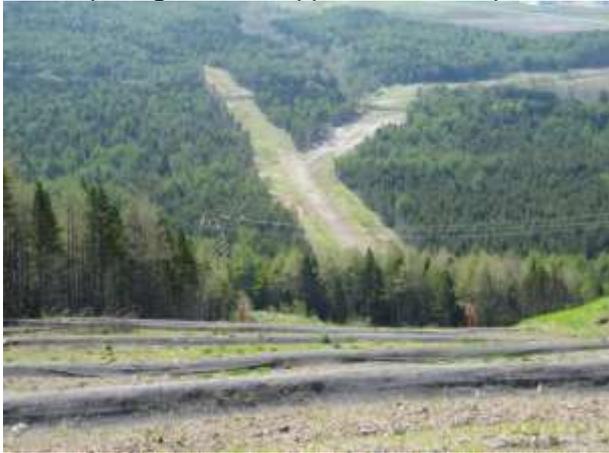
The RoW before and after the split has good vegetation cover and the slope from the BVS to the Mereya River valley is well protected with slope breakers (Photo 1). A view from the BVS to the north shows the RoW slopes protected with slope breakers but with poor vegetation cover (Photo 2).

Photo 1 – View south at the Mereya slope and the ROW splitting in two at approach to LNG plant.

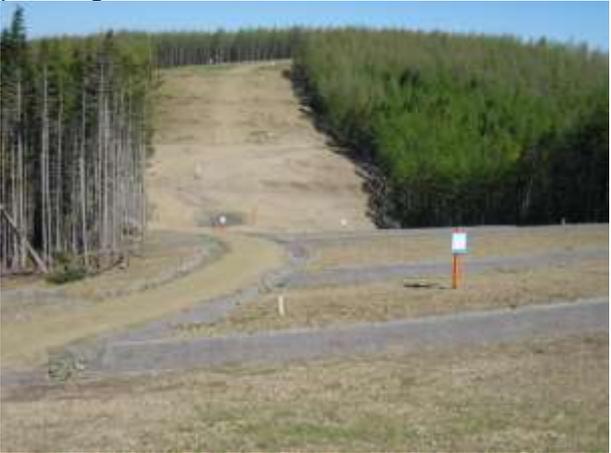
Photo 2 – View of RoW north of the BVS showing poor vegetation cover.

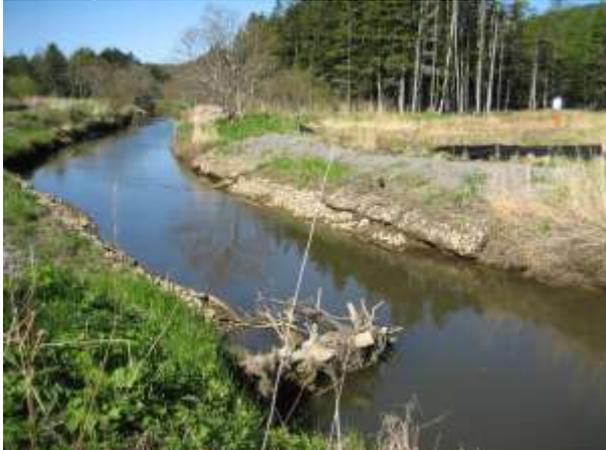
The Mereya River is crossed with two separated RoWs, one for the oil pipe (Photos 1 and 2) and one for the gas pipe (Photos 3 and 4). Both crossings are protected with Reno matting which fall short of the river bottom (photos 1 and 3). Company personnel noted this situation and reportedly it will be added to the maintenance schedule for repairs.

Photo 1 – View to north bank on oil pipe crossing showing Reno mats and some vegetation

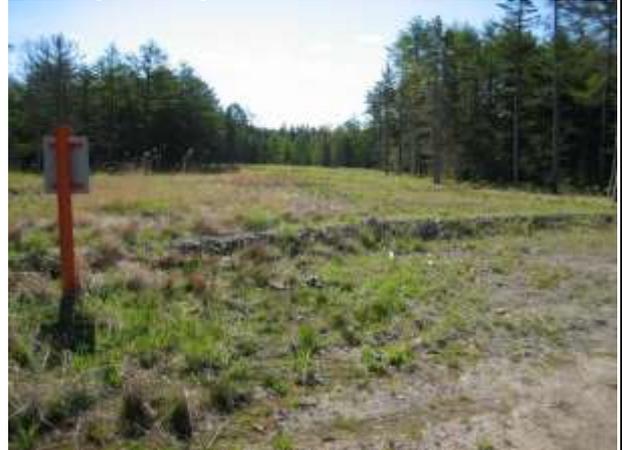
Photo 2 – View to the south from oil pipe crossing showing well vegetated RoW

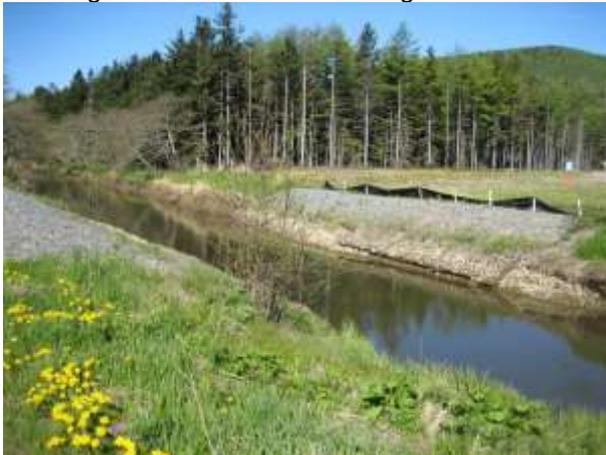
Photo 3 – View to north bank on gas pipe crossing showing Reno mats and some vegetation

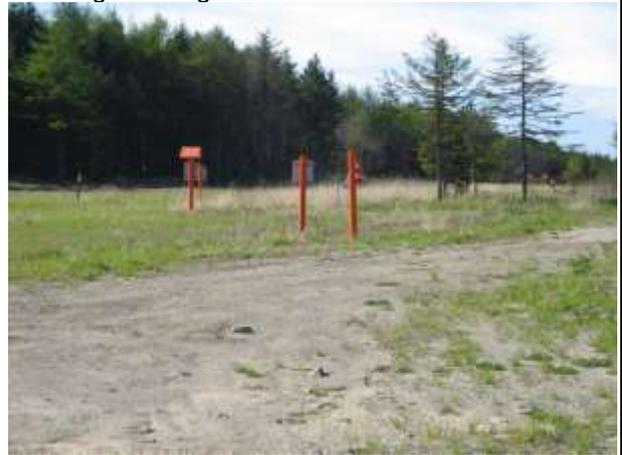
Photo 4 - View to the south from oil pipe crossing showing well vegetated ROW

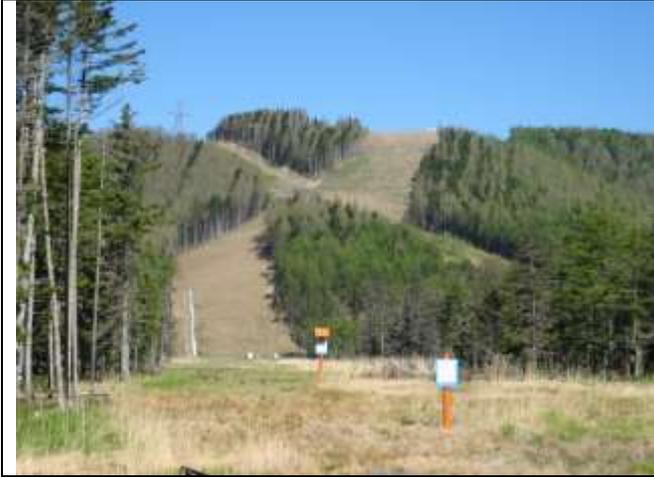
The RoW on both banks is well vegetated. The slope to the north of the valley is protected with many slope breakers and well vegetated (Photo 5).

Photo 5 – View to the north across the river crossing showing grass covered river valley and the slope protected with slope breakers and with vegetation.
